**COPLOWE BARN
BLETSOE
BEDFORDSHIRE**

ARCHAEOLOGICAL FIELD EVALUATION

Project: CB2227

Document: 2014/65
OASIS ref no: albionar1-172587

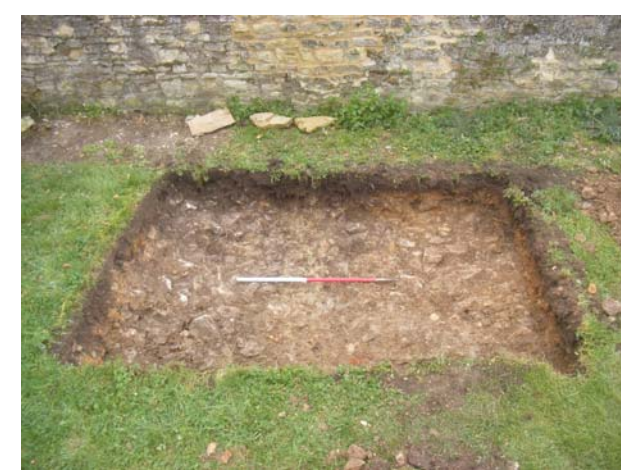
Trench 1 was investigated to a depth of 0.25–0.38m below the existing ground level.

Beneath topsoil (100), Trench 1 revealed the following stratigraphic sequence of deposits (from top to bottom):

In addition, a NW-SE aligned modern service trench [104], 0.4m wide and more than 0.2m deep, was cut from the base of the topsoil through all the above deposits.

Tr 1. Looking SE. Scale 1m

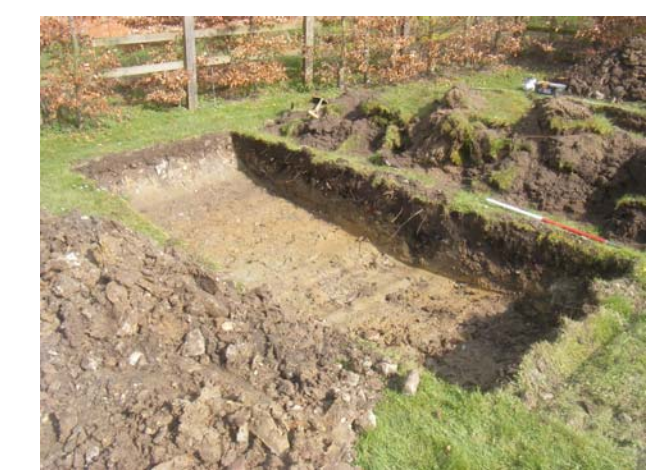
Trench 2 was investigated to a depth of 0.58m below the existing ground level.

A modern, NW-SE aligned sewage pipe trench [204] bisected Trench 2. It was more than 0.35m deep by 1.25m wide and was part of the same feature as [303] to the east.

Tr 2. Looking E. Scale 1m

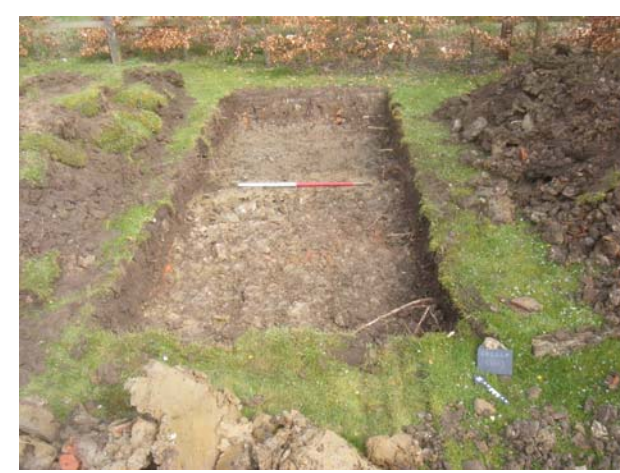
Tr 2. Looking NE. Scale 1m

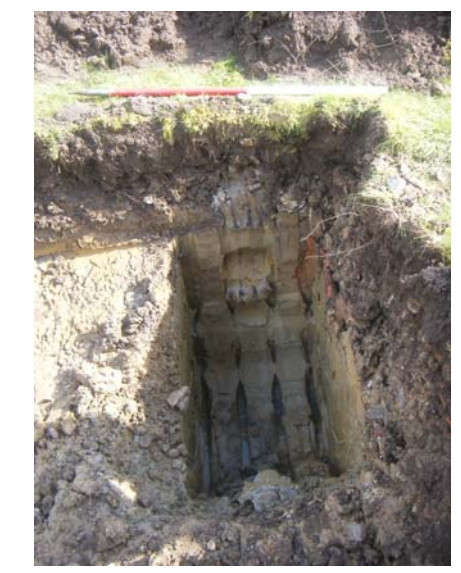
On completion of the archaeological fieldwork a geotechnical pit was machine-excavated in the south-eastern corner of Trench 2 to establish the nature of the underlying geological strata.

Geological deposits, comprising blue-grey silty clay with yellow-brown staining, were uncovered in Trench 2.

Tr 2. Geotechnical pit – looking SE. Scale 1m

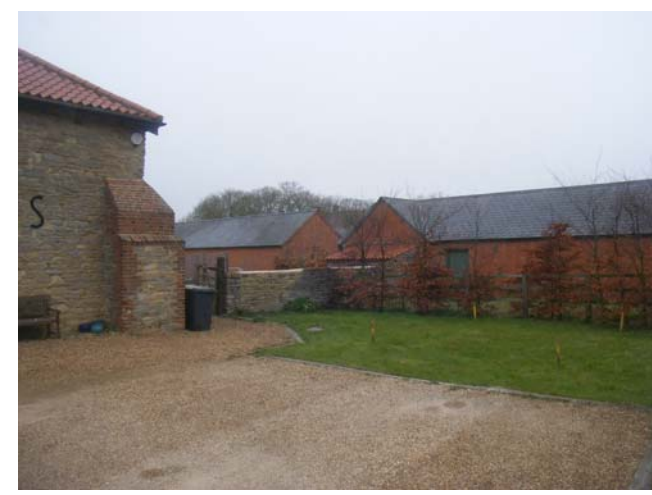
Pre-excavation – Trenches 2 and 3
