**LAND AT THE GLEBE
RADSTONE ROAD
BRACKLEY
NORTHAMPTONSHIRE**

**ARCHAEOLOGICAL EVALUATION AND
BUILDING RECORDING**

Project: GR2360
OASIS ref: albionar1-175549

Document: 2014/83
Version 1.0

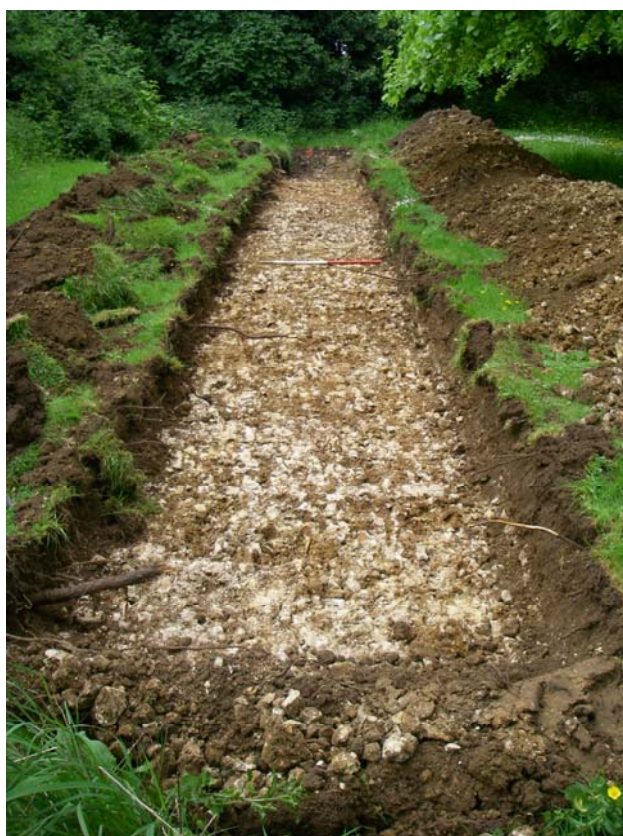
Figure 2b: Trench 4 in The Old Glebe grounds, looking east

The eastern end of Trench 4 revealed a modern rubbish pit filled with remains of plastic sheeting, bricks and fragmented timber (Figure 2b). The quarry pit marked on the 1884 OS map is still evident to the north of Trench 4 in the general topography of the site.

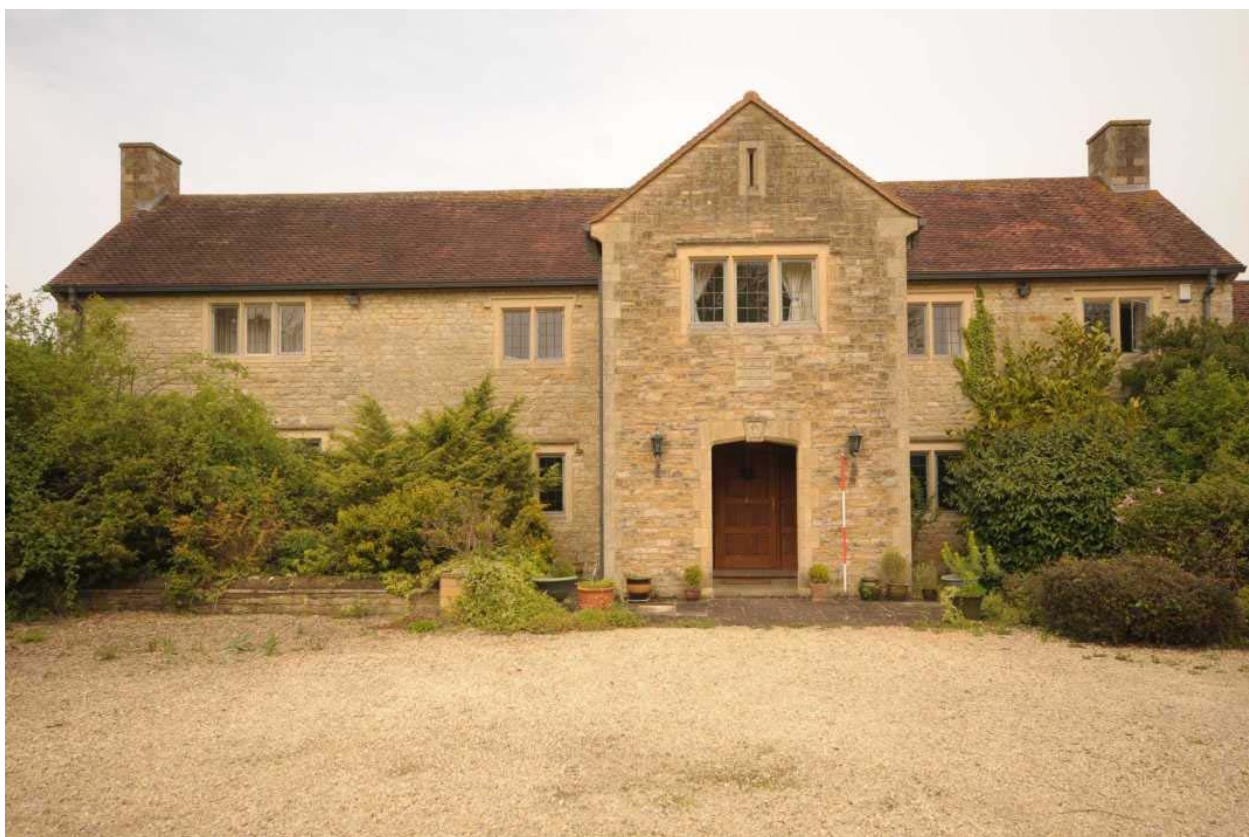
Figure 6: East-facing main façade of The Old Glebe

The residential wing of The Old Glebe lies along the western edge of the courtyard and consists of a two-storey building with a red tiled roof (Figure 6). It is built of golden limestone which is roughly shaped and hammer dressed and laid in regular courses. Two chimneys lie at either end of the main block.

The building has a central two-storey entrance porch facing the courtyard with a recessed main door and a central tri-partite window above. A shorter central porch lies on the opposing side of the building facing into the garden (Figure 7). It has double width doors on the ground floor and four windows with a top and bottom light separated by a stone transom. The corners of the two porches and the surrounds of the main doors are edged with ashlar.

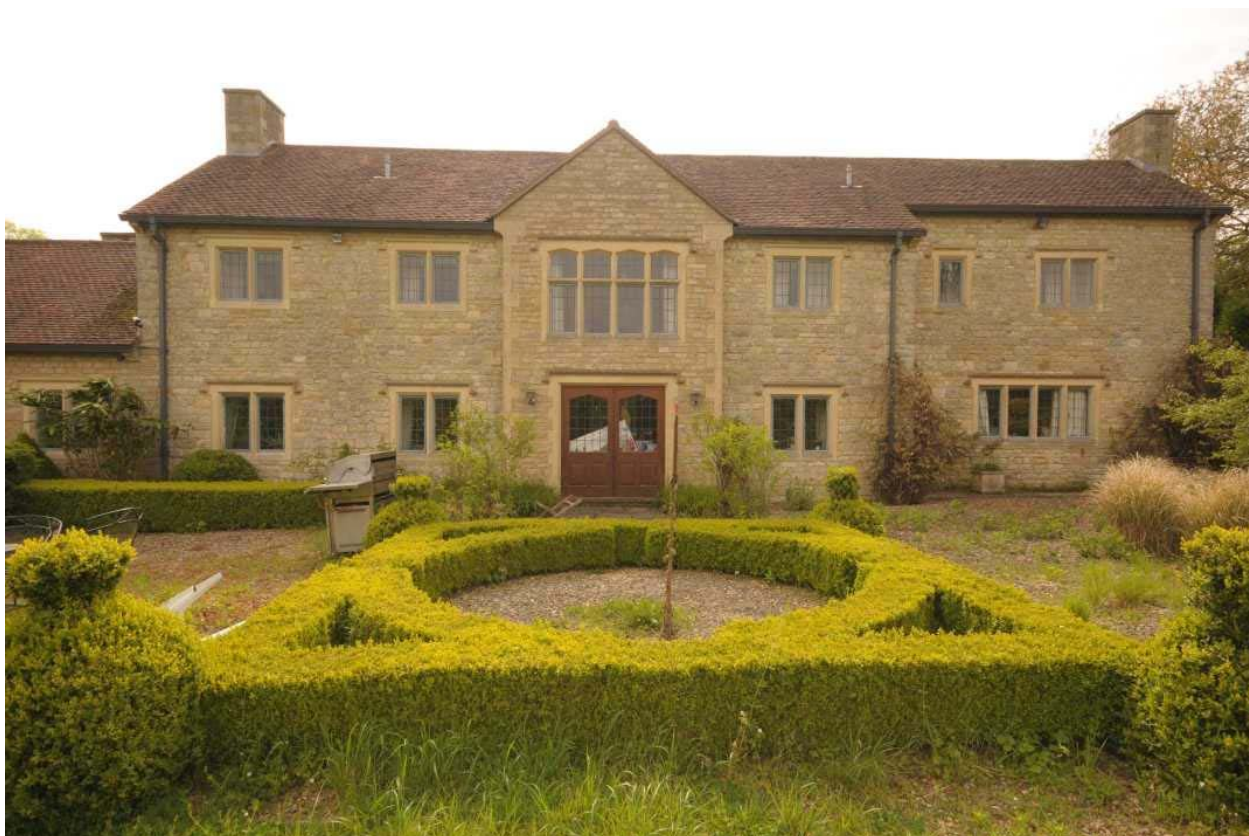
Figure 7: West-facing garden façade of The Old Glebe

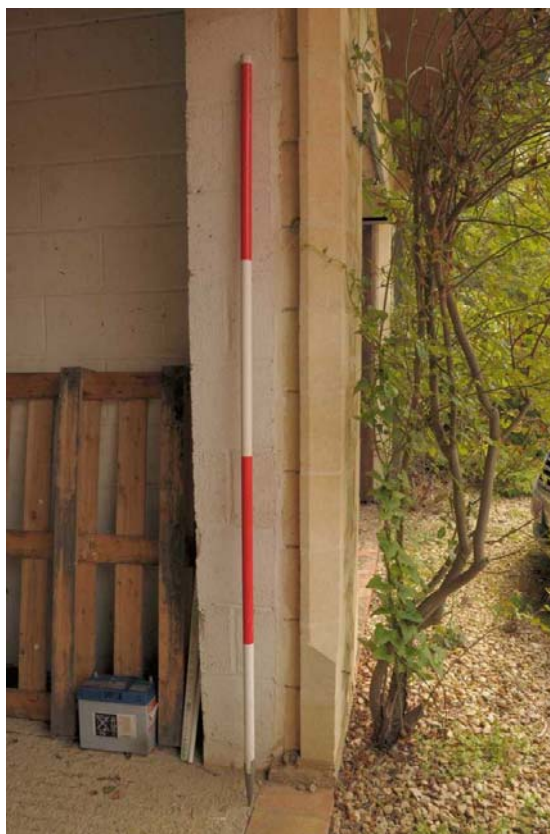
Figure 9: Breeze block and stone-clad construction of garage complex

The garage and utility wing lies along the northern side of the courtyard. It is one storey high and built in the same style with the same type windows and doors as the main wing. The eastern part of this wing has two large garage openings towards the courtyard. The garages are built with concrete breeze blocks with a cladding of golden limestone (Figure 9).

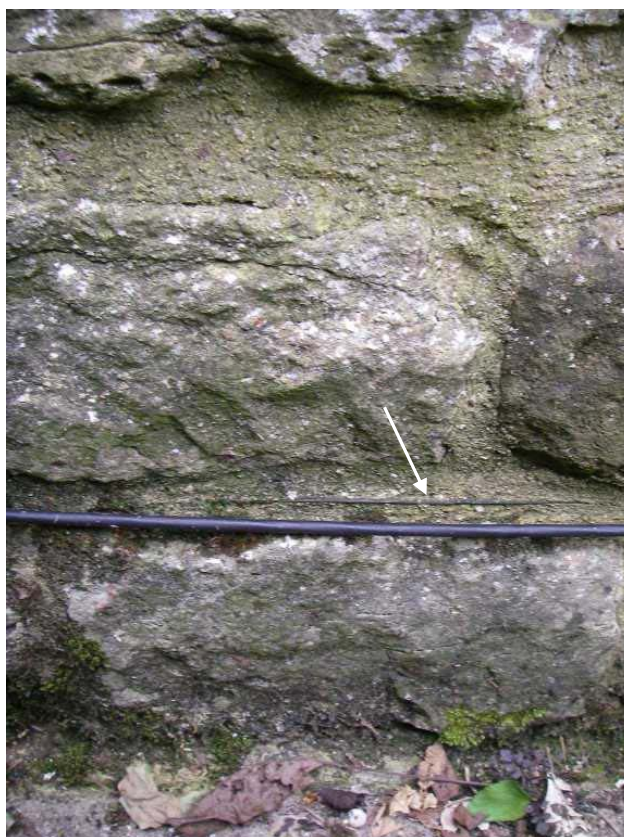
Figure 10: Damp course at base of building

A damp course along the porches, southern chimney and northern utility and garage complex shows that these were newly built in 1989. The OS map of 1991 shows the eastern porch for the first time. No damp course is visible in the main residential wing of the building at the western side of the courtyard, apart from underneath one of its windows (Figure 10) and it is possible that some of the original fabric of the barn survives in this wing. However, it is also likely that only the footprint of this building is original and anything from its lowest stone courses upwards was completely rebuilt in 1989.
