**THE GARDEN HOUSE  
BATTLEDEN  
BEDFORDSHIRE**

**ARCHAEOLOGICAL OBSERVATION  
INVESTIGATION, RECORDING, ANALYSIS AND  
PUBLICATION**

Project: GH2107  
Document: 2015/10  
Version 1.0

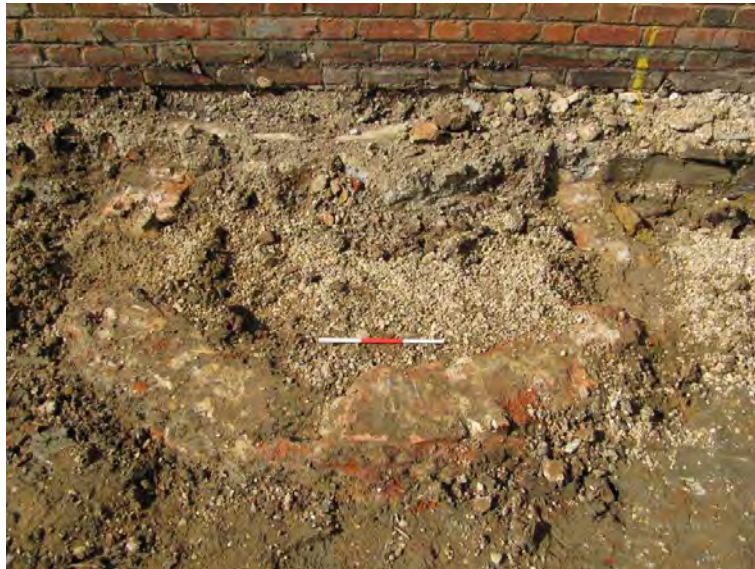
The upper 0.15m of a brick-lined well (11), 1.7m in diameter, was exposed beneath the existing paving slabs on the north-east side of the Garden House (see photograph on Figure 3). The brick lining lay partly beneath the foundations of the eastern extension to the house added in the 1980s. The well had been backfilled with grey-brown clay silt, stones and modern building rubble.

Brick-lined well [11] (30cm scale)

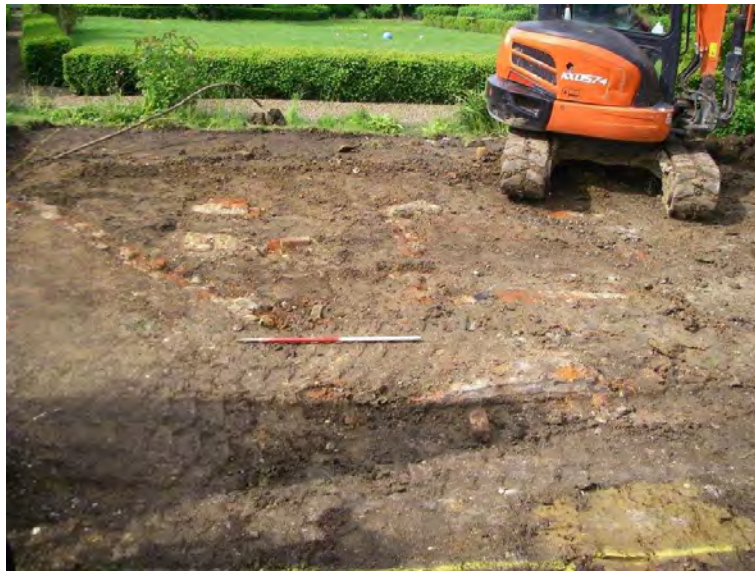
Narrow, insubstantial brick foundations measuring 0.10–0.2m wide were revealed following the removal of topsoil to the south of the Garden House. Some of these appeared to define the back and one of the end walls of a rectangular structure (29), measuring at least 12m long and 2m wide (see photograph on Figure 3). Its location indicates that it is likely to be the remnants of greenhouses marked on the OS first edition 25-inch map of 1881 (Figure 4). A line of brick pads is likely to define the south-west, glazed side, of the structure. All the brick foundations appeared to have been laid upon a layer of silty clay and building rubble (16) used to make-up and level the ground.

View of brick footings (29) revealed in the walled garden area (1m scale)

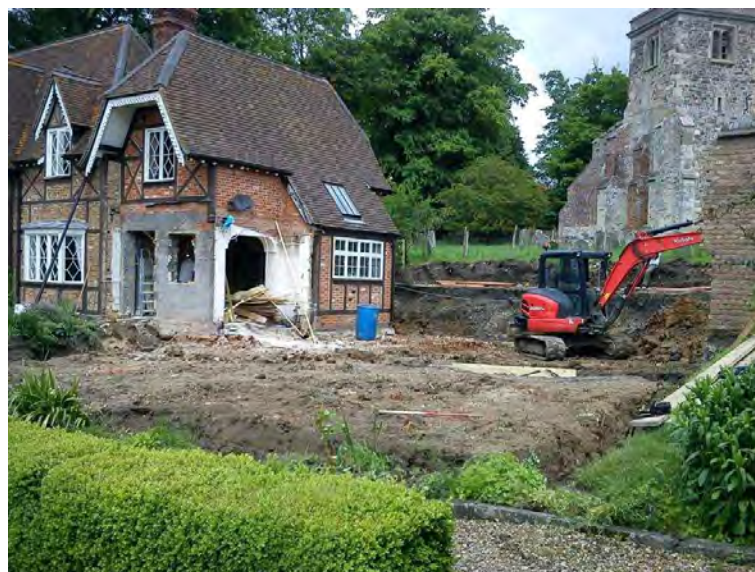
The depth and nature of the observed overburden varied throughout the groundworks. The existing building had been constructed on a level terrace cut back into the hillside. This meant that the ground immediately adjacent to the north-eastern side of the building had already been reduced by up to 1.5m below the natural ground. As a result, a steep scarp rose to the north-east of the house in the vicinity of its north corner and a brick retaining wall ran along the majority of the north-east side. Demolition of the retaining wall and subsequent ground reduction allowed the hillside deposits to be recorded (Figure 2, sections 1 and 2). These comprised a 0.2m-thick topsoil (1), overlying dark brown silty clay deposits (2) and (3) that were up to 1m thick. Containing small fragments of brick and tile, these deposits are likely to have been re-deposited after the construction of the house. The top of the underlying geological deposits (5) appeared to slope back into the hillside (Figure 2, section 2), which might indicate that there had previously been some ground reduction to the north-east of the house associated with landscaping of the grounds. Less ground reduction had taken place next to the northern corner of the house, where buried topsoil (9) and subsoil (10) deposits still survived beneath a 0.2m-thick layer of brick rubble and the existing, 0.2m-thick topsoil layer.

View of ground reduction to the south-east of the house (1m scale)

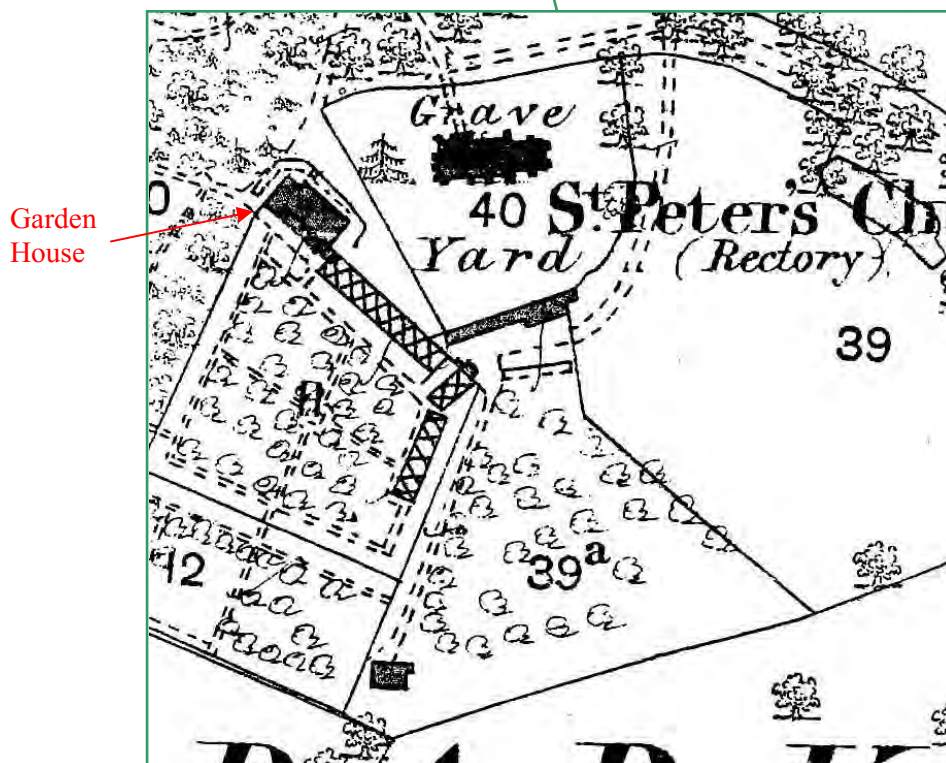
Figure 4: First edition 25-inch OS map 1881

Several brick structures were revealed during the groundworks; they are likely to be associated with the existing 19th-century Garden House. They include the brick footings of greenhouses marked on the OS 25-inch map of 1881 and a well lying near to the corner of the original 19th-century footprint of the house. As physical evidence of structures directly associated with the Grade II listed Garden House and Battlesden Park, these are potentially of regional significance.
