**CENTRAL BEDFORDSHIRE COLLEGE
KINGSWAY
DUNSTABLE
BEDFORDSHIRE**

**ARCHAEOLOGICAL OBSERVATION,
INVESTIGATION, RECORDING, ANALYSIS
AND PUBLICATION
&
STAGE 2 EVALUATION**

Document: 2016/75
Version: 1.0

Project: CBC2338
Museum accession no.: LUTNM: 2014/08
OASIS ID: albionar1-177009

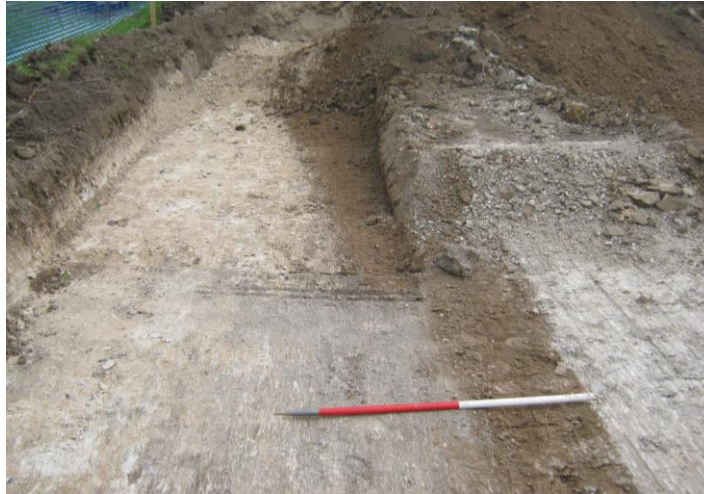
Figure 3: Area A photographs

Two parallel NE–SW aligned ditches [600] and [602], spaced c.12m apart, crossed the central and north-west parts of the area (Figures 2 and 3). Ditch [600] was traced for c.82m and ditch [602] for c.21m. An excavated section through ditch [602]¹ revealed an asymmetrical profile and a narrow flat base. The ditch was 1.5m wide and 0.58m deep; it contained four deposits that varied from mid-grey-brown silt to dark grey-brown sandy silt. No artefacts were recovered.

Roman ditch [600], looking NE (scale 1m)

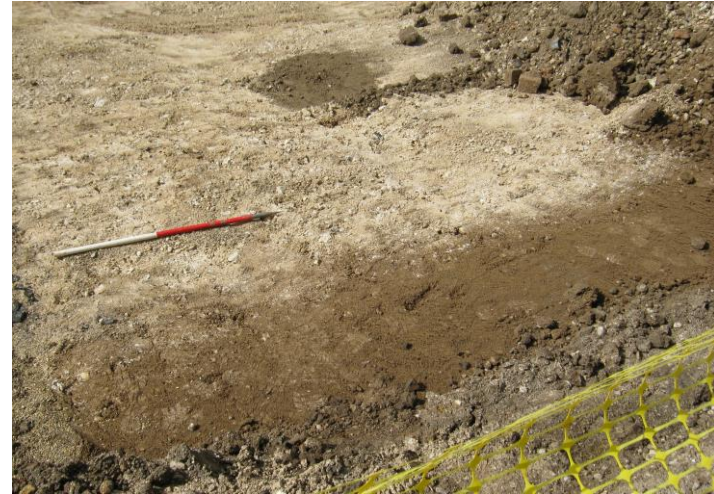
A small, circular pit [611], containing frequent modern brick fragments, was recorded within the path of the trackway.

Roman ditch [602] and modern pit [611], looking north (scale 1m)

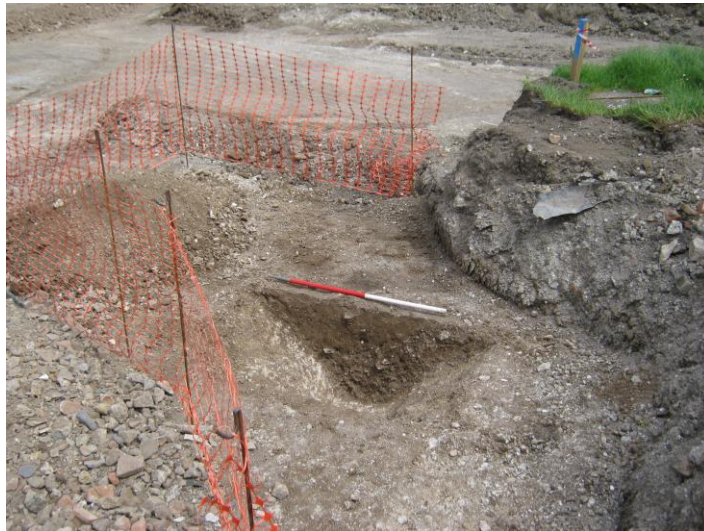
¹ Ditch [602] was also recorded as ditch [606] (see section on Figure 2).

Roman ditch [606], looking NE (scale 1m)

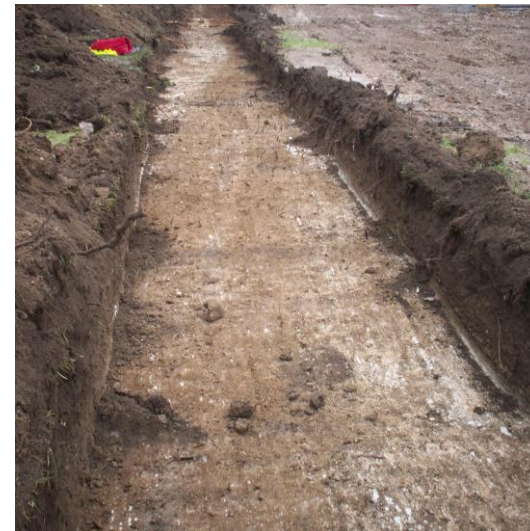
A third parallel ditch [604] was revealed to the north-west of the track. It ran for a distance of *c.*17m before turning to the west. This ditch had also been investigated during the trial trenching. No artefacts were recovered but its similar form to the trackway ditches suggests it is a related, contemporary boundary or enclosure ditch.

Roman ditch [604], looking NE

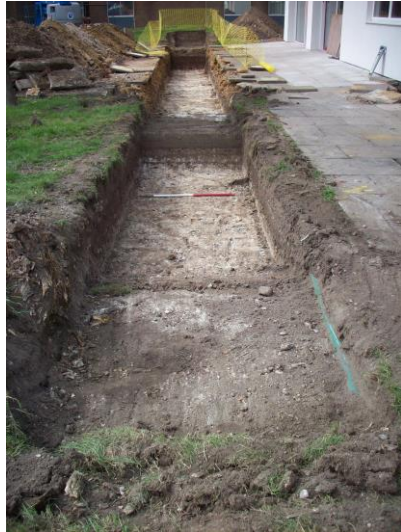
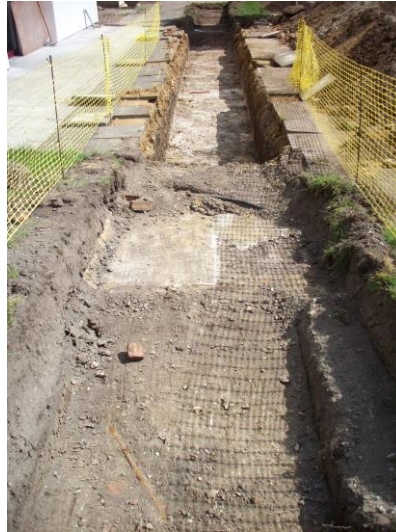
Figure 4: Areas B–E photographs

No archaeological features or deposits were present in Trench 5. Several NE–SW aligned, modern service trenches (associated with the college) crossed the trench.

Area B: Trench 5, looking NW
(scale 1m)

Area B: Trench 5, looking SE
(scale 1m)

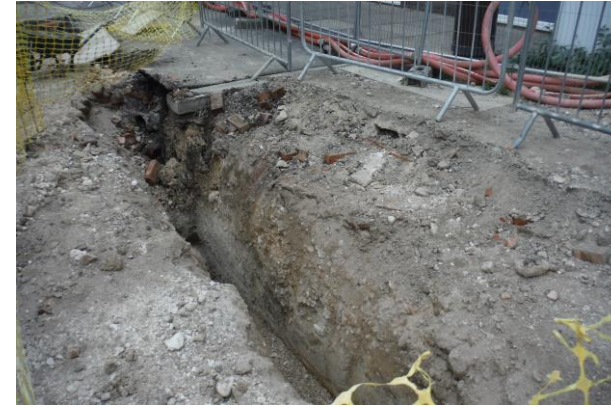
The pipe trenches were excavated through a 0.25m-thick demolition layer of loose modern brick rubble, which sealed undisturbed chalk bedrock. No archaeological features or deposits were present in either pipe trench.

Area C: pipe trench, looking south

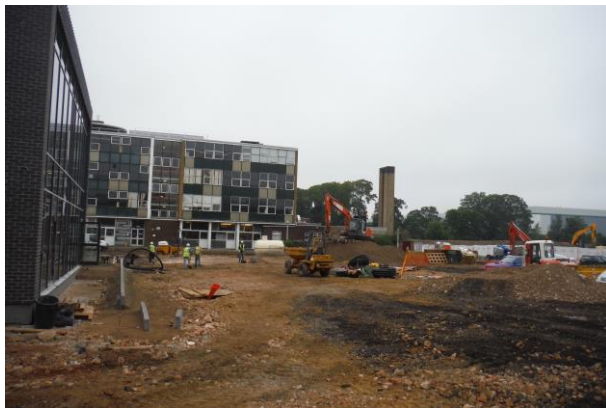
Area D had previously been occupied by a large college building and a layer of demolition rubble covered most of the area. In a few small isolated spots, the undisturbed chalk bedrock was exposed. No archaeological features or deposits were observed.

Area D: shallow stripped area, looking north

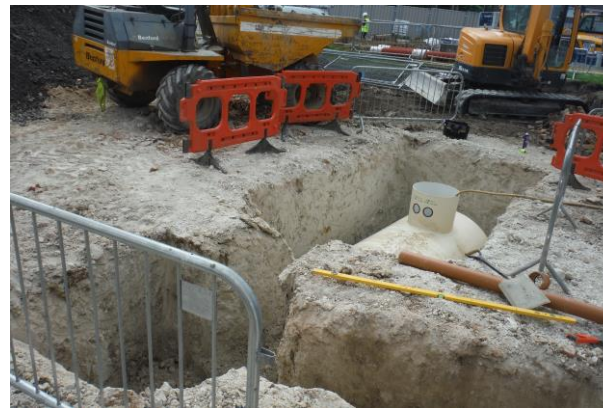
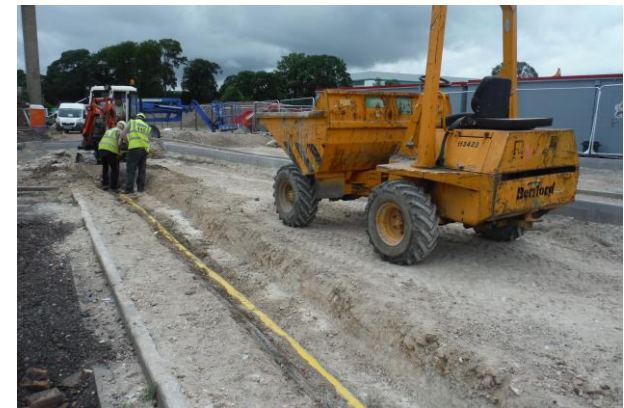
Area E contained a c.0.3m layer of demolition rubble that was removed to expose the chalk bedrock. No archaeological features or deposits were present within the building footprint or the other elements of ground reduction.

Area E: water-tank trench, looking SE

Area E: service trench, looking north
