**WEST COTTAGE
HINXWORTH ROAD
EDWORTH
BEDFORDSHIRE**

**ARCHAEOLOGICAL OBSERVATION,
INVESTIGATION, RECORDING, ANALYSIS
AND PUBLICATION**

Project: WC1891

Document: 2014/112

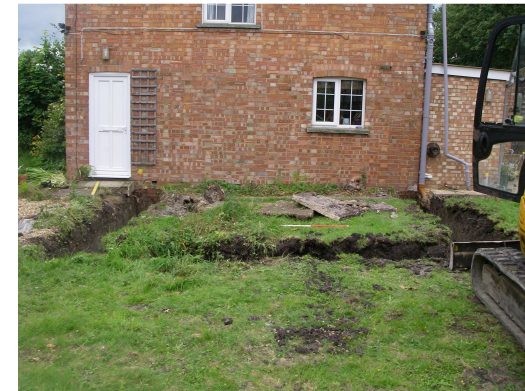
Image 1: General view of footing trench with gable end of West Cottage beyond

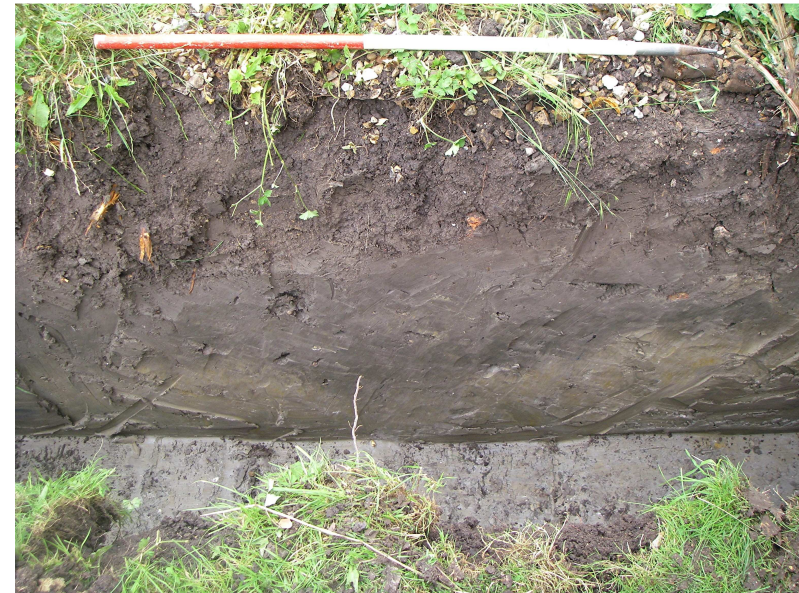
Examination of the northern footing trench revealed a ditch [5] beneath the buried cultivation soil aligned NNW-SSE (Figure 2, Image 2 and Section 1). The southern continuation of the ditch would have been beyond the eastern extent of the footing trench. The ditch was 1.1m wide, but as it crossed the footing trench obliquely, it appears wider in section. The ditch had a faceted profile, possibly suggesting recutting, though no evidence for this was apparent within the dark undifferentiated fill of the ditch. This fill would appear to have been derived from an unstable upper soil profile; it produced no artefacts.

Image 2: Oblique section through ditch [5], with a distinctive grey fill, contrasting with the lighter colour of the geological strata. Scale 1m in 50cm divisions.
