**HARROLD LOWER SCHOOL
THE GREEN
HARROLD
BEDFORDSHIRE**

**ARCHAEOLOGICAL OBSERVATION,
INVESTIGATION, RECORDING, ANALYSIS
AND PUBLICATION**

Document: 2014/181
Version: 1.0

Project Code: HLS2455
Bedford Museum accession no.: BEDFM 2014.52
OASIS ID: albionar1-185678

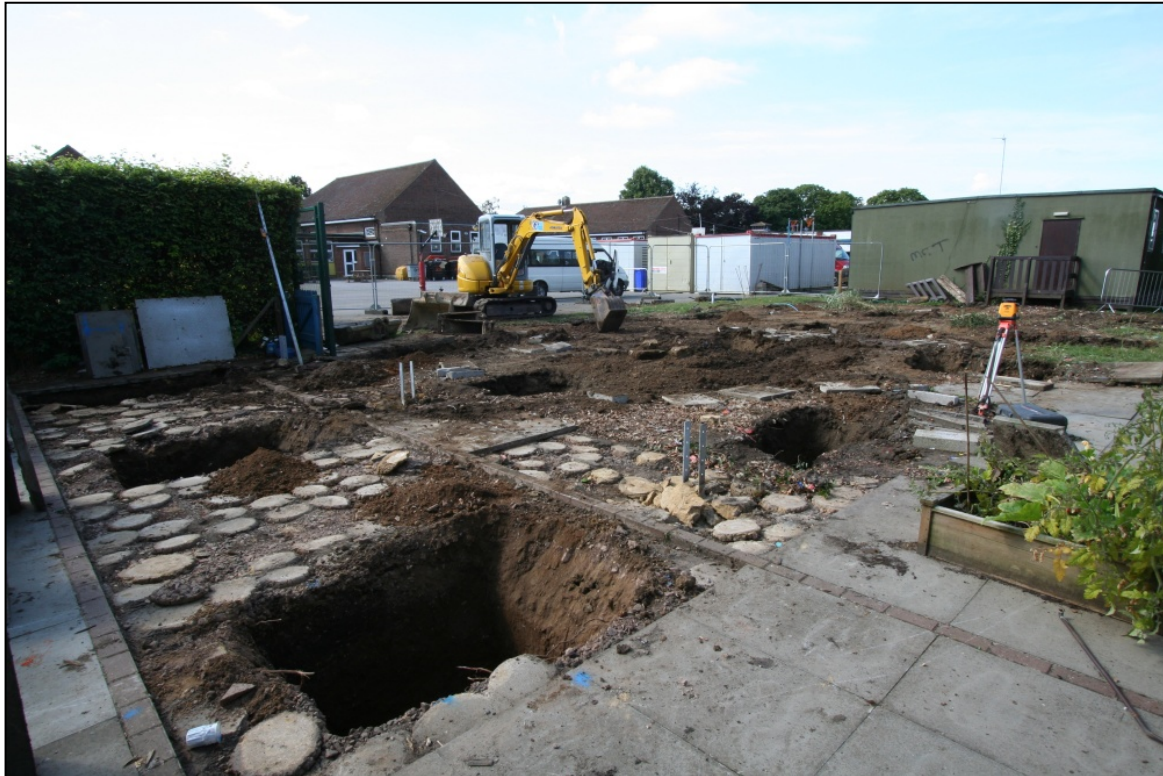
Figure 3: Area 1, view looking towards the south-west

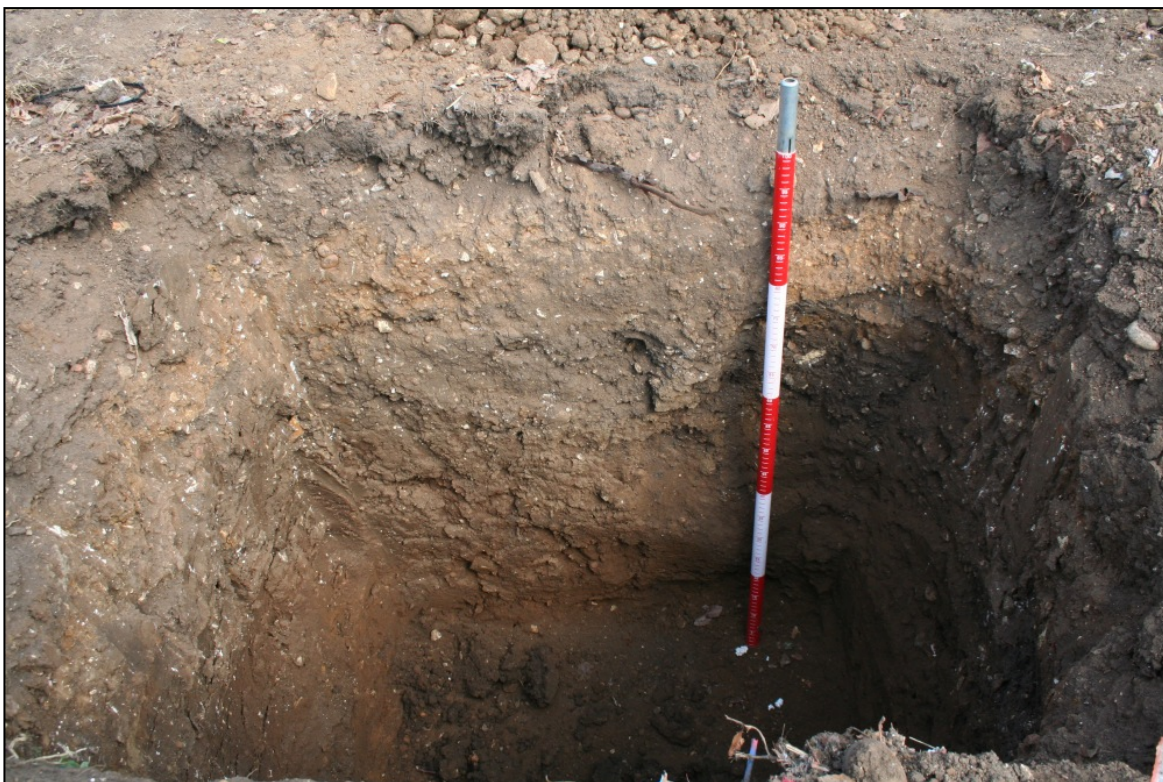
Figure 4: Area 1, Section B
(Photograph shows from the base: geological deposits, buried topsoil, made-ground and topsoil. Scale 1m)

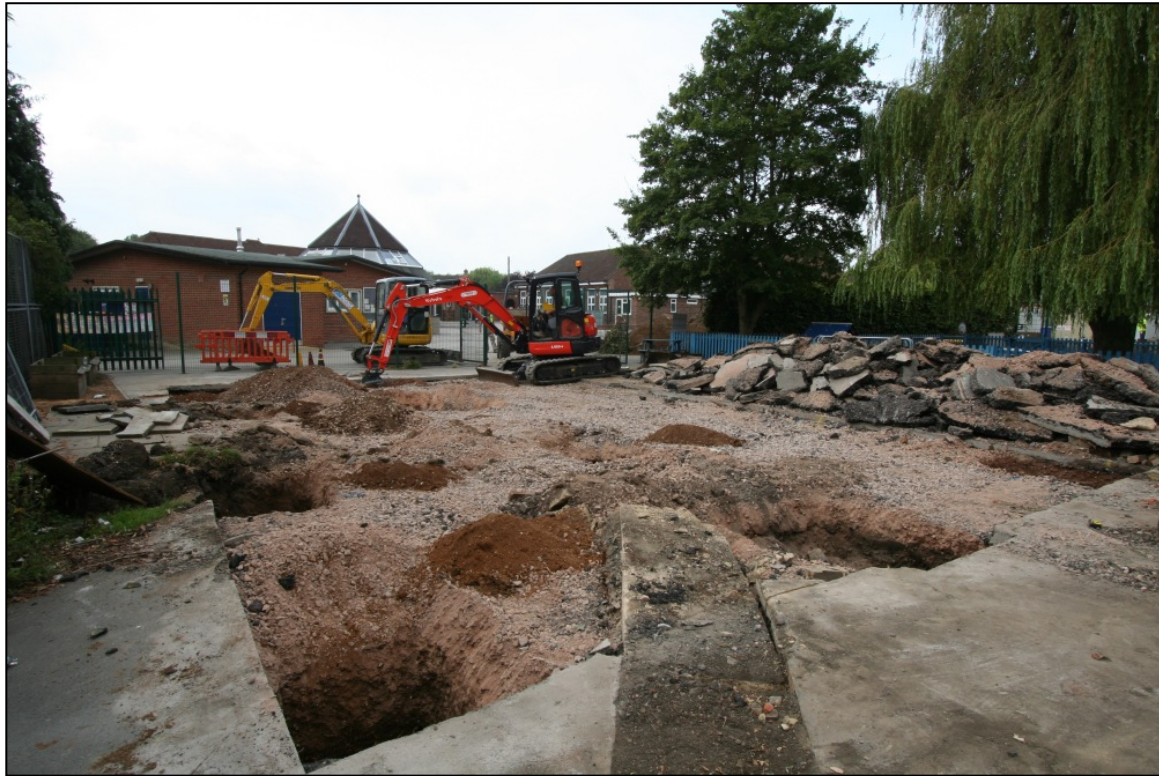
A large part of Area 2 contained remains of disused brick and concrete structures.

Foundation pits excavated across the western half of the area uncovered the extensive remains of a concrete slab which lay at a depth of 0.8m below the ground surface. The slab terminated at a curving brick wall towards the south end of Area 2. The upper parts of the wall had been demolished and the area above the slab filled with soil.

Figure 5: Area 2, view looking towards the south-west

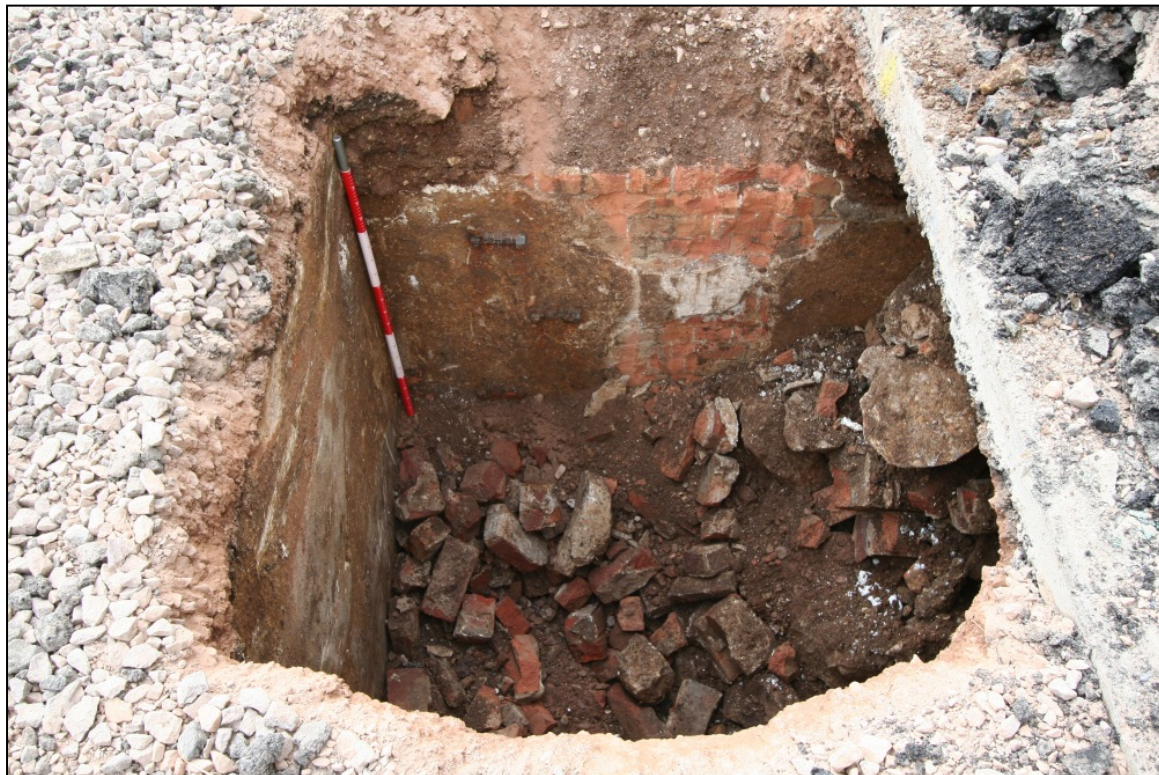
Excavation for one of the foundations on the west side of Area 2 uncovered a large brick-lined cistern. It was aligned ENE-WSW and extended beyond the development area towards the west. It was 1.4m wide and approximately 2.5m deep. It was constructed from red brick in English bond and had been lined with a layer of cement render. Cast iron rungs set in the brickwork in the south wall of the pit formed an access ladder. The disused feature had been filled with brick rubble which included some larger blocks of brickwork and fragments of concrete and other debris.

Figure 6: Area 2, brick-lined cistern
(Looking south. Scale 1m)
