**LAND AT ST JOHN'S CHURCH,  
ST JOHN'S STREET, BEDFORD**

**ARCHAEOLOGICAL FIELD EVALUATION**

Document: 2006/21  
Project: SJ1093

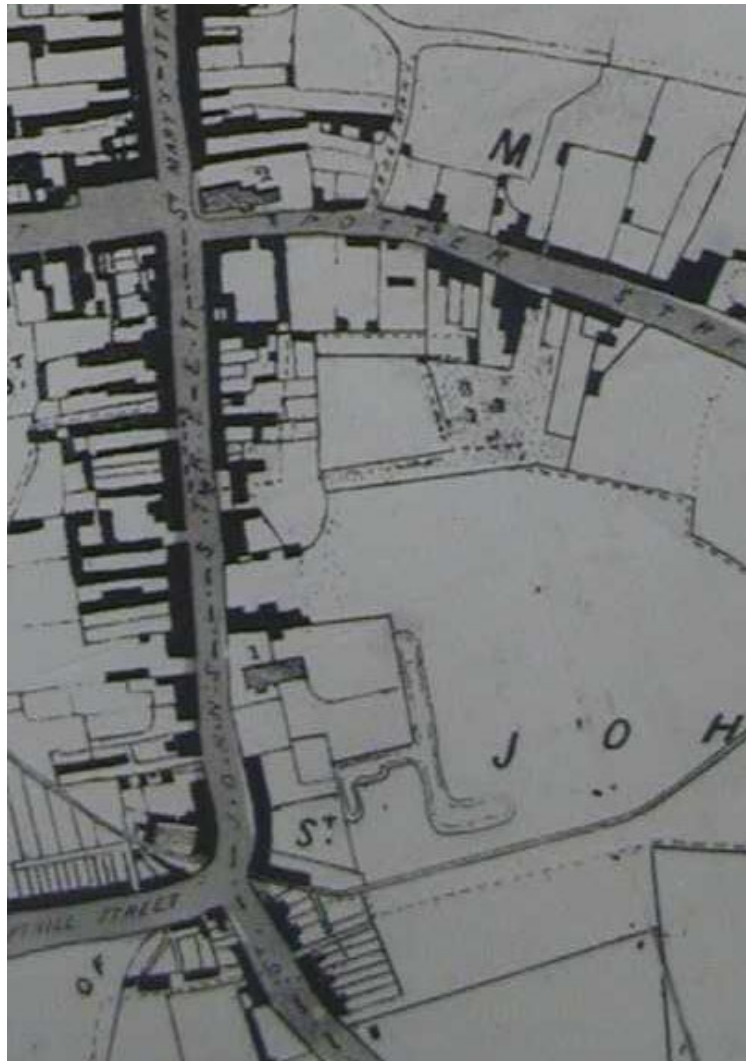
**Figure 5:** The ponds south-east of St John's Church, depicted on the Dewhurst & Nichol map of 1836

Surviving earthworks on land between the church and the King’s Ditch are thought to be the remnants of a series of large ponds that were first recorded on Dewhurst & Nichol’s map of Bedford in 1836 (Figure 5). The evidence indicates that they were definitely in existence during the post-medieval period, but it has been suggested that they could be the remains of medieval fish ponds contemporary with the working life of St. John’s Hospital<sup>6</sup>. On the eastern side of the site the earthworks appear to be relatively well preserved, indicating that there has been little disturbance of the land subsequently. However, the ponds depicted on the southern boundary of the site on the 1884 1<sup>st</sup> edition OS map (Figure 7) are no longer visible and are reported to have been deliberately backfilled in the 1970s.

Trenches 1, 2, 3 and 4 located the remains of two of the large ponds which were probably those depicted on the Dewhurst & Nichol map of 1836 (see Figure 5). These ponds appeared to post-date the site-wide levelling discussed above, but the 'cuts' may alternatively be the naturally steep banks of the ponds. As the basal fills of the ponds were not investigated there is no corroborative dating evidence from them. Also, the edges observed during the evaluation may not be the original edge of the ponds, as constructed, and may have been created by later remodelling, natural erosion or collapse of the sides (especially in Trench 1, where the edge of the pond extends further north than is shown on the historical maps). More precise evidence for the date of construction may possibly have been obtained by examining the basal fills of the ponds, but it was not possible to do this as part of the recent evaluation.

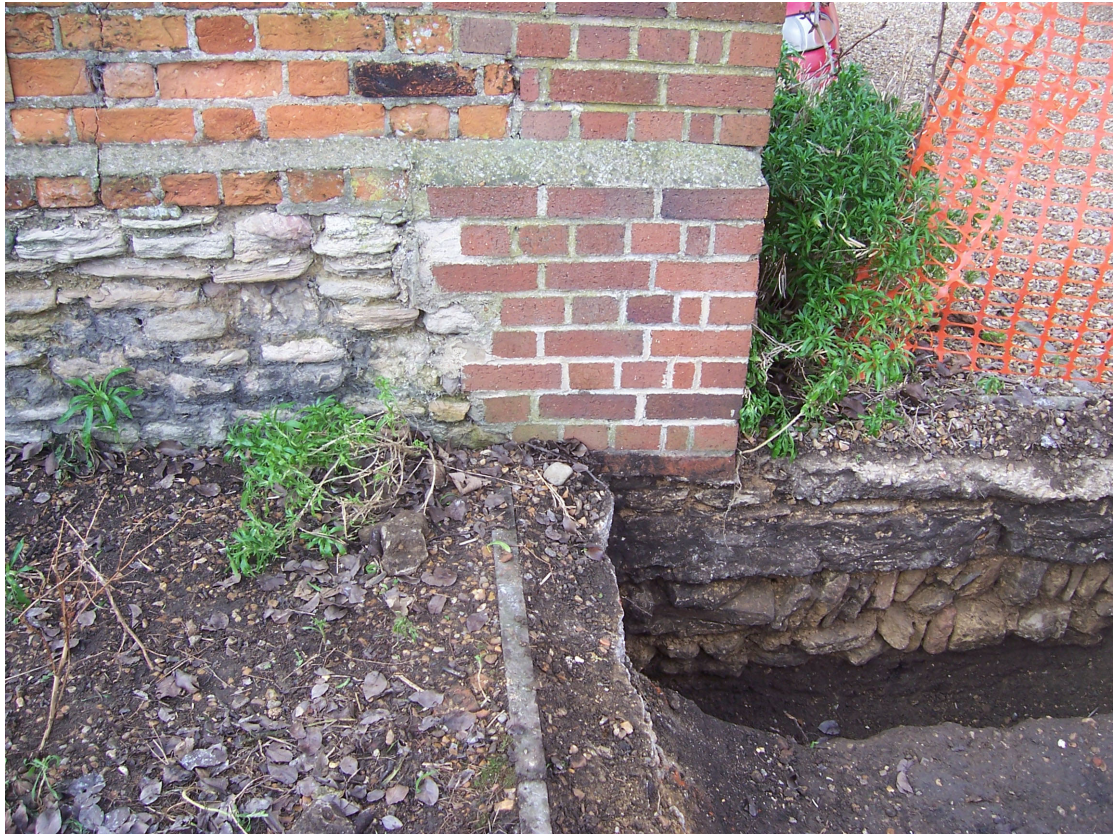
**Figure 8:** Foundation of wall in Trench 5 in context with upstanding wall

The wall was exposed to a depth of 0.5m (Figures 3, 8 and 9). It consisted of two possible phases [47] and [54]. The lower part of the wall [47] consisted of three courses of sandstone blocks. The stones of the lower two courses measured an average of 200 x 50mm in width and formed two distinct but irregularly built courses. The majority of the sandstone blocks of the lower courses were pitched on their edges, a method commonly used for foundations. The top course of wall [47] was made up of two very large, rectangular, horizontal slabs of sandstone, each of which measured 1000mm wide by 50mm thick. The upper part of the wall [54] consisted of smaller and exclusively horizontally laid blocks of sandstone measuring 200 x 50mm and 150 x 30mm. A modern rebuild in red brick [55] was built on top of [54].

The evidence from Trench 5 suggests that the wall to the rear of the existing church hall is post-medieval in origin. It appears to post-date the site-wide levelling. The wall is also first recorded on the Bedford map of 1836 and could, therefore, be contemporary with the construction of the ponds. A suggested medieval date and association of the wall with the medieval hospital of St John's is unlikely<sup>9</sup>.
