**THE CHURCH OF ST PETER
SHARNBROOK
BEDFORDSHIRE**

**A PROGRAMME OF ARCHAEOLOGICAL
INVESTIGATION, RECORDING,
ANALYSIS AND REPORTING**

Document: 2005/31
Project: SPS 1076

27th May 2005

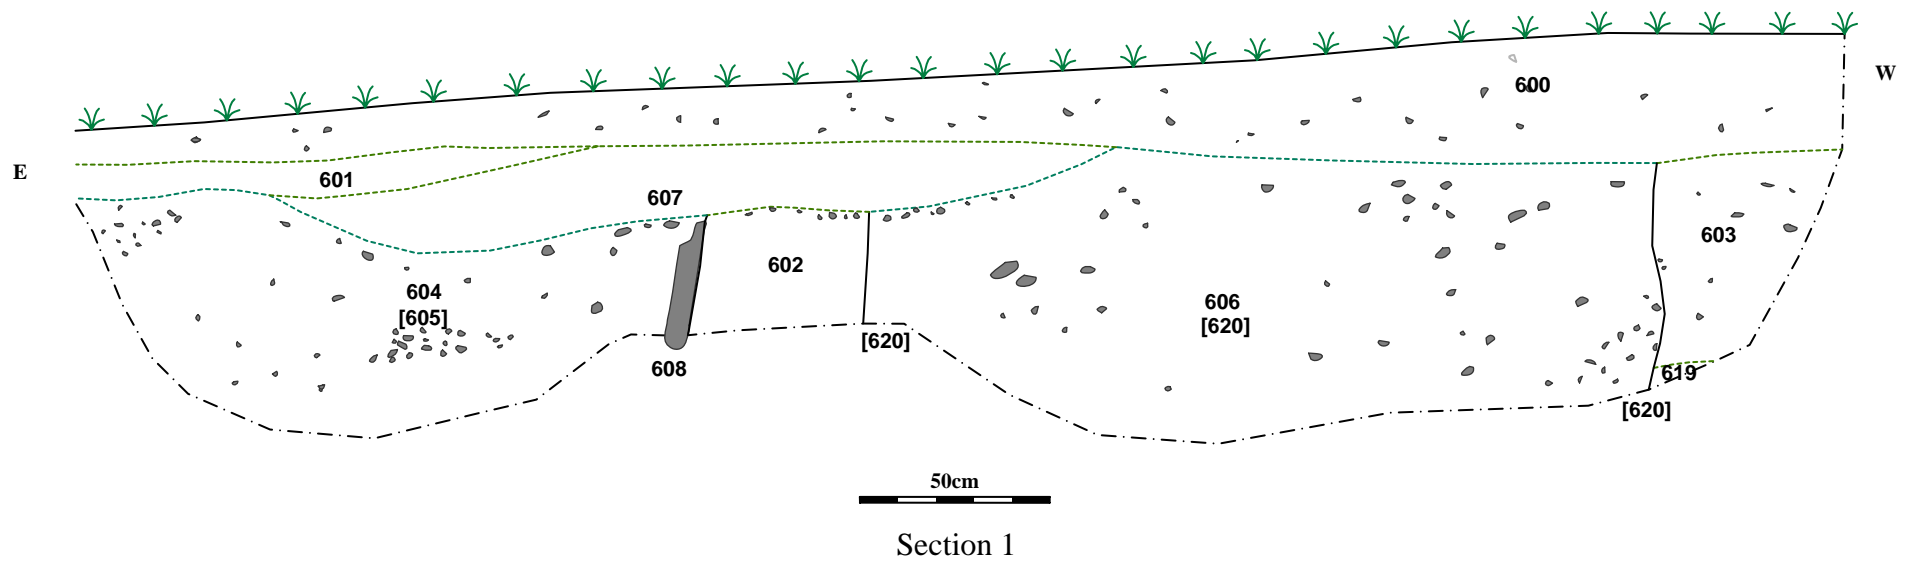
Figure 4: Section of Trench 6

Trench 6 was approximately 1.4m wide and 5m long, sampling 5% of the development area. It was located in order to assess the archaeological potential of the area within the footprint of the new extension (Figures 2 and 4).

Topsoil (600), was c.0.3m in depth and overlay graveyard subsoils (601) and (607) both c.0.4m in depth. Two further graveyard subsoils (602) and (603) lay below (607). Both were 0.35m in depth and sealed the undisturbed geological deposit (619) (Figure 4).

2.4.2 Graves (Figures 2 and 4)

Four graves [605], [620], [611] and [609] were observed below graveyard subsoils (601) and (607). They were aligned E to W and ranged in length from 2.10m to 1.25m. These had definitely been cut through graveyard subsoils (602) and (603) and may also have truncated 601 and 607, although it was not possible to discern this. Two graves [609] and [611] intercut each other suggesting at least two phases of burial activity within this group.

Skeletal remains (608) and (617) were observed in graves [605] and [609] respectively. These were recorded at a depth of c.1.0m below ground level (c.59.20m AOD). Due to their relatively shallow position in relation to the present ground level, it is thought that these graves are also medieval in date.

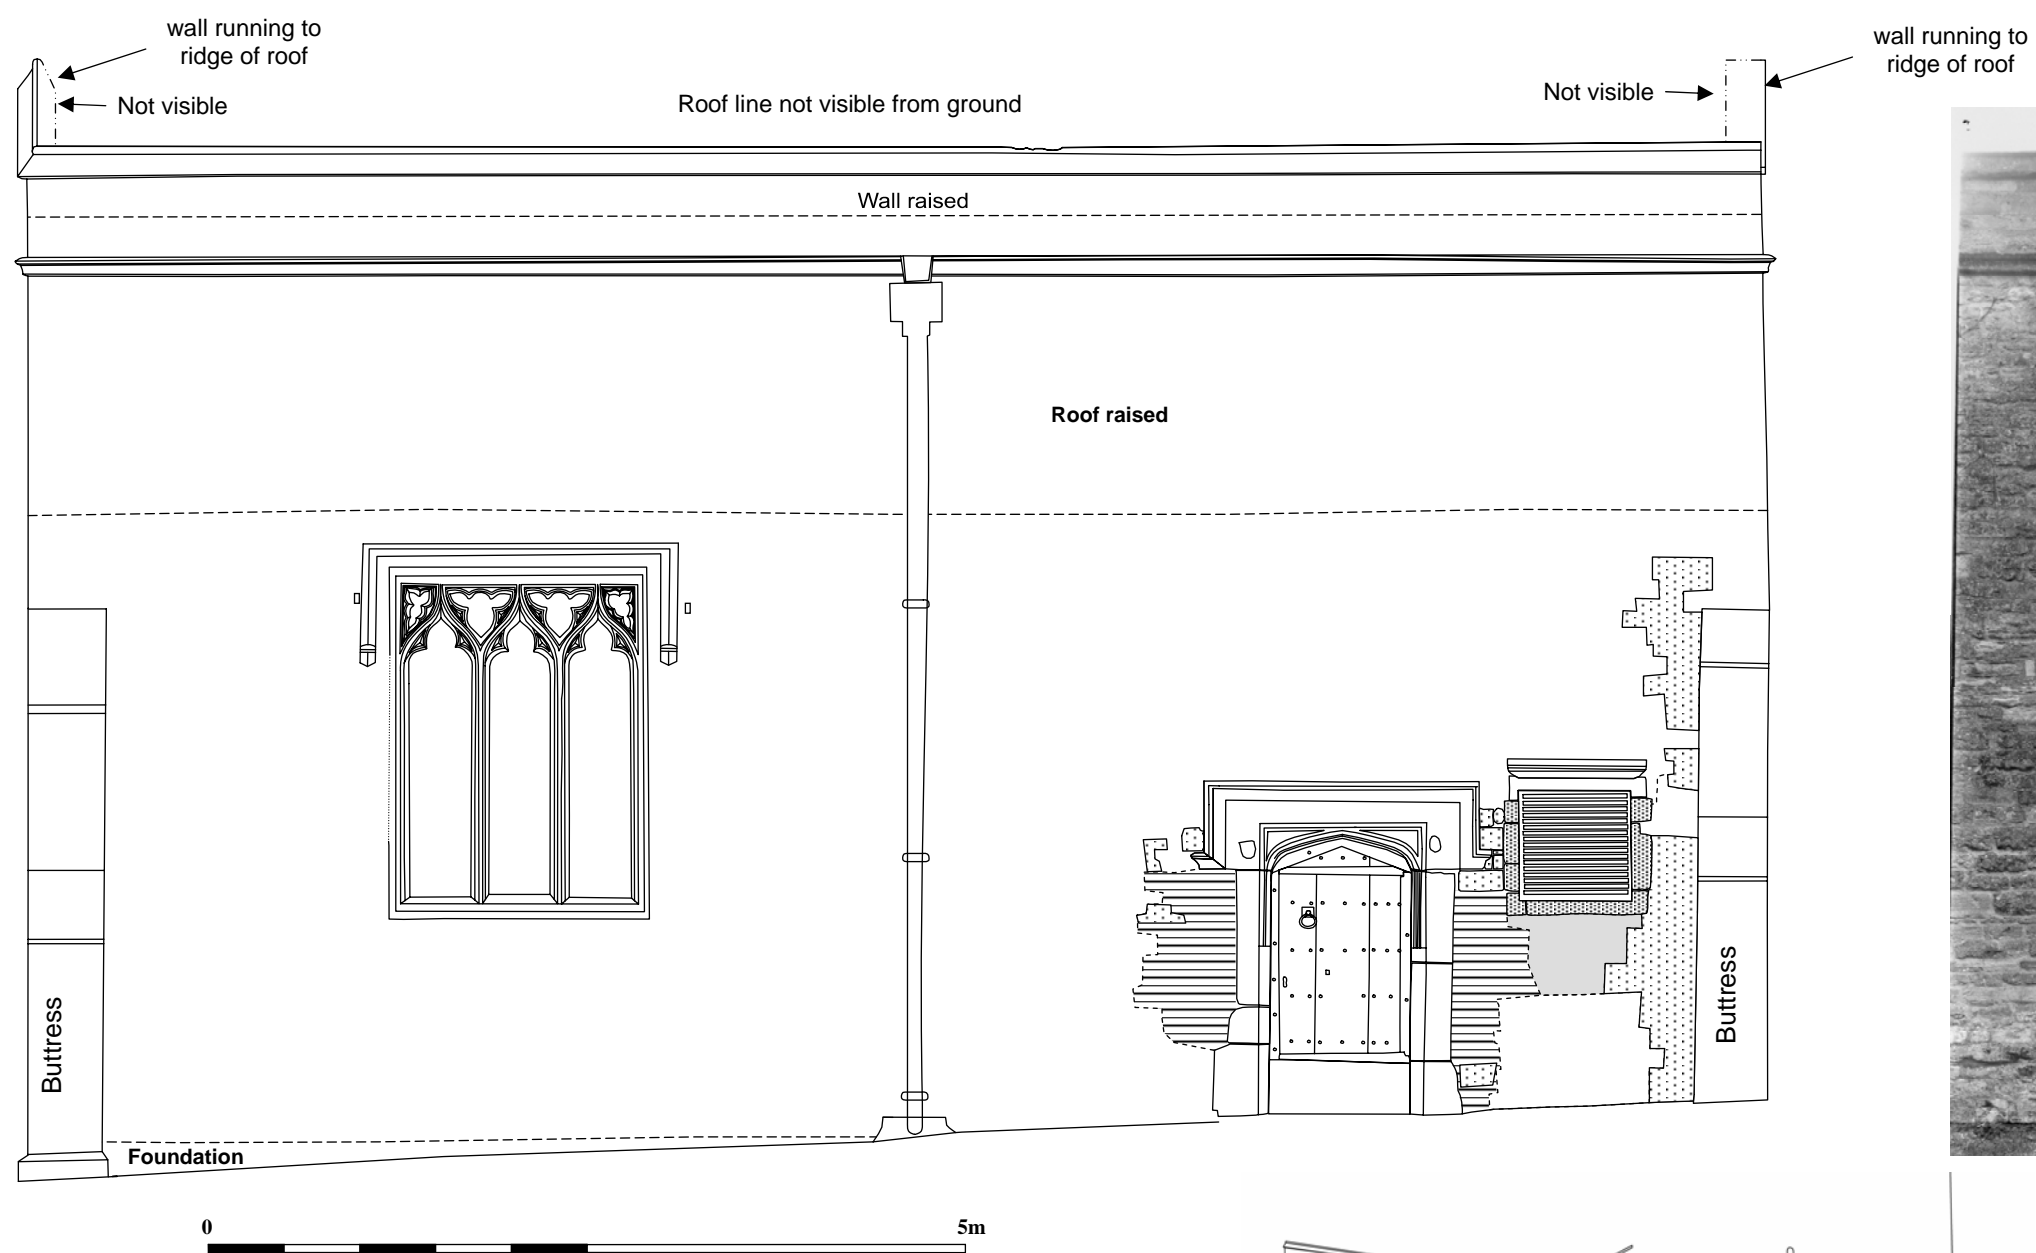
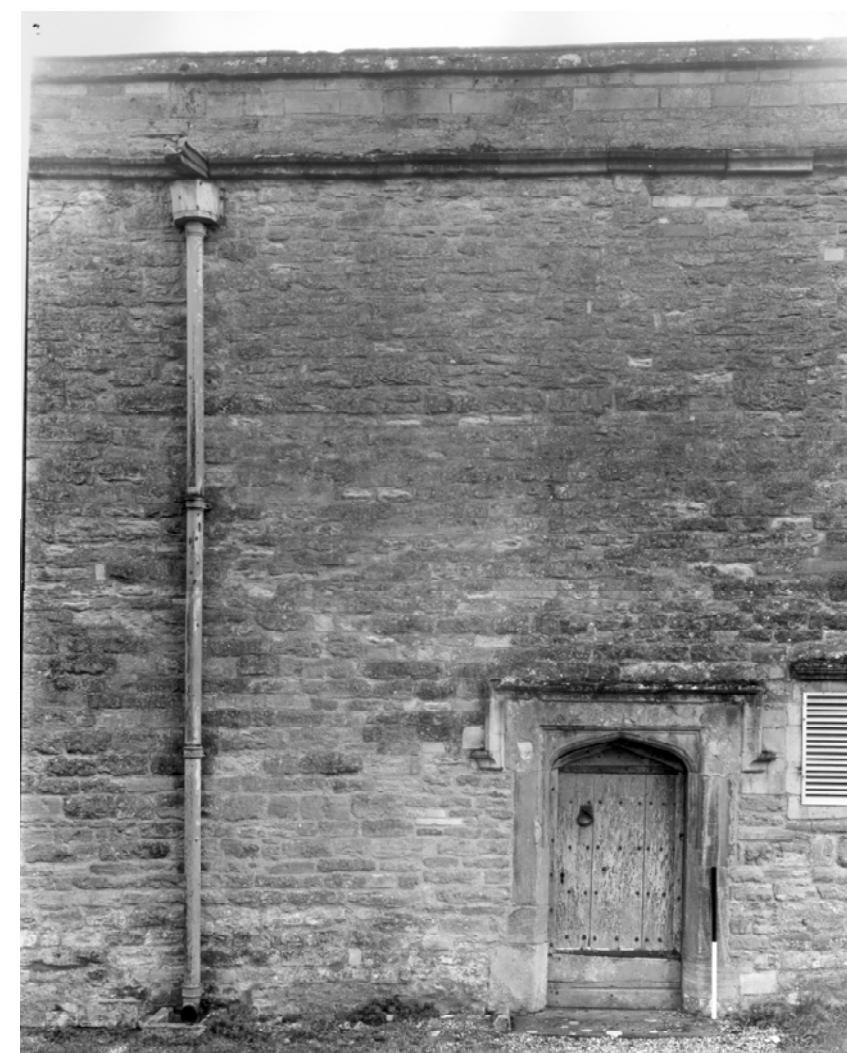
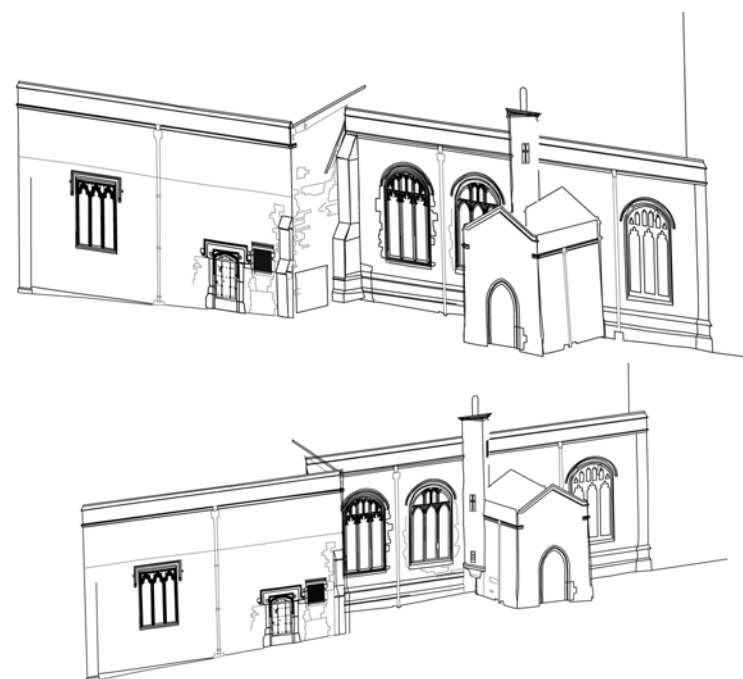
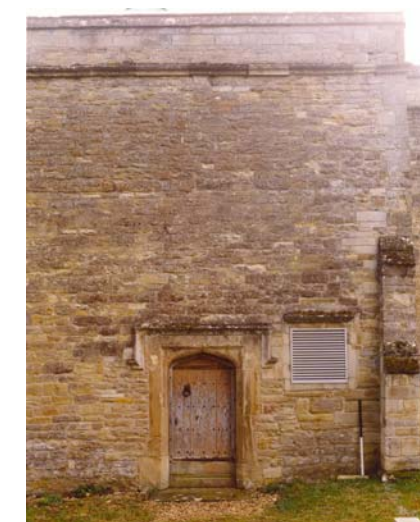
Figure 5: Elevation of the Chapel (north wall)

3.4.1 The north and west walls of the North Chapel (Toft Chapel, Figures 5 and 6)

A window, comprising three lights, is located on the eastern half of the 14th century North, or Toft Chapel wall. This measures c.1.75m in width and 2.5m in height. The masonry around the window is unaltered suggesting that this is original to the chapel and therefore of the same date.

A door and window on the western half of the wall (Figure 5) show evidence of considerable alteration. The door measures approximately 1.85m by 0.8m with the entire stone frame and arch measuring 1.6m by 2.2m. The window measures 0.95m by 1.0m. Significant changes in masonry around the frame and arch demonstrate that this window is a later addition. Previous observations (Collett-White *unpublished*) indicate that this is likely to have occurred in the 17th century. Further recent alteration of the window has occurred. This was to allow for the installation of a vent for the church heating system. The wooden door is not original either, having been installed in 1866.

Wall repairs
-

Change in construction

Evidence of change is also present on the western face of the chapel (Figure 6), in the form of a scar from a roofline probably associated with the construction and removal of the 17th century roof. This scar was most apparent on the western wall of the north chapel (Figure 6). Modern alteration associated with the installation of a heating system was also apparent (Figure 5).

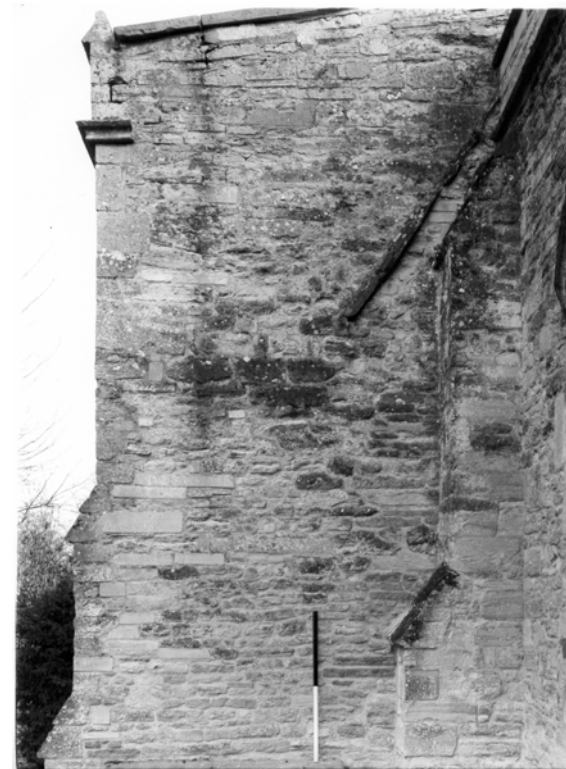
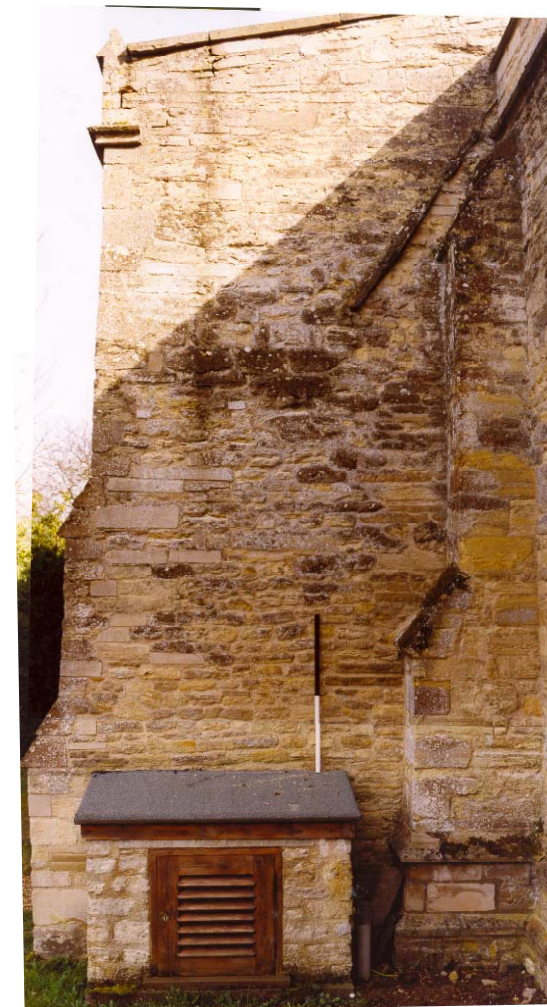
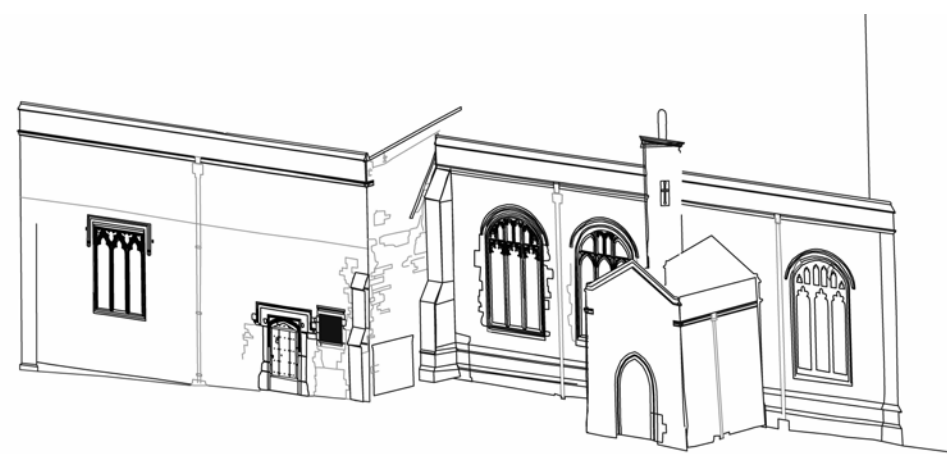
Figure 6: Elevation of the Chapel (west wall)

The north-western corner of the chapel contains further examples of masonry alteration, including the addition of a buttress. Evidence of this is present on the western face of the chapel (Figure 6), along with the scar of a roofline probably associated with the construction and removal of the 17th century roof. A small modern stone built structure can be seen on this face and is related to utility supply heating for the church.

Crack
-

Relatively modern wall repairs
-

Older wall repairs?

Building recording has demonstrated the existence of several additions made to the building between the 13th and 20th centuries. These affected the north-western corner of the chapel, which has been subject to several changes, including the addition of a buttress (Figure 6).

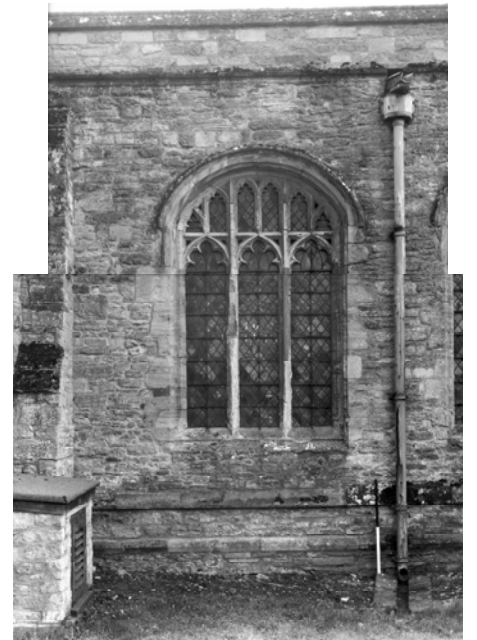
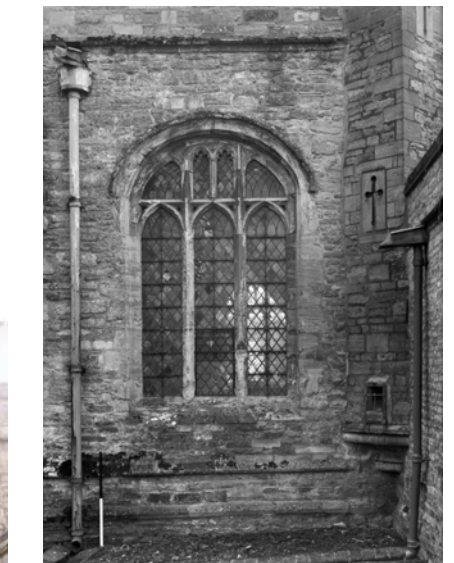
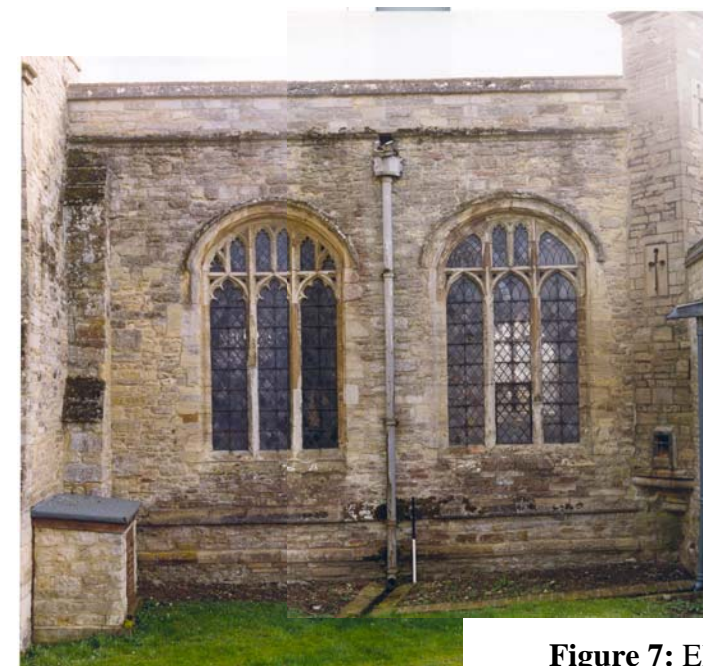
Figure 7: Elevation of the North Aisle

3.4.2 The north wall of the North Aisle (Figure 7)

The north wall of the north aisle is of 13th century date and represents one of the earliest elements of the church. The north porch is a later 15th century addition.

Two large windows measuring approximately 1.8m in width and 3.35m in height exist to the east of the porch. Alteration of the masonry around these features indicates that they are later additions. Although of similar dimensions, stylistic difference in the design suggests that these windows are unlikely to be contemporary.
