**LAND AT 2 GREEN'S ROAD
CAMBRIDGE**

**BUILDING RECORDING
AND
ARCHAEOLOGICAL EVALUATION**

Report no: 2015/03 v1.1

Project: GR2494
CHER event no: ECB4302
OASIS ref: albionar1-192870

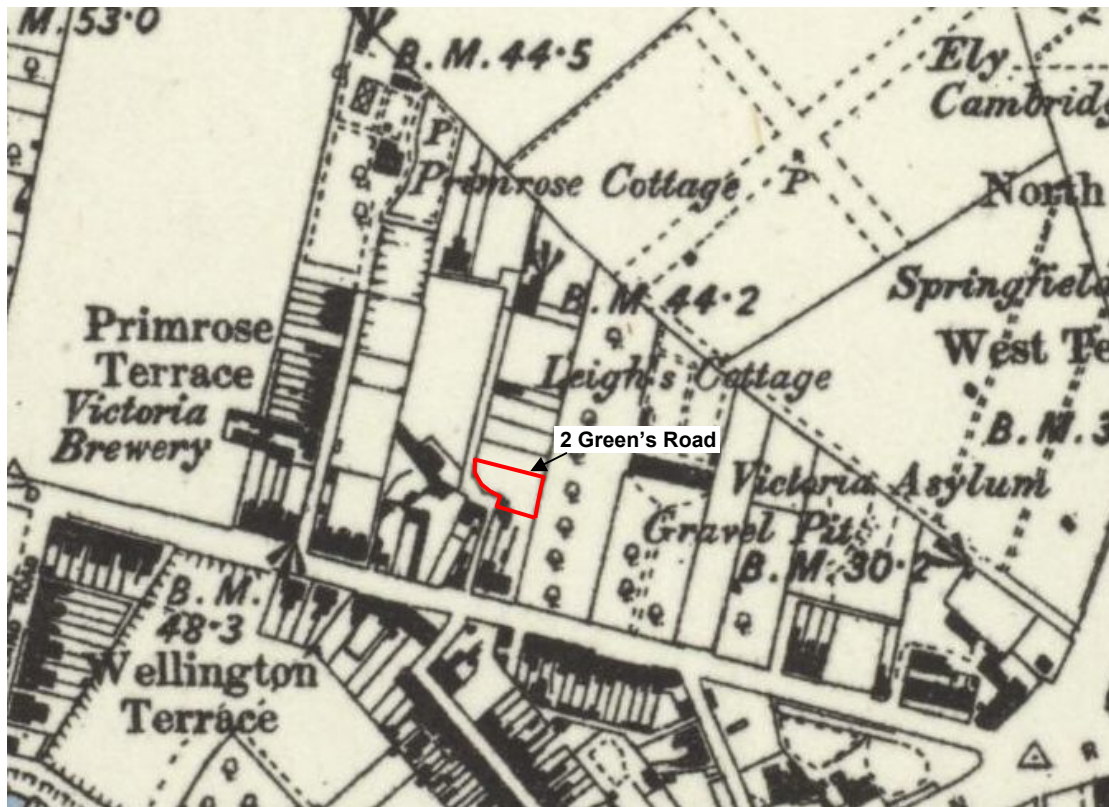
Figure 2: 1886 OS map of Cambridge

Historical maps show that the industrial units at 2 Green's Road were built between 1886 and 1904 (Figures 2 and 3). The early use of the buildings is unclear as no historical records exist and no entries are listed for the address in any of the early commercial directories for Cambridge.

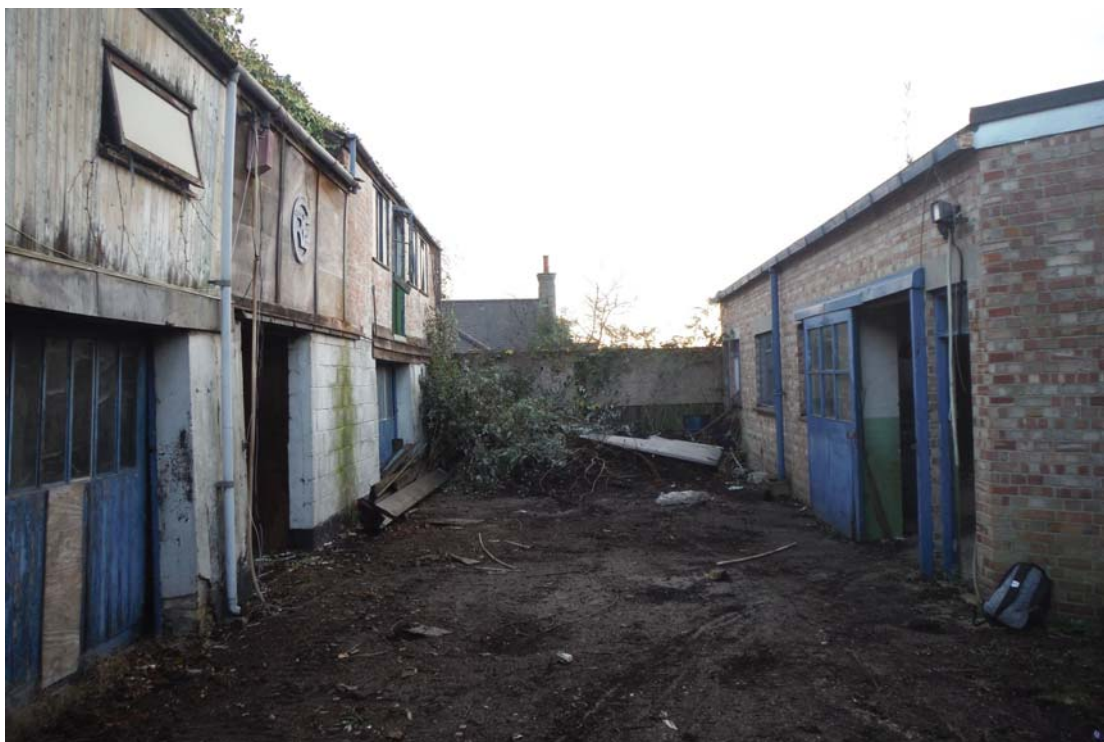
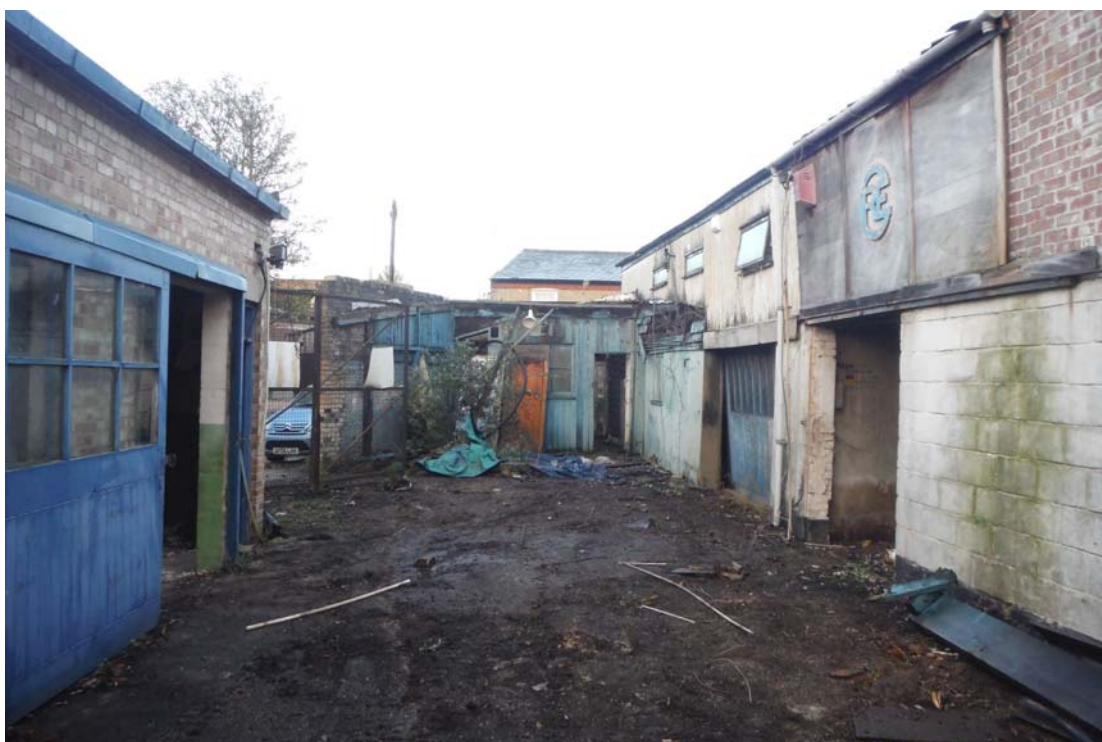
The site consists of two buildings which lie opposite each other along the northern and south-eastern boundaries of the site, forming an elongated rectangular yard between them (Plates 3 and 4).

Most of the roof tiles of the western part of the northern buildings are missing, leading to considerable decay of the roof and its underlying structure.

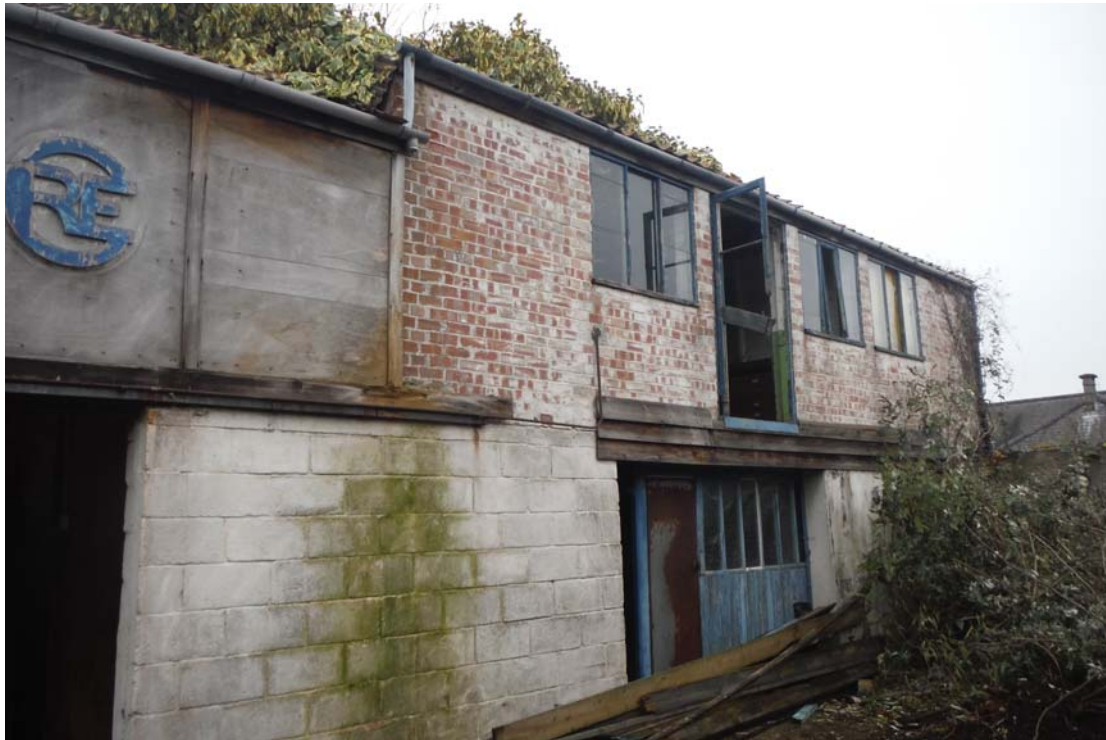
Plate 5: Northern building eastern end

The eastern section of the building has two storeys and a red clay tile covered gabled roof (Plate 5). Both storeys of the building are brick-built. The lower part

of the building is plastered and whitewashed while the upper storey is bare brick. A band of timber cladding divides the two storeys.

On the ground floor is a centrally placed timber sliding door. This consists of a lower timber part with seven parallel vertical glass lights in its upper section. A simple one-leafed batten swinging door is inserted within the sliding door.

A simple rectangular casement window is located to the east of the sliding door. It has a wooden frame, two vertical lights and a grille of vertical metal bars on its inside. Along the northern wall of the ground floor, just below the ceiling, are two regularly spaced, horizontal, rectangular windows with a non-movable single pane and a metal grille on their inside.

The upper floor has a central main double door that extends from floor to ceiling and was most likely part of a loading bay. It is a casement door with a barely surviving wooden frame. Three windows, one to the west, and two to the east of the door are rectangular with three vertical panes and thin wooden frames. There are no windows in the northern or eastern walls.

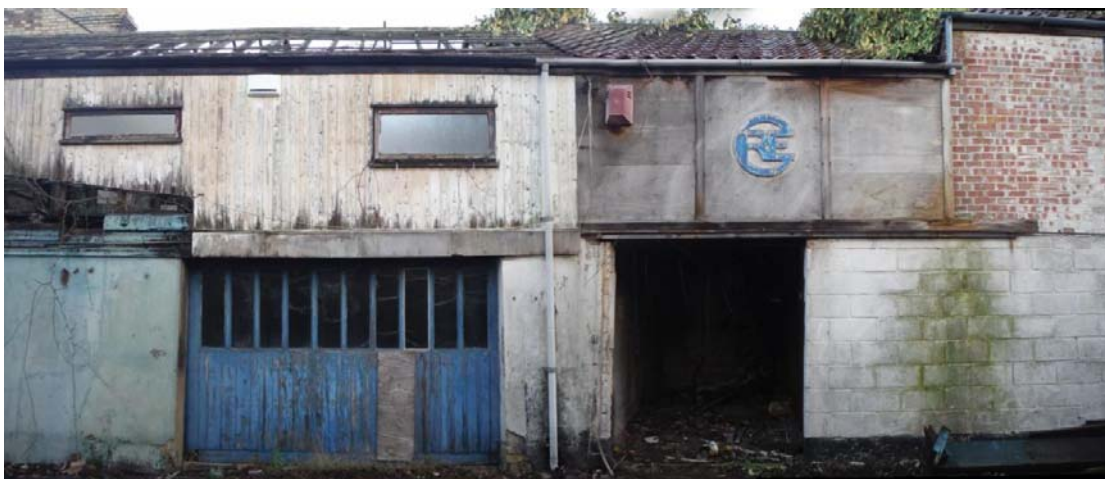
Plate 6: Northern building central section

The western section of the northern building has a lower roofline that is also gabled and covered in red clay tiles. The walls on the ground floor are brick-built while the upper floor is entirely of timber (Plate 6).

A wall section built of concrete breeze blocks was inserted on the southern side of the ground floor (Plate 6). It extends from the sliding door of the eastern, higher building across to the eastern end of the western, lower building, and forms one side of a simple opening into the central room. When this wall was inserted and what it replaced is not clear.

To what extent timbers and partitions were replaced throughout the 20th century is unclear. One definite alteration to the northern building is represented by the central section of concrete breeze block wall. What this replaced, however, is unclear.

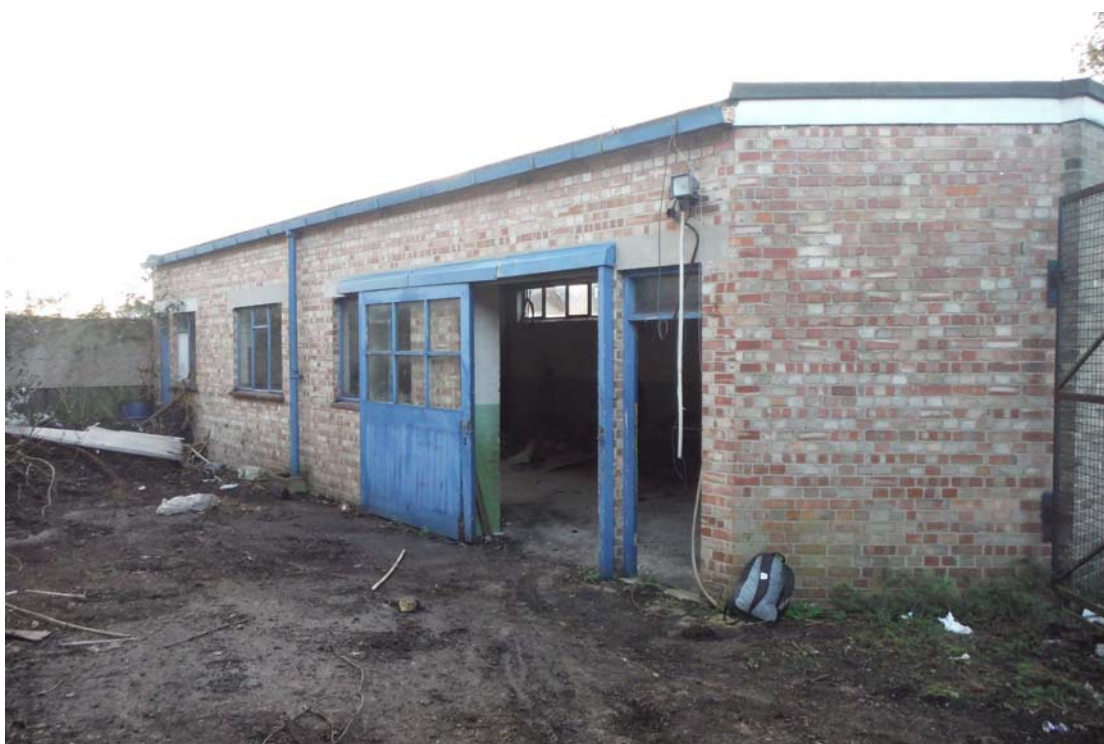
Plate 8: Southern building

Both buildings are first shown on the OS map of 1904. While the ground plan of the buildings has not changed, the southern building is a complete replacement of the original building. Its replacement most likely dates from the occupation of the site by the Cambridge Repetition Engineers in the 1950s and 1960s.

The industrial units were built between 1886 and 1902 but have been remodelled throughout the 20th century. The southern unit represents a complete replacement in the 1950s or '60s of the original building on the same footprint.

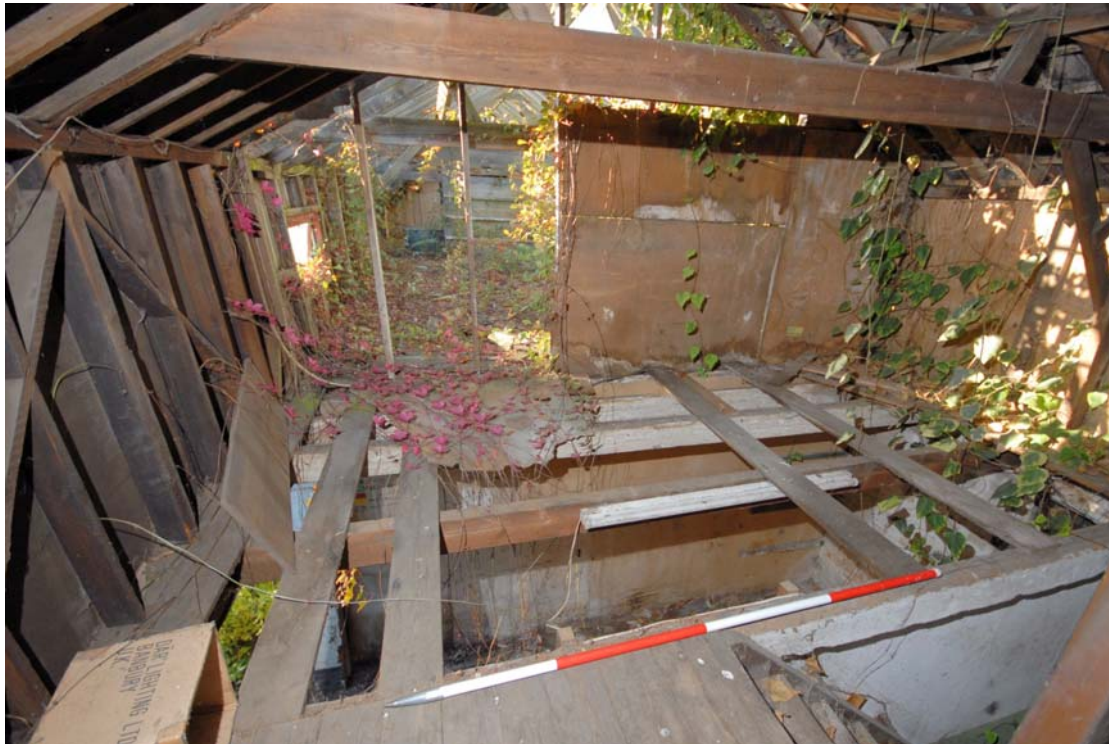
Plate 11: Northern building, eastern-central first floor, looking west
(scale 2m in 50cm divisions)

On the upper floor the steps arrive on a landing outside the upper eastern room (Plate 11). A timber wall forms the western side of the first floor of the eastern, higher part of the main building.

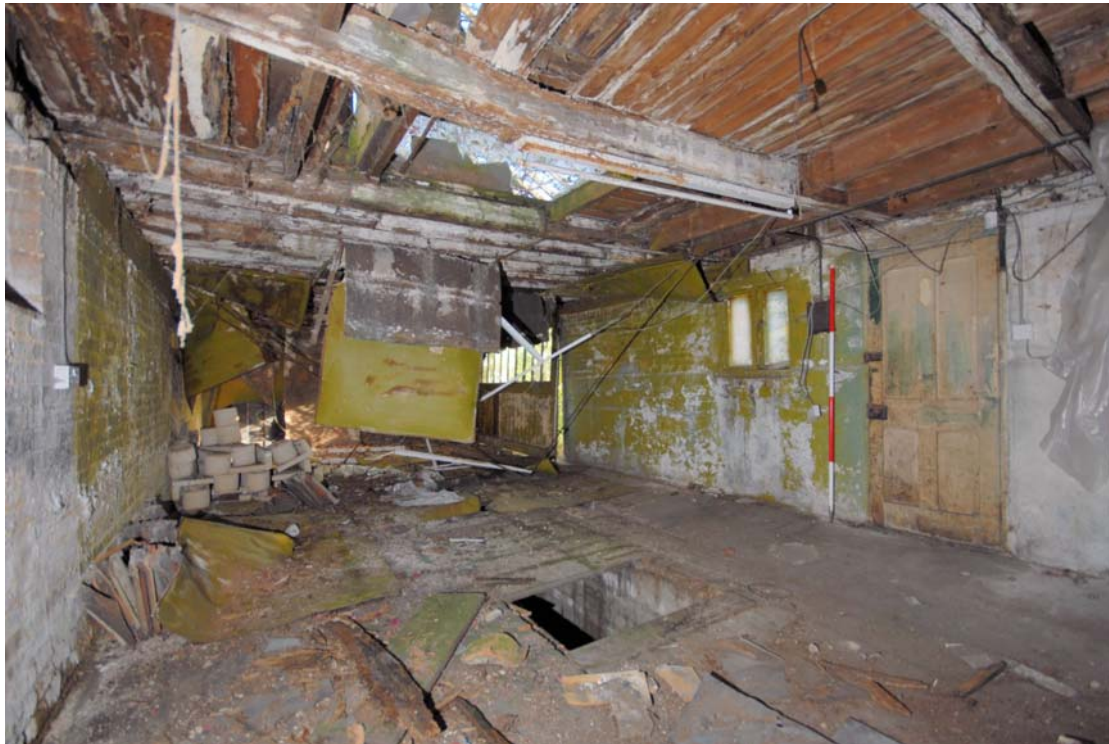
Plate 13: Northern building, western ground floor, looking east
(scale 2m in 50cm divisions)

The western room of the northern building has bare brick walls (Plates 13 and 14). The majority of the walls, ceiling and the internal timber frames of the windows and doors are painted green with a few whitewashed sections. In the central

western section an inspection pit with a set of concrete steps is let into the floor (Plate 13). This dates from the use of the building as a motor garage. The inspection pit is covered by timber planks.

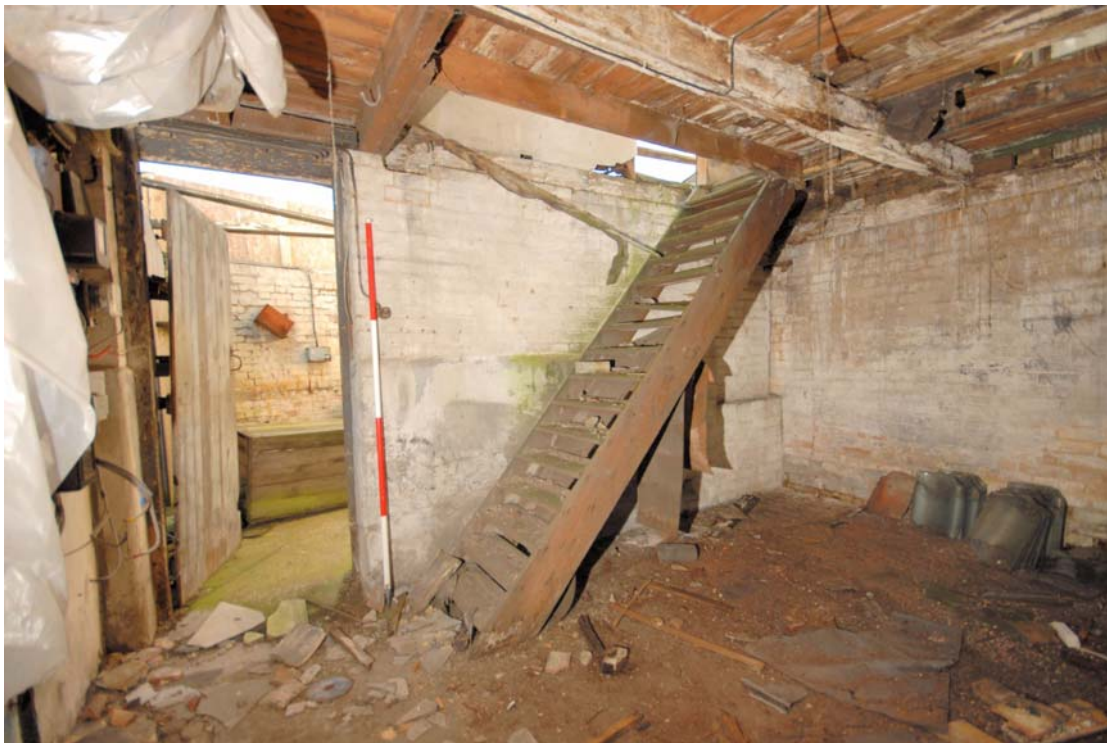
Plate 14: Northern building, western ground floor, looking east
(scale 2m in 50cm divisions)

A free-standing timber stair is located along the western brick wall of the room (Plate 14). It leads through a simple opening in the ceiling to the upper storey. A further rectangular opening is located in the ceiling, approximately above the inspection pit.

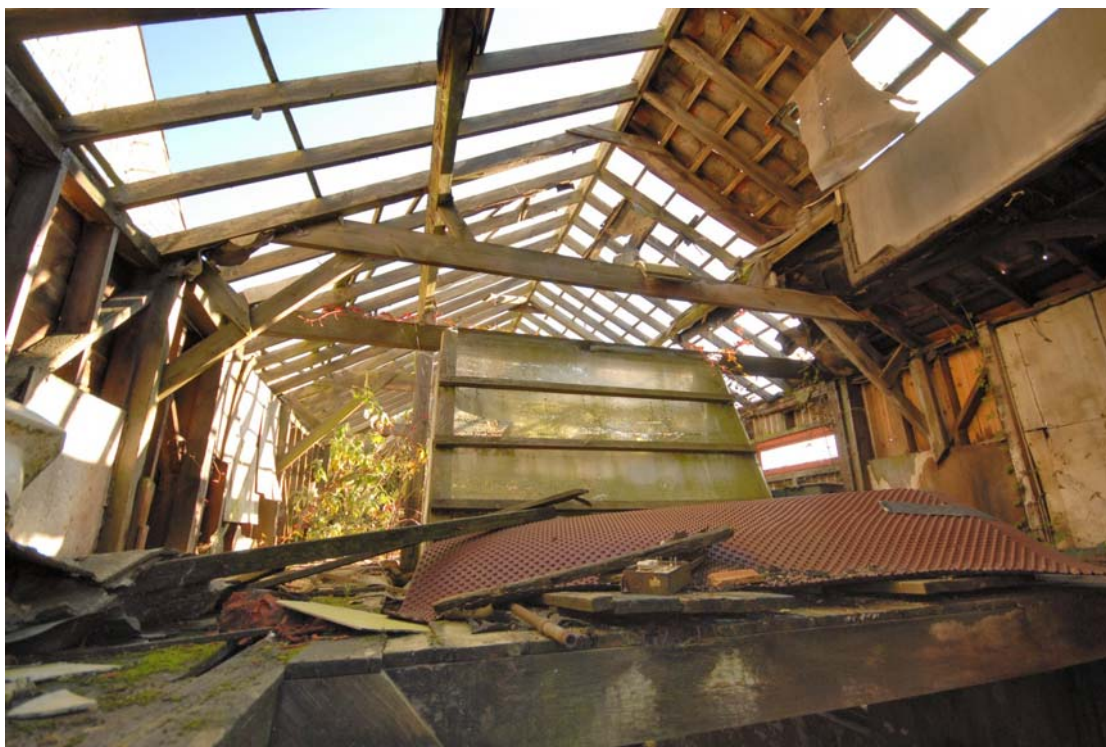
Plate 15: Northern building, western first floor, looking east

The upper storey of the western, lower roofed section of the northern building is bare with considerable timber and roof debris. It had at least one partition but only the timber frame of this survives. A pyramidal timber structure covered in a light fabric mesh covers the hole in the ceiling/floor above the inspection pit (Plate 15).

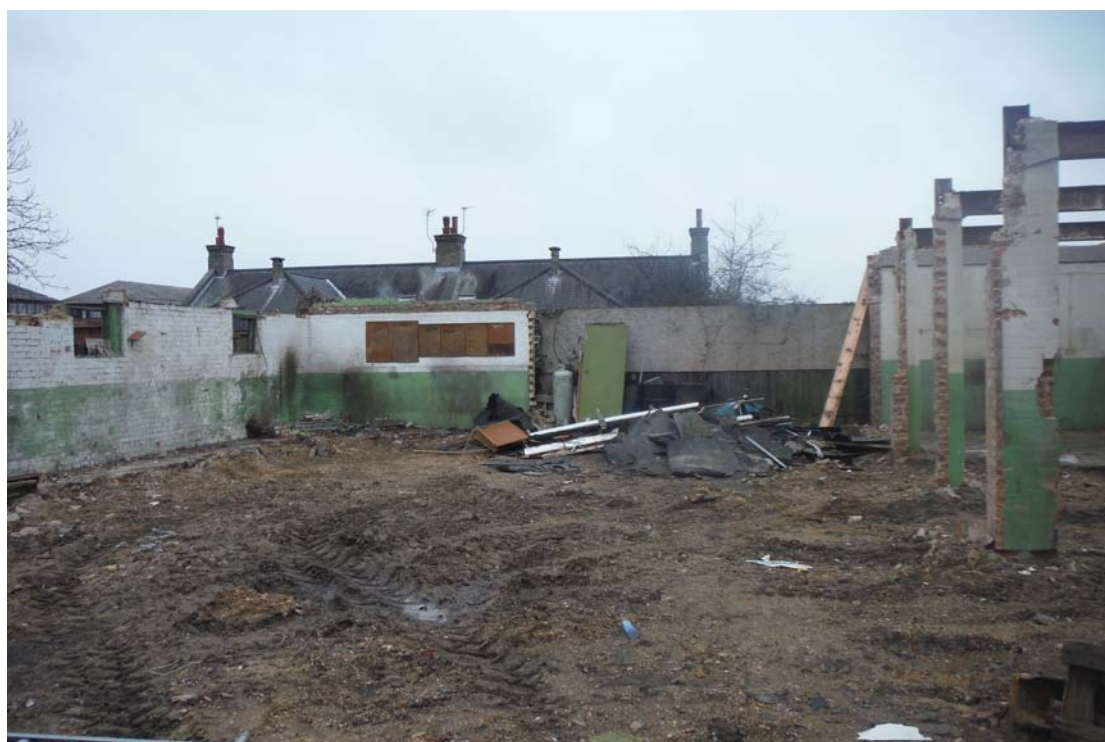
Plate 16: The site post-demolition, looking east

The trench lay in the area of the former yard of the industrial unit. The concrete surface of the yard had been removed by the demolition contractors prior to the excavation of the trench (Plate 16). The trench was excavated through its underlying make-up layer (100).

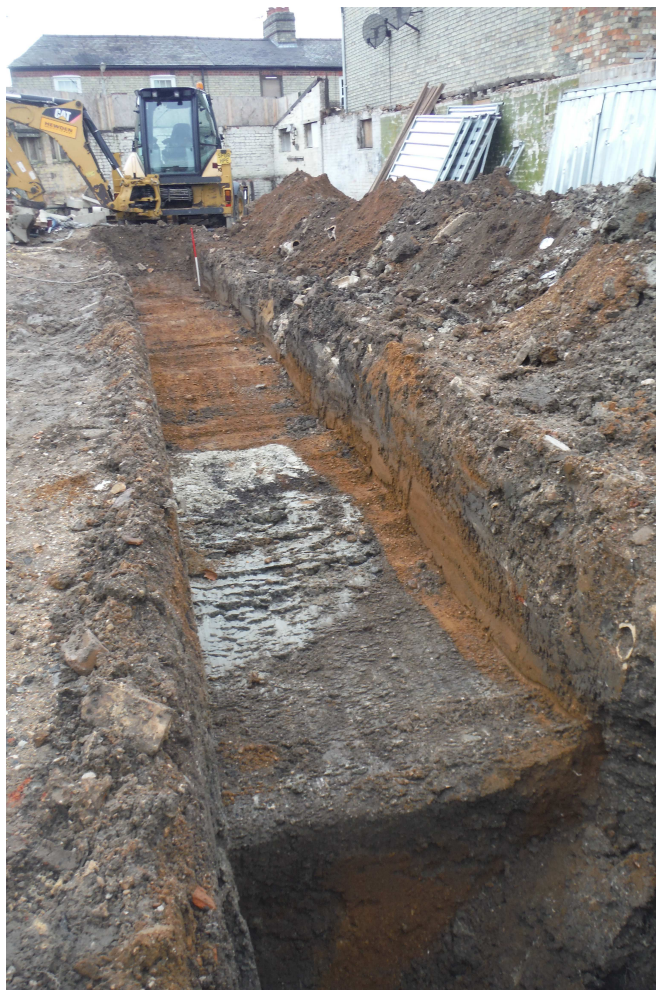
Plate 17: Trench 1 looking west, pit [102] in foreground

The trench revealed a thick post-medieval make-up layer (108) through which two possible quarry pits [102] and [111] were excavated at the southern end of the trench. The remainder of the trench contained no features (Figure 5, Plate 17).

Two pits were located at the eastern end of the trench. Pit [102] was elongated and sub-rectangular in plan and deliberately backfilled with white chalk (104), grey clay (105) and grey gravelly soil (106) (Plate 17). It is possible that this pit was dug to obtain aggregate and was then backfilled with left-over construction materials (chalk and clay).

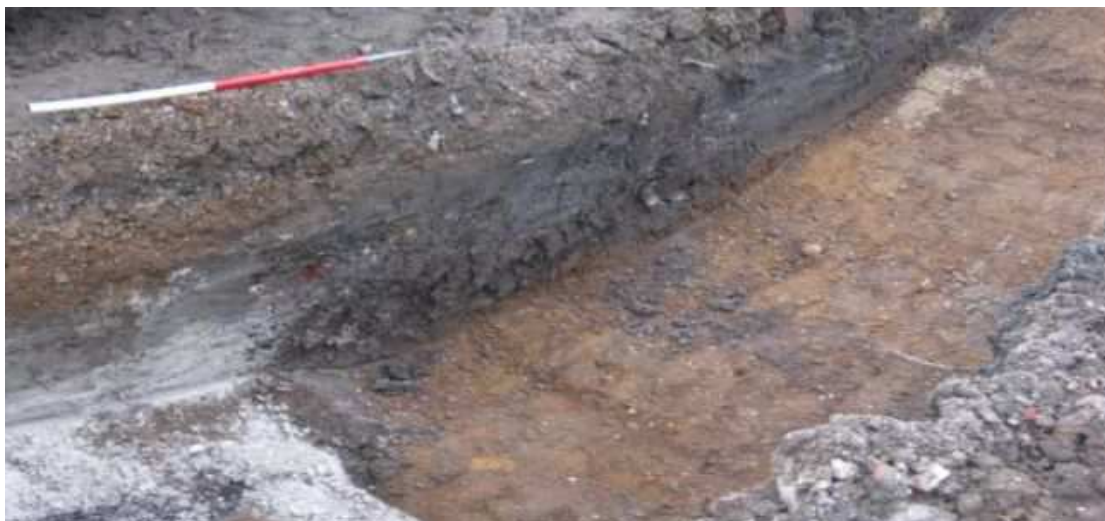
Plate 18: Make-up layer (108) in north-facing section

Make-up layer (108) was present throughout the majority of the trench (Plate 18). It was truncated by quarry pits [102] and [108] in the east and throughout its length by service pipe [109]. It contained fragments of building debris, iron piping, brick rubble and ceramic crockery (see Section 3.3 below). It is possible that this layer formed before the construction of the industrial units, or was laid down to level the ground for their construction.

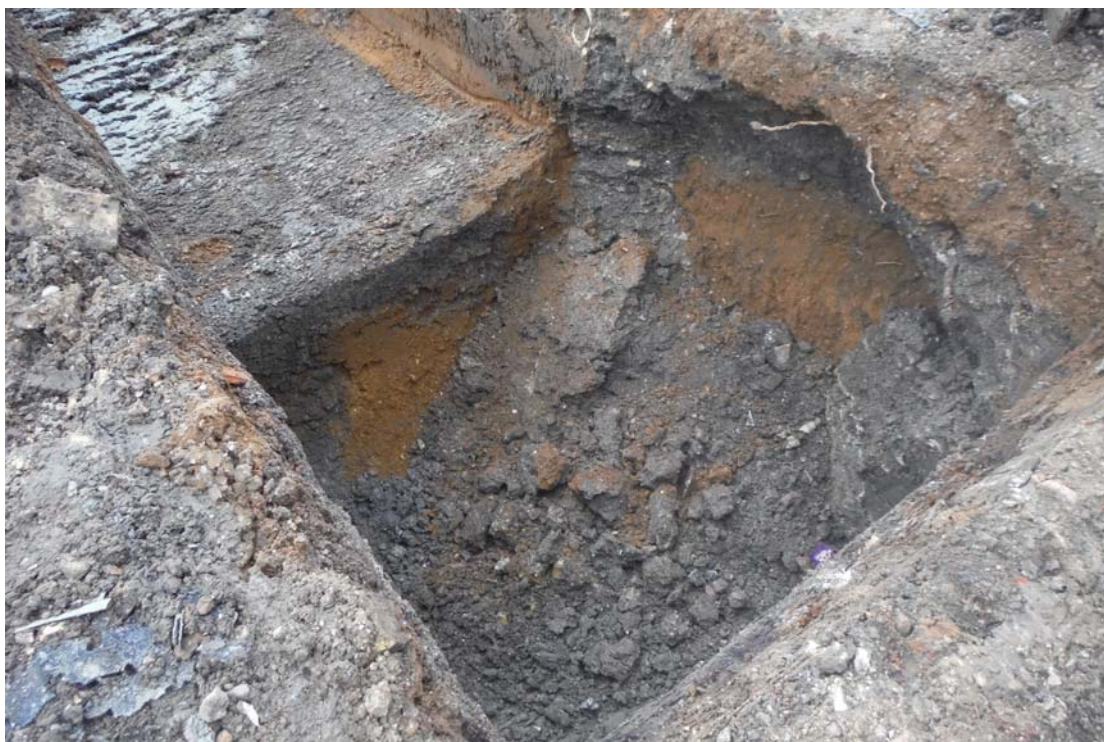
Plate 19: Possible quarry pit [111] in eastern end of trench
(fill collapsed from pit sides)

Pit [111] was more than 2m deep and extended beyond the limit of excavation in the north, east and south. It was mainly defined by the level of trench collapse around the edges of the pit, as well as fill (101), which fell off the gravelly sides of the pit near the base of the 2m-deep sondage (Plate 19). The trench was deemed too unsafe to investigate this feature in more detail.

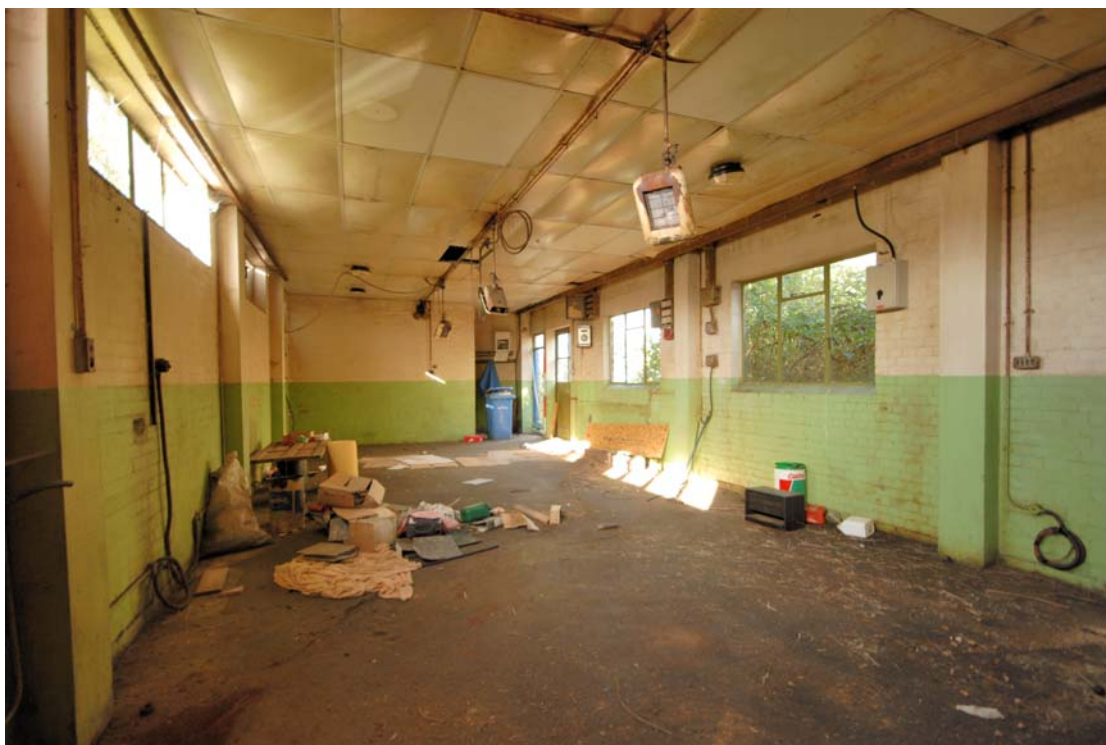
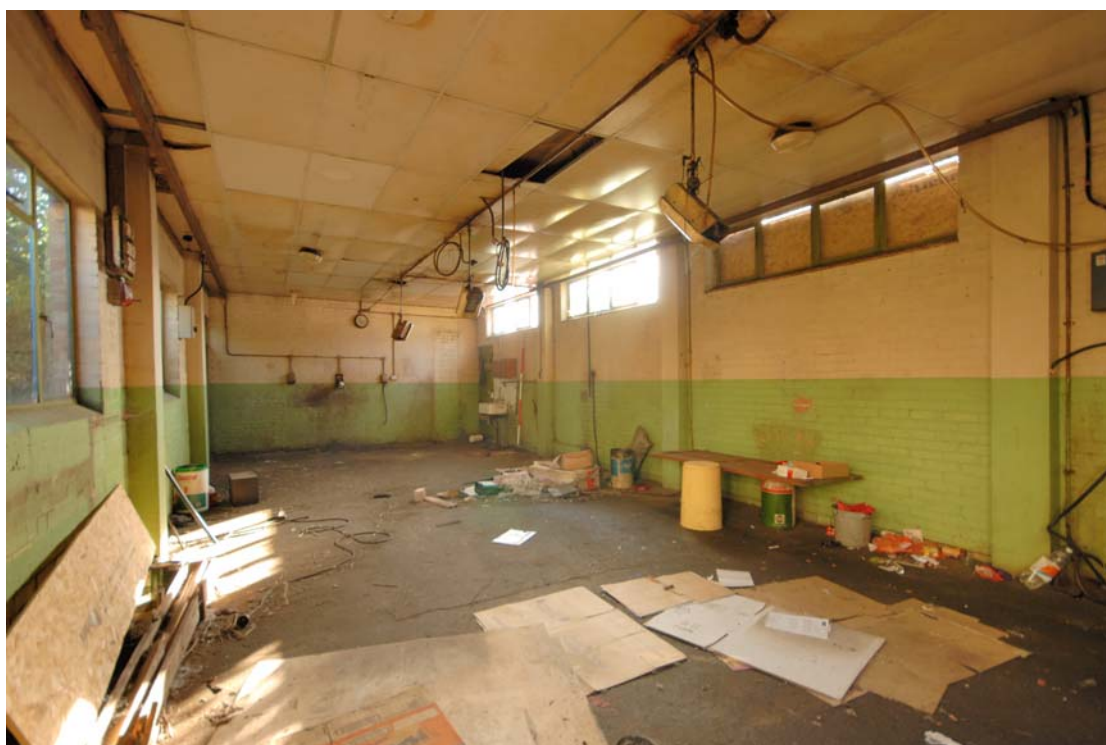
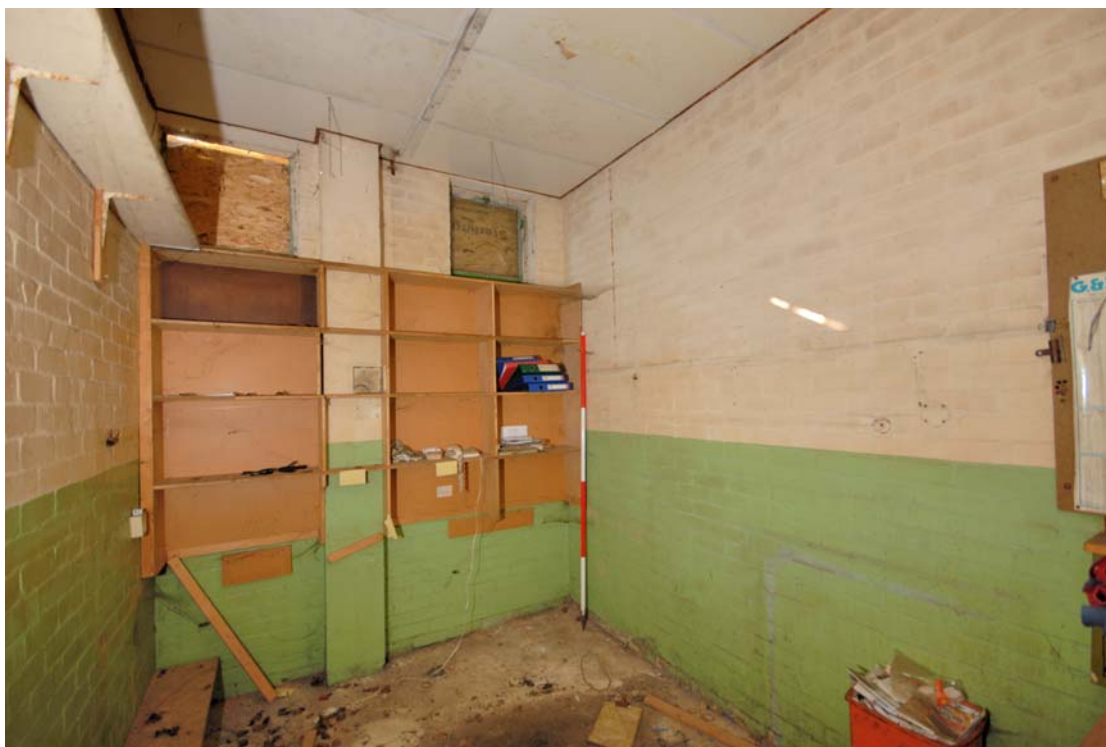
The southern buildings consisted of one large open rectangular room with a small separate office opposite the main door at the western end (Plates 20, 21, 22). The building is of a steel frame construction supporting the brick walls. Internally regular brick columns within the side walls indicate the location of the upright steel posts.
