CHURCH OF ST NICHOLAS, WILDEN, BEDFORDSHIRE

PROGRAMME OF ARCHAEOLOGICAL WORKS

Report No: 2004/4

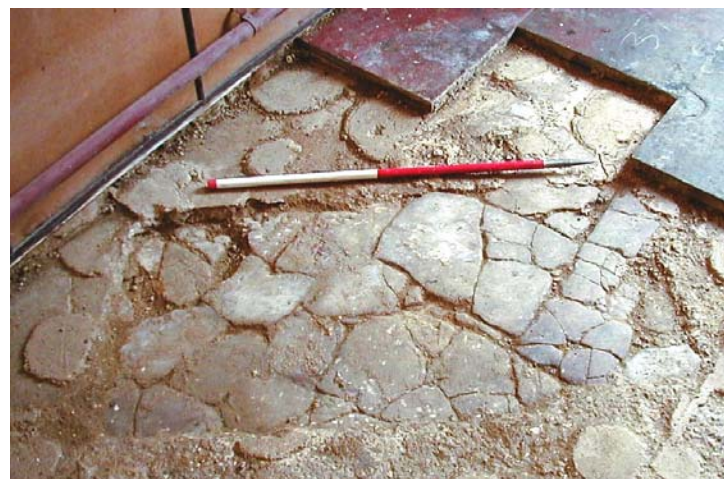
Photograph of top of trench 1

The current floor surface consists of flagstones (1). These are laid in rows of unequal width orientated east-west. The slabs appear to be machine cut, with uniform finish; they are exactly the same thickness with perfectly straight edges and 90° corners. The corners of the slabs are set on circular pads of cement (2) which are laid on a thin skim of hard cement (3) used to cover an earlier floor surface below.

An earlier floor was found beneath the flagstone flooring. In trench 1 it consisted of limestone slabs (4) and in trench 2 a mixture of the same limestone slabs and tiles (13). Most of the slabs were sub-rectangular or polygonal in outline and were laid in an irregular pattern with smaller stones infilling gaps. One area in trench 1, towards the west door of the tower, appeared more regular with rectangular slabs measuring up to 500mm by 400mm. Throughout, the surface was uneven and heavily worn with many of the slabs broken by numerous cracks. The tiles found in trench 2 were of two sizes, 160mm square by 30mm thick and 130mm square by 25mm thick. They were of unglazed, red clay. The upper surfaces of many were covered by a thin, dark grey deposit, which may have been remnants of a floor finish or accumulated grime. The position of the tiles suggests that they formed a strip, approximately 1m wide, along the east side of the tower floor.

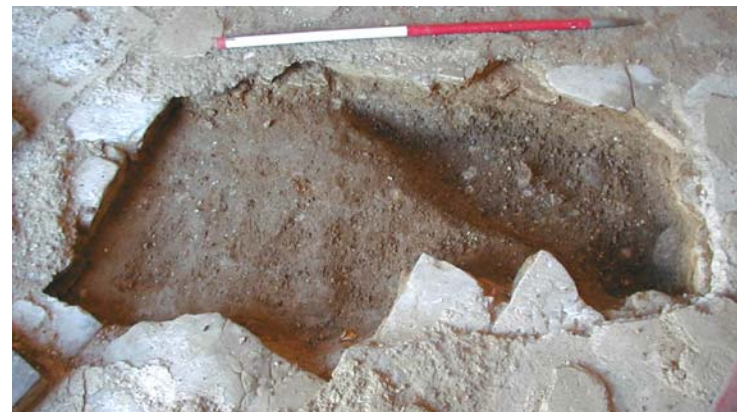
Photograph showing cut [7] prior to removal of layers 9-11

In trench 1, a shallow cut [7] was found, sealed by the construction deposits (5 and 6) associated with the limestone flooring (4). This was a shallow, flat based cut 120mm deep. Only the western side of the feature was observed in plan; it was straight and

orientated north-south. The fill of the feature (8) consisted of loose mid yellow brown silty loam. No evidence was found to suggest a function for this feature.

The shallow, flat based cut feature found in trench 1 predated the floor surface discussed above but is otherwise undated. Insufficient of this feature was observed to ascertain its purpose.

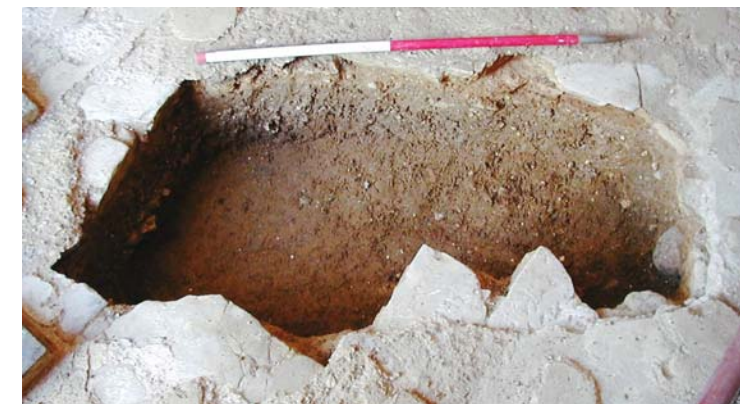
Photograph of base of trench 1

Layer (9), yellow brown clay silt in trench 1 may be the equivalent of layer (15), yellow grey silty clay in trench 2. The former contained two undiagnostic pot sherds (9g) in shell tempered (type B07) and sand tempered (type C01) fabrics⁵, dateable to the 12th-13th century. Layer (10) in trench 1, yellow brown clay silt with frequent grit and stones probably equates to (16) in trench 2, yellow grey silty clay with frequent stones. Layer (16) yielded seven undiagnostic pot sherds (73g) in shell tempered (types B07 and B09) and sand tempered (types C01 and C05) fabrics. With the exception of two sherds of Lyveden/Stanion ware (type B09), a regional import from Northamptonshire, all are of local manufacture. All are datable to the 12th-13th century. Trench 1 contained an additional layer of yellow brown clay silt (11) which lay directly above the natural stratum (12).

A layer (12) interpreted as undisturbed natural strata was observed in the base of both trenches. This consisted of yellow brown slightly silty clay with occasional small stones and flecks of chalk.
