**ST MARY'S CHURCH
FELMERSHAM
BEDFORDSHIRE**

ARCHAEOLOGICAL MONITORING

Document: 2015/009
Version: 1.0

Project Code: SM2307
OASIS ID: albionar1-201089

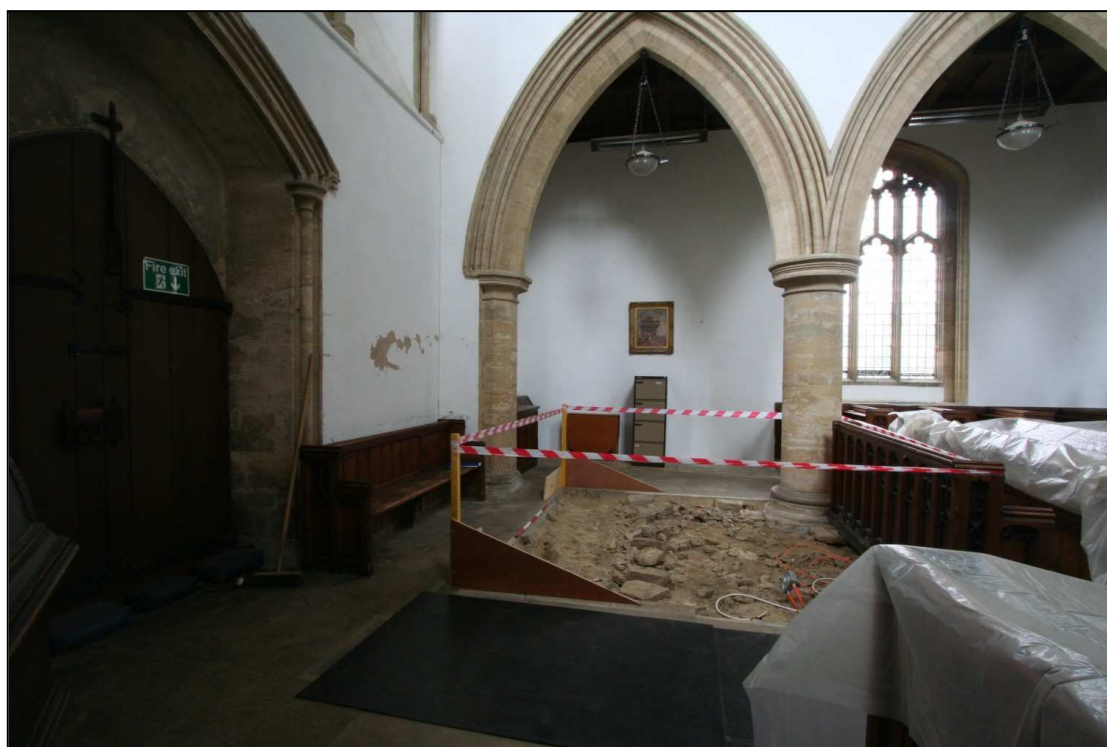
Figure 2: Image showing location of works

Looking north showing location of removed pew base with the west door to the left and the north aisle to the rear

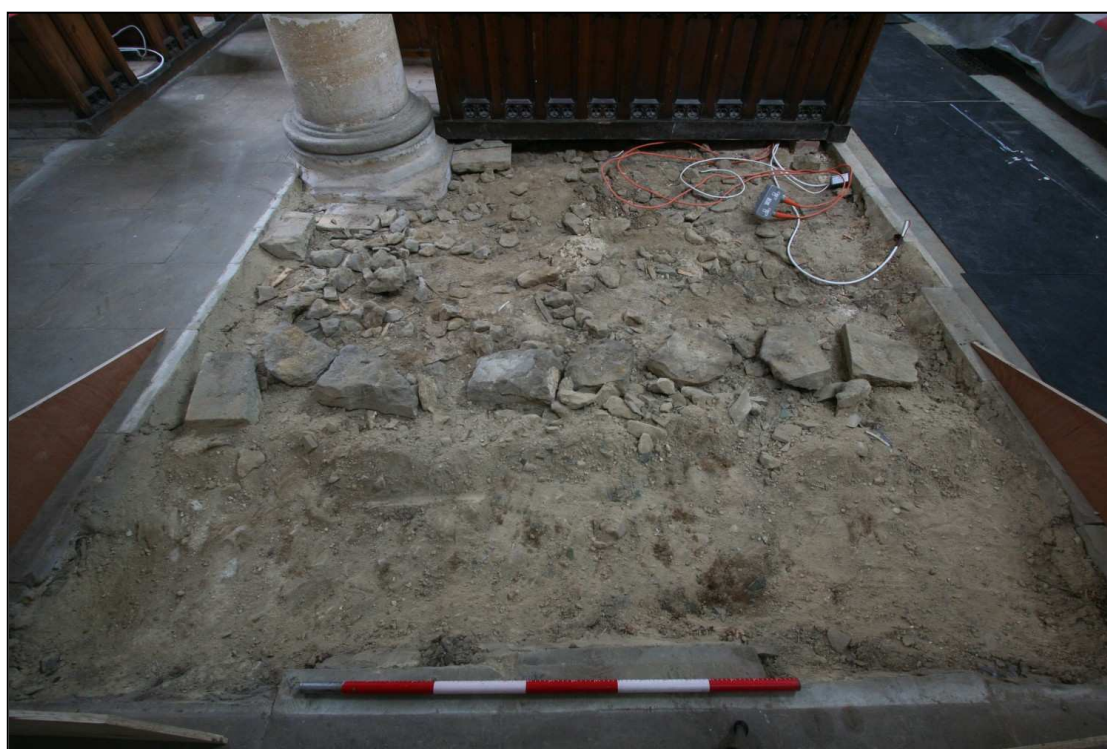
Figure 3: Image showing void beneath removed pew base

The base of the void was covered in a layer of dusty debris with loose fragments of limestone. The majority of the limestone consisted of small, irregular-shaped fragments spread across the surface. A line of larger, irregular-shaped slabs of limestone formed a north-south aligned row — they had presumably been arranged to support a timber joist in the pew base. To the west of these larger stones, the surface was examined by trowelling. The material consisted of fine dust and limestone debris. Debris on the surface of the layer comprised limestone fragments, a fragment of window glass and a fragment of lead window came, all of which were left on site. The window glass consisted of slightly greenish, plain glass. No examples of painted window glass were identified.

The material uncovered beneath the floor comprised building debris, consisting mostly of small fragments of limestone waste. It is likely to have been deposited during the restoration of the church in the mid-19th century. The current pew bases were probably installed when the nave was re-seated. This was done during the first phase of the restoration works which were carried out in 1857–1858 (Pickford 1994, 290).

Looking east showing line of large limestone fragments and limestone rubble spread (scale 1m)

The results of the investigation and information from the architects on the nature of the planned works indicate that the works will have no significant impact on sub-surface archaeological deposits. Any surviving archaeological layers are sealed beneath a layer of limestone building waste which was probably deposited during the restoration of the church in the mid-19th century. Monitoring during the construction works is unlikely to uncover any useful data on the earlier development of the building.
