**HARLINGTON MANOR  
HARLINGTON  
BEDFORDSHIRE**

**ARCHAEOLOGICAL OBSERVATION,  
INVESTIGATION, RECORDING,  
ANALYSIS AND PUBLICATION**

Document: 2016/157  
Version 1.0

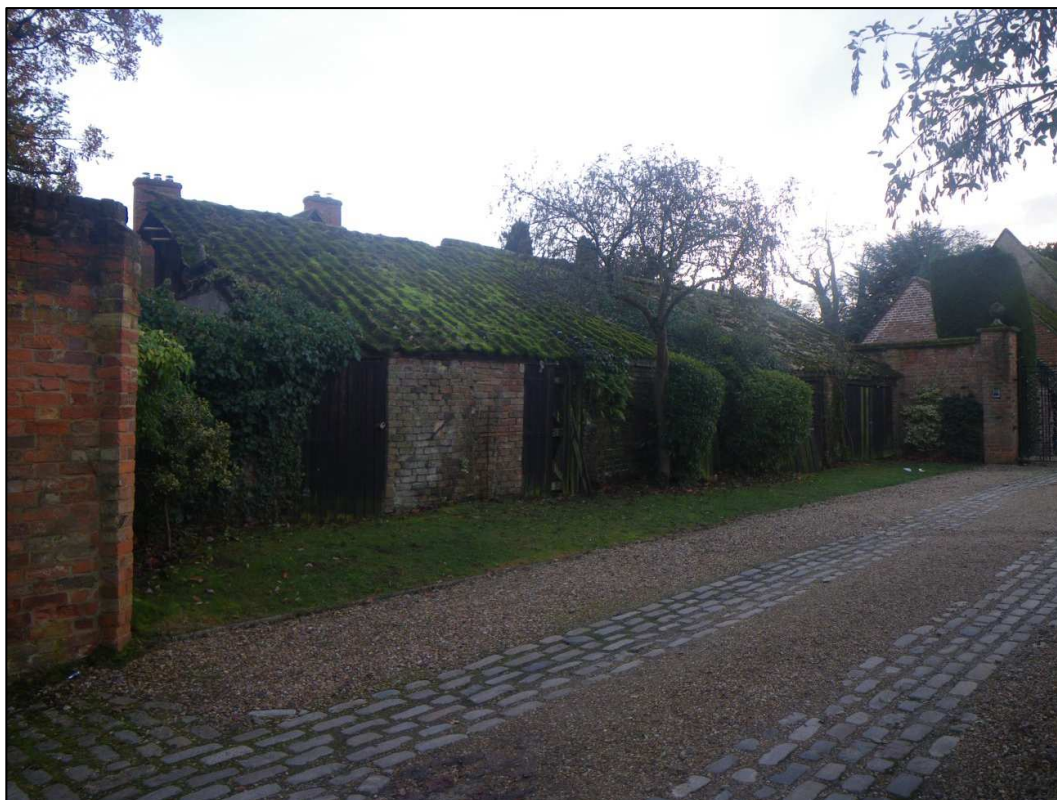
**Image 1:** Front of building prior to development  
(Looking south-west from gateway off Westoning Road. Photographed in 2013.)

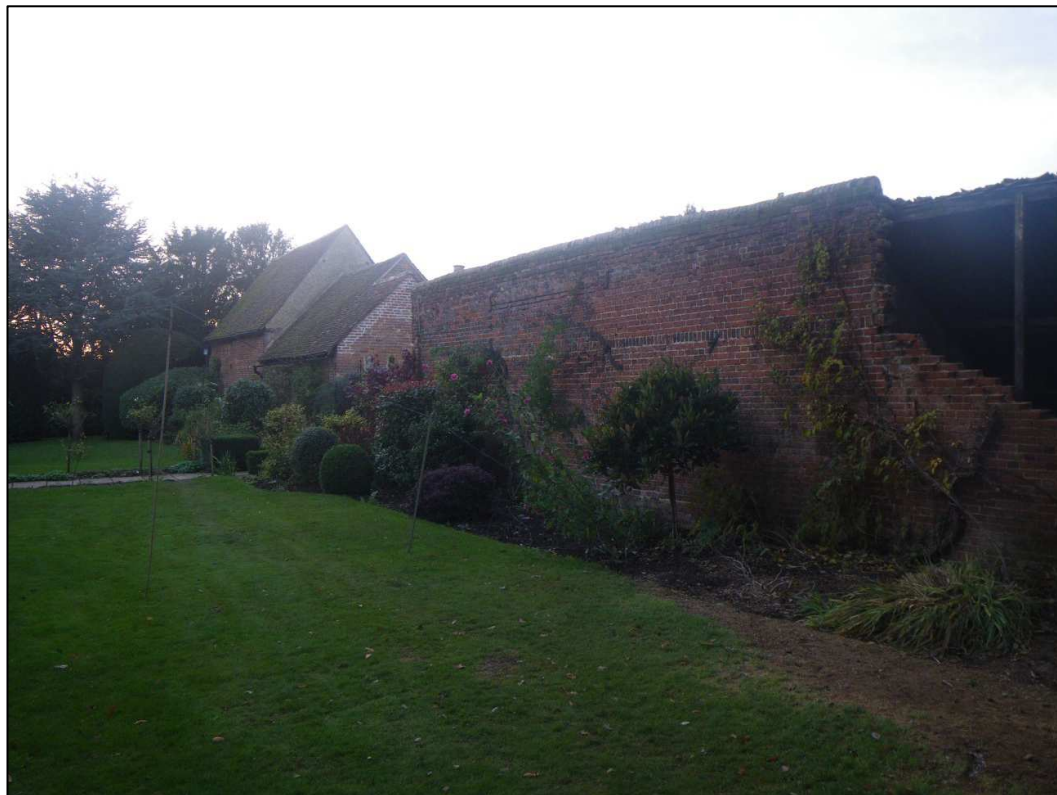
**Image 2:** Rear wall of building prior to development  
(View looking west from garden. Photographed in 2013.)

(Figure 4). In its final form the building had probably been subject to various alterations, which are hinted at by differences in the brickwork. The western gable wall was made from red brick, 50mm to 60mm thick, in Flemish garden wall bond. In the rear wall the brickwork consisted of Flemish bond in the lower two-thirds with English bond above, the two being separated by a rowlock course (Image 2). The internal dividing walls included some timber-framed partitions (Figure 3).

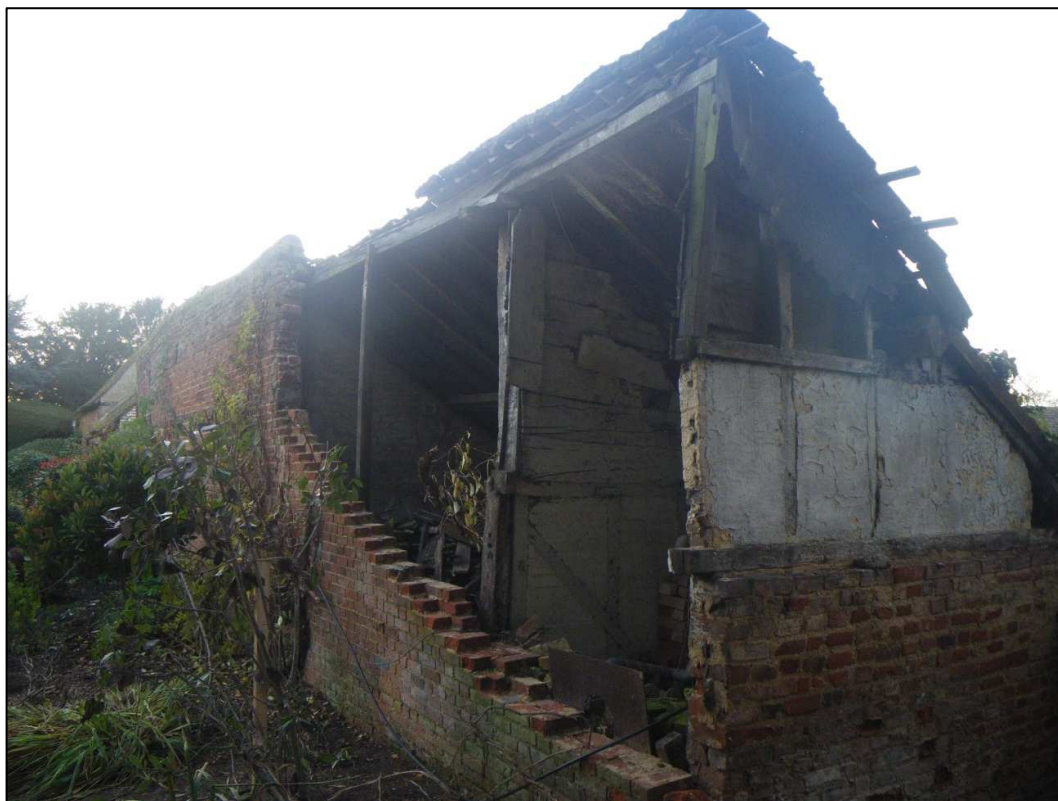
**Image 3:** East end of building prior to development  
(View looking west. Photographed in 2013.)

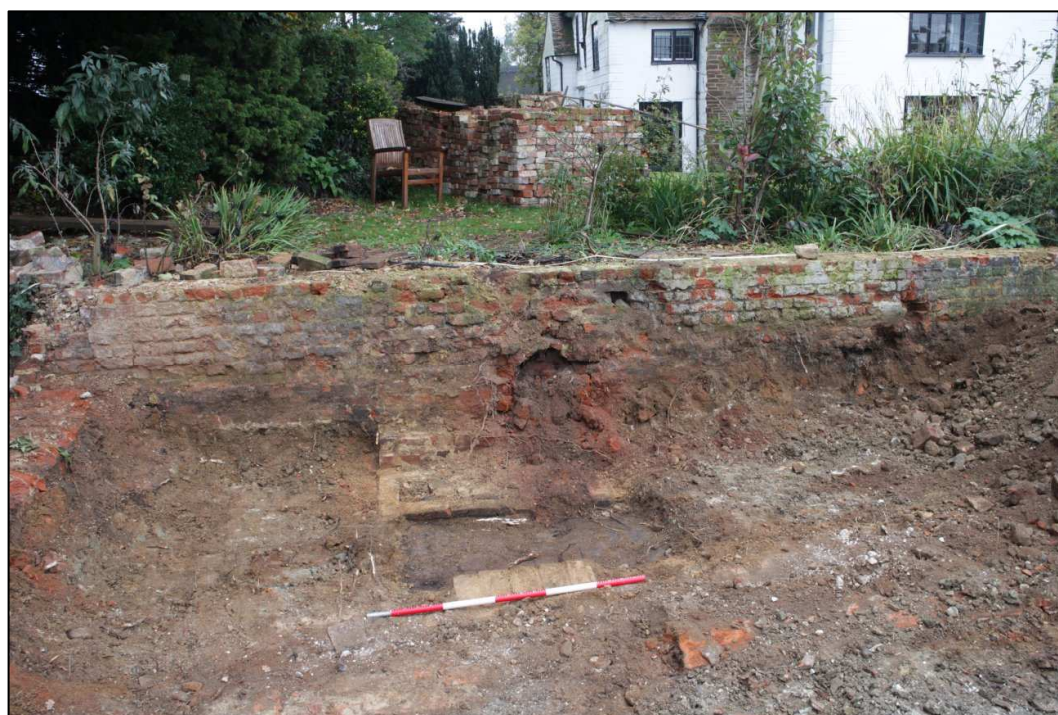
**Image 4:** Eastern end of trench, looking south  
(Shows hearth (9) with parts of wall (8) just visible in the foreground (scale 1m))

A brick hearth base (9) and surrounding wall (8) was found in the easternmost end of the trench. The hearth and wall were made from plain red bricks measuring *c.* 220mm x 105mm x 65mm.

The hearth base was located against the rear wall of the outbuilding. It was rectangular in plan, measuring 1.6m by 1.3m. It contained a 600mm-wide stokehole aligned parallel with the rear wall of the building. A 250mm-wide flue (towards the western end of the structure) extended into the rear wall of the outbuilding. Where it entered the rear wall it was covered by a semi-circular brick arch.

The hearth was set in a sunken area which had been cut into the undisturbed geology. It was enclosed on the north and west sides by a 220mm-thick (single brick) wall with a course of header bricks in the uppermost surviving course. The area enclosed by the wall measured 3.4m long by 2m wide. Its western side had been largely removed during demolition but a short section remained at the back wall of the outbuilding to indicate its location.

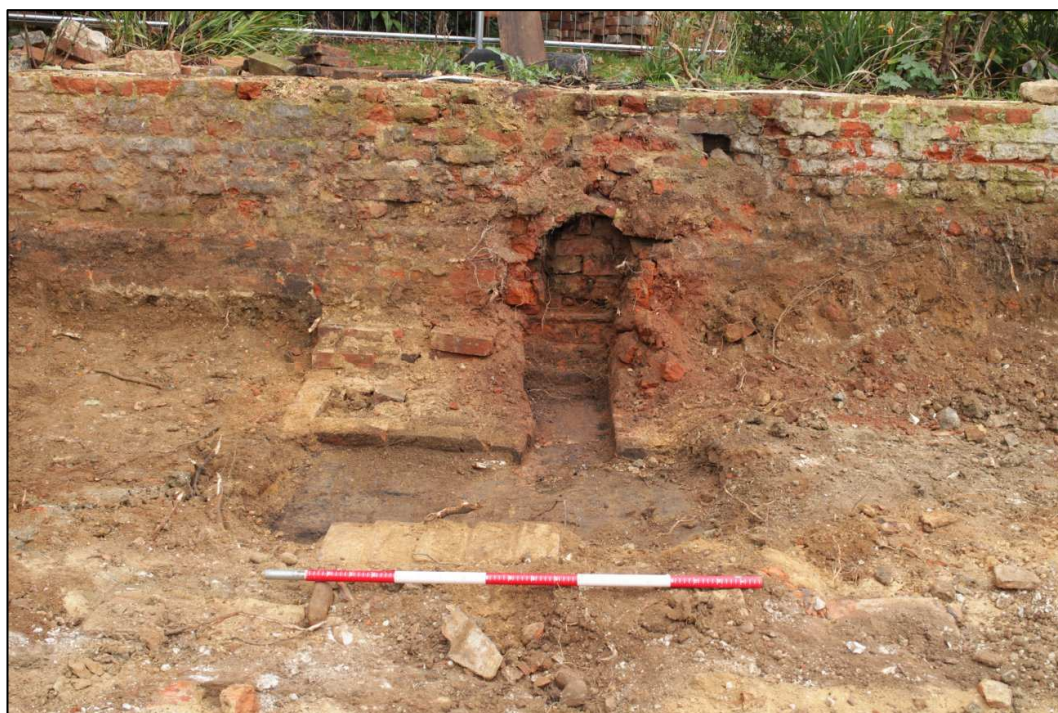
**Image 5:** Hearth (9), looking south-west  
(Shows stokehole parallel to scale and flue in rear wall (scale 1m))

The base of the stokehole and flue had a brick floor which was covered by a thin layer of charcoal and ash. The floor was located approximately 600mm below the modern ground level. The arrangement of the stokehole and flue suggests that the stokehole would have been fired from its eastern end. The western end also appeared to be open at this level but it is possible that brickwork at this end had been removed during demolition.

A brick hearth found towards the eastern end of the building was contemporary with the use of the outbuilding. It appears to be the base of a furnace that would have been used to heat a greenhouse, formerly located next to the outbuilding. The Ordnance Survey map of 1882 shows a rectangular outline against the south side of the outbuilding (Figure 4) and in the subsequent 1901 edition the outline is cross-hatched, indicating a greenhouse. The hearth was found below ground level, surrounded by a brick retaining wall. A flue from the hearth passed through the rear wall of the outbuilding at a level suitable for heating pipes located just above floor level in the former greenhouse.

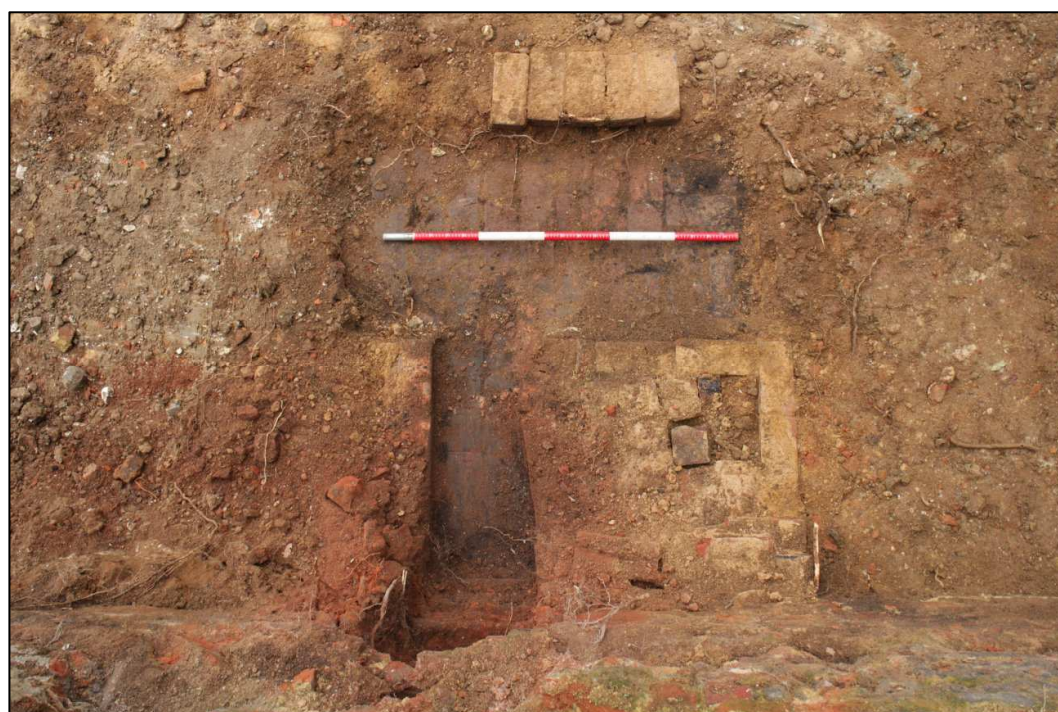
**Image 6:** Hearth (9), vertical view  
(Rear wall of building at base of image (scale 1m))

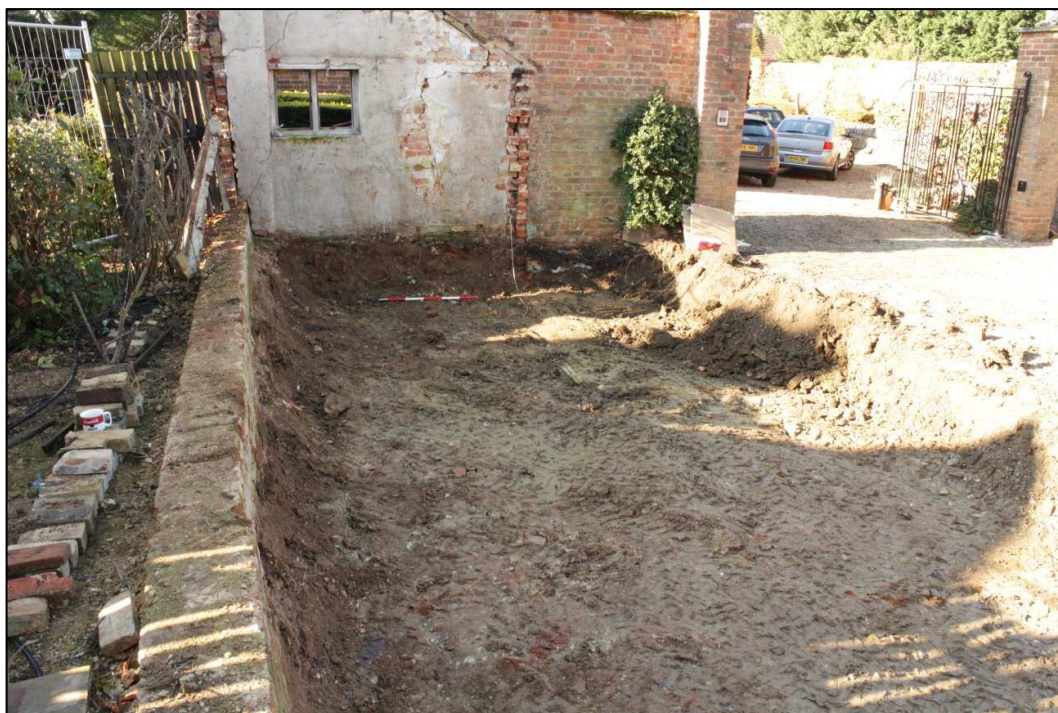
**Image 7:** Western end of trench  
(View looking towards west end of trench following completion of machine excavation (scale 1m))

After the demolition of the existing outbuilding the internal concrete floors were broken up and removed and the ground beneath was reduced using a mini-digger fitted with a toothless bucket. The ground reduction took place under archaeological supervision between 20th and 26th October 2015. The completed trench was 18.7m long, 5m wide and up to 600mm deep.
