WOLVERTON PARK, MILTON KEYNES

**A PROGRAMME OF ARCHAEOLOGICAL AND
ARCHITECTURAL INVESTIGATION
OF THE
ROYAL TRAIN SHED
TRIANGULAR BUILDING
AND READING ROOM**

Project: WP1213

Document: 2008/92
Version 1.1

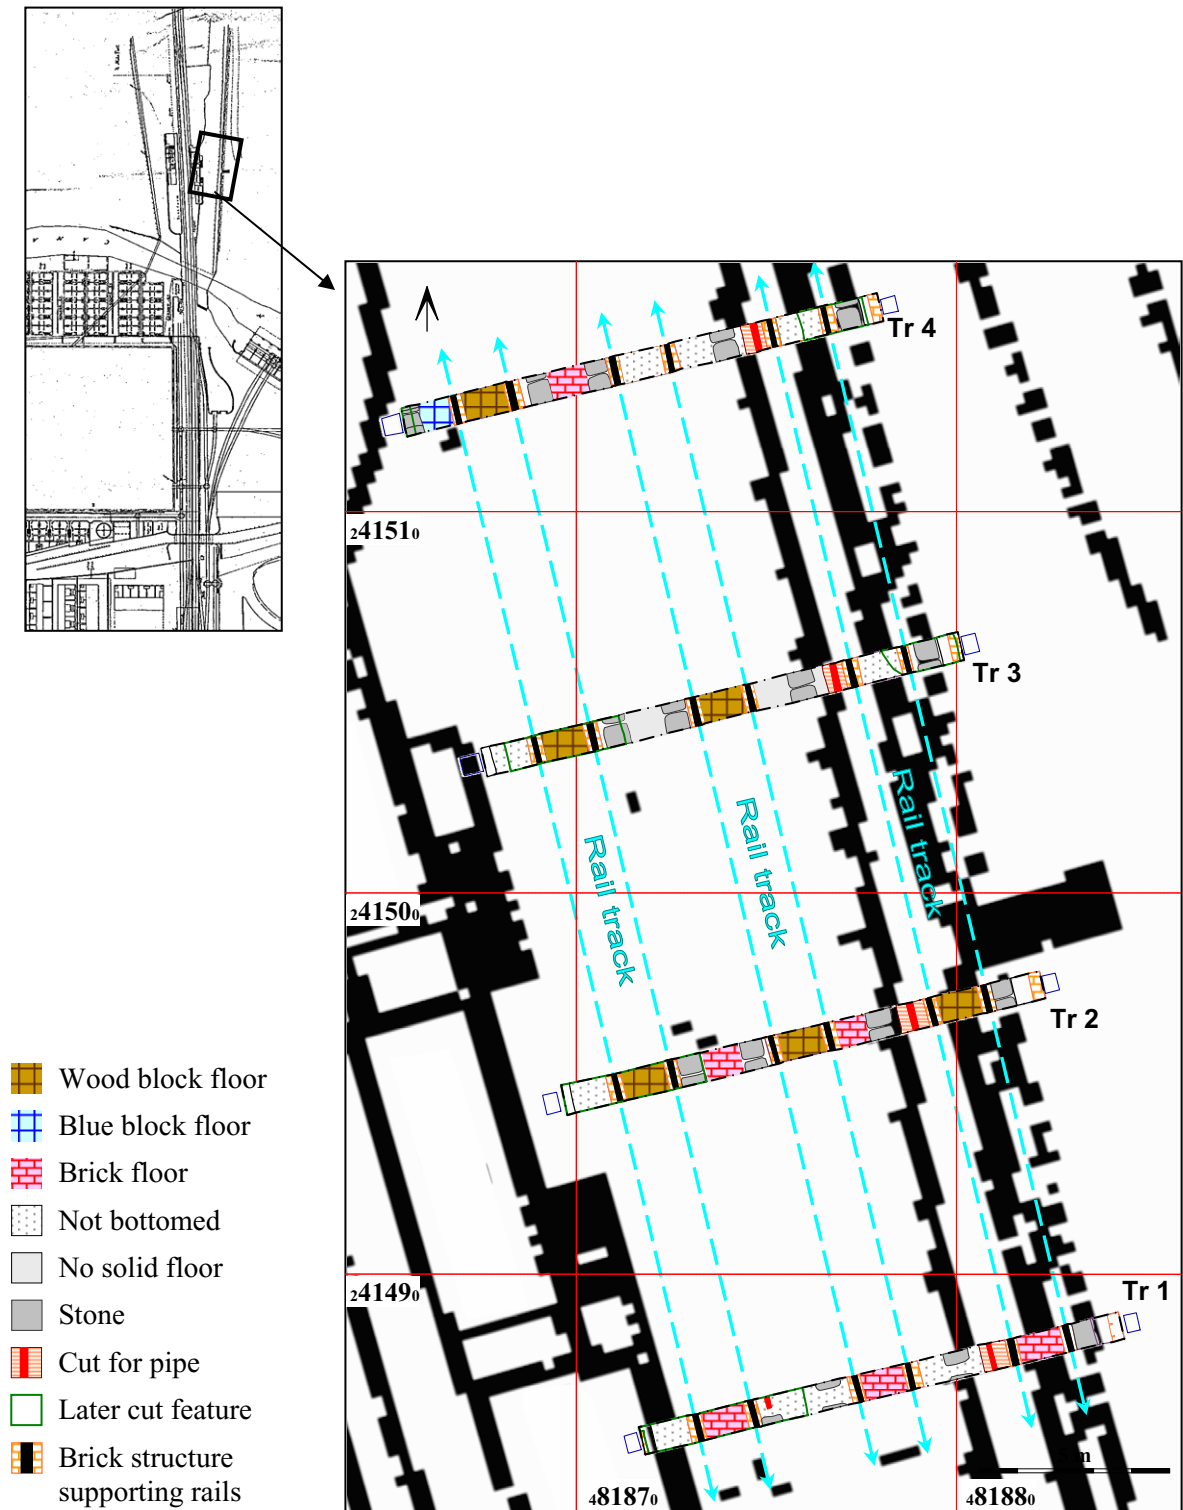
Figure 23: Sondage trenches within Royal Train Shed overlaid on modern OS map

Four sondage trenches were excavated by Willmott Dixon in the southern 40m of the Royal Train Shed in order to investigate ground conditions (Figure 23). The trenches were excavated by a tracked mini-digger with a toothless ditching bucket under constant archaeological supervision. The sondage trenches were situated on an east-west alignment and measured c.13m in length and 0.80m in width. Archaeological observations were recorded in plan and in section (Figure 24 and Figure 25).

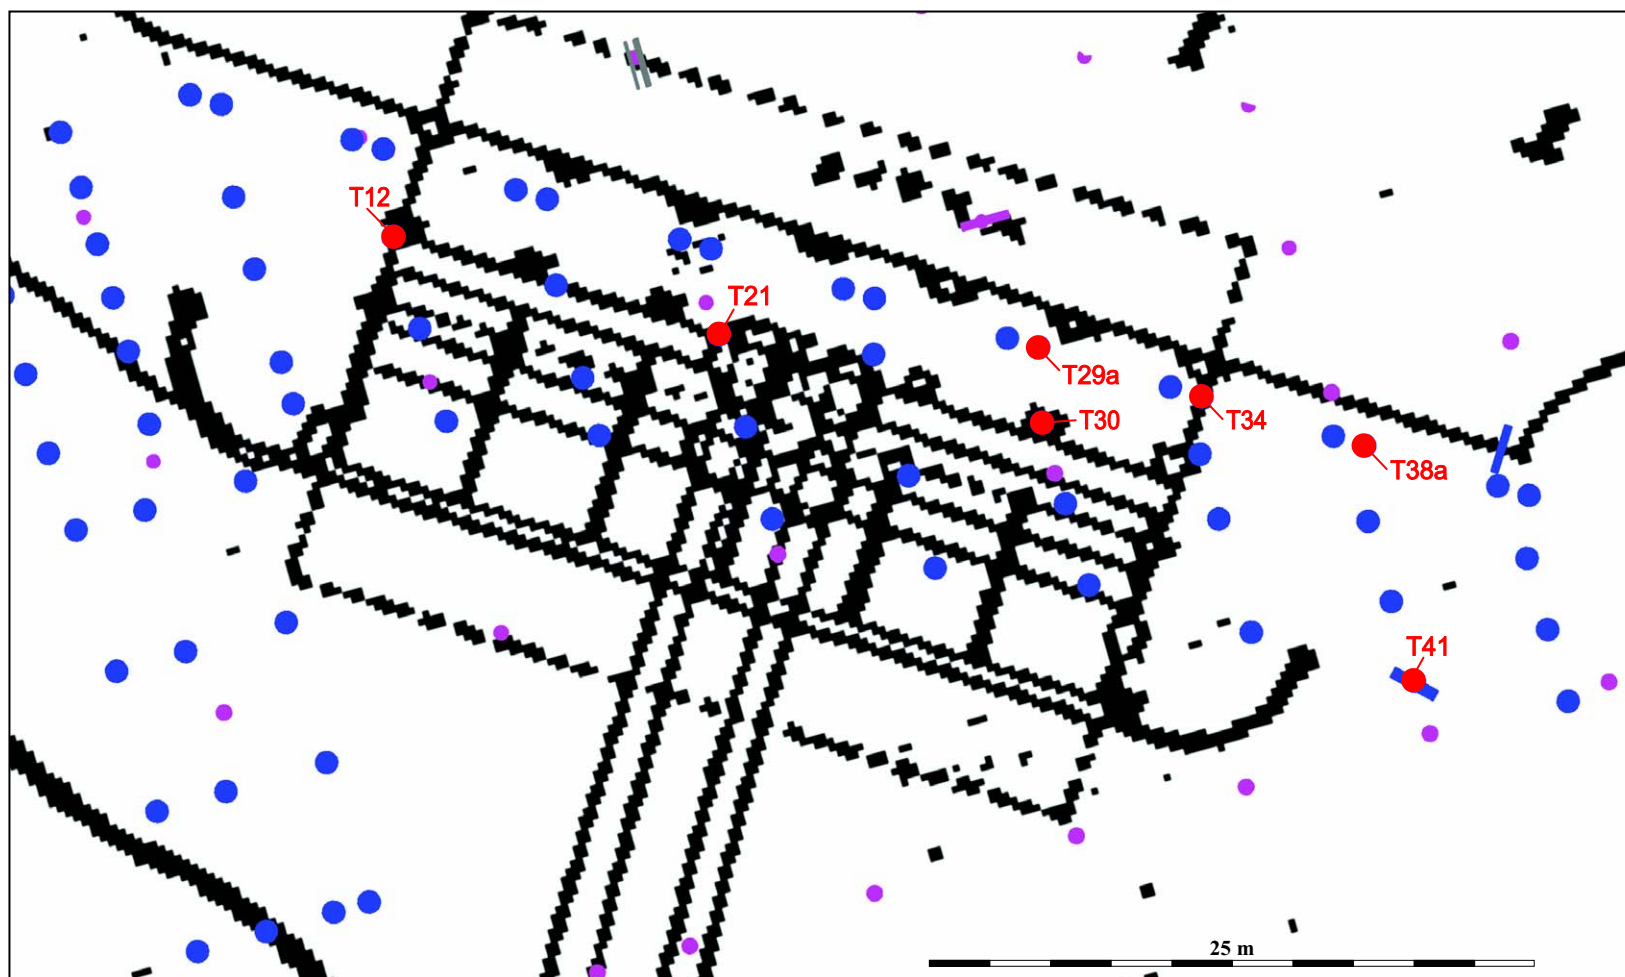
Figure 26: Location of piles in relation to 1840s wharf building on site of Triangular building (numbered piles are described in pile logs in Appendix 1)

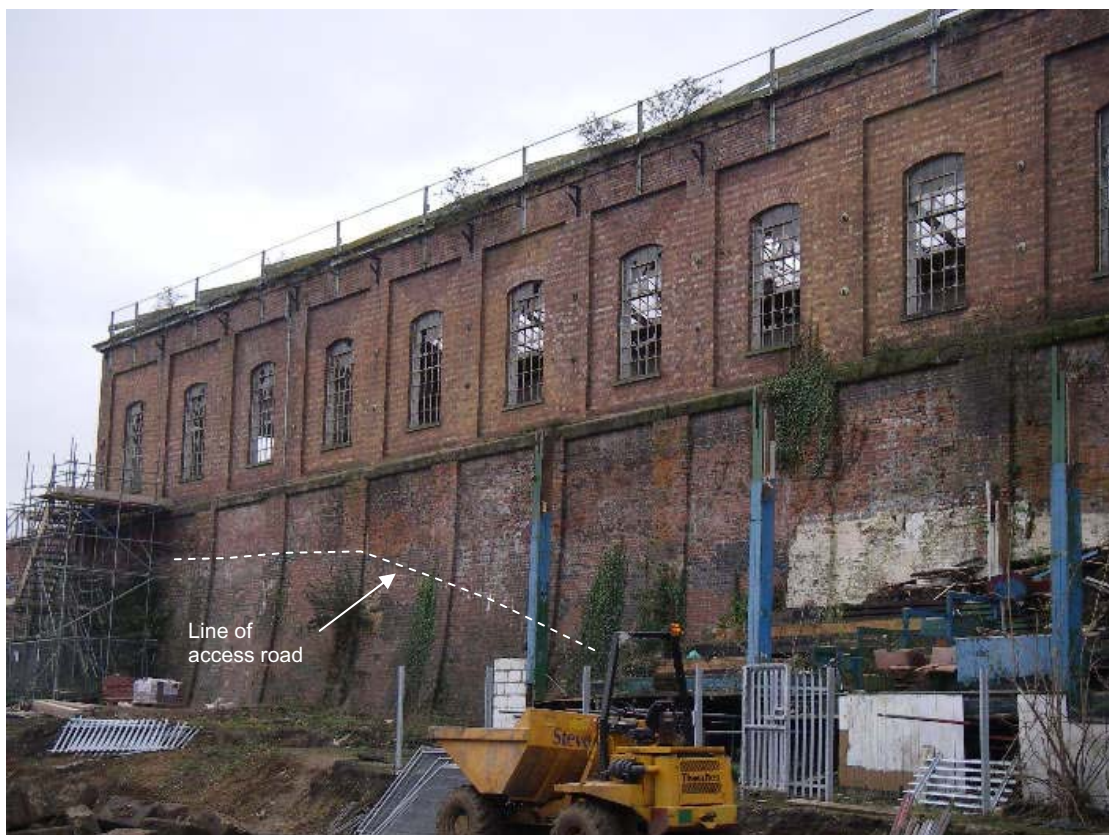
Figure 28: Retaining wall of Wolverton Station showing line of old access road as different coloured bricks

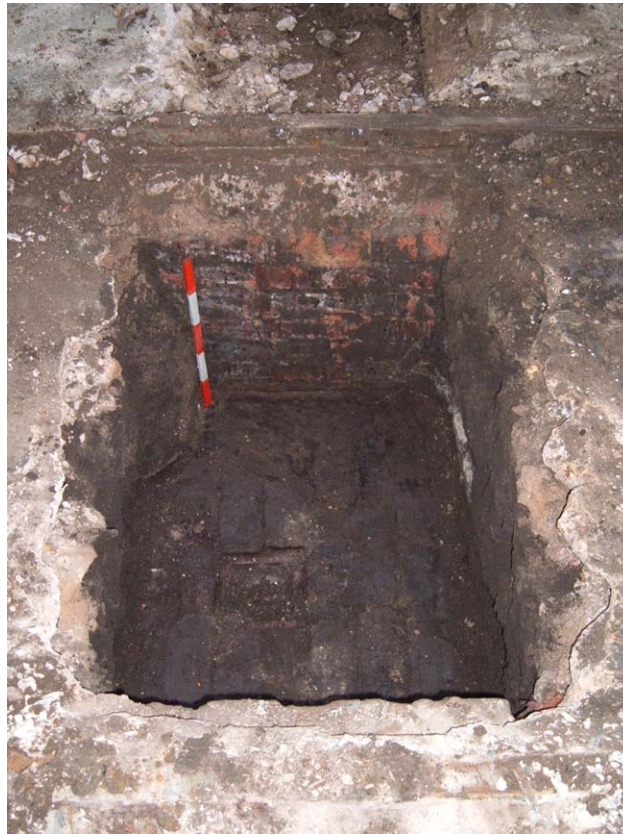
Figure 29: Inspection pit of carriage shed that is now the Royal Train Shed (looking West). Showing brick built foundation with steel rail and brick floor.

Three phases of track construction were visible in the trenches. The first phase consisted of possible track foundations in the form of large sandstone blocks, spaced c. 1.5m apart. The uppermost of the sandstone blocks may have carried a steel rail. Some remains of brick paving were recorded between the corresponding foundations, suggesting that they were pit roads for the inspection of the carriages and their running gear (Figure 29).

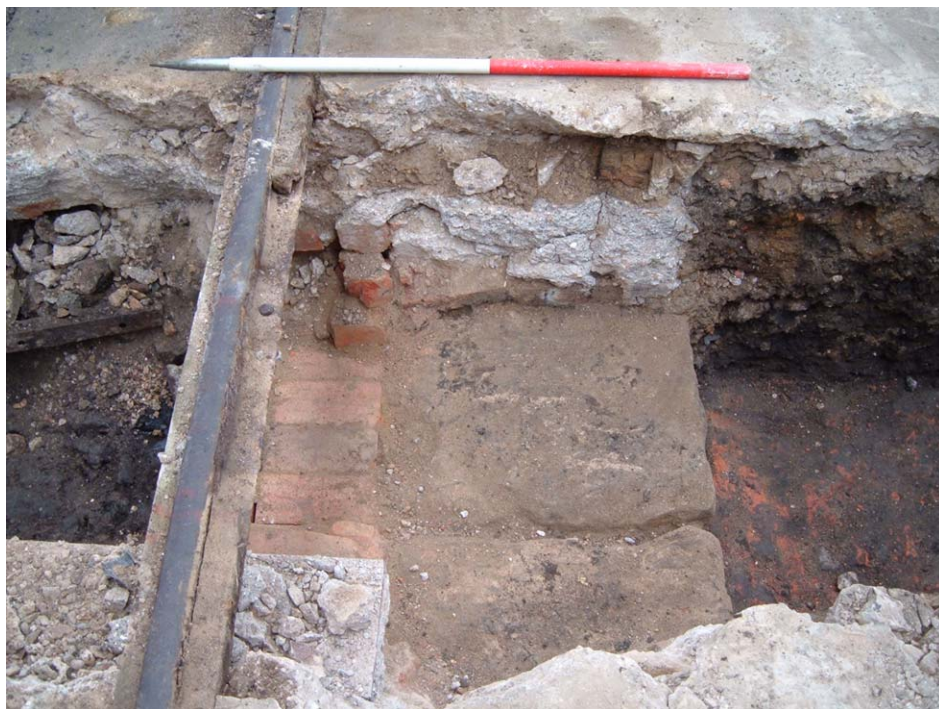
Figure 30: Sequence of rail foundations in Royal Train Shed. The sandstone blocks visible to the right are replaced by a brick-built foundation with steel rail.

In most of the trenches the early sandstone track foundations had been partially damaged by new brick-built track foundations, again most likely for the tracks of the new lifting shed. The new tracks had been shifted slightly over to the east but were also spaced c. 1.5m apart. Remains of brick and wooden block paving survived between the corresponding brick walls (Figure 30). Again, all tracks were in the form of pit roads.

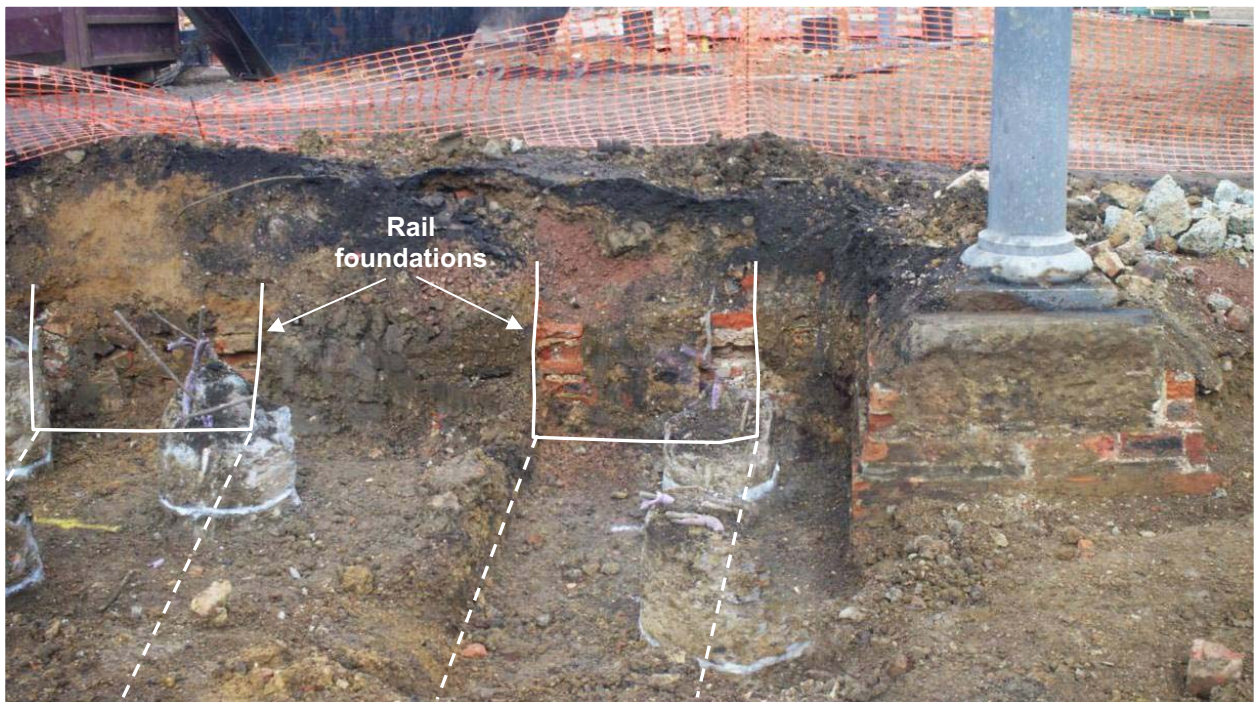
Figure 31: Deposits below floor of Triangular building, looking North. Showing rail foundations for parallel tracks and brick foundation for cast iron column.

In places the large foundation blocks for the cast iron columns that supported the roof trusses had been exposed (Figure 31). These consisted of a large, square sandstone block that was in turn imbedded within a brick foundation. The brick foundations measured >1.05m in height and width. The brick courses were gradually stepped out until the full width of the base was reached. They were built of red brick with a singular band of blue brick running around the foundation one course below the stone block.

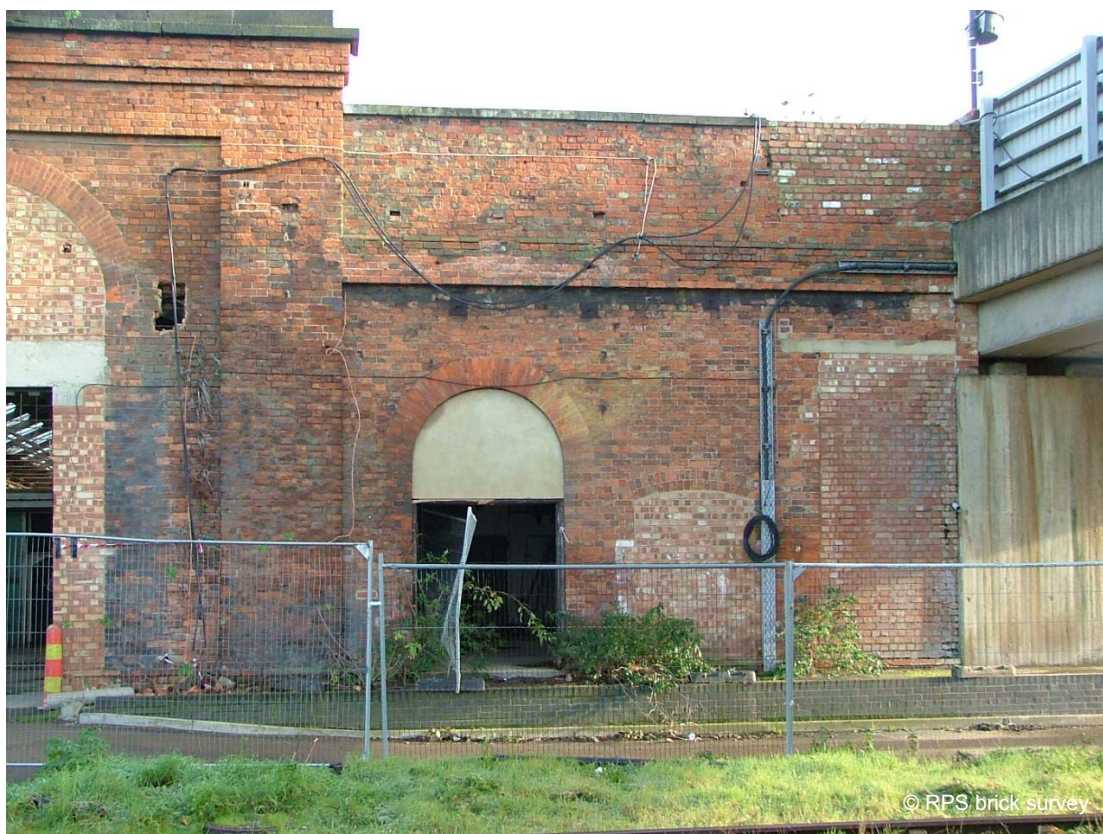
Figure 32: Arched wall foundation in eastern external wall of Triangular Building

Short sections of the lower outer wall foundations of the Triangular Building were also exposed. These were observed during one visit by the Milton Keynes Conservation Officer Simon Peart and also on a later visit by an Albion Project Officer (Figure 32).

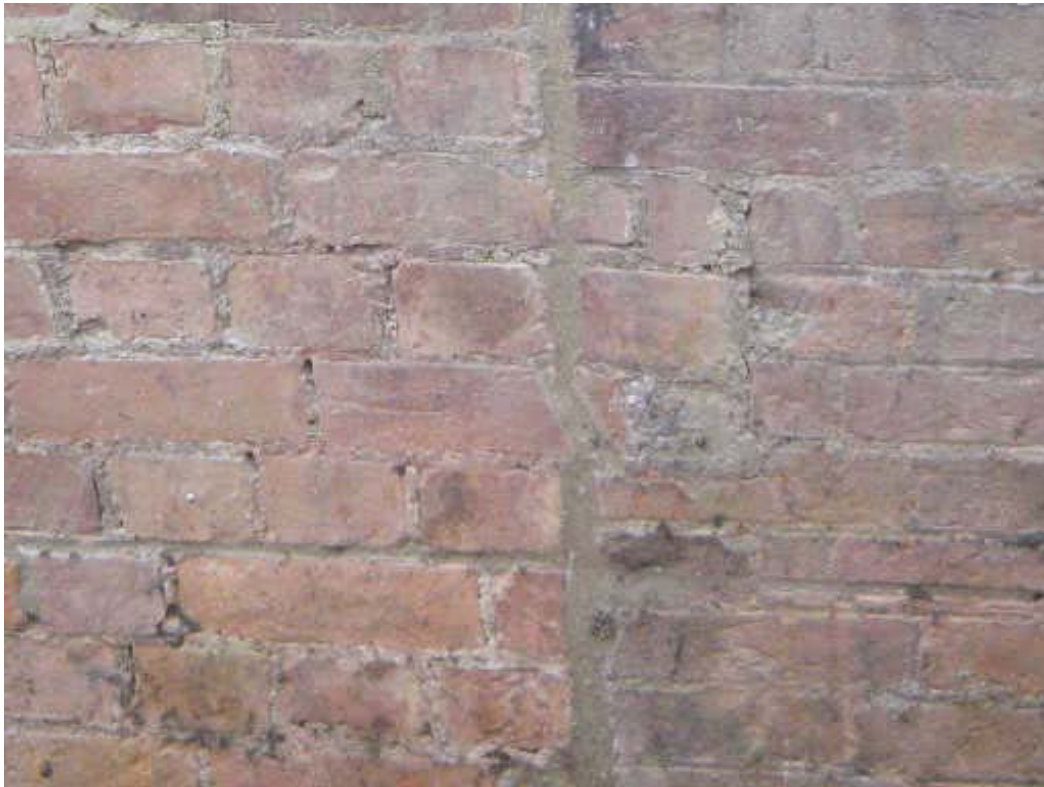
Figure 37: Reading Room building seam from original building (right) to extension (left)

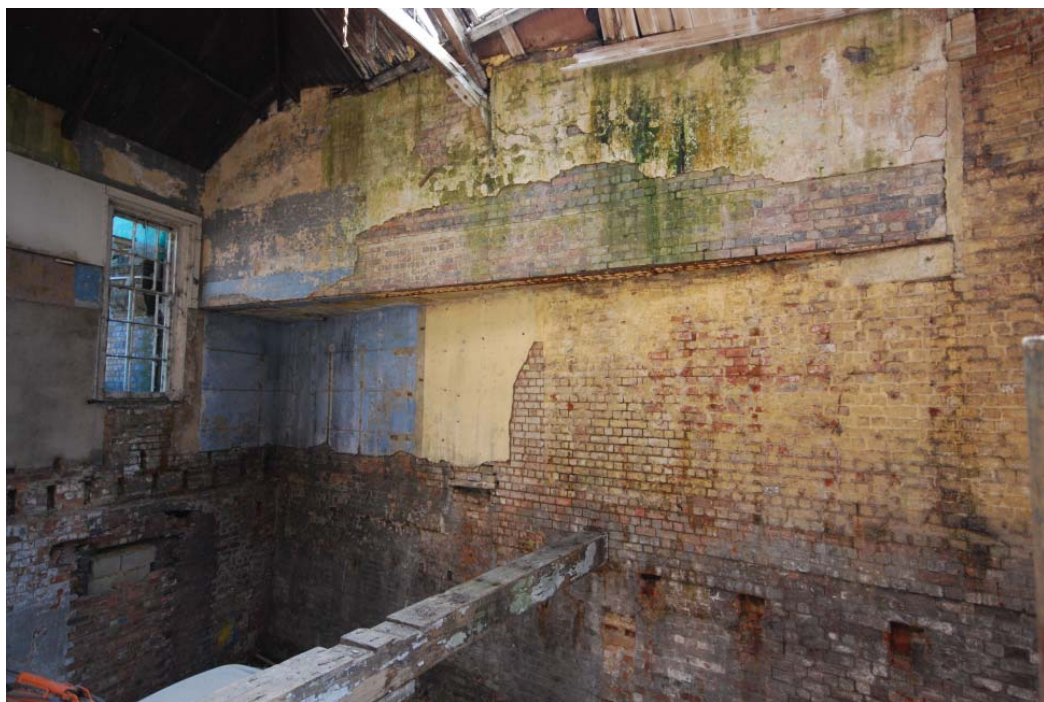
Figure 38: Reading Room southern wall, showing insertion of widened Stratford Road.

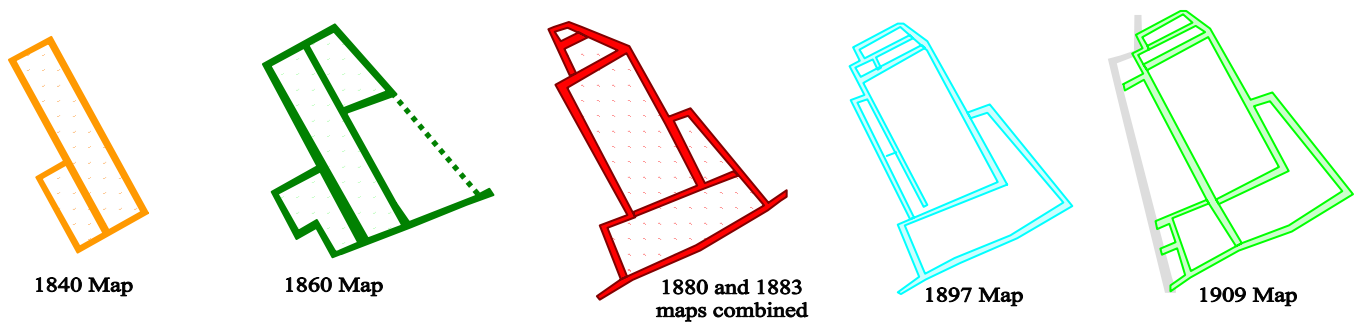
Evolution of Reading Room as seen from historical maps

Dates of surviving walls in existing building

The Reading Room has undergone considerable alterations during its history and due to the fragmented survival of the building and its state of repair, certain parts of its evolution are difficult to reconstruct. Figure 47 gives an indication of the development of the Reading Room and its constituent parts and which elements survive within the fabric of the present building.
