**LAND AT BRIDGE FARM  
BEDFORD ROAD  
SANDY  
BEDFORDSHIRE**

**ARCHAEOLOGICAL OBSERVATION  
INVESTIGATION, RECORDING, ANALYSIS  
AND PUBLICATION**

Project: BF1979  
Museum accession no.: BEDFM 2015.51  
OASIS ref.: albionar1-214724

Document: 2015/176  
Version 1.0

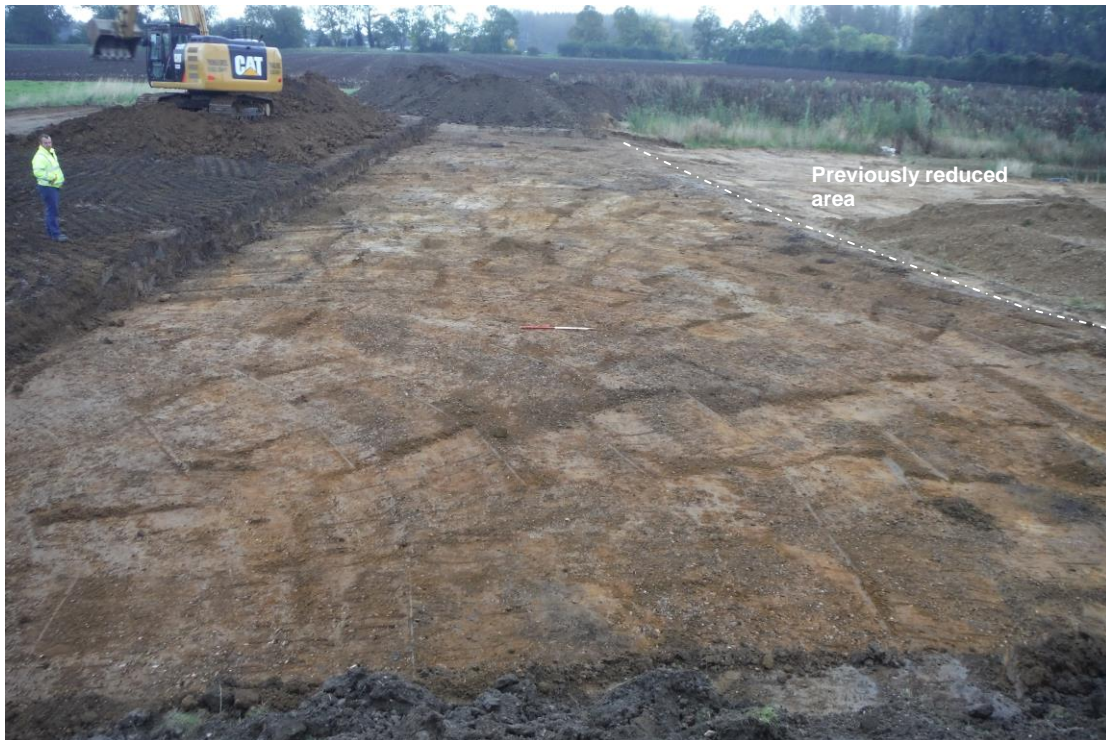
Excavation of the remaining area of the lake under archaeological supervision revealed no archaeological features. An elongated curvilinear tree bowl with a dark blackish fill was the only feature present.

Overburden consisted of a friable dark red-brown clayey silt topsoil with moderate small and medium-sized stones (100). It was *c.* 280mm thick. Below this was a subsoil (101) of friable mid brown-orange clayey silt gravel that was *c.* 320mm thick.

Undisturbed alluvial deposits (102) comprised a brick-orange gravel with large orange-yellow patches of clayey.

**Figure 3:** Newly excavated area, looking south (1m scale)

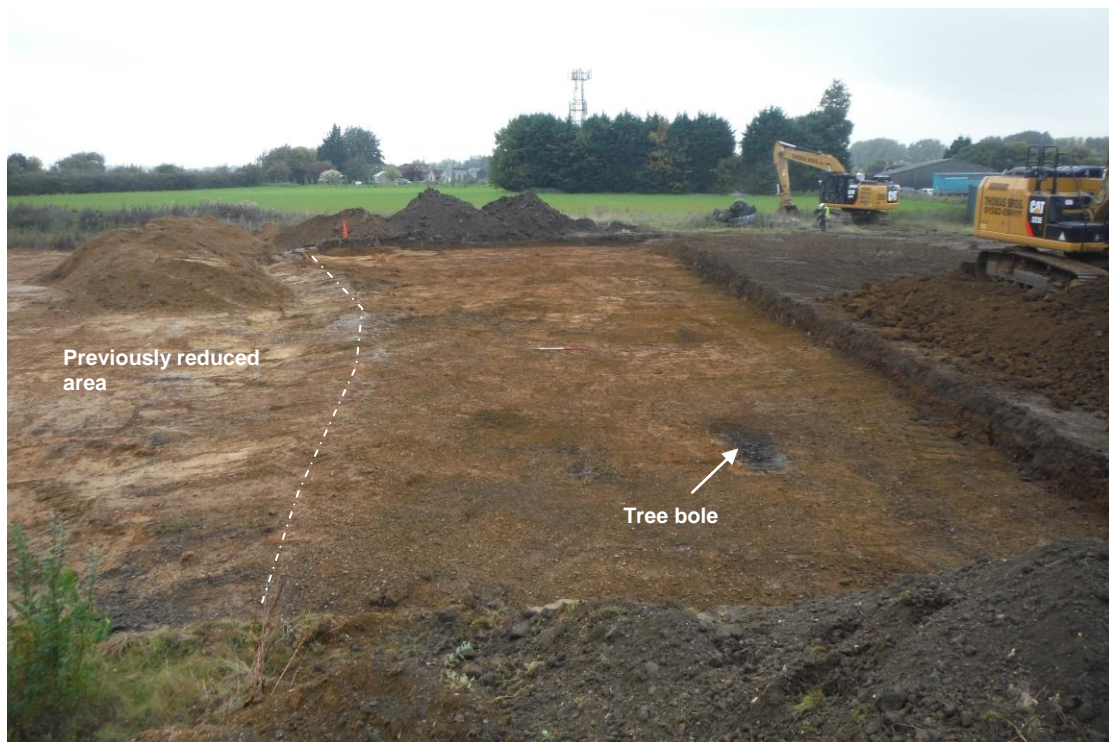
**Figure 4:** Newly excavated area, looking north (1m scale)
