**LAND AT 52 LONDON ROAD
SANDY
BEDFORDSHIRE**

HISTORIC BUILDING RECORDING

Document: 2015/152
Version: 1.0
23rd November 2015

Project: LRS2458
Bedford Museum Accession Number: BEDFM 2015.66
Oasis reference: albionar1-222238

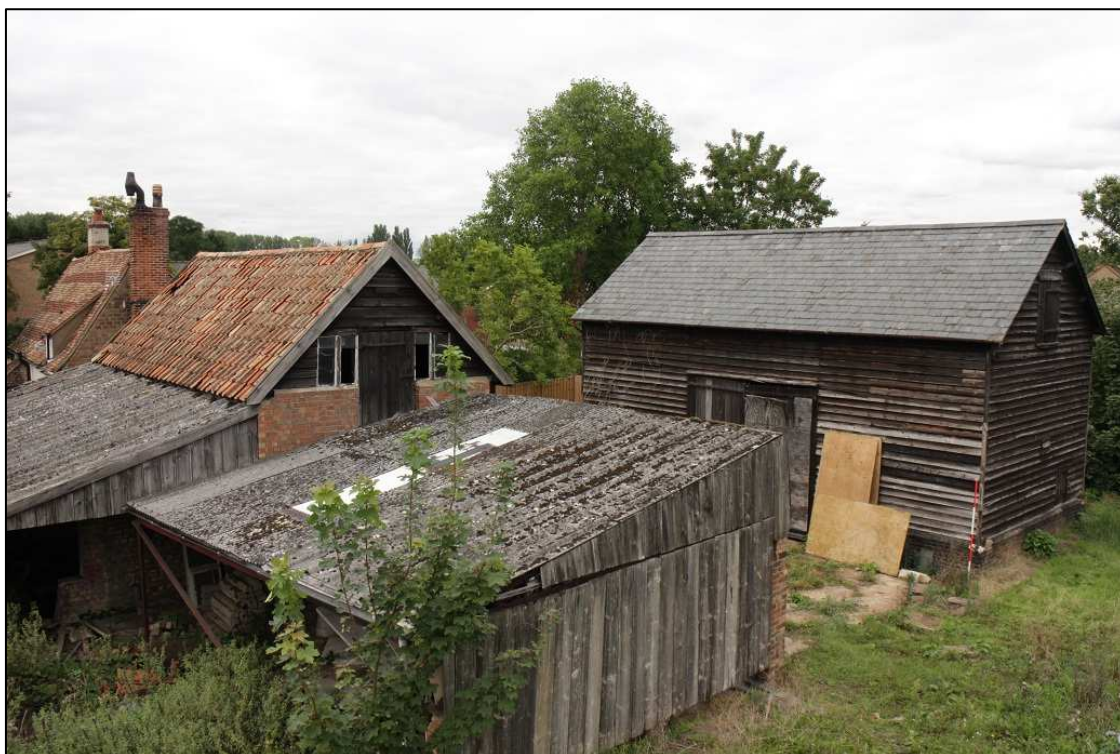
Image 1: Barn and cart shed viewed looking north-west

Overview of site taken with a camera pole (2m scale)

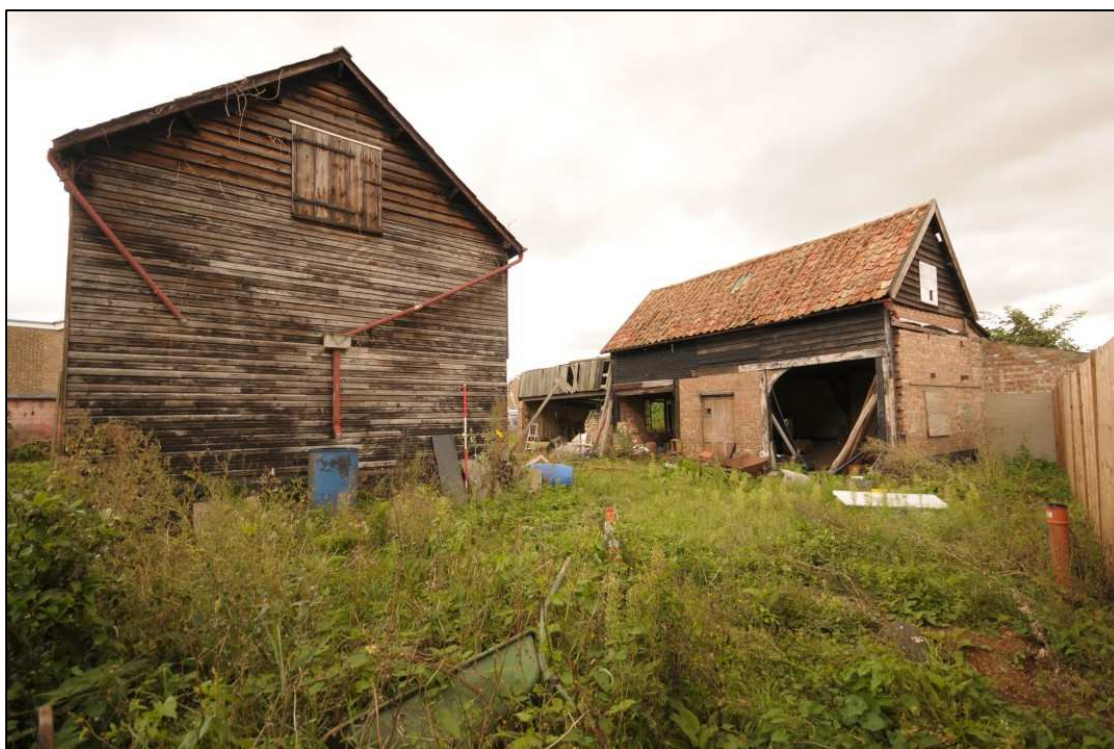
Image 2: Barn and cart shed viewed looking south-east

Showing west end of barn at left and cart shed at right

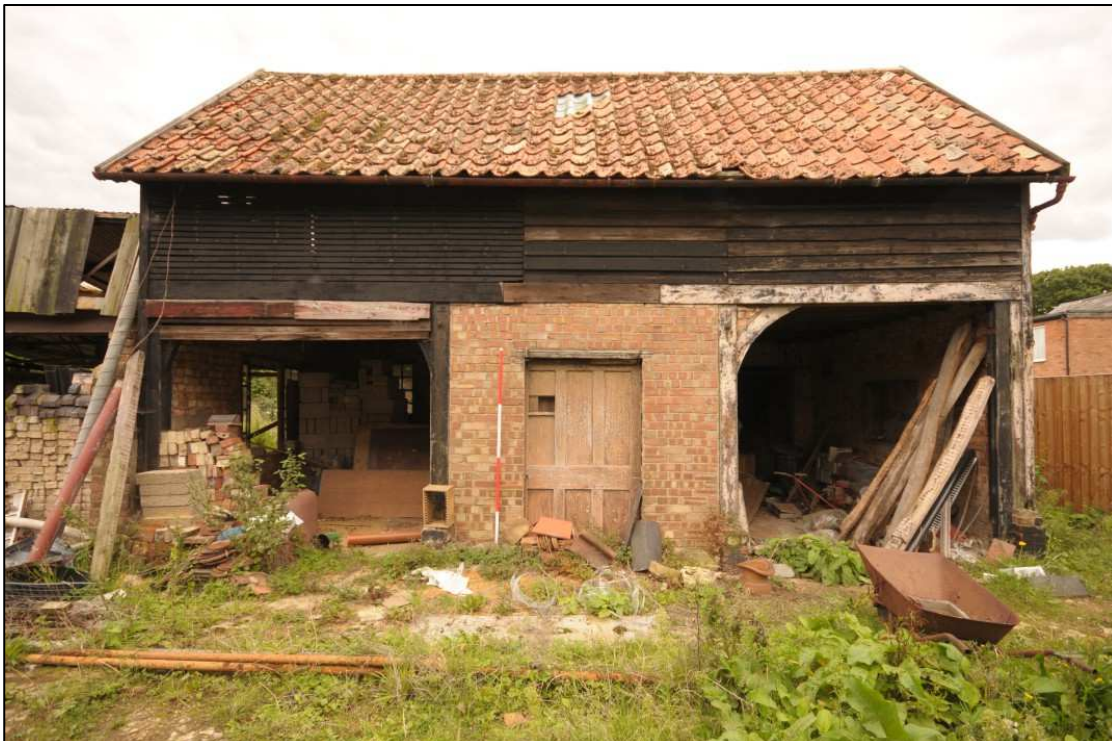
Image 4: Cart shed; front (north) elevation

Image shows open-fronted east and west bays with modern brick infill in central bay.
The loft above has a slatted ventilation wall above the east bay. (2m scale)

The primary structure is a three-bay cart shed with an open-front on the north side (Image 4). As first built, it would have been a fully timber-framed structure standing on a brick sill wall. During later alterations the walls were infilled with brick; parts of the frame were removed during this process.

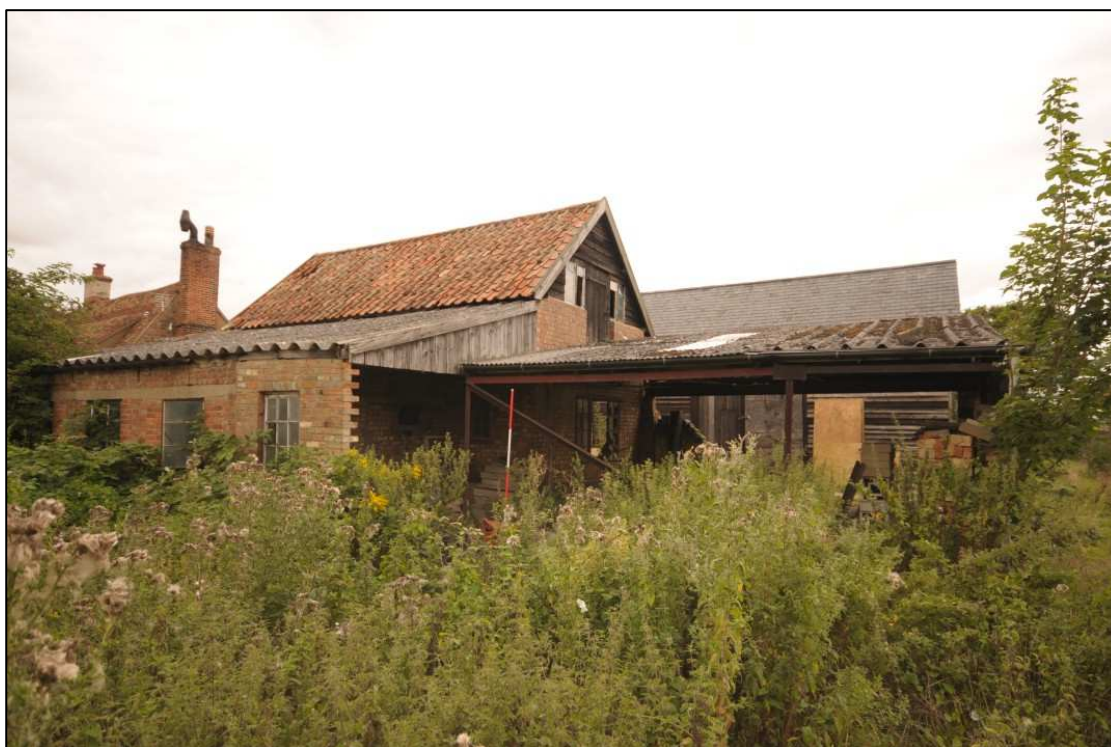
Image 5: Cart shed and extensions viewed looking north-west
Shows open east extension to right and brick south extension to left

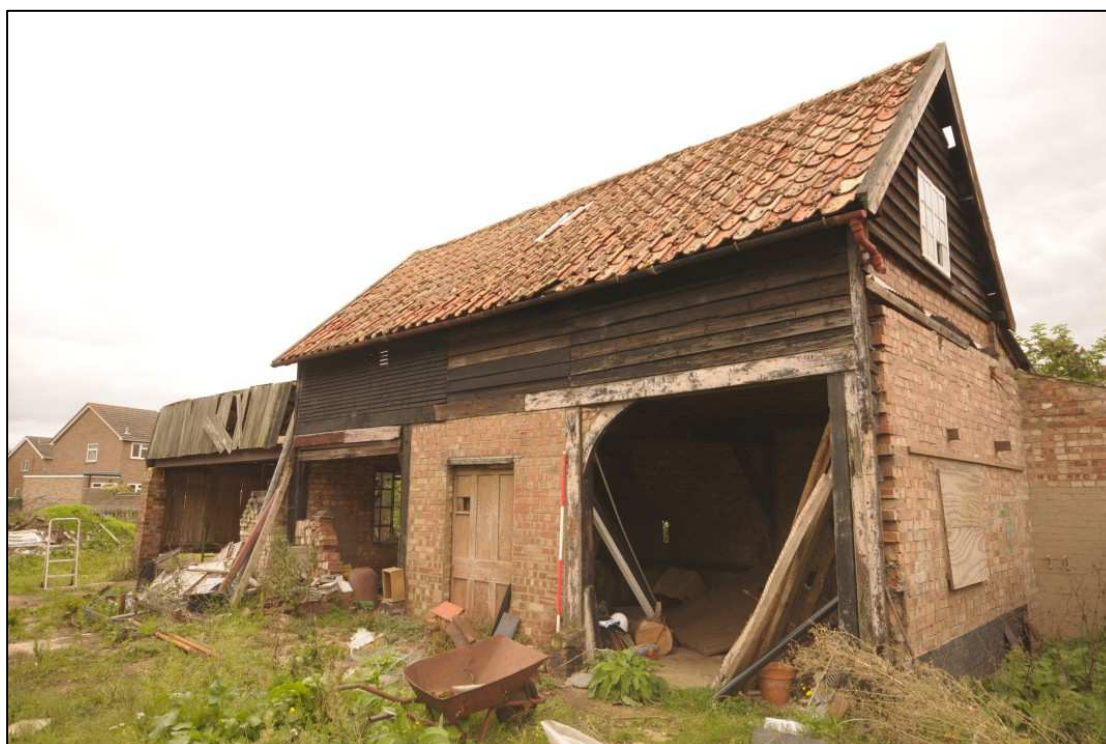
Image 6: Cart shed viewed looking south-east

Brick infill of a former west extension is visible at the right of the image. Above that is the window in west end of the onion loft over the cart shed. (2m scale)

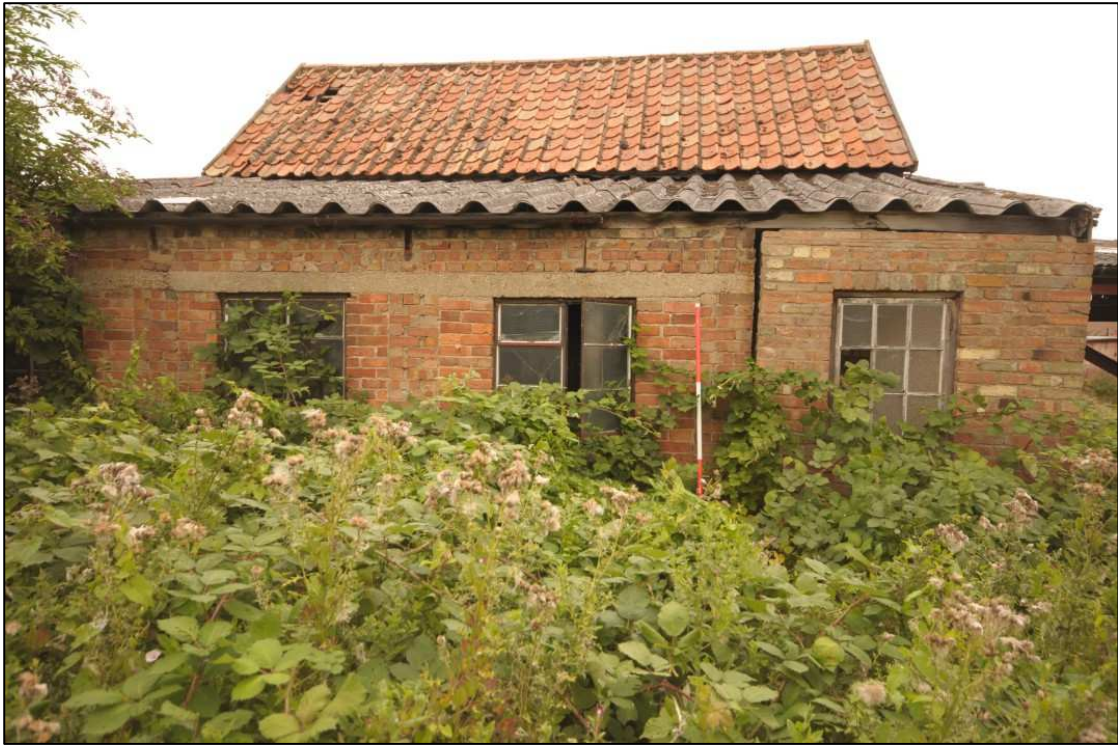
Image 7: South extension to cart shed, viewed looking north

Shows concrete lintel and metal-framed windows in main section with smaller, later addition to the right

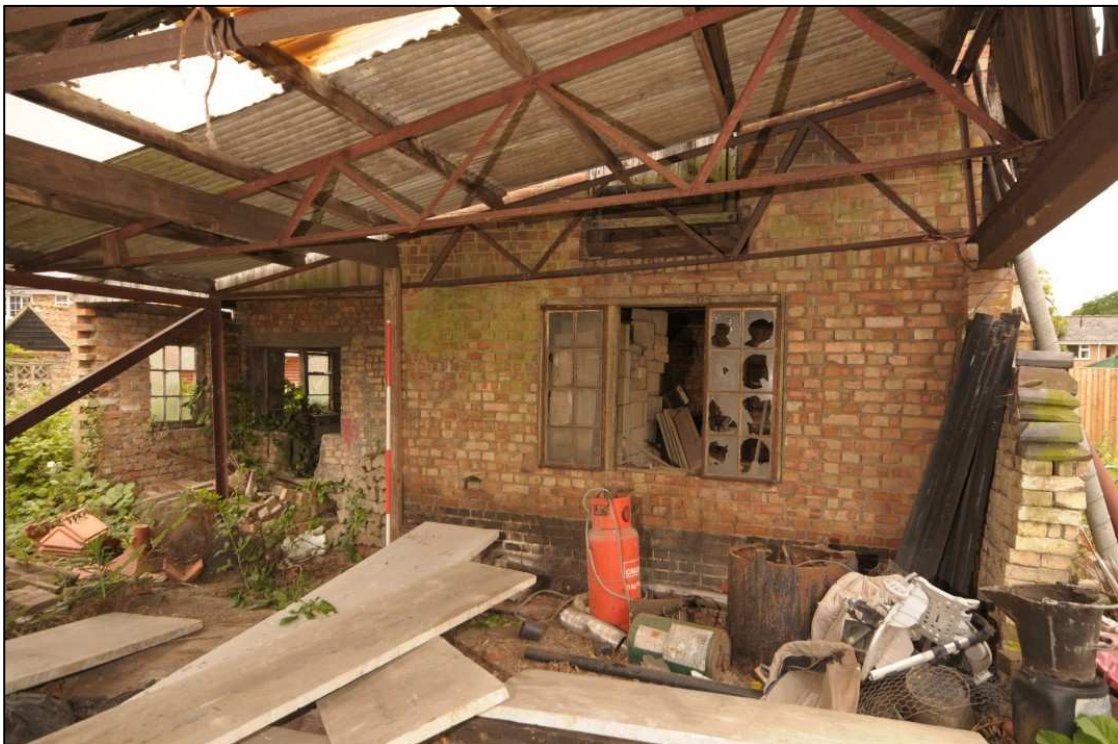
Image 8: Interior of east extension and east end of cart shed

The dark brick at the base of the wall is the original sill wall of the cart shed. The lighter coloured brick above is later infill using Fletton brick. (2m scale)

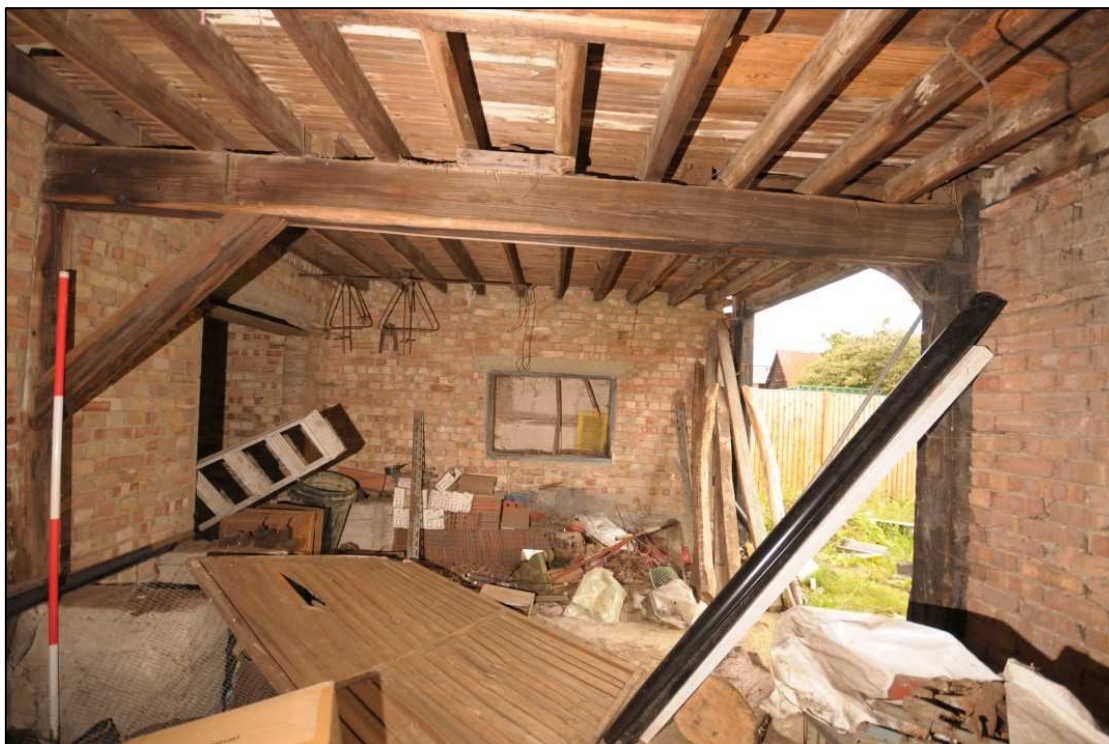
Image 9: Interior of cart shed, view looking west

Shows inserted Fletton brickwork in west end, rear wall and central front bay.

The principal elements of the frame consist of four trusses which form the end walls and the two internal bay divisions (Images 9–12). Parts of the trusses in the end walls and any intermediate wall-framing have been lost when the walls were later replaced in brick. The trusses forming the bay divisions survive intact with the posts in the rear wall embedded in the later brickwork.

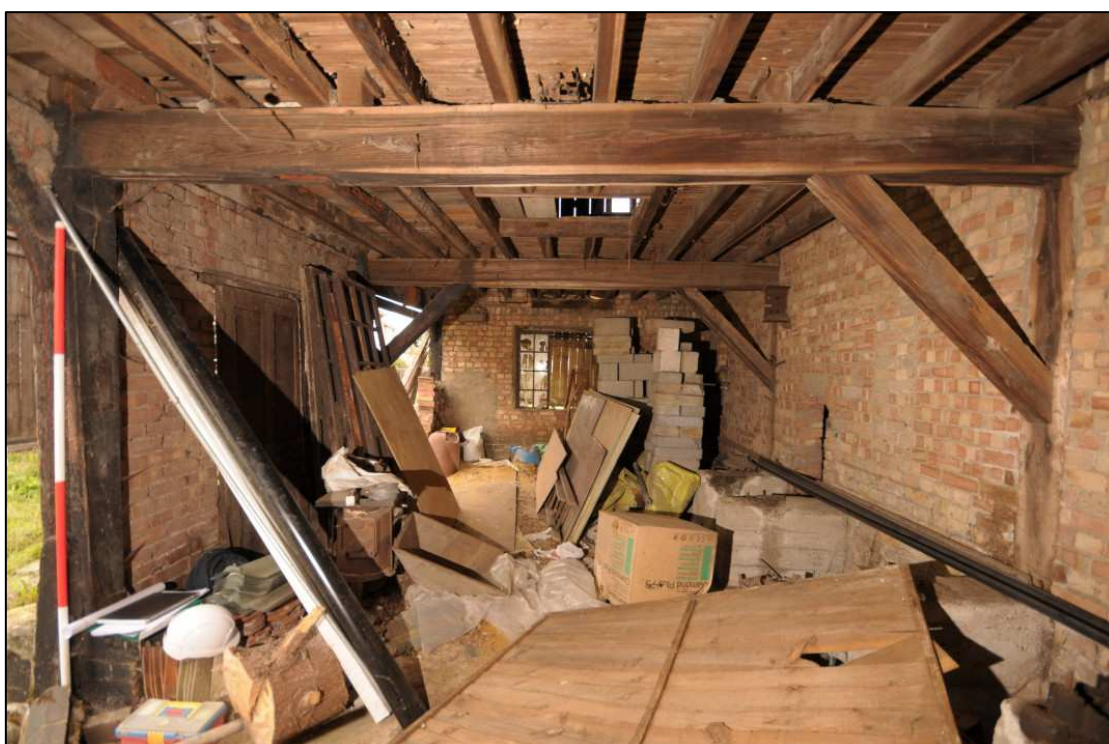
Image 10: Interior of cart shed, view looking east

Shows inserted Fletton brickwork in walls. Concrete bases visible next to the rear wall (right hand of image) are supports for line-shafting to power machinery. (2m scale)

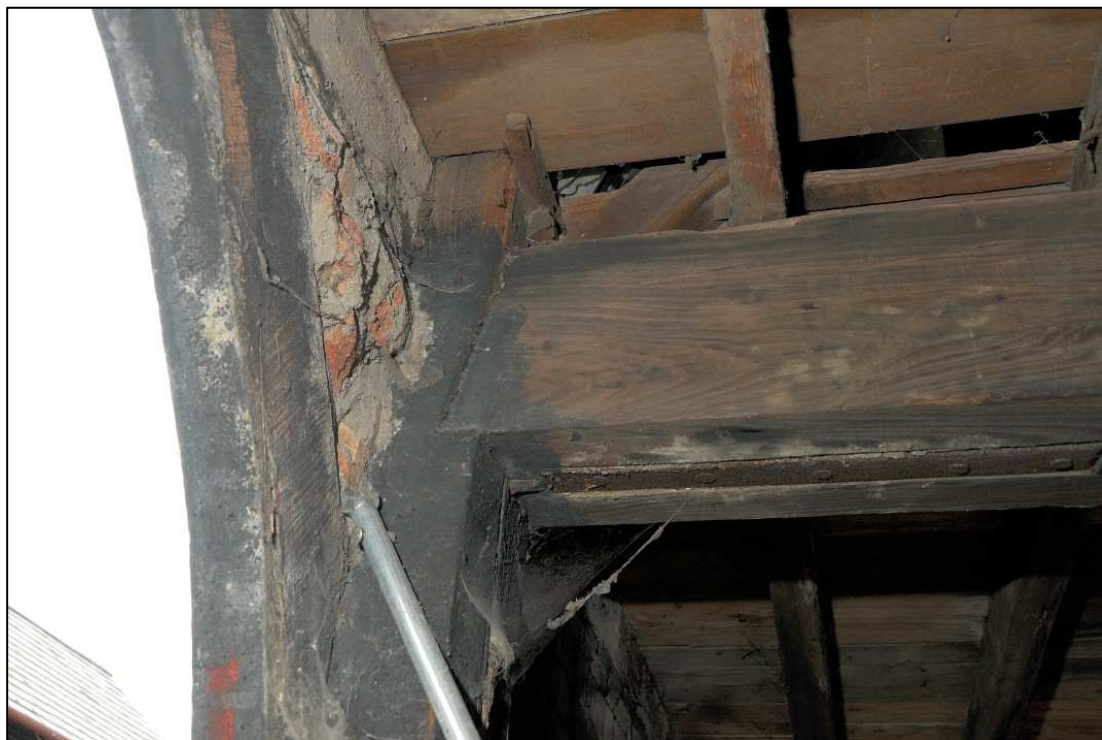
Image 11: Interior of cart shed, showing construction details

Shows beam mortised into post with diminished haunch. The two are fixed with a bolt, the flattened inner end of the bolt being visible on the underside of the beam.

The trusses consist of full height wall posts (190mm x 190mm) in the front and rear walls, joined by a transverse beam (230mm deep x 180mm) with straight braces below the beam. The braces are tenoned and pegged into the beams. The junction between the beams and wall posts consists of a tenon and diminished haunch with a through-bolt (Image 11). The bolt has a flattened section which is nailed in a recess in the underside of the beam. The remaining section passes through the post and is fixed on the external face with a square nut. The openings in the front of the cart shed consist of a beam supported by curved braces on either side of the opening. The braces have pegged fixings.

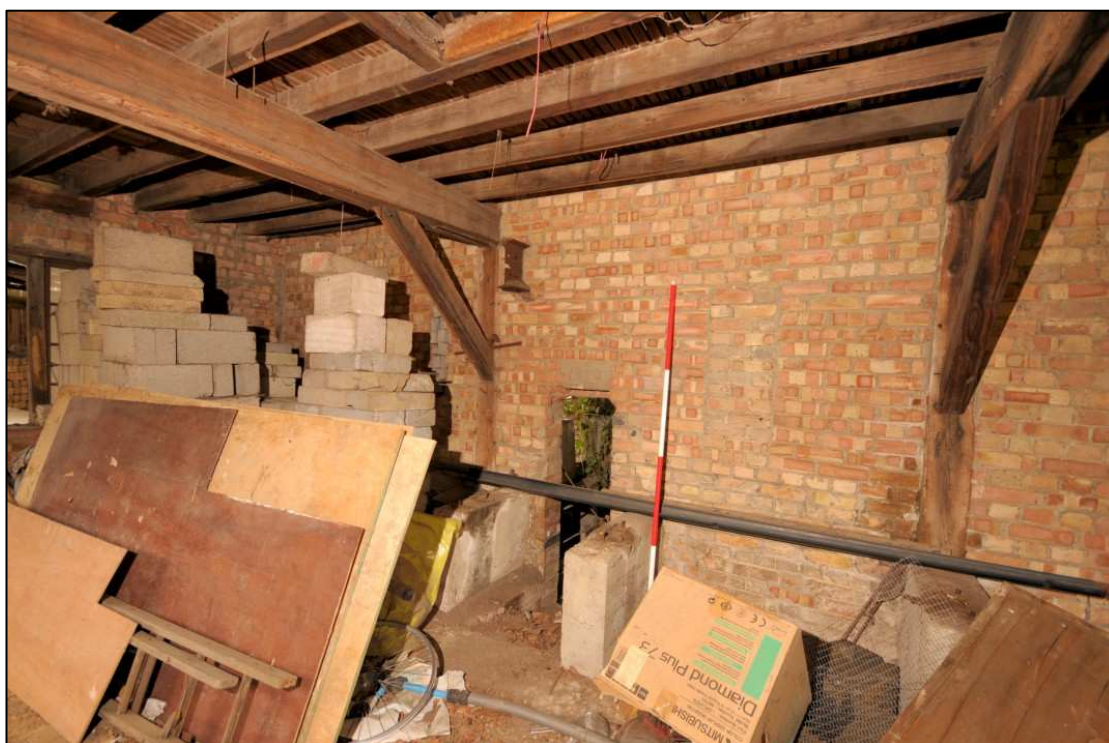
Image 12: Interior of cart shed, view looking south-east

Shows the rear wall infilled with Fletton brick with concrete supports for line-shafting and an opening in the central part of the wall for a drive belt. (2m scale)

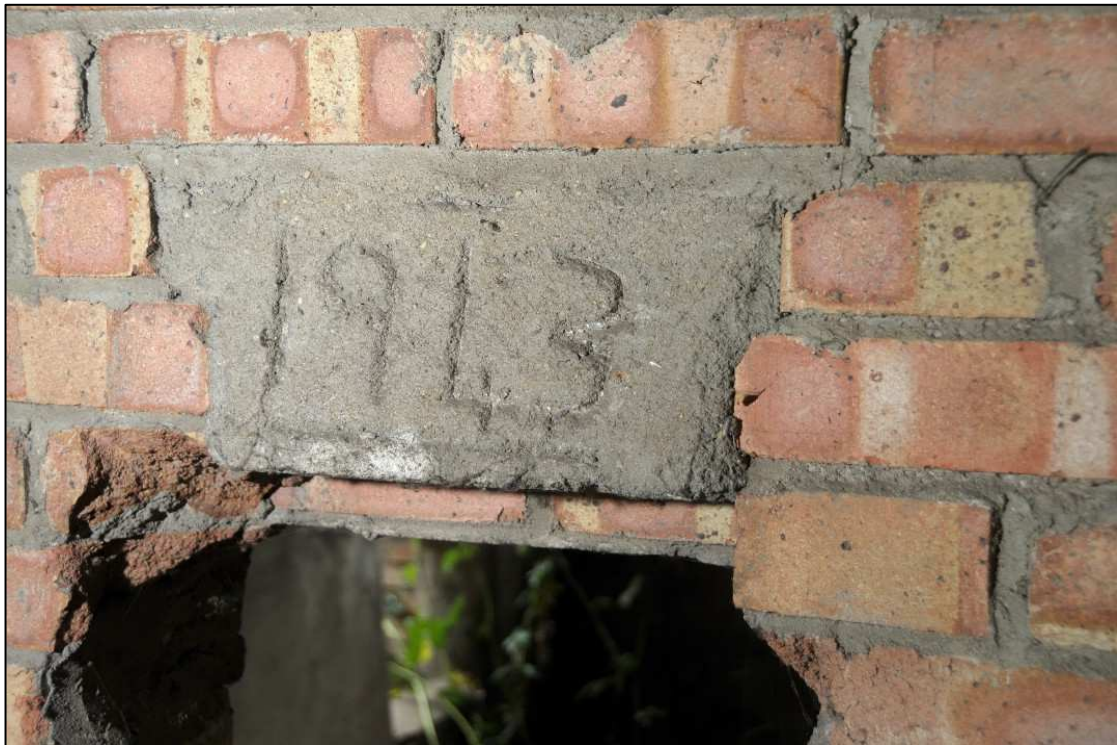
Image 13: Interior of cart shed, showing date

1943 scratched into wet concrete above the drive-belt opening in the rear wall of the cart shed. Its location is shown in the previous image.

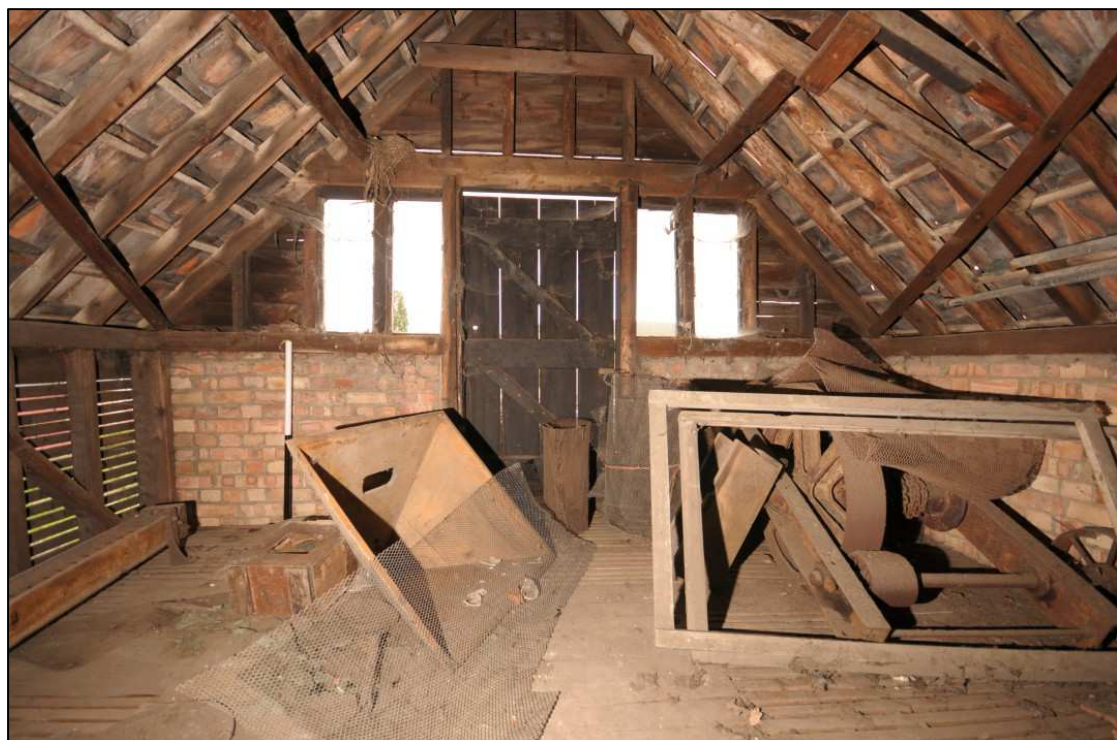
Image 14: Interior of cart shed loft, view looking east

Shows door and windows in east end, slatted floor and north wall. Stored equipment comprises a winch (right hand side), wooden hopper (centre) and Archimedes screw drive at left. (1m scale)

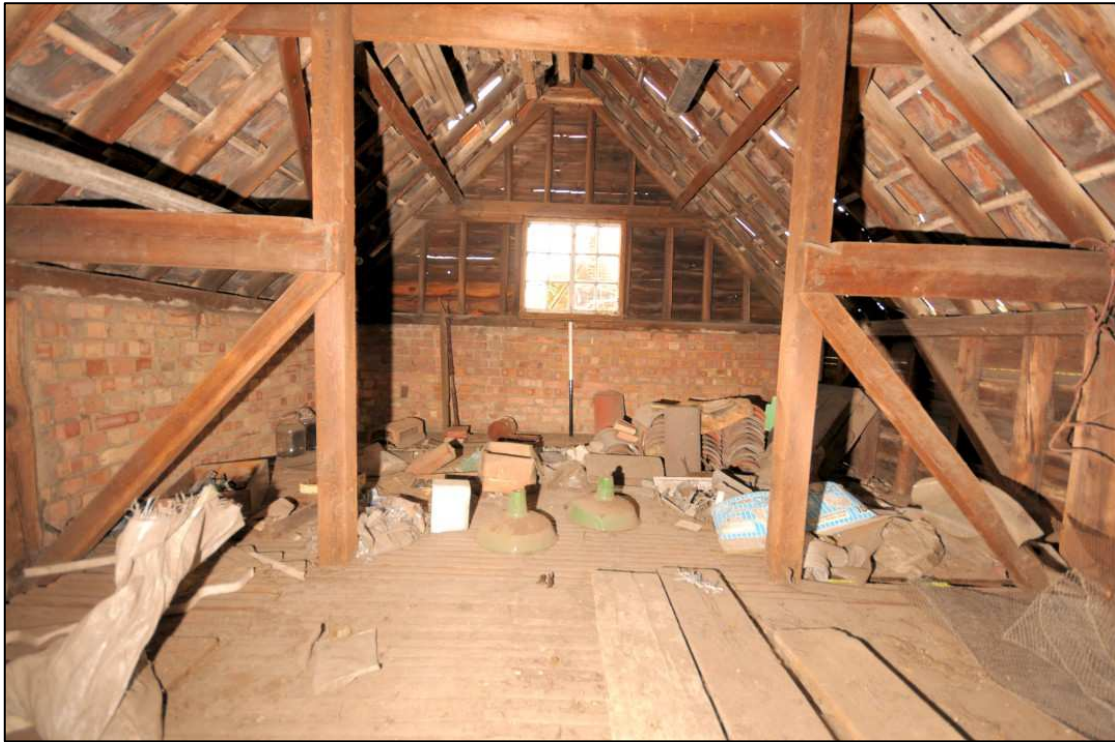
Image 15: Interior of cart shed loft, view looking west

Shows window in the west wall and framing on bay division. Just outside of the image to the left was a small frame for a belt drive coming up from the ground floor to power equipment in the loft. (1m scale)

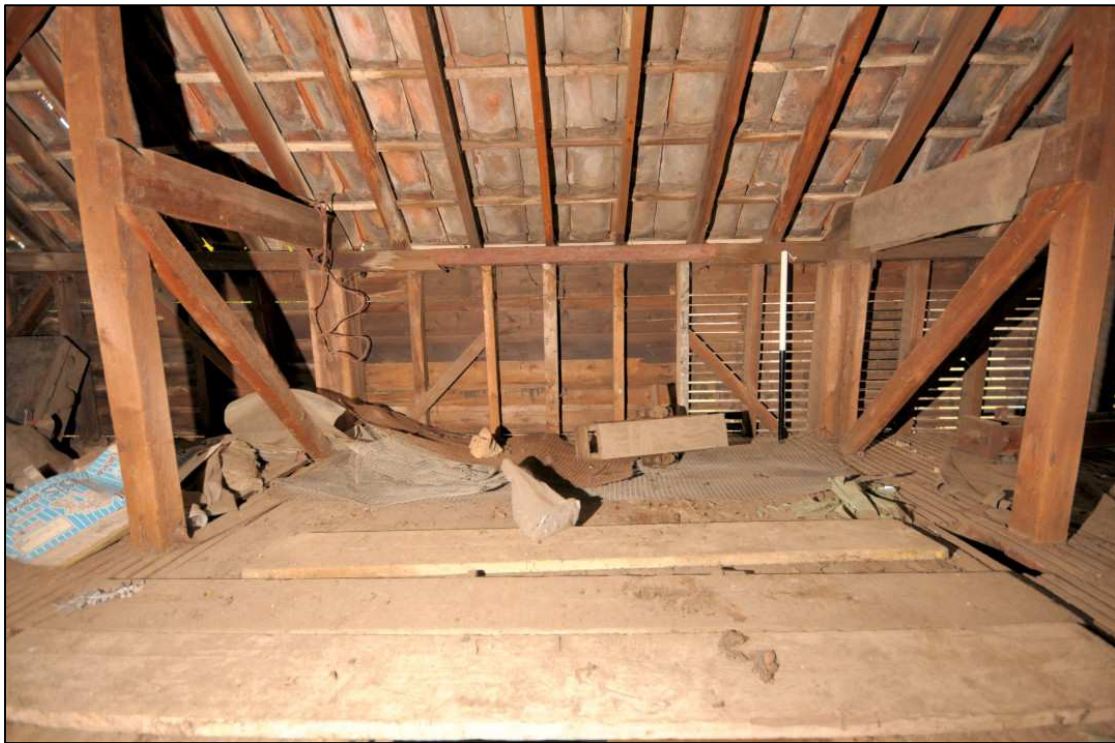
Image 16: Interior of cart shed loft, view looking north

Shows north wall in central bay with weatherboards and slatted wall. (1m scale)

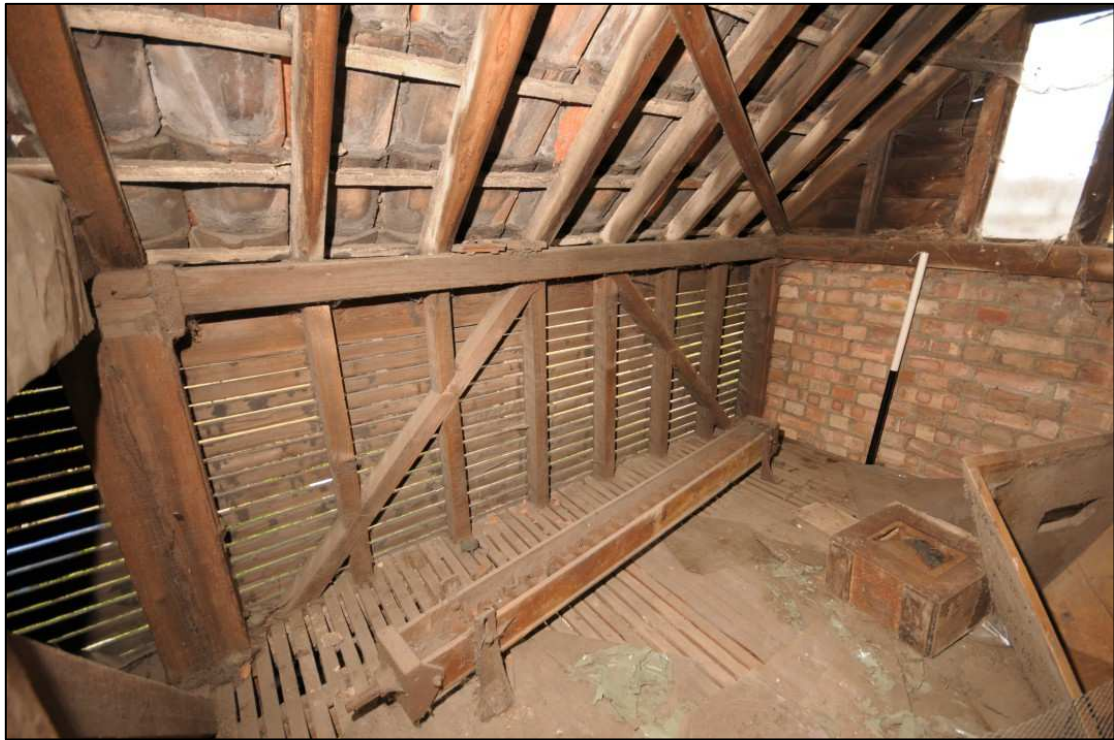
Image 17: Interior of cart shed loft, north-east corner

Shows framing of the north wall with primary bracing; also shows slatted floor and wall cladding and Fletton brick infill in east gable end wall. (1m scale)

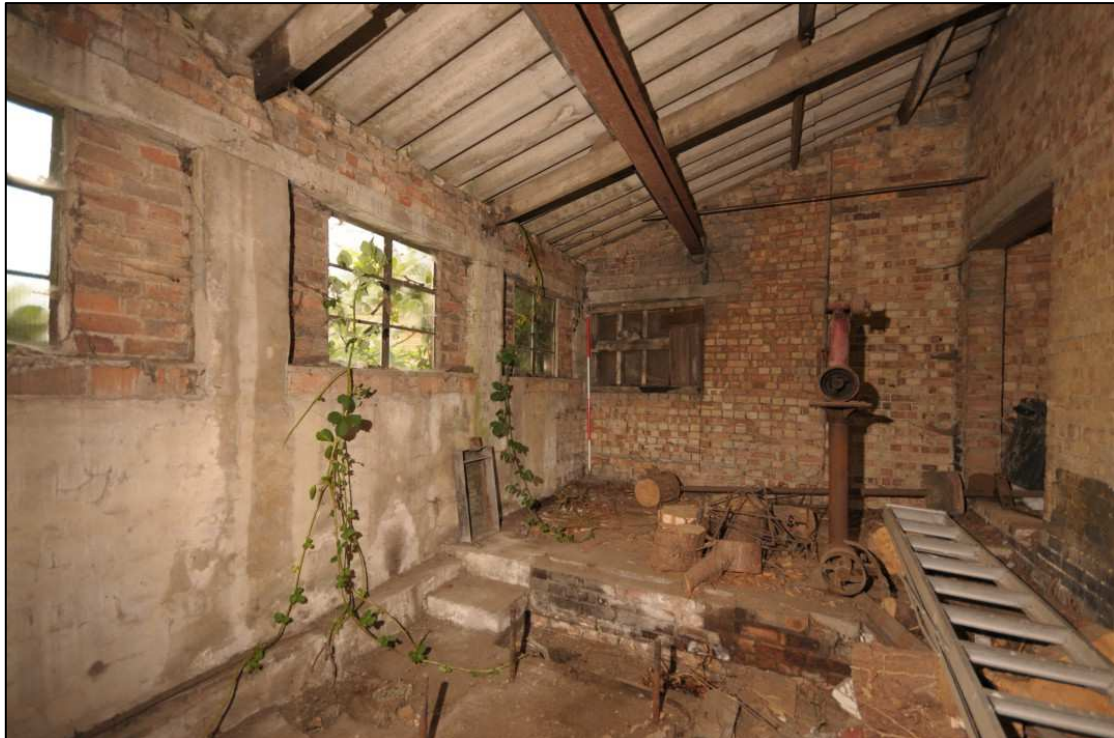
Image 18: Interior of south extension, view looking west

Shows pit with bolts for fixing a machine base in the middle foreground. Shows concrete lintel and metal-framed windows in south wall. (2m scale)

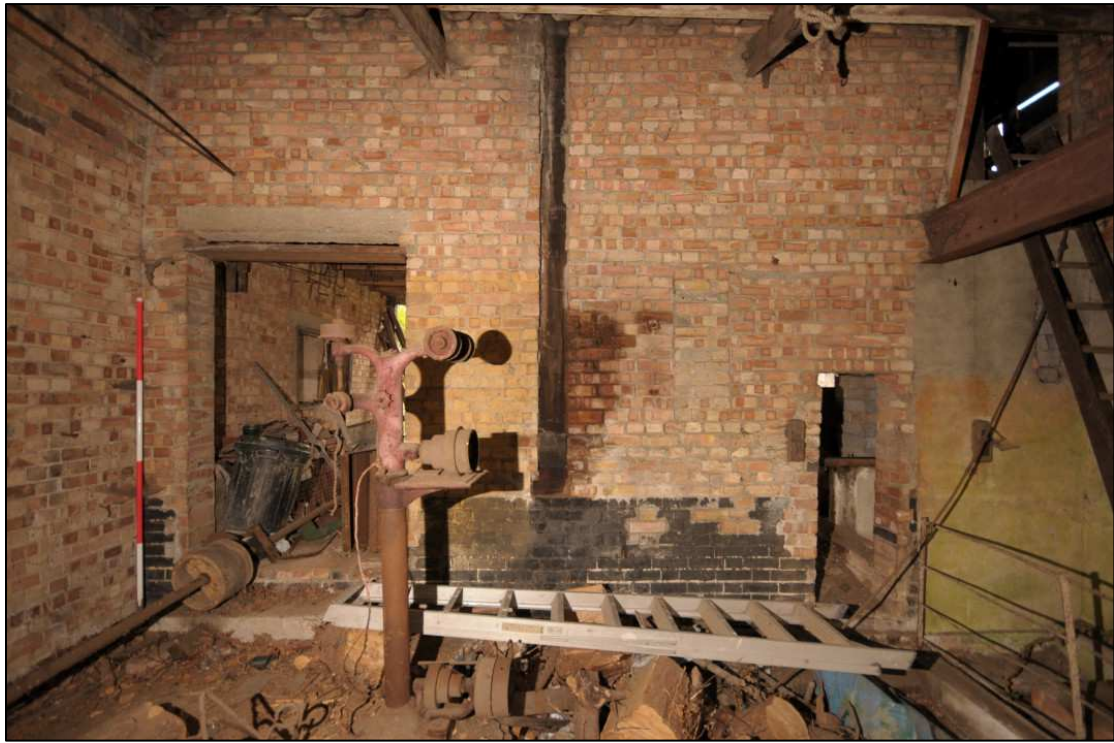
Image 19: Interior of south extension, view looking north

Shows the back wall of the cart shed with dark bricks forming the sill wall supporting a post which is now embedded in later Fletton brick infill. The small opening at the right is for a belt drive. Remains of dismantled line-shafting can be seen next to the left wall.

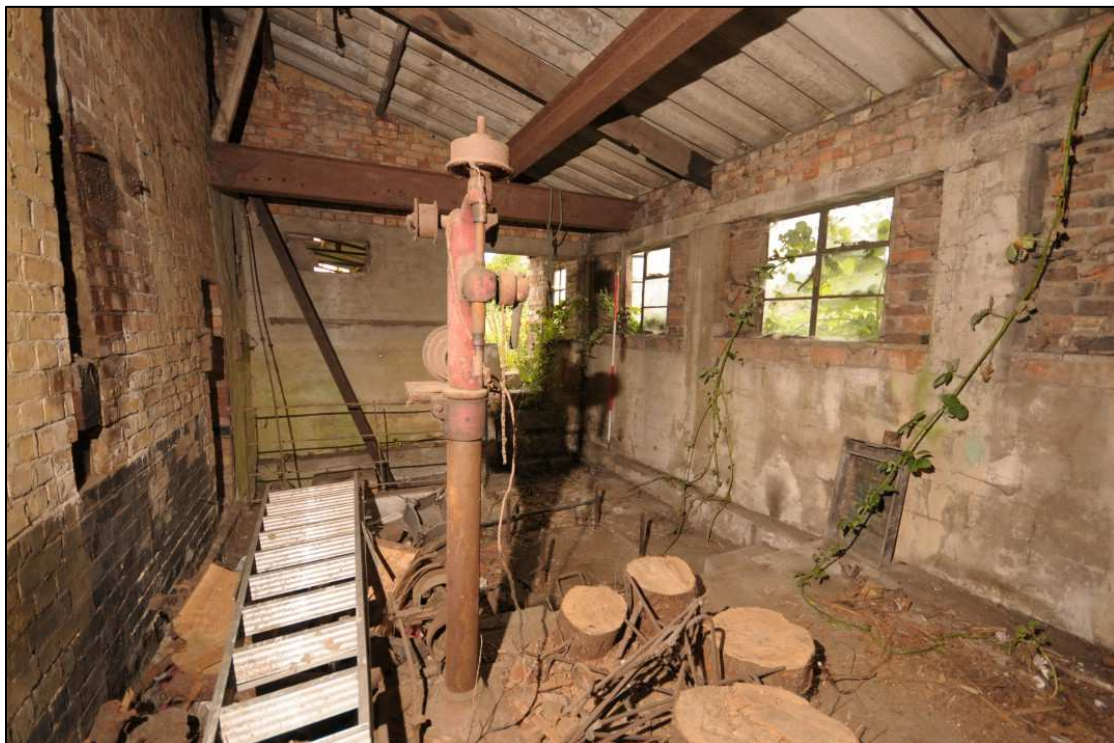
Image 20: Interior of south extension, view looking south-east

Shows machinery in foreground and machine pit beyond and details of the roof construction with RSJ supports.

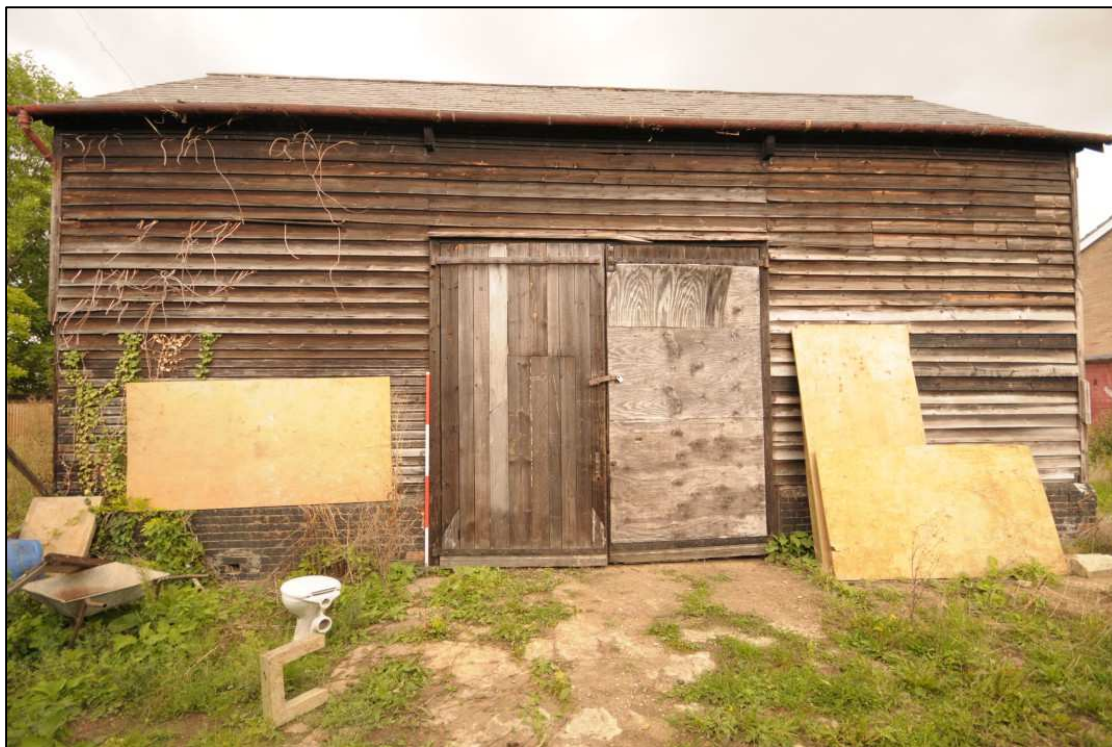
Image 21: South elevation of barn

Shows the weatherboard cladding with narrower shiplap boards at the lower left-hand side. The plywood panel to the left of the door is covering a window. (2m scale)

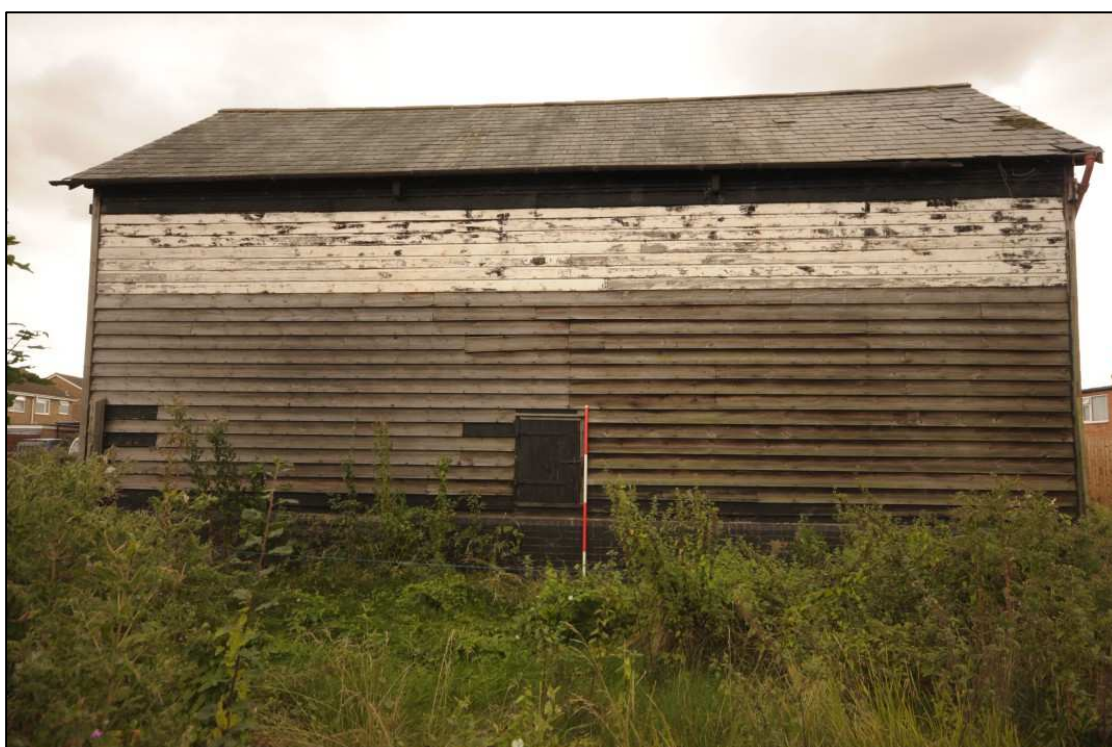
Image 22: North elevation of barn

Shows small access hatch in the centre of the wall, above the sill wall. (2m scale)

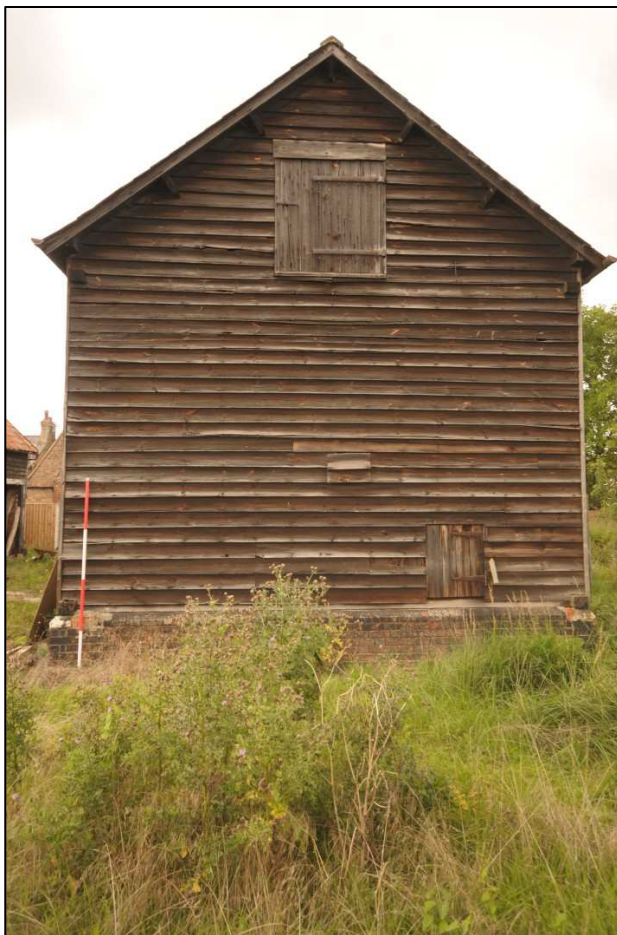
Image 23: East end of barn

Shows small access hatch at lower right and high-level door in gable.
(2m scale)

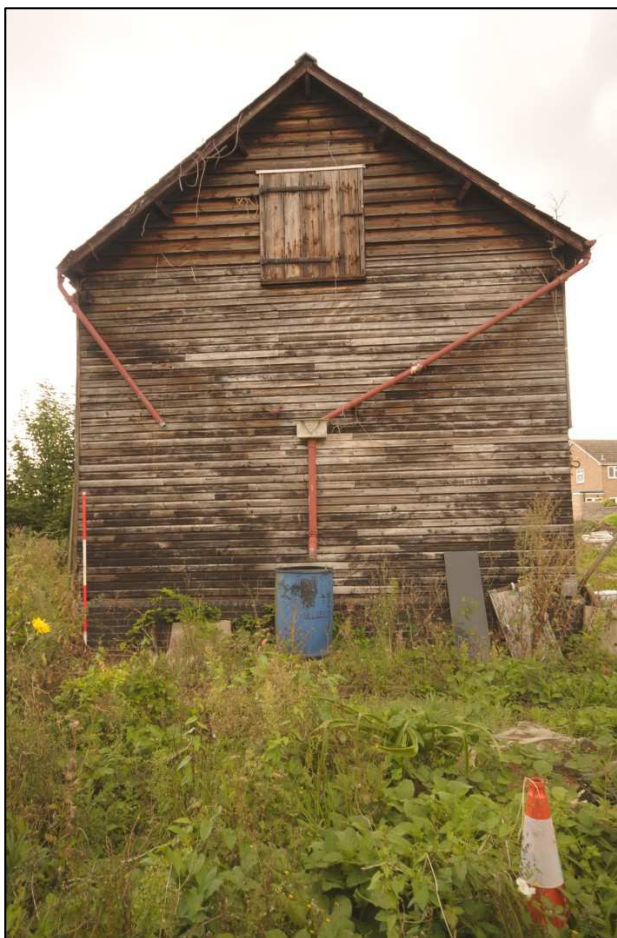
Image 24: West end of barn

Shows shiplap cladding on lower part of wall with high-level door in gable (2m scale)

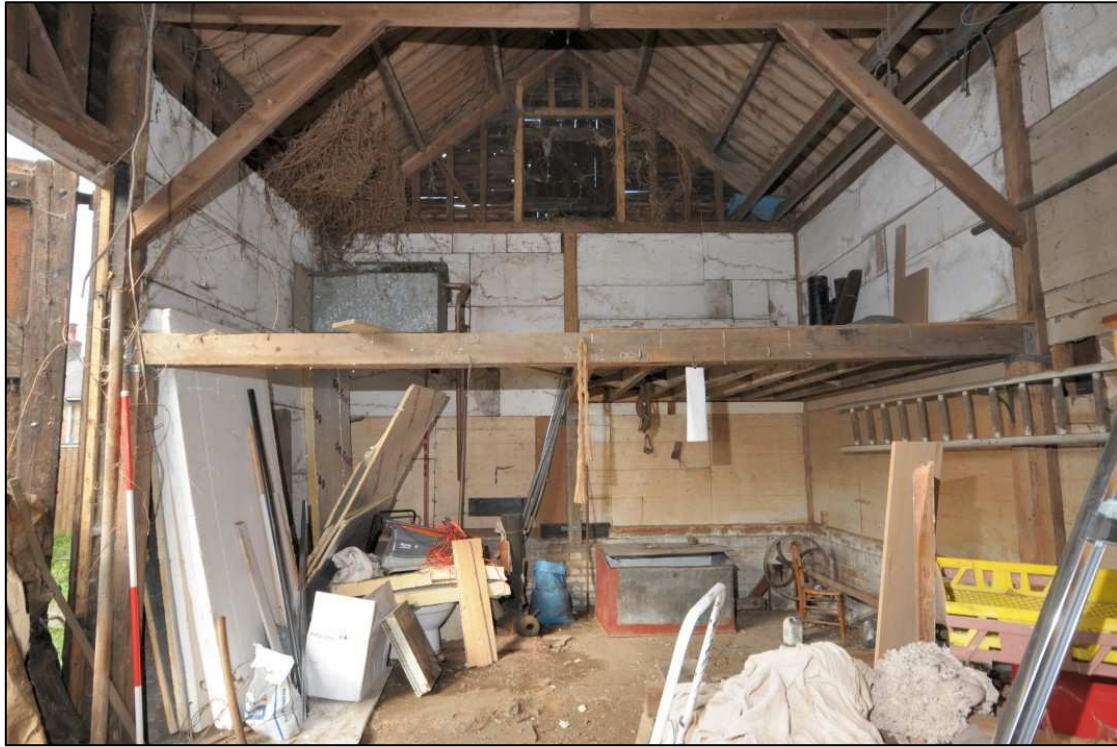
Image 25: Interior of barn, view looking west

Shows inserted floor in north-west corner. The remains of line-shafting are visible in the corner below the inserted floor. (2m scale)

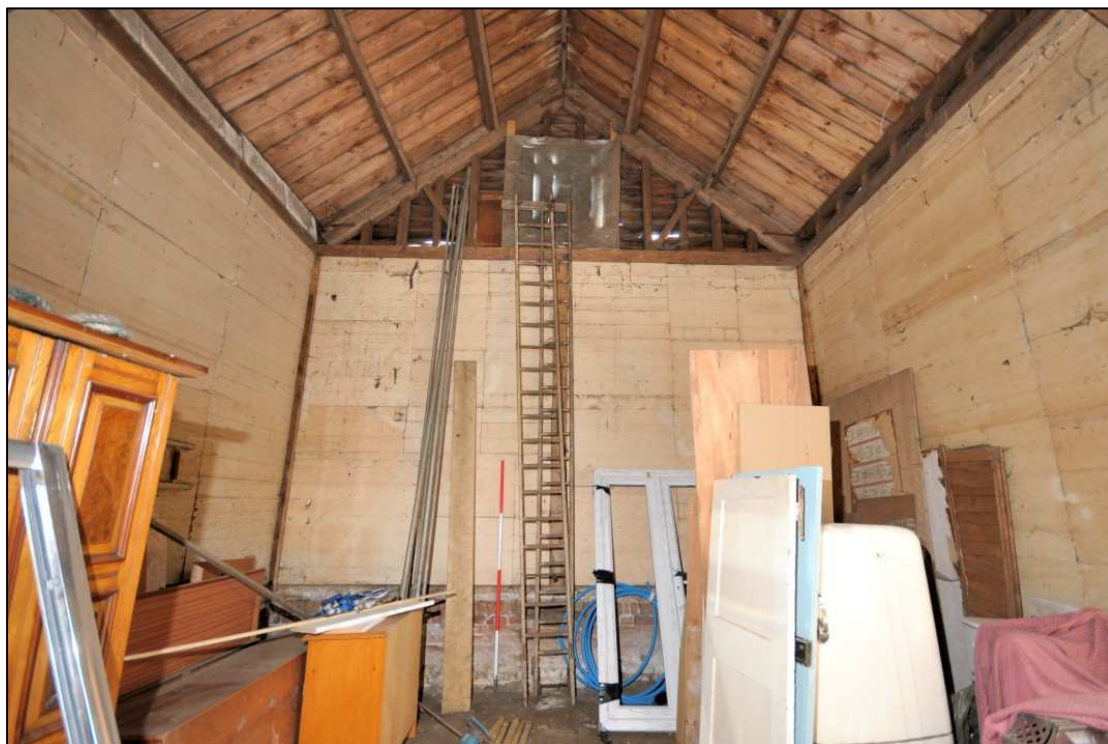
Image 27: Interior of barn, view looking east

Detail mostly obscured by modern cladding. Wall studs and primary bracing are visible in the gable. (2m scale)

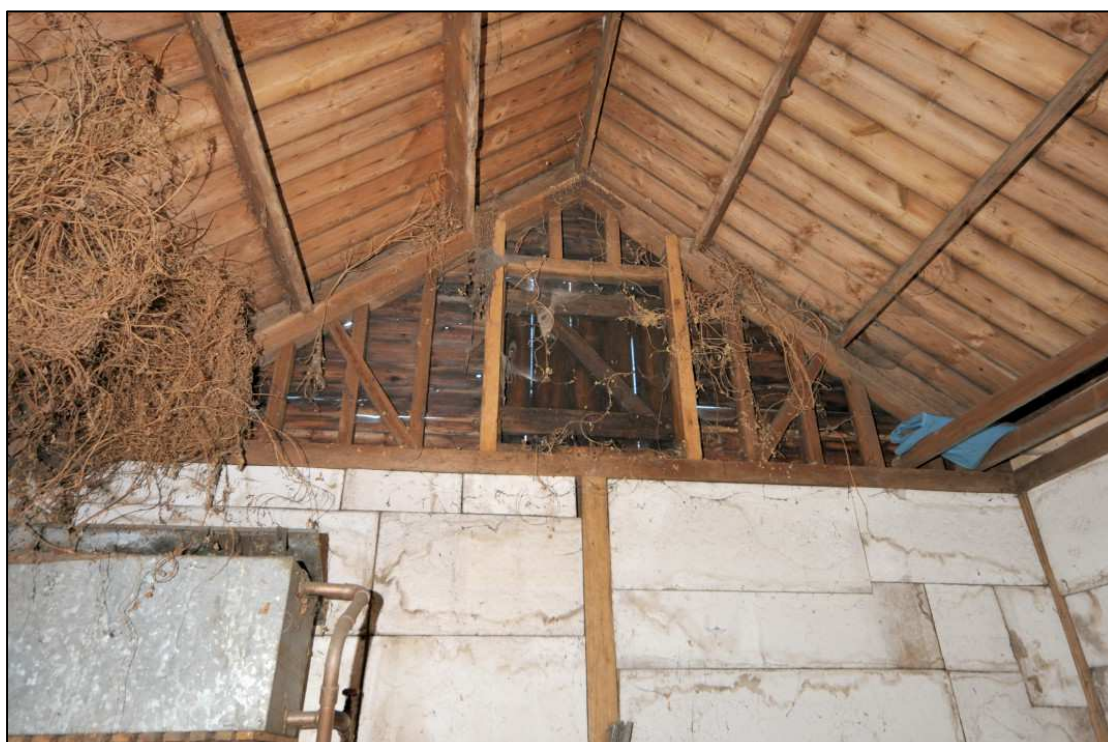
Image 28: Interior of barn showing west gable end

Shows framing of gable end with studs and primary bracing. Also shows high-level door.
