**LAND AT 52 LONDON ROAD
SANDY
BEDFORDSHIRE**

HISTORIC BUILDING RECORDING

Document: 2015/152
Version: 1.0
23rd November 2015

Project: LRS2458
Bedford Museum Accession Number: BEDFM 2015.66
Oasis reference: albionar1-222238

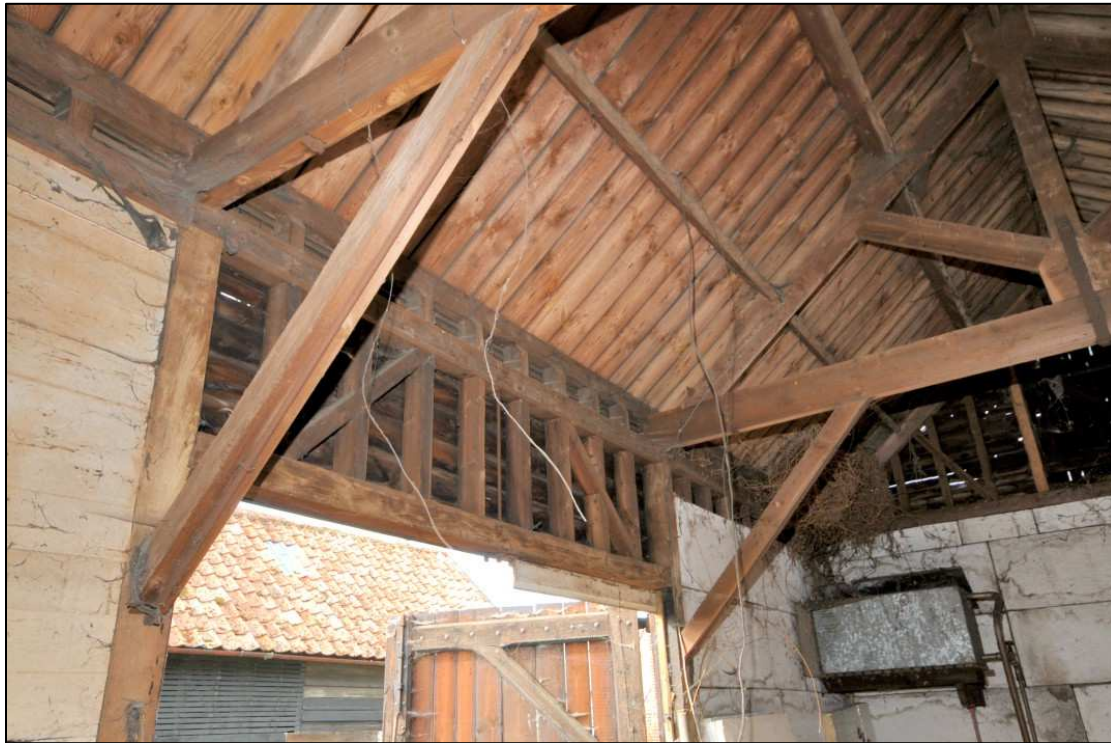
Image 29: Interior of barn, showing detail above double doors

The closely set studs and primary bracing above the door indicate the type of wall structure which is obscured by modern lining elsewhere. Note the iron tie-rod which is visible below the brace to the left of the door.

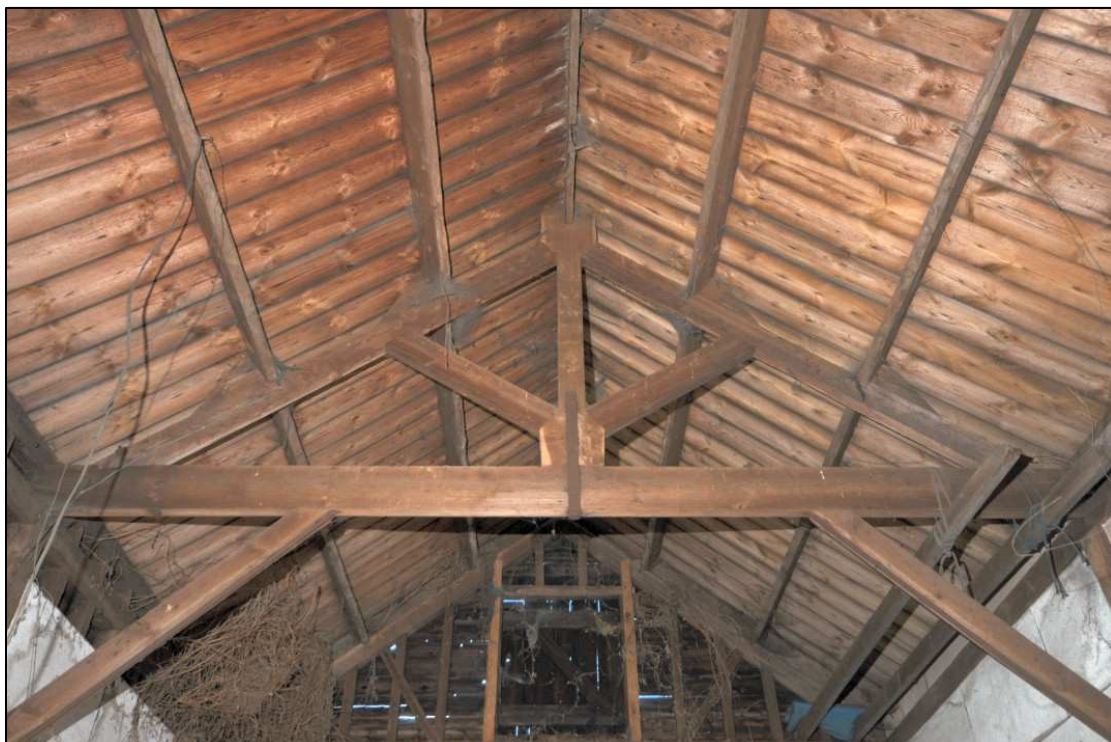
Image 30: Interior of barn, showing roof truss

Shows king-post truss with long straight braces below the tie-beam.

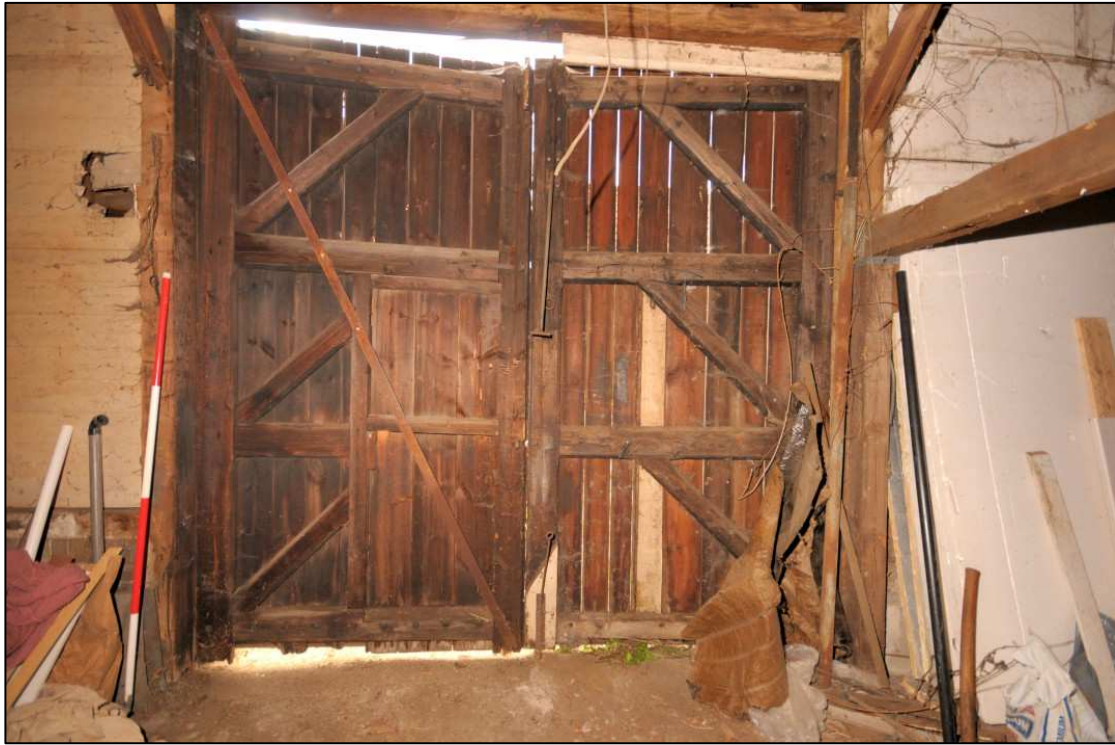
Image 31: Interior of barn, showing construction of double doors

Note different framing in left door for possible wicket gate. (2m scale)

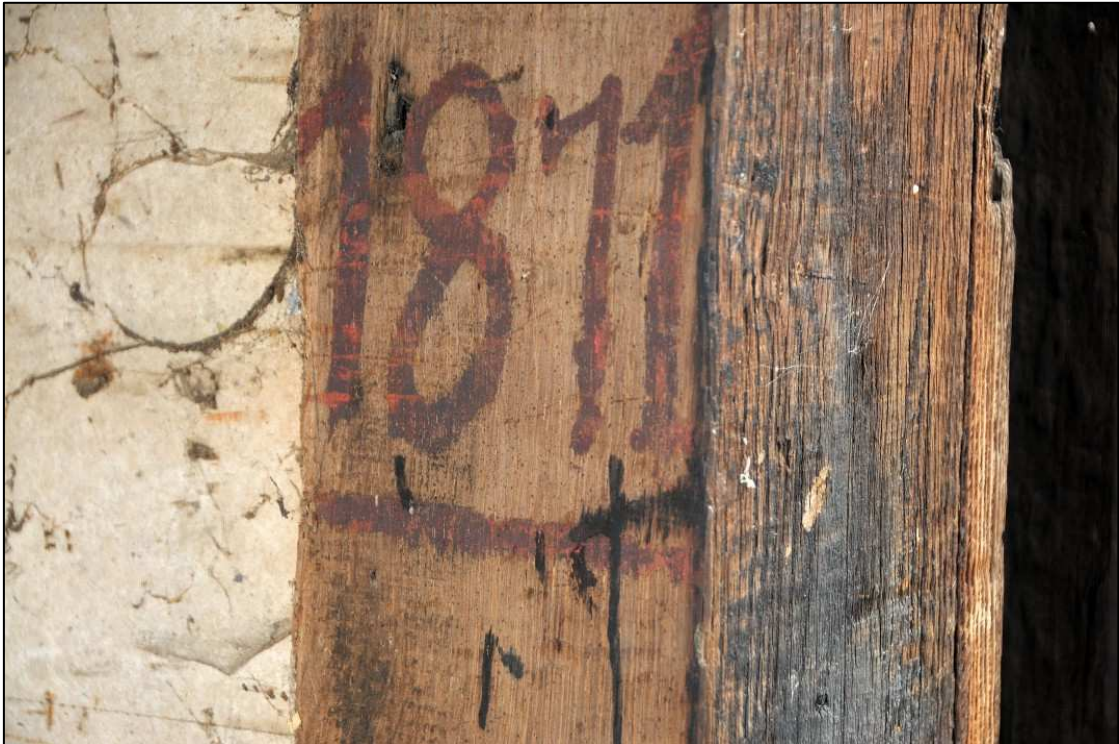
Image 33: Interior detail of barn, possible date

Shows painted number or date of 1871 on inside face of left-hand (east) door post.
