**TALLY HO
UPPER STAPLOE
BEDFORDSHIRE**

**ARCHAEOLOGICAL OBSERVATION
INVESTIGATION, RECORDING, ANALYSIS AND
PUBLICATION**

Project: TH2740
Document: 2018/57
Version 1.0

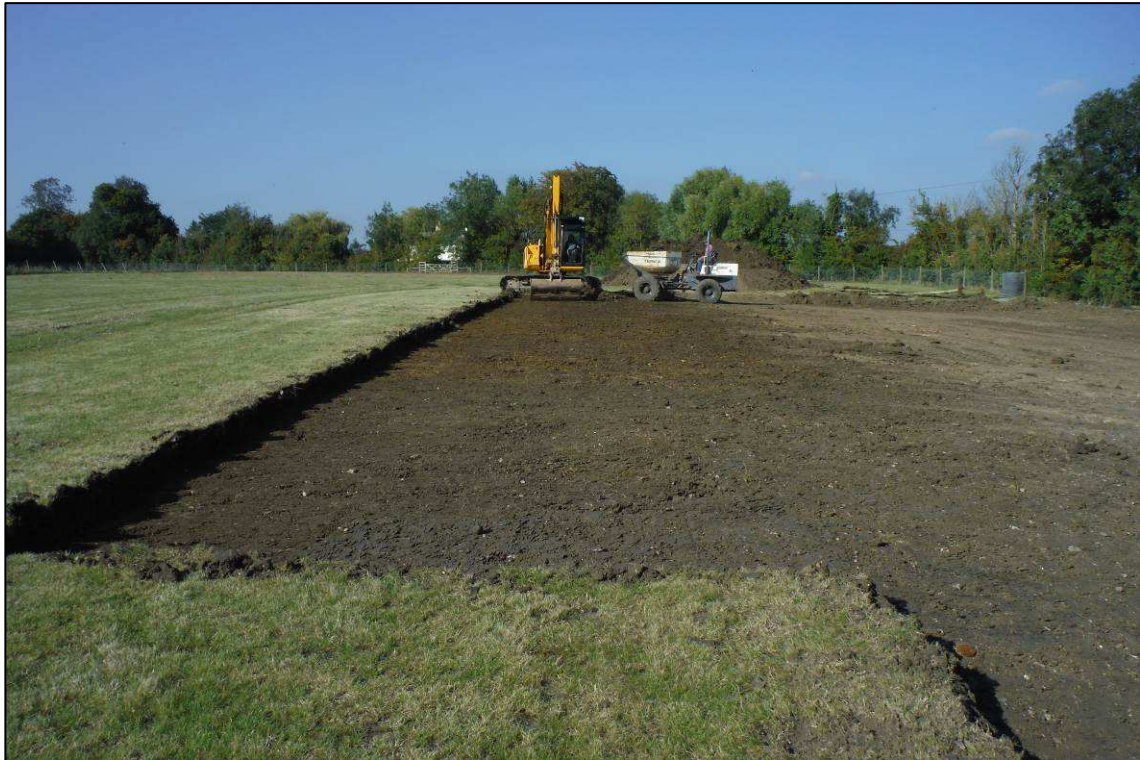
Plate 1: General view of topsoil strip of manège, looking north

A detailed methodology is provided in the Written Scheme of Investigation (Albion Archaeology 2015). Archaeological observation and investigation during the groundworks took place on 2nd and 3rd October 2015. The observed groundworks comprised the levelling of ground for the manège. The north-west corner of the manège was reduced by c.1m with the south-east side built-up to create a level surface (Figure 2; Plates 1–3).

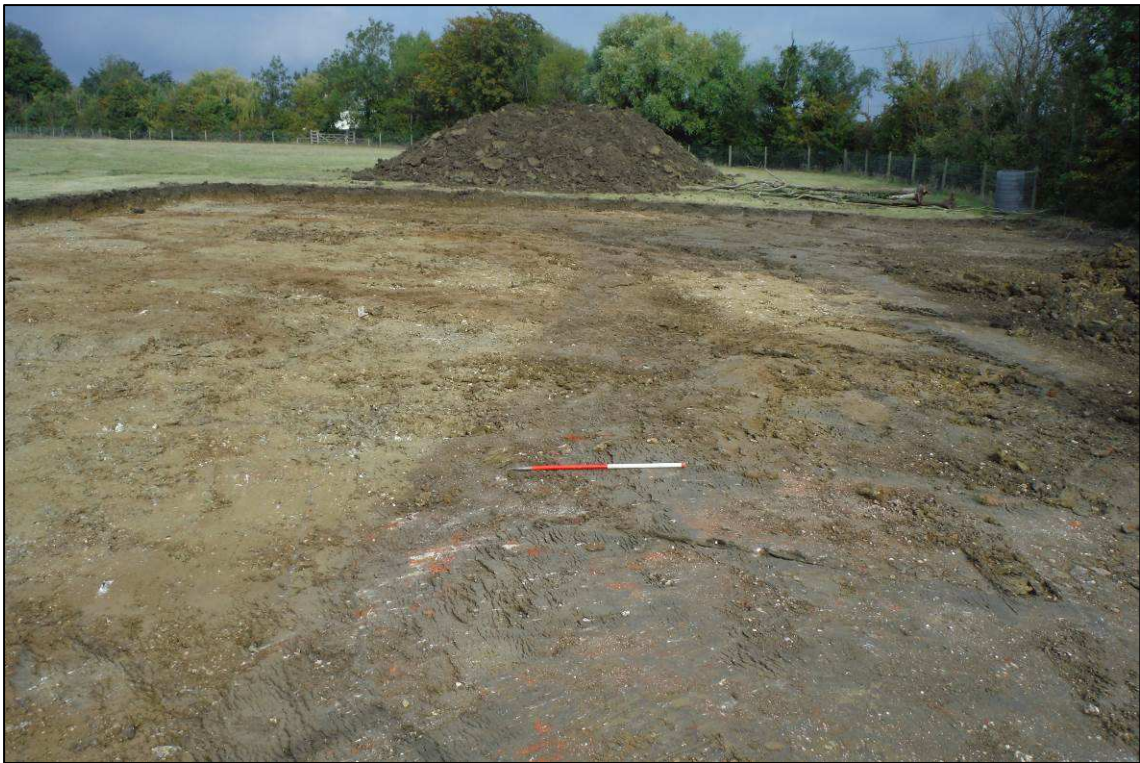
Plate 3: Modern features and overburden in area of manège, looking north

In the south and west parts of the site a make-up layer (10) comprising friable dark brown-grey clayey sand with modern building material fragments, metal and glass fragments lay beneath the topsoil (1) (Figure 2, Plate 3). This layer was not reduced down to the archaeological level.

A broadly N-S aligned ditch [8] contained large fragments of glass, brick and scrap metal (not retained), indicating that it was modern in date (Figure 2, Plate 3).
