**45-47 MILL STREET
BEDFORD**

**ARCHAEOLOGICAL OBSERVATION,
INVESTIGATION, RECORDING, ANALYSIS AND
PUBLICATION**

Project: MS2748
Museum accession No.: BEDFM:2015.73
OASIS no.: albionar1-225599

Document: 2015/206
Version 1.0

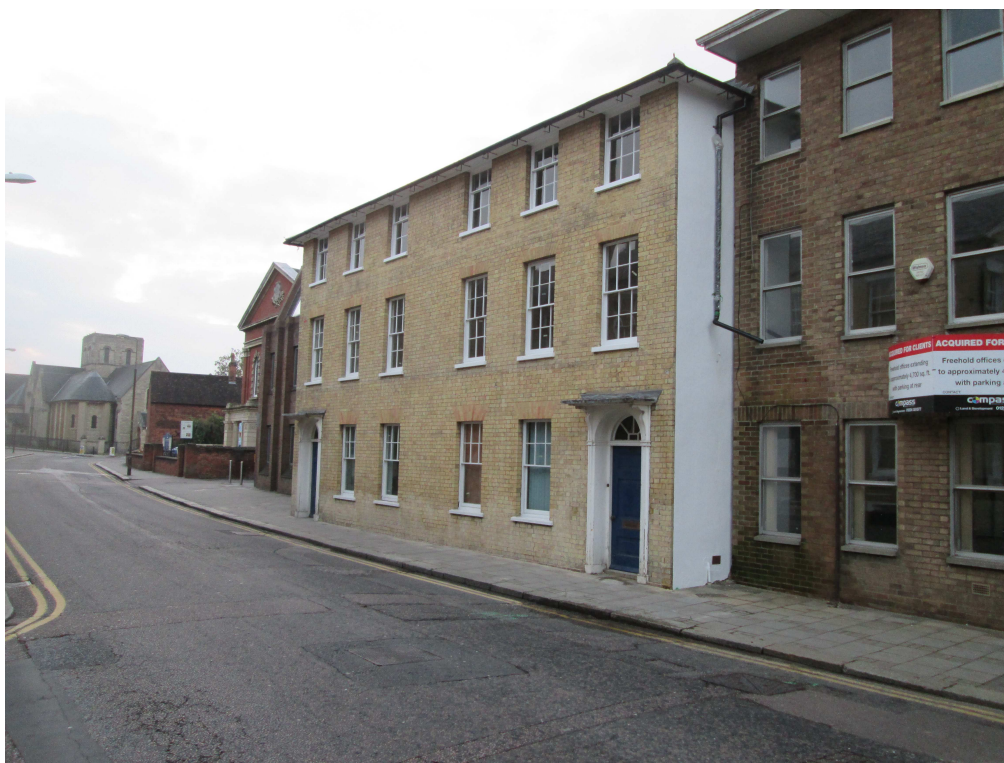
Image 1: View down Mill Street, looking eastwards, with the yellow brick building of 45-47 Mill Street, off-set from adjacent modern properties.

The site is located within the heart of Bedford, towards the eastern end of Mill Street, centred on grid reference TL 518379 498329 (Figure 1). Mill Street (formerly School Lane) extends eastwards from a crossroads with the High Street (aligned N-S) and Silver Street to the west. The site is located on the southern side of the street, with the roughly rectangular land parcel extending almost to Castle Lane in the south, a short distance from the River Great Ouse. The plot is roughly rectangular in plan — up to 13m wide at the street frontage, and extending some 31m to the south, where the plot tapers to around 10m. The street frontage is aligned slightly obliquely to Mill Street, with an off-set to the north from the adjacent properties (Figure 3: image 1).

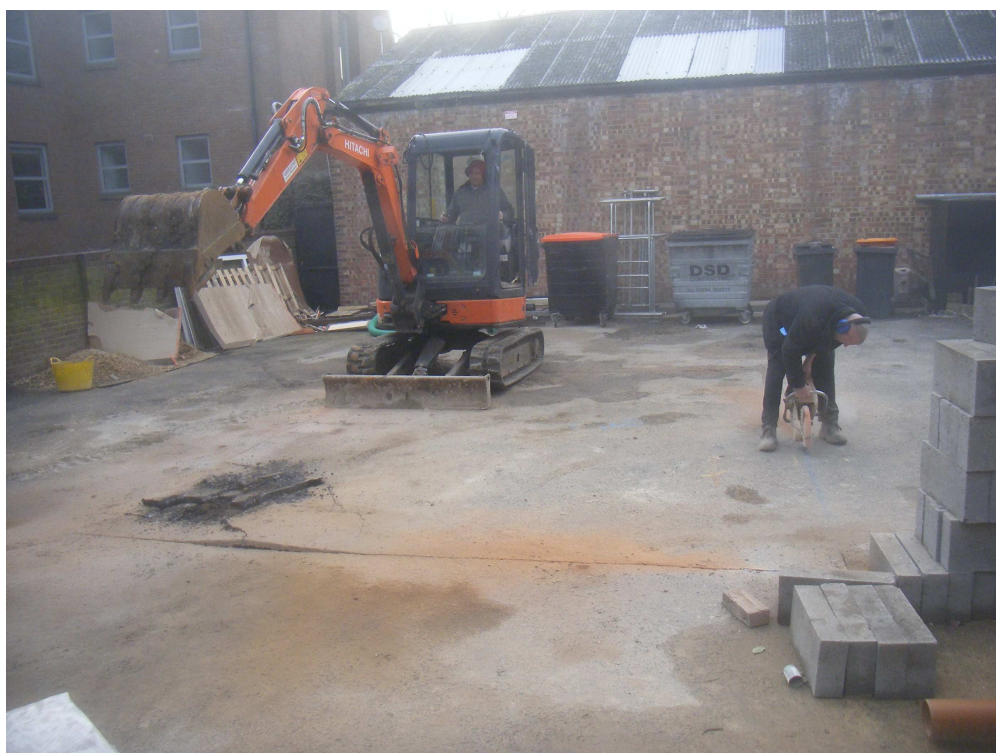
Image 2: View of open area to the rear of the site during the initial stage of the investigation. This image is looking towards the SE corner of the site.

To the rear of the buildings was a tarmac car park which extended to the eastern and southern limits of the property (Figure 3: image 2). Access to Mill

Prior to excavation the area consisted of a tarmac car park (Figure 3: image 2). Ground reduction exposed several modern deposits consisting of tarmac (1), and associated made ground (2, 3, and 4) – grey hatched deposits on Figure 2: sections 1 and 2. These deposits covered the entirety of the investigation area and represent the levelling and subsequent construction of the modern car park surface.

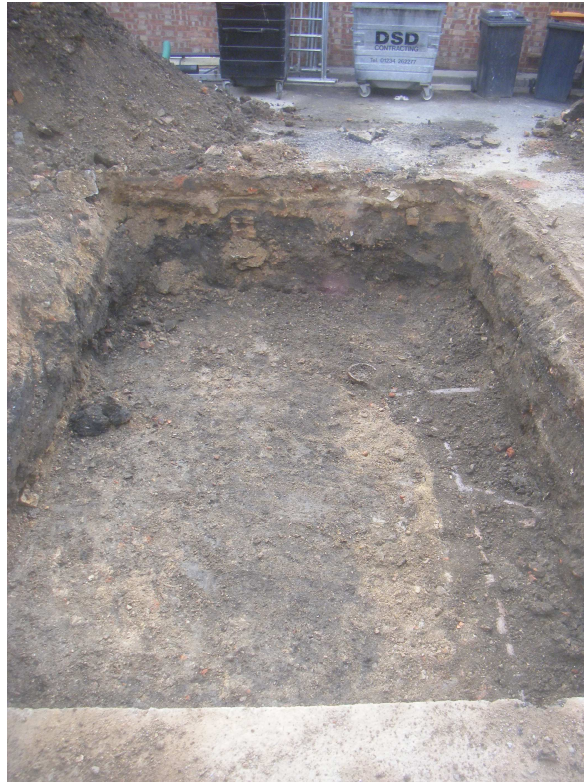
Image 3: Initial phase of machining of the open area looking south, with a modern drain to the west. The yellow rubble spread (13) extends across the rest of the area. The limestone and brick wall [7] is visible in the southern section.

Directly below the car park deposits and aligned N-S was a modern drain [11] that turned to the SE c. 3m from the northern edge of excavation (Figure 2: red/pink feature and Figure 4: images 3 and 4). In section this feature was defined by a series of backfill deposits (6), (26) and (12) (Figure 2: section 1). This drain appeared to pass under modern wall footing (8) — not unusual for this type of feature which need to maintain ‘fall’ or flow.

Sealed below the garden soil was a distinctive yellow deposit of sandy limestone material with frequent brick and tile rubble (13), which spread across most of the area (Figure 4: image 3). The deposit was up to 0.24m thick and would appear to have been deliberately spread on the former ground surface prior to creation of the later garden with imported material (pale yellow deposit on Figure 2: sections 1 and 2 and Figure 5: image 5). The lack of compaction or erosion of the limestone suggests that this was not an external surface. This material may have been associated with construction of the street-front properties, rather than demolition and levelling of adjacent structures; its composition suggests that it may have been associated with the lining of the cellar.

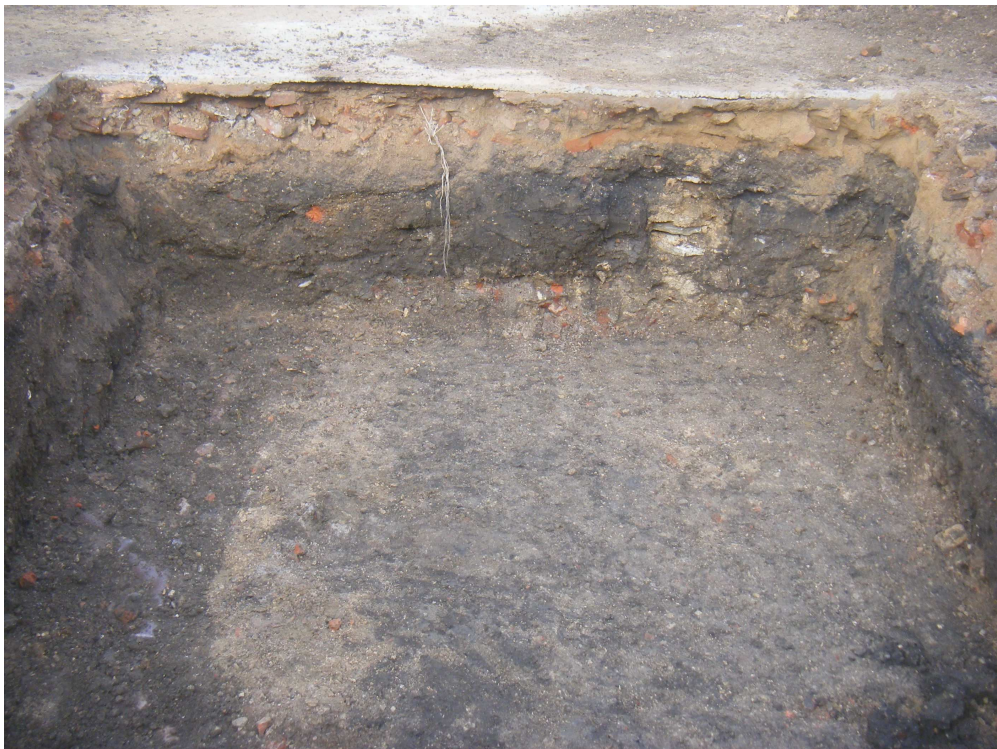
Image 4: View of the northern part of the area during the initial phase of machining. In this area the wall footing [7] is composed entirely of limestone. The dark upper cultivation soil (5/10) is above the yellow rubble spread (13).

A modern garden wall, aligned roughly N-S, extended along the eastern side of the investigation area, comprising a cut [7], masonry footing, which mostly utilised horizontal limestone slabs (8), and traces of bricks in the south (25) (Figure 2 section 1 and Figure 4: images 3 and 4). The wall would have been a single brick wide, indicating that it was not part of a substantial building. The alignment was heading for the junction between the two 19th-century properties, although this area had been the focus of later building work and so no scar from the wall visible.

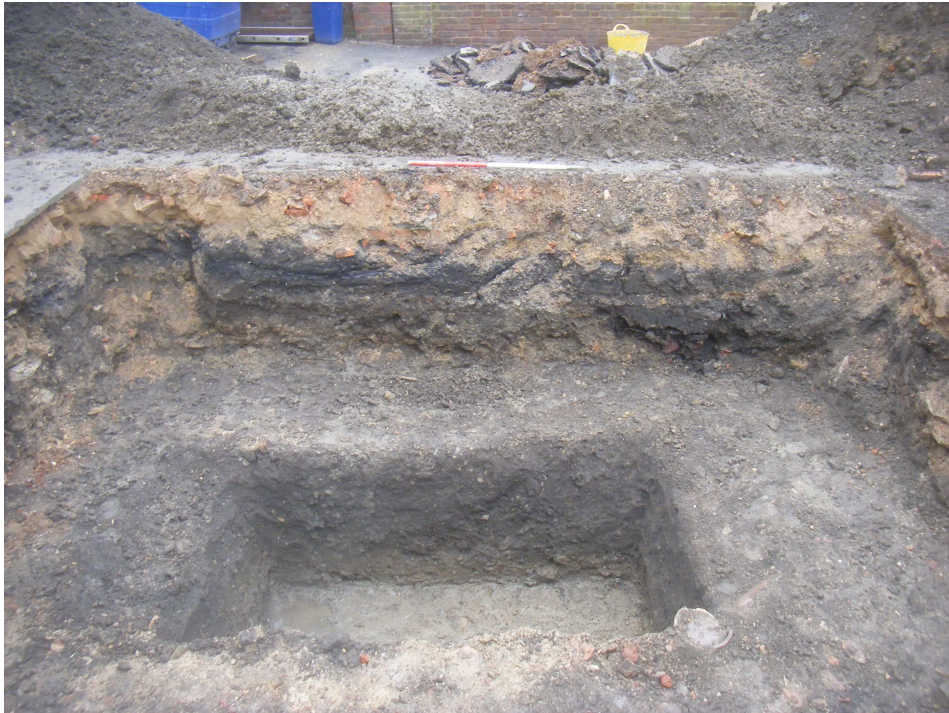
Image 5: General view of area showing two substantial cultivation soils below modern deposits. They were separated by the yellow rubble deposit (13) visible in the base of the section just above the first step. Scale 1m in 50cm divisions.

The upper garden soil appeared to consist of two components separated by a pit [14] and the construction cut [7] for the wall (Figure 2: sections 1 and 2). However, this is considered to be misleading — the result of cultivation of the upper element of the soil (5), leading to the removal of the upper part of these features. The upper element of the soil profile (5) was dark grey-black and up to 0.38m thick (Figure 2: sections 1 and 2). The lower element comprised a black to grey brown deposit (10), (23) and (24), up to 0.42m thick (Figure 2: sections 1 and 2 and Figure 4: images 3 and 4). This material is thought to have been deposited as one event, although its source is uncertain. A small quantity of modern artefacts from this layer was sent directly to Bedford Museum in accordance with the methodology in the WSI.

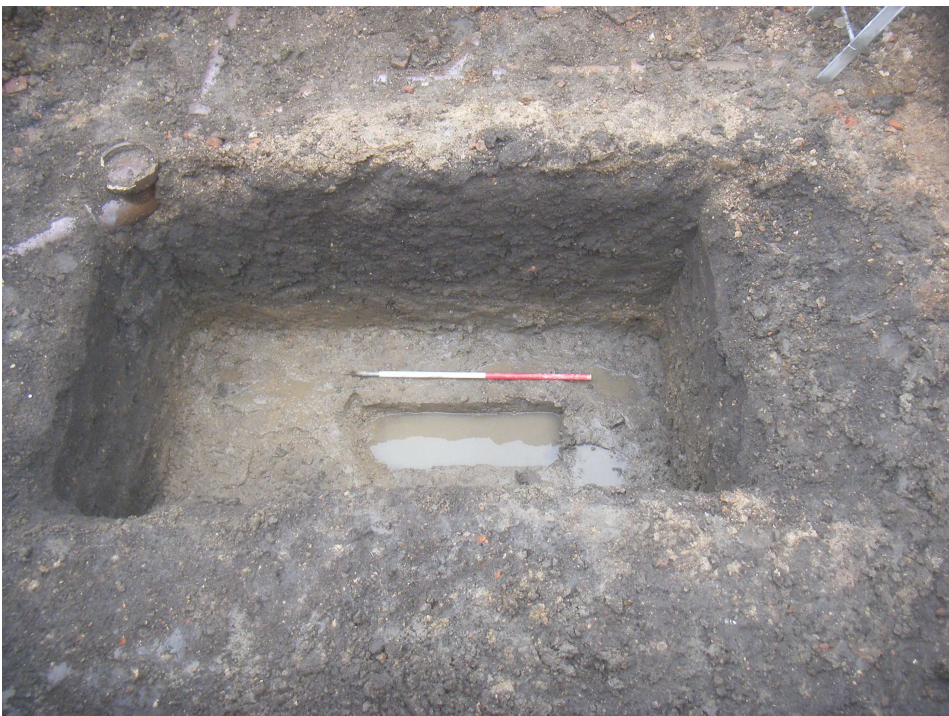
Image 6: View of pit [18], which was revealed below the lower cultivation soil. The water table was high, hampering investigation at this depth — some 1.85m below the present ground level. Scale 1m in 50cm divisions.

Pit [18] lay *c.* 1.85m below surface level and was overlain by deposit (16) (Figure 2 – brown / brown-hatched feature, section 2 and Figure 5: image 6). In plan, this feature was at least 1.56m N-S by 1.24m wide, with a curving southern extent; its western, eastern and northern limits lay beyond the trench. In section the pit had a concave southern edge (Figure 2: section 2), which was excavated to a depth of 0.28m before rapid ingress of groundwater prevented further work. An auger was used to determine the total depth of the feature at approximately 0.68m. The mid brown-grey clay silt fill (19) contained a piece of sand-tempered flat roof tile (45g), seven abraded animal limb bone and pelvis(?) fragments (112g), and three pottery sherds (42g). The latter comprise two late Saxon shell-tempered St Neots-type sherds (fabrics B01 and variant B01C) and a 13th–14th-century glazed sherd from a Brill-Boarstall ware jug (fabric C09), a regional fine ware import from Buckinghamshire.

Pit [18] cut a mid orange-grey gravelly silt deposit (20); the limited scope of the investigation area at this level and the ingress of groundwater prevented further characterisation of this deposit (Figure 5: image 6).

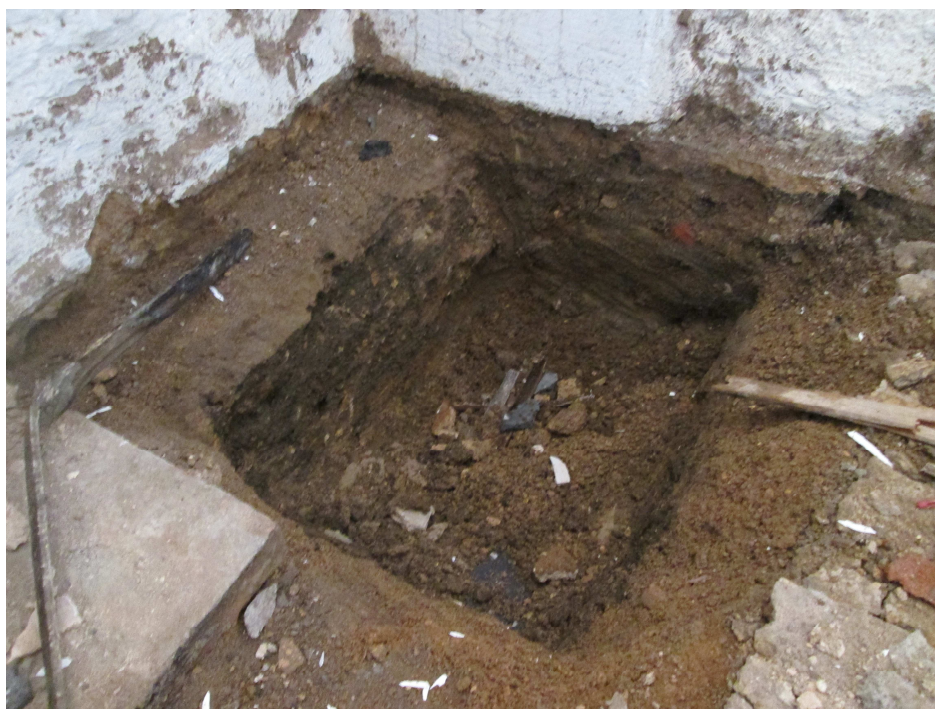
Image 7: Small test pit dug by contractors in SE corner of cellar of western property, measuring *c.* 0.6 by 0.3m and showing dark deposits continuing beneath southern cellar wall.

During the initial site visit on 2nd October 2015, observations were made of a small test pit previously excavated by the contractors in the SE corner of the western cellar. The sections were cleaned up and photographed (Figure 6: image 7). This revealed an orange sand bedding layer up to 0.15m thick for the former tiled floor. Beneath this was a dark deposit which continued below the base of the southern cellar wall. This indicated that pre-cellar deposits survived some 2m below the present external ground level.

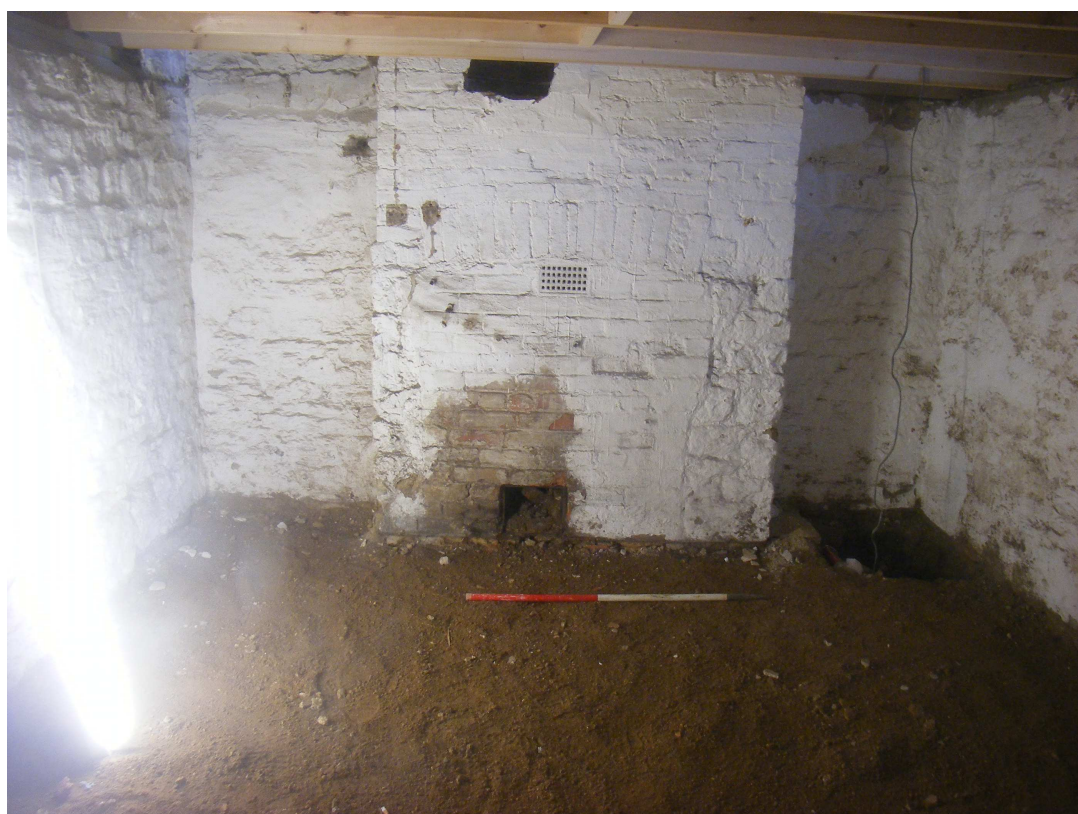
Image 8: General view of eastern half of cellar of western property, showing stone walls and brick and stone chimney stack. Scale 1m in 50cm divisions.

The contractors intended to reduce the floor level within the cellar in late November 2015, initially removing the orange sandy bedding layer for the former tiled floor. However, it quickly became clear that the potential ground reduction was restricted by the depth of the walls and so this work was not progressed (Figure 6: image 8).
