**TREOW HOUSE
PARKSIDE DRIVE
HOUGHTON REGIS
BEDFORDSHIRE**

**ARCHAEOLOGICAL INVESTIGATION,
RECORDING, ANALYSIS AND PUBLICATION**

STAGE 1 TRIAL TRENCH EVALUATION

Document: 2016/112
Version 1.0

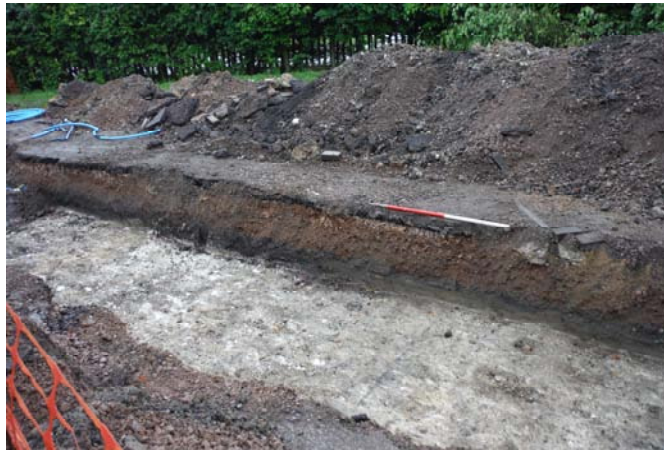
Tr 1. Layers [105] & [106]. Scale 1m. Looking SW.

A dark grey-black clay-silt layer (105) in Trench 1 contained fragments of brick and ceramic roof tile (73g), 19th-century transfer-printed earthenware (fabric P45) with blue willow pattern decoration (1g), and a residual sherd of 17th-century glazed red earthenware (fabric P01:17g). The layer was up to 0.18m thick along most of the trench and directly overlay the chalk geology, except towards the north-west end where it petered out to 0.05m thick above layer (106). The layer is interpreted as a former farmyard deposit of 19th-century date.

A mid brown-grey clay silt layer (106), containing fragments of ceramic roof tile (109g) and roofing slate (7g), was present at the south-west end of Trench 1. It was 0.03–0.13m thick and directly overlay the chalk geology at the north-west end of the trench. The layer is interpreted as a disturbed subsoil deposit, associated with the overlying farmyard deposit (105).

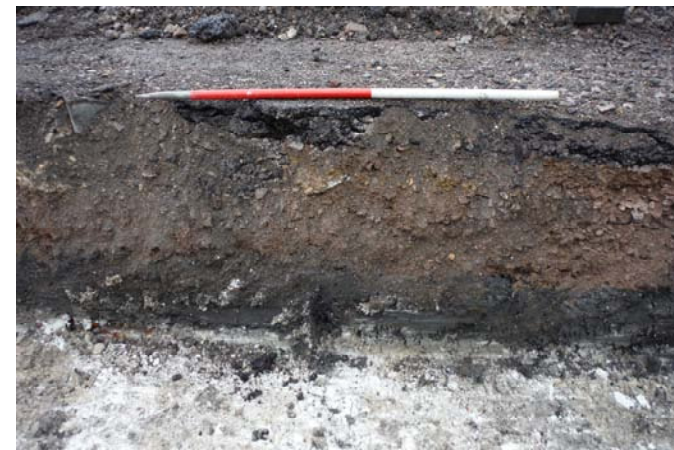
Tr 1. Layer [105]. Scale 1m. Looking NW.

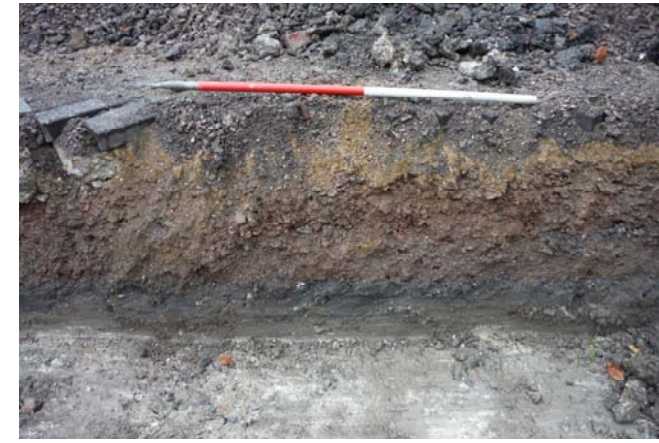
Tr 1. Layer [106]. Scale 1m. Looking SW.

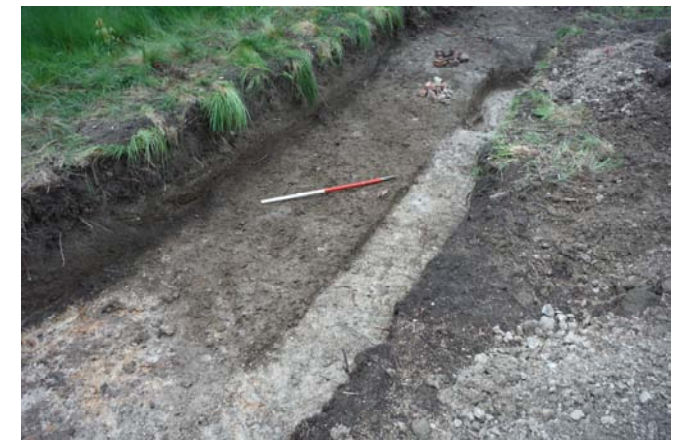
Tr 2. Feature [203]. Scale 1m. Looking SE.

A broadly linear expansive shallow feature [203] on a NNW-SSE alignment crossed Trench 2 immediately east of foundation [212]. It had concave sides and a flat base. It was *c.* 3.6m wide, 0.2m deep and contained mid grey-brown clay-silt. Four animal rib fragments (52g) were collected from fill (204).

The feature is interpreted as an erosional hollow, located immediately outside the structure represented by foundations [308] and [212] and associated with its use.

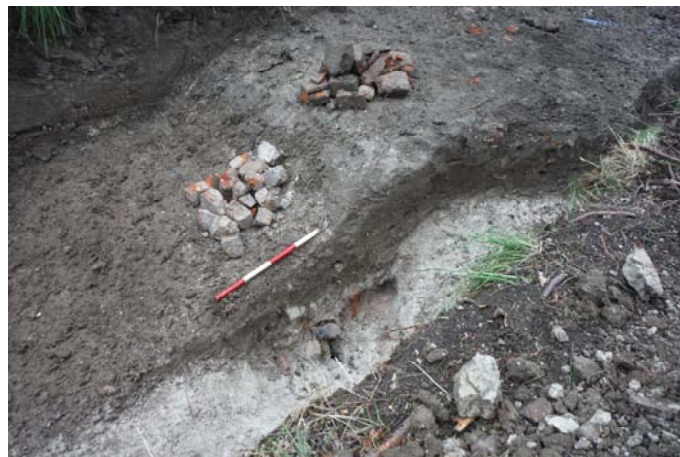
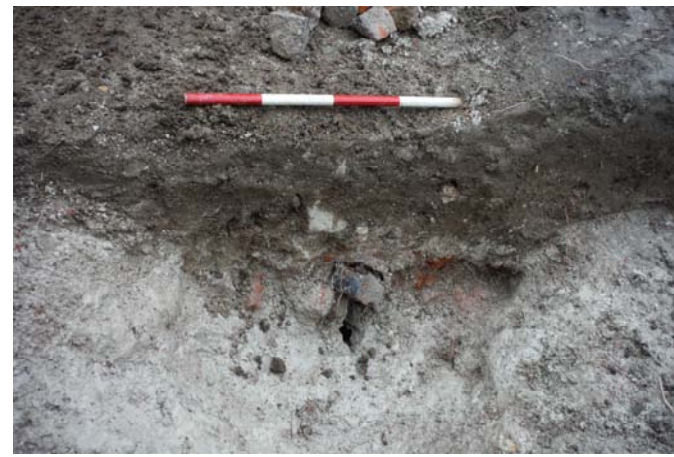
Tr 2. Post hole [209]. Scale 40 cm. Looking SE.

Tr 2. Post hole [209]. Scale 40 cm. Looking SE

Sub-circular post hole [209] was present close to foundation [212] within Trench 2. It had convex sides with a concave base; it was 0.85m in diameter, 0.3m deep and contained light grey-brown clay silt. Six vitrified half-bricks (3.4kg), each measuring approximately W105mm x D60mm, and probably representing packing material, were collected from the lower fill (210).

The post hole is likely to be associated with the same structure as foundations [308] and [212].

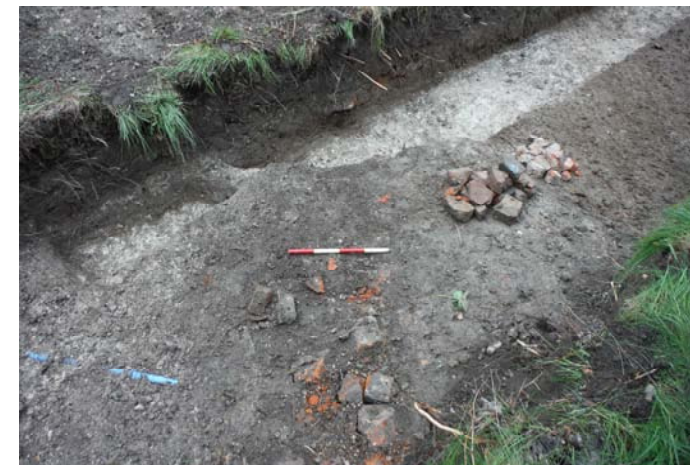
Tr 2. Foundation [212]. Scale 40 cm. Looking NW.

A shallow NNW-SSE aligned feature containing a layer of half-bricks was identified in Trench 2. Foundation trench [212] truncated subsoil layer (201) and pit [205] (see below). The feature had concave sides with a flat base (0.6m wide and 0.1m deep); it contained half-bricks (806g) and ceramic roof tile fragments (430g) arranged end-to-end to form a relatively flat surface. The gaps between the bricks were packed and in-filled with mid grey clay-silt (213). A large iron pyramidal-headed masonry spike (L160mm) was collected from the same deposit.

Feature [212] is interpreted as a construction trench containing bricks that acted as ‘pads’ to support a beam, onto which a wall, possibly of wattle and daub was constructed. The brick ‘pads’ would have acted to support the beam in position and slow the rot from the moist surrounding soil.

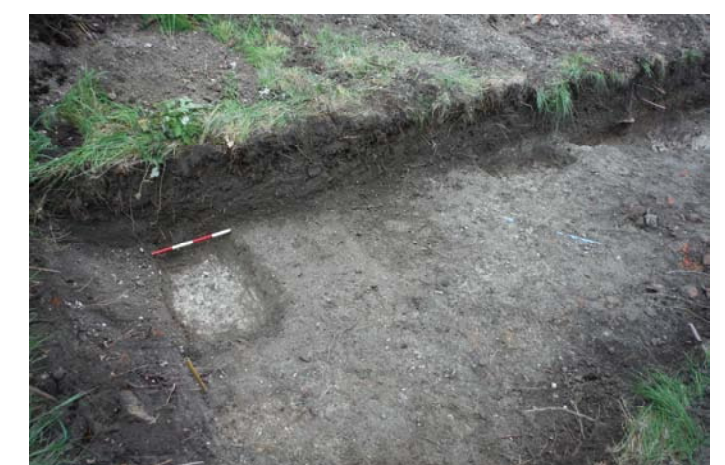
Tr 2. Pit [205]. Scale 40 cm. Looking NW.

A large pit [205] was present at the south-west end of Trench 2. It had concave sides and a flat base; it was at least 3.5m long, 1.1m wide and 0.28m deep. It contained three deposits varying from mid grey clay-silt with frequent chalk fragments to mid grey-brown clay-silt. Finds collected from primary fill (206) comprise modern ceramic land drain (75g), an abraded frogged brick fragment (1.1kg), a perforated iron strip, an incomplete horseshoe, and a piece of animal limb bone (13g).

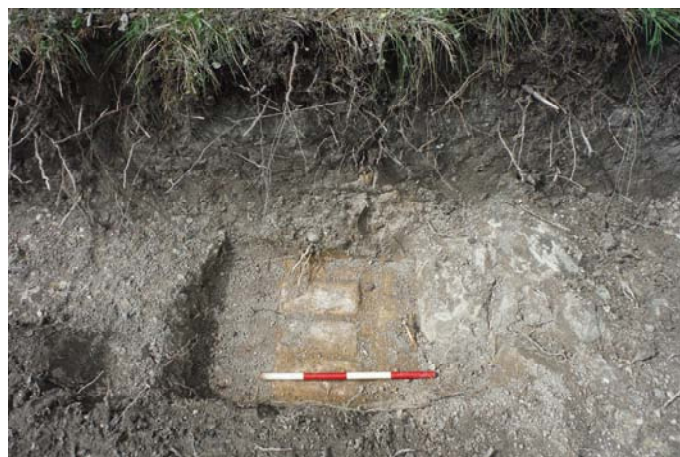
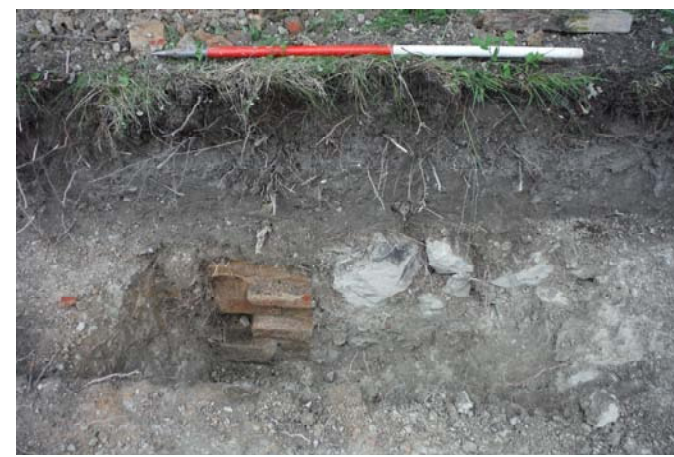
Tr 3. Foundation [308], (314). Scale 40 cm. Looking NW.

Tr 3. Foundation [308] & (314). Scale 1m. Looking NW.

A substantial NNW-SSE aligned foundation was identified in Trench 3. Foundation trench [308], cut into the natural chalk, had vertical sides and a flat base; it was 1.37m wide and 0.6m deep. It contained a brick wall foundation that was 0.35m wide and only 0.42m high, constructed of un-frogged bricks (314) within a loose sandy mortar. The bricks retained traces of a different coloured hard mortar, indicating that they had been re-used. The remainder of the foundation trench had been backfilled with mid brown-grey silt containing frequent medium and large chalk fragments. Ceramic flat roof tile (62g) and a sherd of 19th-century refined white ware (fabric P100¹: 4g) was collected from backfill (311).

The foundation is interpreted as a ‘dwarf wall’ on which a wooden beam would have been laid for a structure that was made predominantly of wood. The structure could have been domestic or an outbuilding, such as a barn.

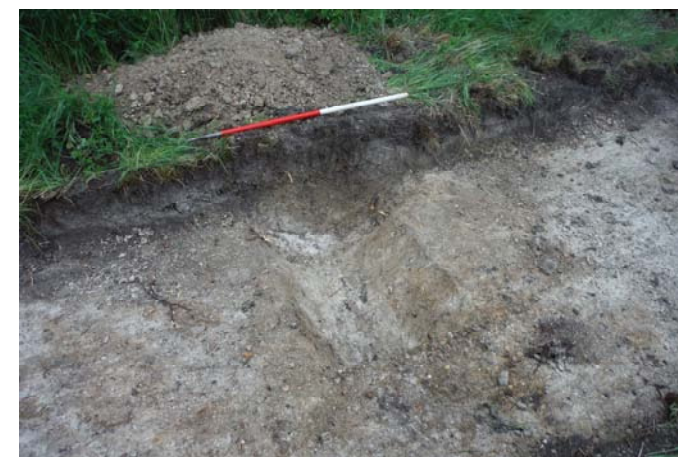
Tr 3. Ditch [315]. Scale 1m. Looking N.

Ditches [305] and [315] had concave profiles; they were 0.53–1m wide and 0.2–0.35m deep, containing deposits that varied from light grey-yellow silt to mid orange-brown sandy silt. The secondary fill (307) of ditch [305] contained four abraded brick fragments (93g).

On the basis of their artefactual dating and their shared alignment, the ditches are interpreted as boundary/drainage features contemporary with the 19th-century structure represented by foundations [212] and [308].

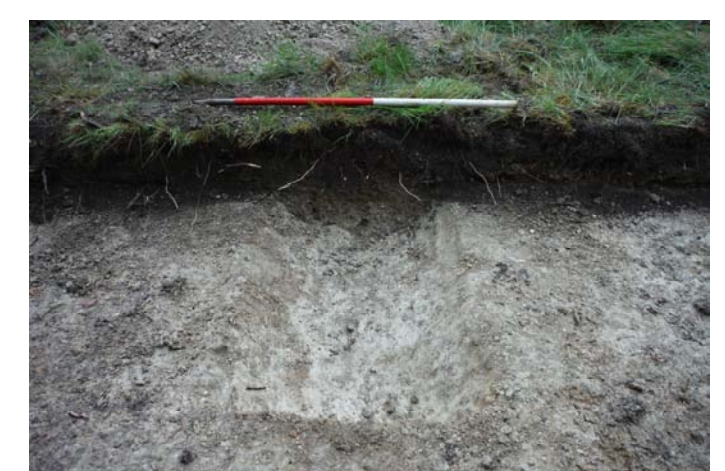
Tr 3. Ditch [305]. Scale 1m. Looking SE.

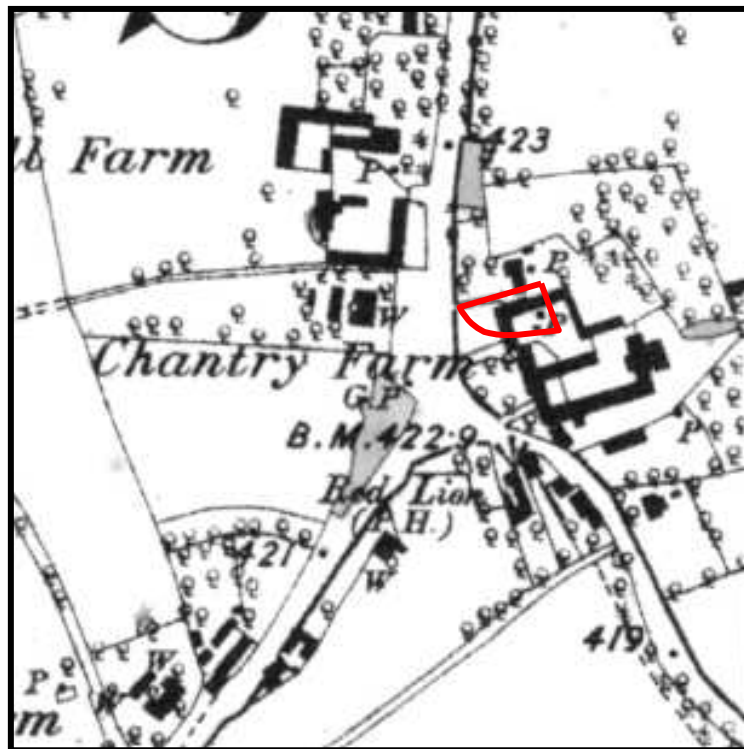
Figure 5: 1886 first edition 6-inch OS map

The OS first edition map of 1886 (Figure 5) illustrates a range of buildings arranged around a rectangular yard within the DA, labelled as *Chantry Farm*. The location, size and alignment of these buildings are a good match for the two foundations identified in Trenches 2 and 3.

The location, alignment and size of the foundations are a good match for a range of buildings illustrated on the OS first edition map of 1886 as *Chantry Farm* (Figure 5). The foundations and other features within the trenches are interpreted as part of the farm and its internal yard area. The farm appears to have been demolished in the late 19th century as it does not appear on the OS 2nd edition map of 1902.
