**20-22 LAKE STREET  
LEIGHTON BUZZARD  
BEDFORDSHIRE**

**ARCHAEOLOGICAL OBSERVATION,  
INVESTIGATION, RECORDING, ANALYSIS AND  
PUBLICATION**

Project: LS2688  
Luton Culture entry no.: LUTNM 1249  
OASIS ref. no.: albionar1-249262  
HER search reference no.: 201516/114

Document: 2017/30  
Version 1.0

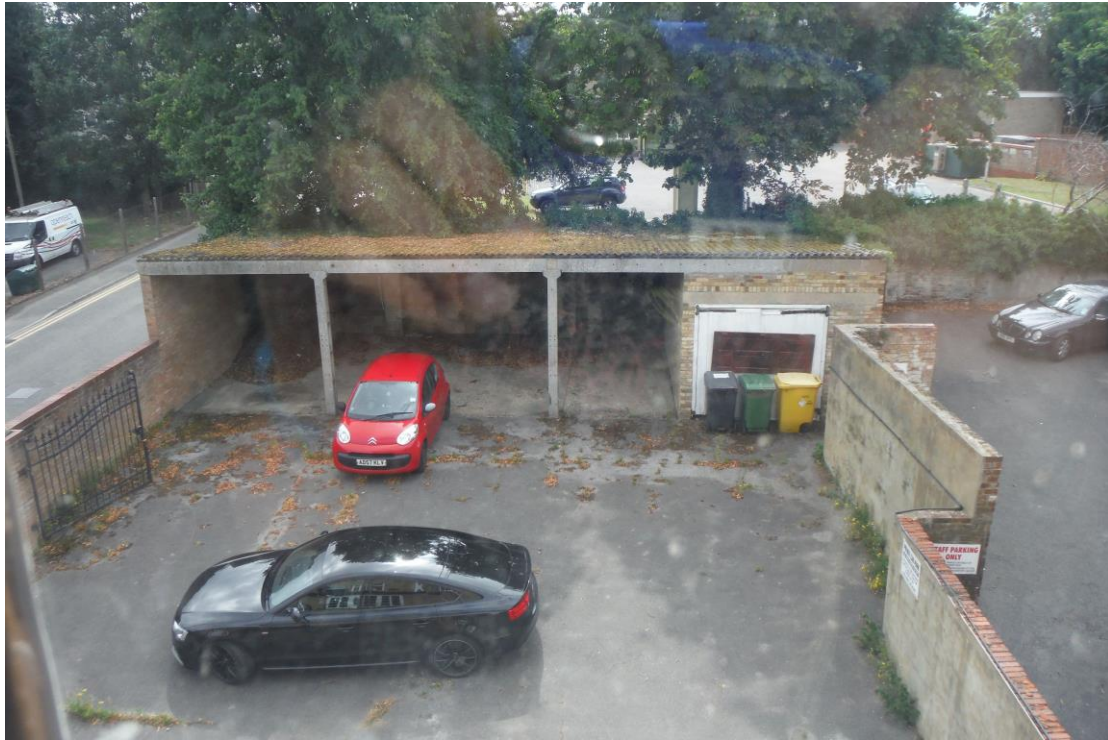
**Figure 3:** View of garages pre-demolition  
(looking south-west out of top window of 20-22 Lake Street)

Works included demolition of the existing garages (Figure 3) and the removal of their foundations, as well as ground reduction and excavations for new foundations, services and the new car parking spaces (Figure 4). A detailed methodology is provided in the Written Scheme of Investigation (Albion 2016).

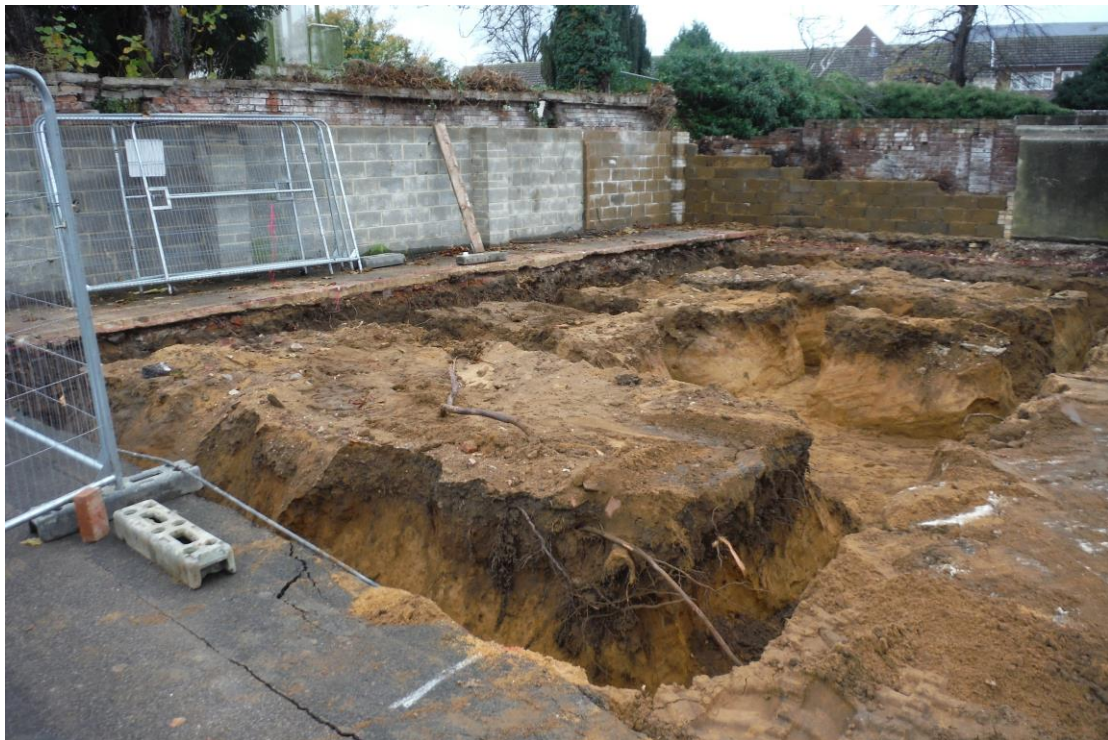
**Figure 4:** Site of garages following demolition and excavation of new foundation trenches  
(looking north-west)

Groundworks comprised the excavation of strip foundation trenches, within the footprint of the new building (Figures 1, 2 and 4). No archaeological features pre-dating the modern period were found.

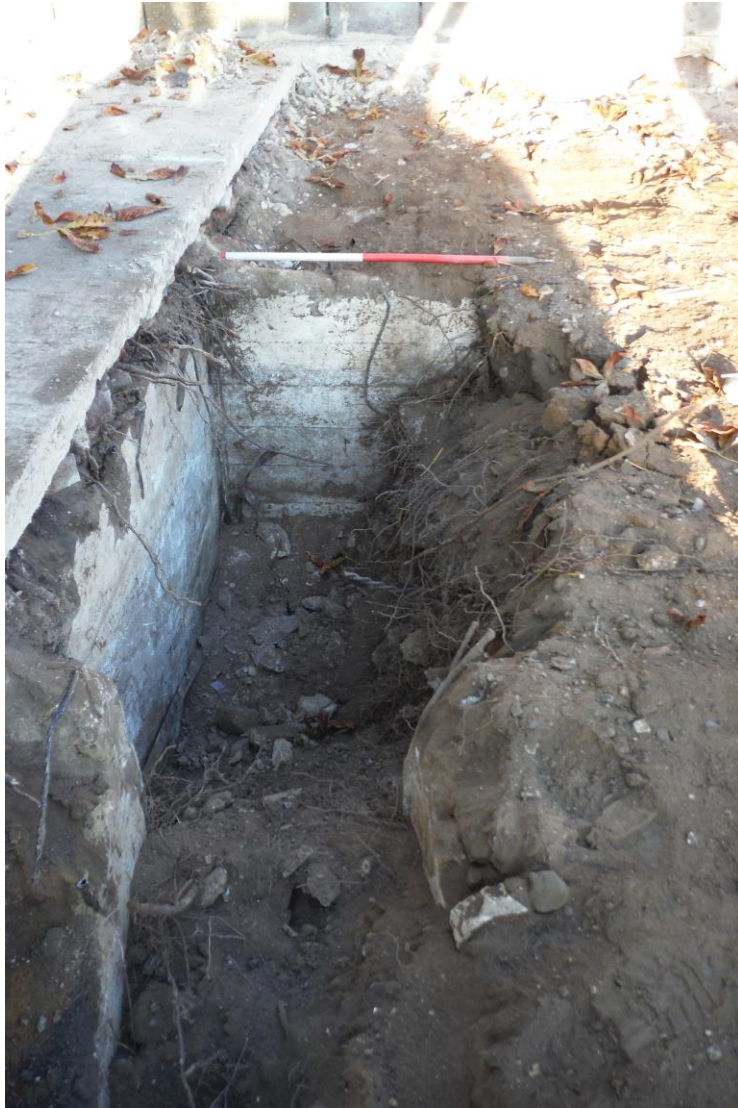
Excavation of the south-west corner of the new strip foundations revealed a small, rectangular concrete structure (6) that was 2m long, 1.4m wide and 1.6m deep (Figures 5 and 6). A 0.6m-wide entrance passage with concrete walls lay to the north-east, turning a sharp right-angle before it met the structure. The floor and walls of the structure were made of concrete and were 0.15m thick; the entrance walls were 0.12m thick. The roof of the structure had been removed and the majority of the structure lay below present ground level.

**Figure 5:** Air-raid shelter, looking north-west

The nature and materials of the small concrete structure (6) suggest that it may have been an air raid shelter. Anticipating the outbreak of the Second World War the government passed the Air Raid Precautions (ARP) Act in 1937, which meant that local government had to provide shelter and take precautions against gas attacks.

Shelters could be in the form of corrugated iron and steel Anderson shelters, issued by the government, or of a 'trench' design which, amongst other materials, often used prefabricated concrete and steel to provide walls and ceilings. The shelters were then covered with spoil that had been excavated from the original trench (Lowry 1996). The shelter at 20-22 Lake Street seems to fit this design. Its roof must have been removed during the remodelling of the yard and construction of the garages in the mid-20th century. The shelter had not previously been known about and represents a structure of low significance.

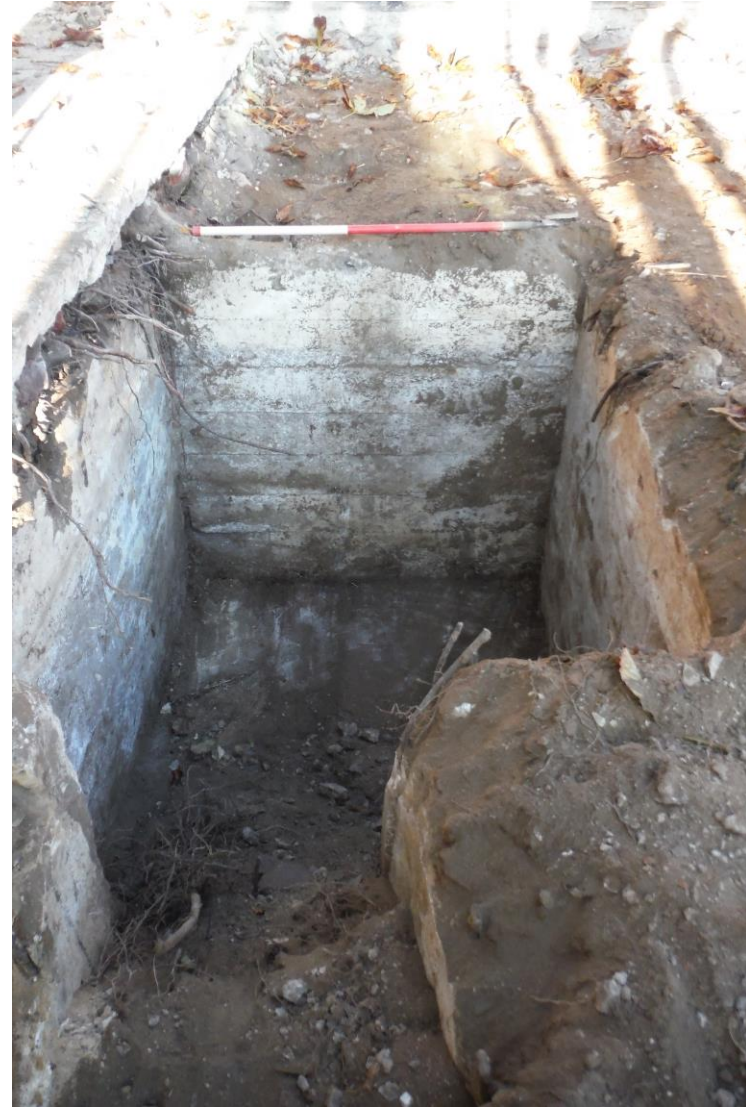
**Figure 6:** Air-raid shelter, looking south-east

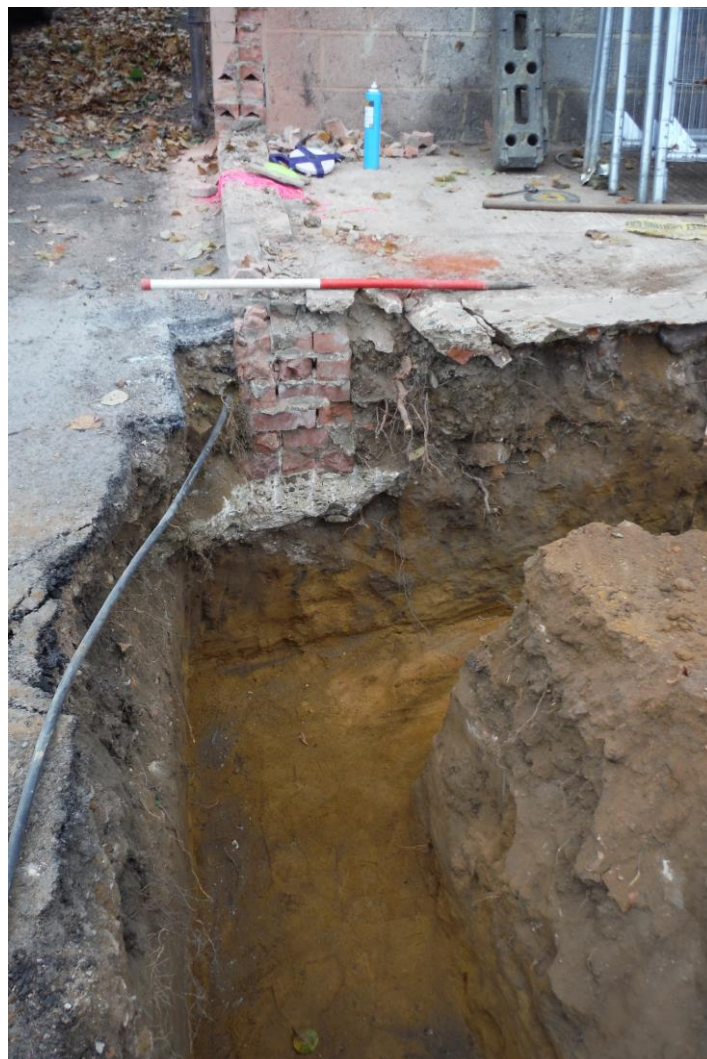
The remains of a brick wall foundation (10) of the demolished garages were recorded in the south-east corner of the strip foundations (Figure 7). It was built of modern machine-made bricks and cement mortar. It was only recorded in section.

**Figure 7:** Wall foundation, looking north-east
