**LAND TO THE REAR OF
21 REGENT STREET
DUNSTABLE
BEDFORDSHIRE**

**ARCHAEOLOGICAL STRIP, MAP
AND SAMPLE EXCAVATION,
ANALYSIS AND PUBLICATION**

Project: RS2817
HER search reference: 201617/57
Luton Culture accession no: LUTNM: 2019/01
OASIS no: albionar1-252242

Document: 2018/156
Version 1.0

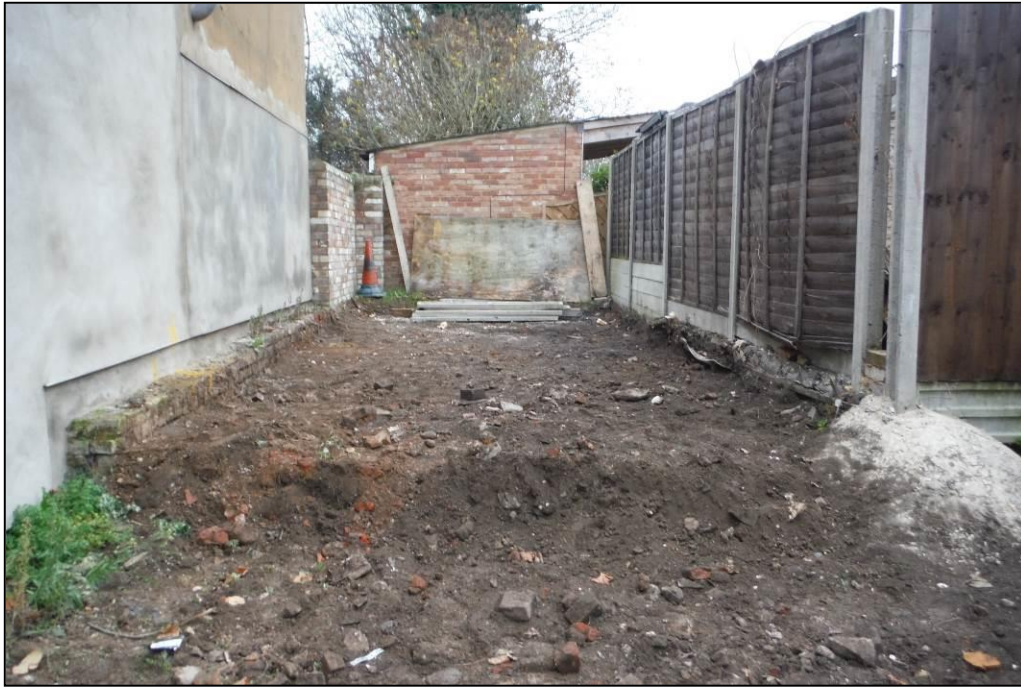
Image 1: Pre-excitation view of garden area of site, looking south-east, showing the height difference between street frontage and the higher ground to the rear of the plot

The patio / garden occupying the higher terrace area was stripped first, revealing undisturbed white chalk (2) only 0.15m below the current ground level (Figure 3: images 1 and 2). This was disturbed in the north-west corner, close to the lower terrace, by a modern service manhole shaft and associated service trench. The chalk on the lower terrace, towards the street frontage was disturbed by a post-medieval gully and a variety of modern features (Figure 2 and Figure 4: images 3 and 4).

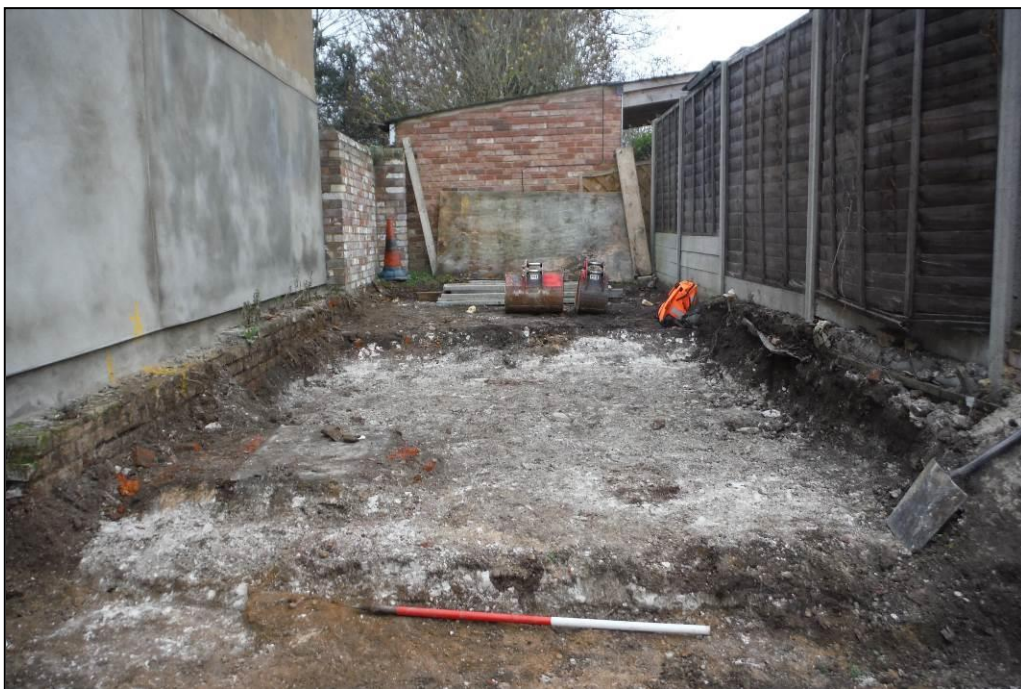
Image 2: Stripping of garden area to the rear of the plot, looking south-east from the street frontage, showing the chalk terrace with foundation trench [7] at extreme left of image and manhole and associated service trench to lower left (Scale 1m in 50cm divisions)

- a rectangular brick-lined manhole *c.* 1m by 0.9m, which disturbed the chalk towards the north-western limit of the upper terrace;
- an associated service trench (with ceramic sewer pipe) extending to the west, towards the street frontage (Figure 2 and Figure 3: image 2).

Extending from the northern margin of the PDA was a 0.2m-wide, linear feature [7], at least 4.5m long and continuing eastwards beyond the investigation area (Figure 2 and Figure 3: image 2). It was backfilled with friable mid-red-brown sandy silt (8) that contained CBM, metal, disused items and sawn animal bone

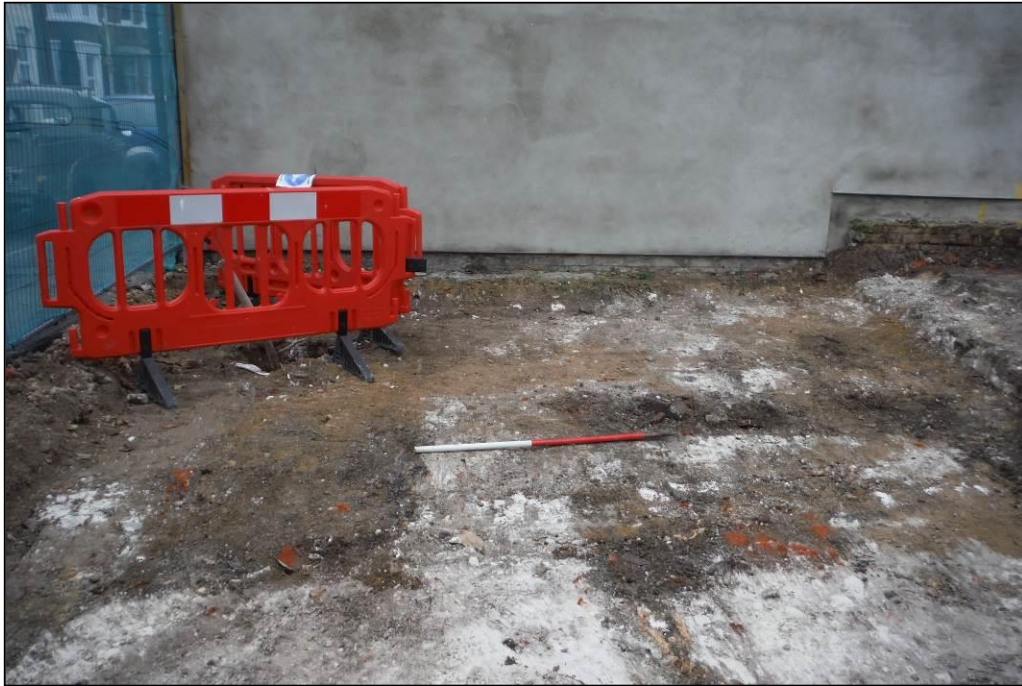
Image 3: Northern part of the lower terrace, with overburden removed, showing perpendicular modern rectangular pits [10], modern services and large irregular feature [5] (Scale 1m in 50cm divisions)

Two modern rectangular machine-dug pits [9], *c.* 2m long by up to 1m wide, were identified on perpendicular alignments (Figure 4: image 3), cutting into the roughly triangular area of disturbance and the service trench. These had been backfilled with modern building rubble and other debris, including redundant scaffold poles, cables and wiring, ‘Styrofoam’ type-insulation, plastic, metal, glass, bricks and clinker.

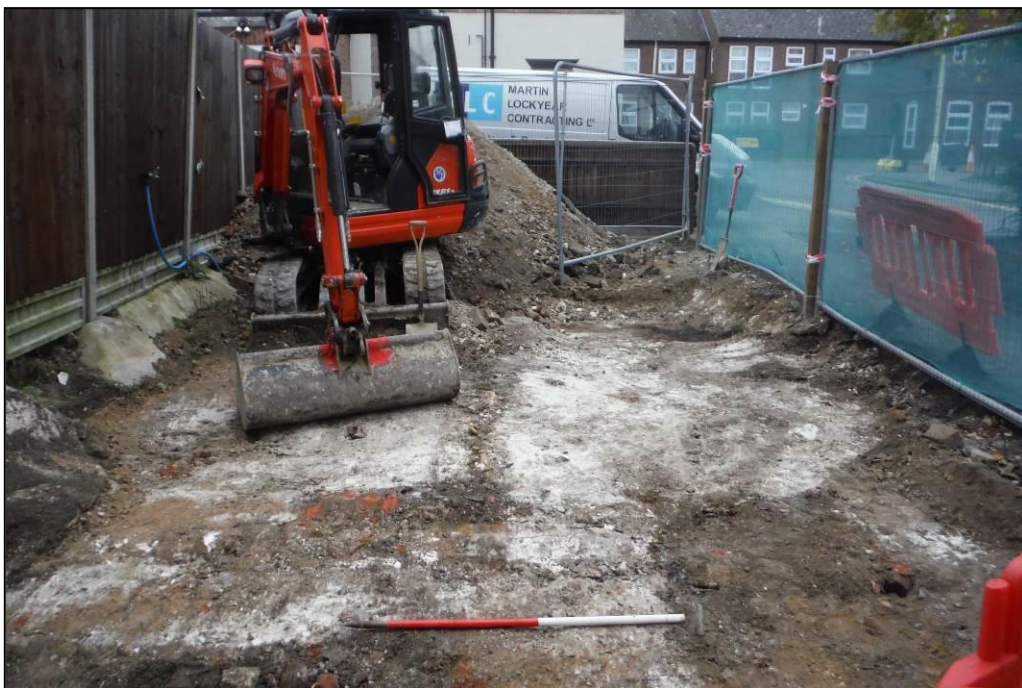
Image 4: South-western part of the lower terrace, with overburden removed, showing modern rectangular pit [10] to bottom right of image, modern service and circular tree-planting pit [11] (Scale 1m in 50cm divisions)

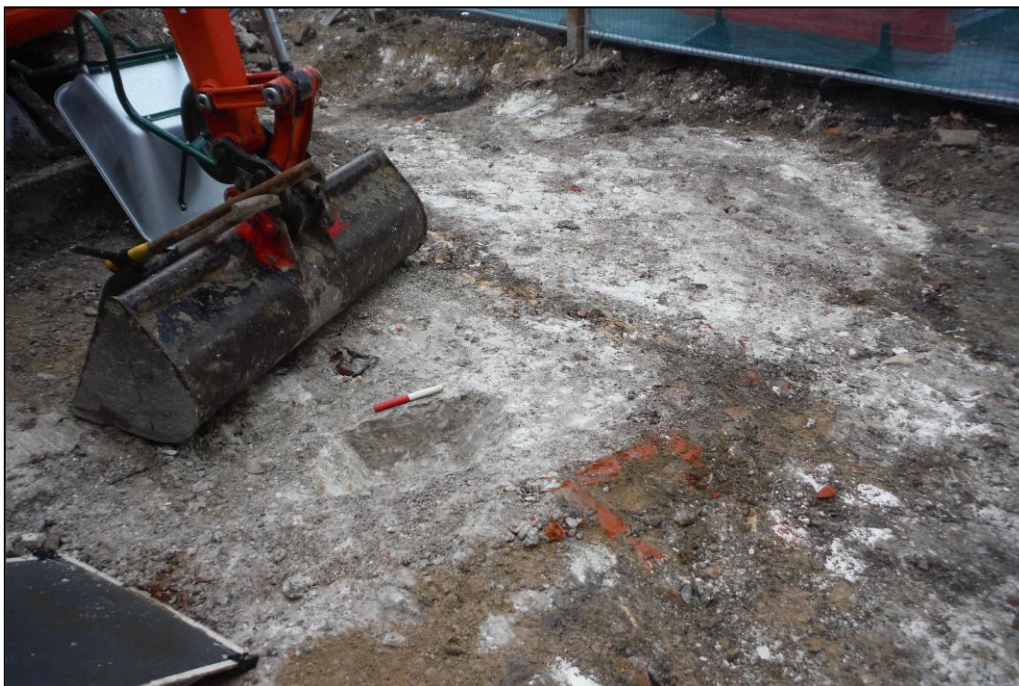
Image 5: The pale fill of the post-medieval NE-SW aligned gully [3], marked by the photographic scale (truncated by modern services including a brick-lined manhole shaft) (Scale 20cm in 10cm divisions)

The narrow truncated gully [3] was observed in the central part of the PDA, aligned roughly NE-SW. It was at least 2.6m long (Figure 2 – brown feature and Figure 5: image 5) and was truncated by service trenches and later activity to the east and west (red features on Figure 2). In section it had an asymmetric profile, 0.45m wide and 0.15m deep, with a steeper southern edge (Figure 2: section 1).

The light grey-brown chalky silt fill (4) contained frequent chalk fragments, as well as CBM and a very small, heavily patinated shard of glass, probably from an 18th-century bottle.

The service trench, probably a sewer, continued onto the lower terrace, with the remains of another brick-lined manhole shaft marking a south-westerly change in the direction of the trench (Figure 2 and Figure 5: image 5).

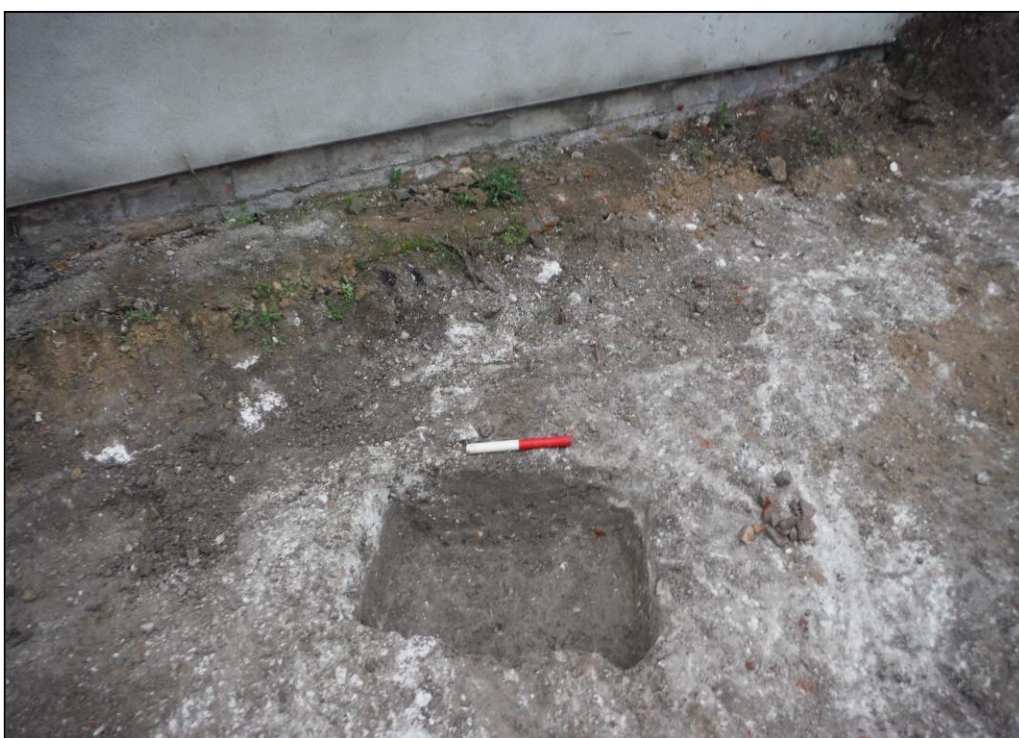
Image 6: Sondage into large irregular feature [5] in the north-western area of the lower terrace — the mixed fill includes lenses of re-deposited chalk geological strata. (Scale 20cm in 10cm divisions)

These comprised an irregular, though roughly triangular area of disturbance [5] in the north-western part of the lower terrace. The area was up to 5m across (extending to the edge of the lower terrace, coinciding with the width of the adjacent properties) by up to 3.4m wide towards the street frontage (Figure 2 – brown feature and Figure 5: image 6). It contained a series of fills, including redeposited chalk lenses and mid-grey-brown clay silt (6) that contained CBM fragments. It is likely that this disturbance is associated with the construction pit for the neighbouring cellar, rather than representing earlier quarrying.

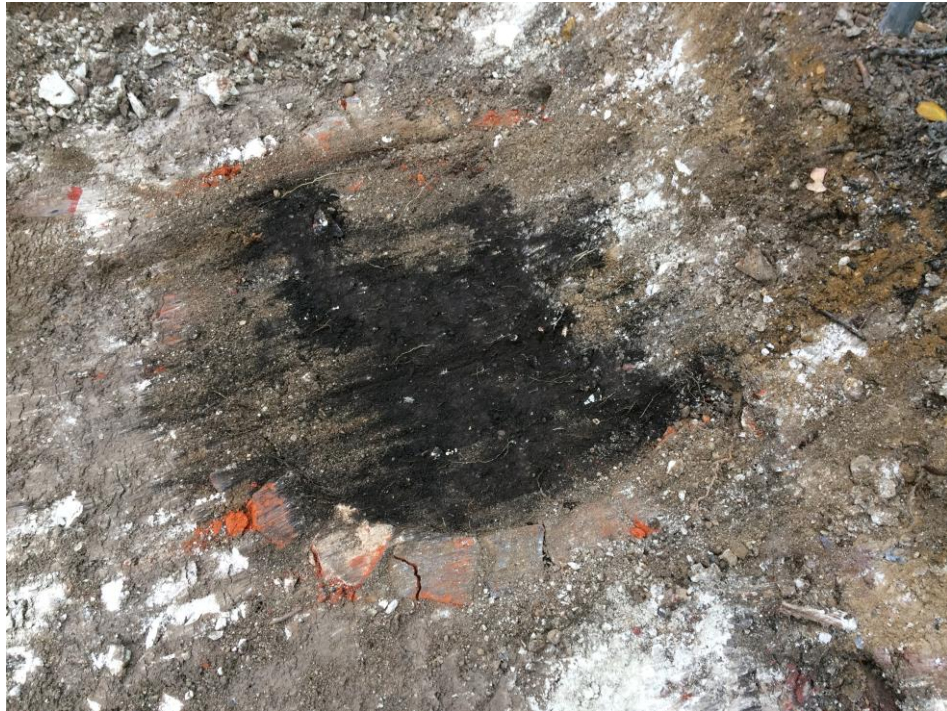
Figure 6: Selected image 7

Image 7: Modern brick-lined circular planting pit [11] (diameter 1m)

Close to the pavement in the south-west part of the PDA was a circular brick-lined feature [11]. It was 1m in diameter and contained dark brown-black friable humic soil (Figure 2 and Figure 6: image 7). Areas of root disturbance radiated out into

the geological strata from this feature, which is thought to be a modern tree planter, associated with recent urban landscaping.
