**URSULA TAYLOR LOWER SCHOOL  
HIGH STREET  
CLAPHAM  
BEDFORDSHIRE**

**ARCHAEOLOGICAL FIELD EVALUATION**

Project: UTA2918  
Museum accession no.: BEDFM: 2016.43  
OASIS ref.: albionar1-255706

Document: 2016/171  
Version 1.0

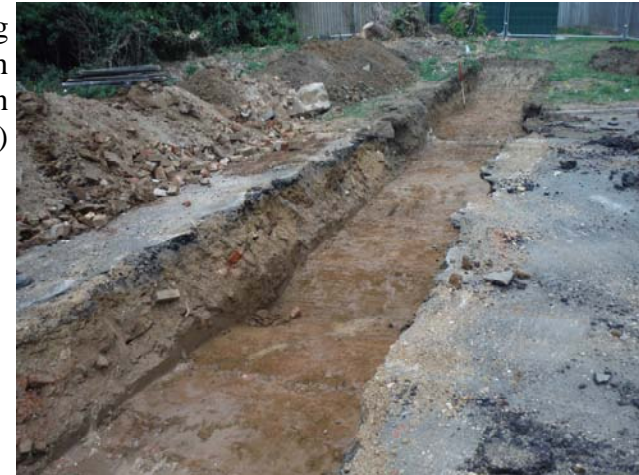
**Figure 2: Trench plan and photographs**

All deposits revealed within the trial trench are summarised below and shown on Figure 2. Context numbers in round brackets refer to fills or layers (\*\*\*). Detailed context information is provided in Appendix 1.

Topsoil (100) comprised grey-brown clayey silt, c. 0.3m thick; it was only present at the ends of the trench, outside the limits of the current car park.

Subsoil (101) comprised mid brown-grey clayey silt, 0.2m thick. Fragments of concrete were present suggesting a small amount of surface disturbance during the previous works on site.

Undisturbed geological deposits comprised mid red-brown silty clay (106).

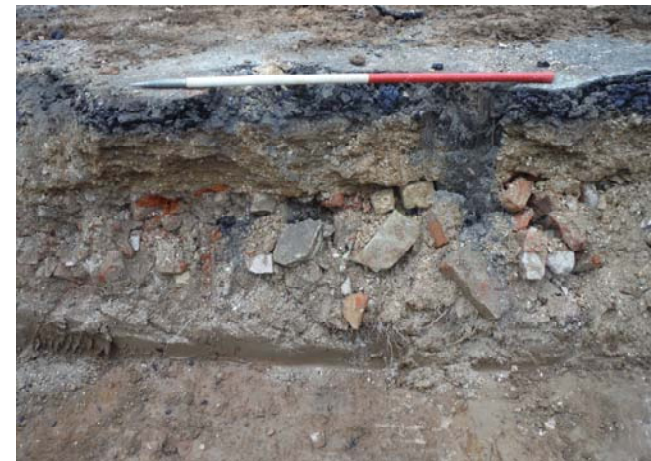
The larger part of the trench revealed construction layers associated with the existing car park (102–105). These were directly above undisturbed geological deposits, suggesting that the topsoil and subsoil had been removed during the construction of the car park.

SE-facing section showing car park construction (2m scale)
