LAND AT 52 PARK LANE
BLUNHAM
BEDFORDSHIRE
ARCHAEOLOGICAL EVALUATION

ARCHAEOLOGICAL EVALUATION

Project: PLB2590

Document: 2017/24
Version 1.0

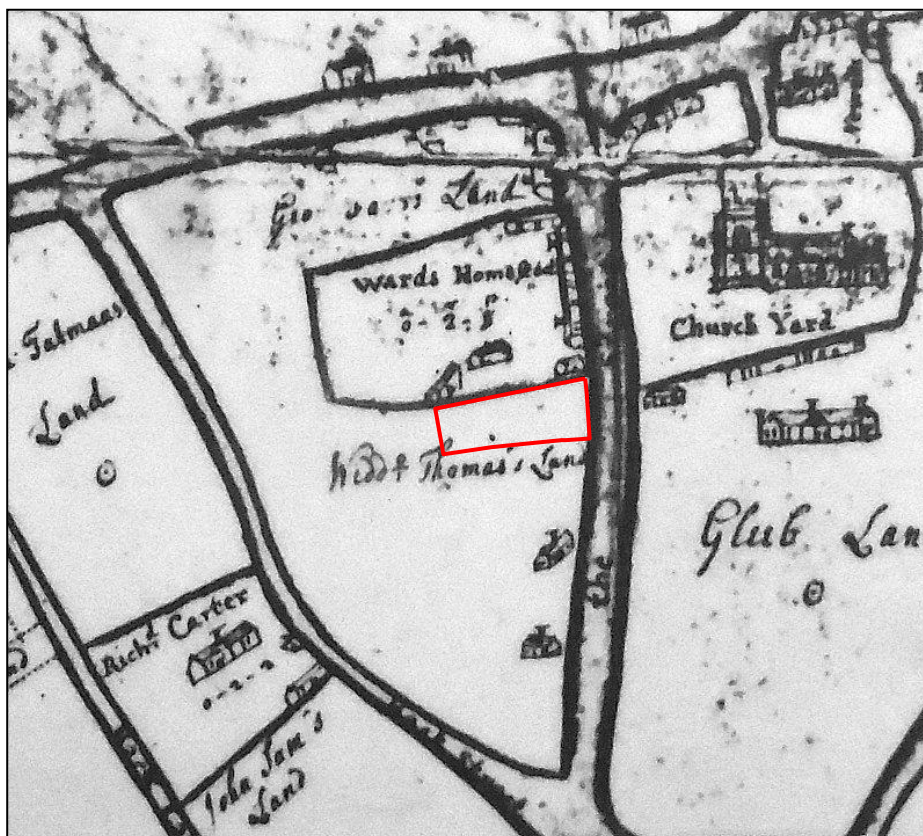
Figure 2: 1719: The Manor of Blunham
(scale and position of DA approximate)

This map shows no detail in the inferred location of the development area (DA). It does, however, have the appearance of a schematic map rather than an accurate topographic survey. Two isolated buildings shown on the west side of the present Park Lane indicate occupation in the general vicinity of the DA. A large enclosed homestead plot to the north of the DA appears to correspond to the plot represented by Manor Court and 54 Park Lane (HER802). The church (HER1024) and the original Blunham rectory (HER9779) are illustrated on the east side of Park Lane.

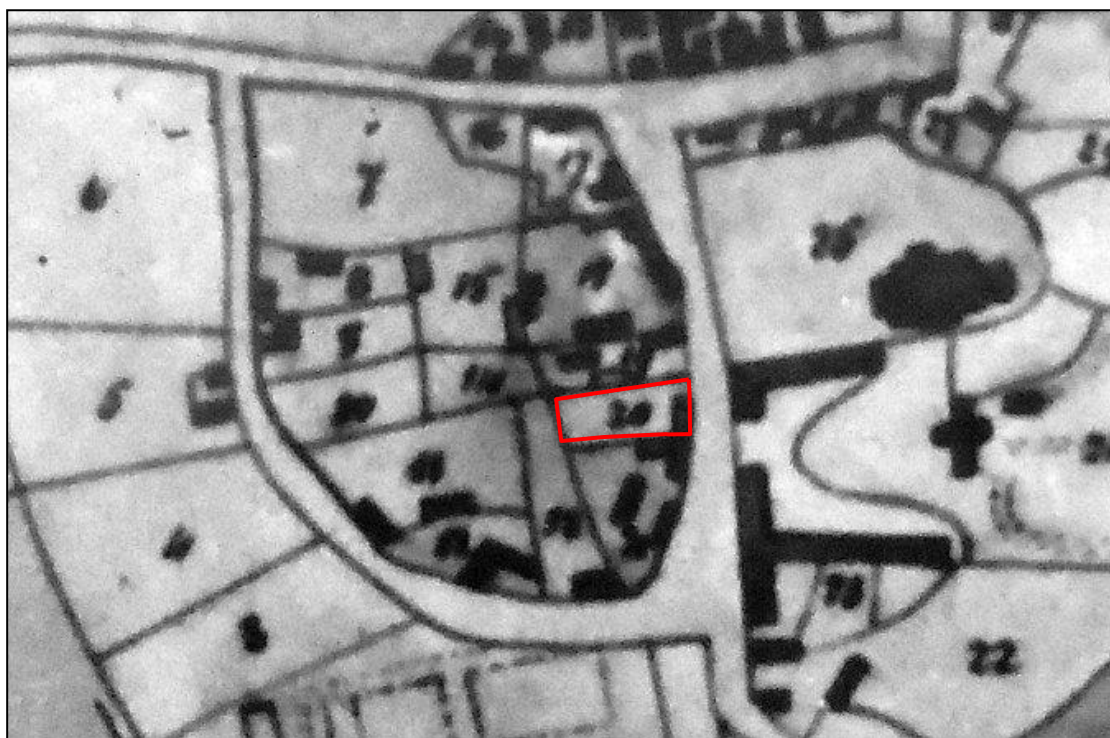
Figure 3: 1799: Enclosure Map
(scale and position of DA approximate)

This map (ref. L33/5) is an 1848 copy of the original 1799 enclosure map (ref. MA10). The map shows the current shape of Park Lane and appears to be a fairly accurate topographical representation.

It shows a plot which corresponds closely to the size, shape and position of the DA. The plot is labelled with the number 20. A building is shown on the street frontage in a position which corresponds to the location of the present house (HER3231).

The DA contains a one-and-a-half storey house (HER3231) dating from the 18th century. This was formerly Grade II listed but has been much altered and has been de-listed. The enclosure map of 1799 shows a building that corresponds to the present house along with outbuildings along the north and south sides of the plot (Figure 3).

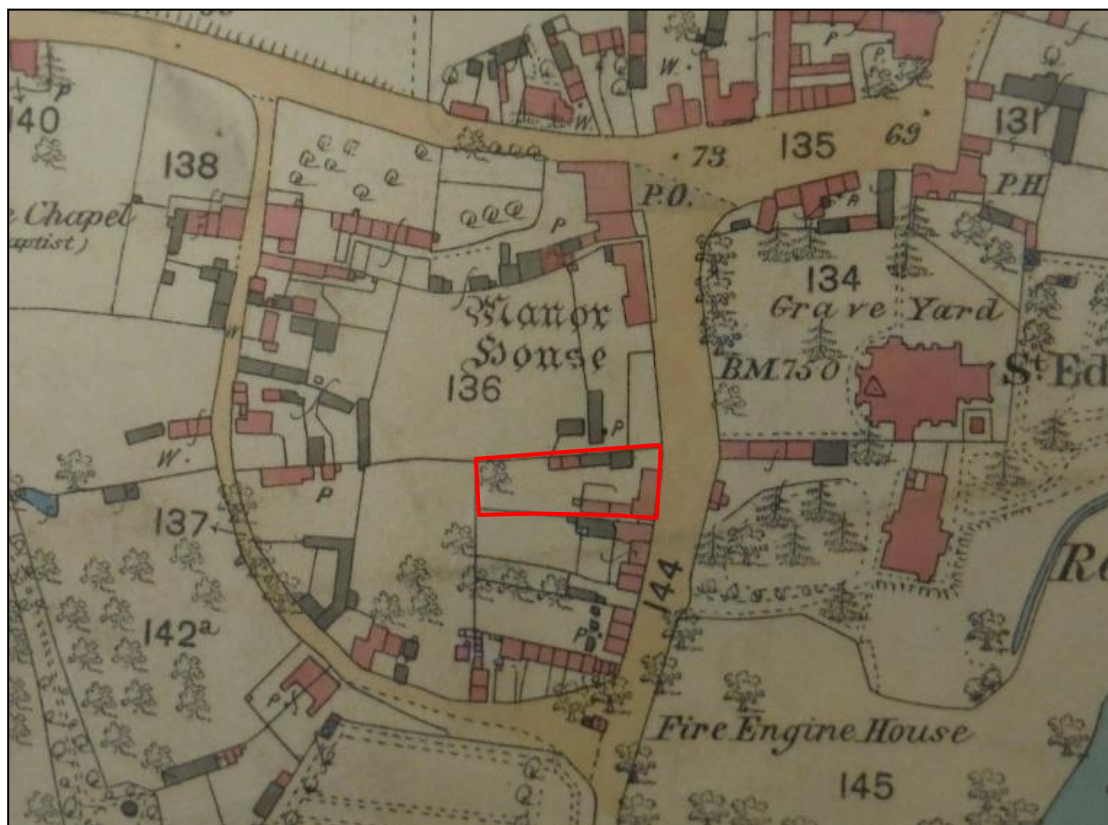
Figure 4: 1884: 25-inch Ordnance Survey map

This map was surveyed in 1882. It is the first highly detailed, topographically accurate map.

In the DA the map shows the building on the street frontage with a range extending along the southern side of the plot from the rear of the house to form an L-shape. Buildings along the northern side of the DA form a detached range of outbuildings. A single symbol for a tree in the west end of the DA suggests its use as a garden or orchard.

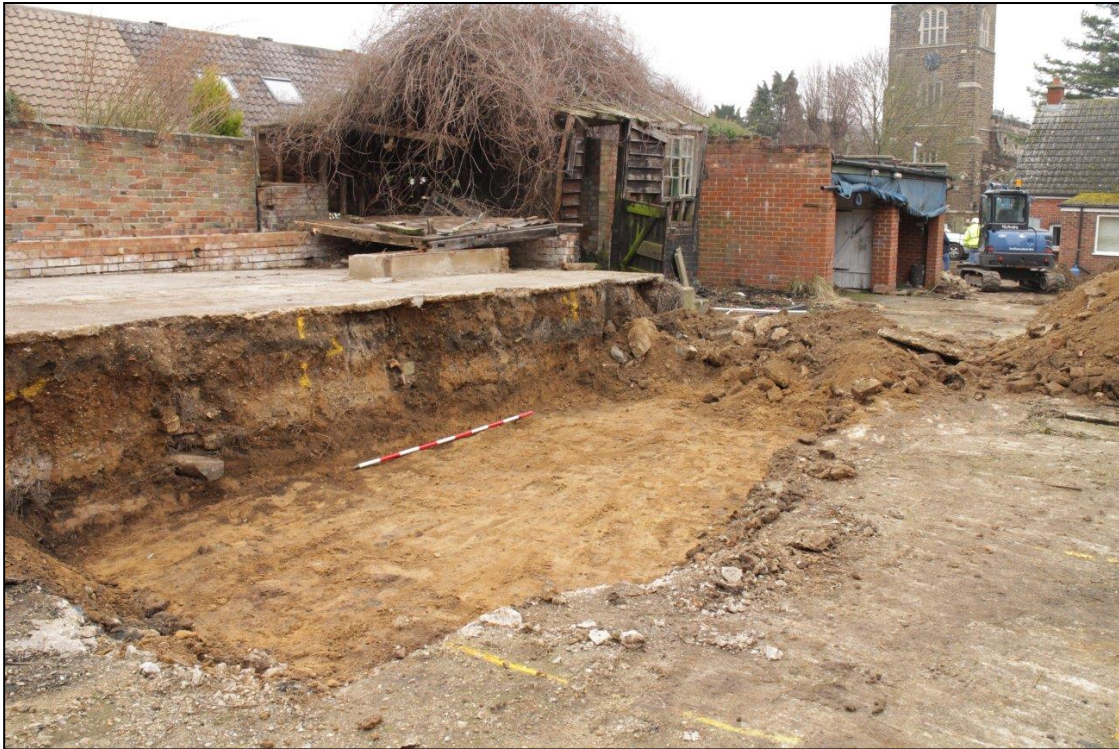
Image 1: Trench 1, looking north-east

Shows difference in ground level at the west end of the site resulting from the truncation of the south-west corner of the site. Scale 2m

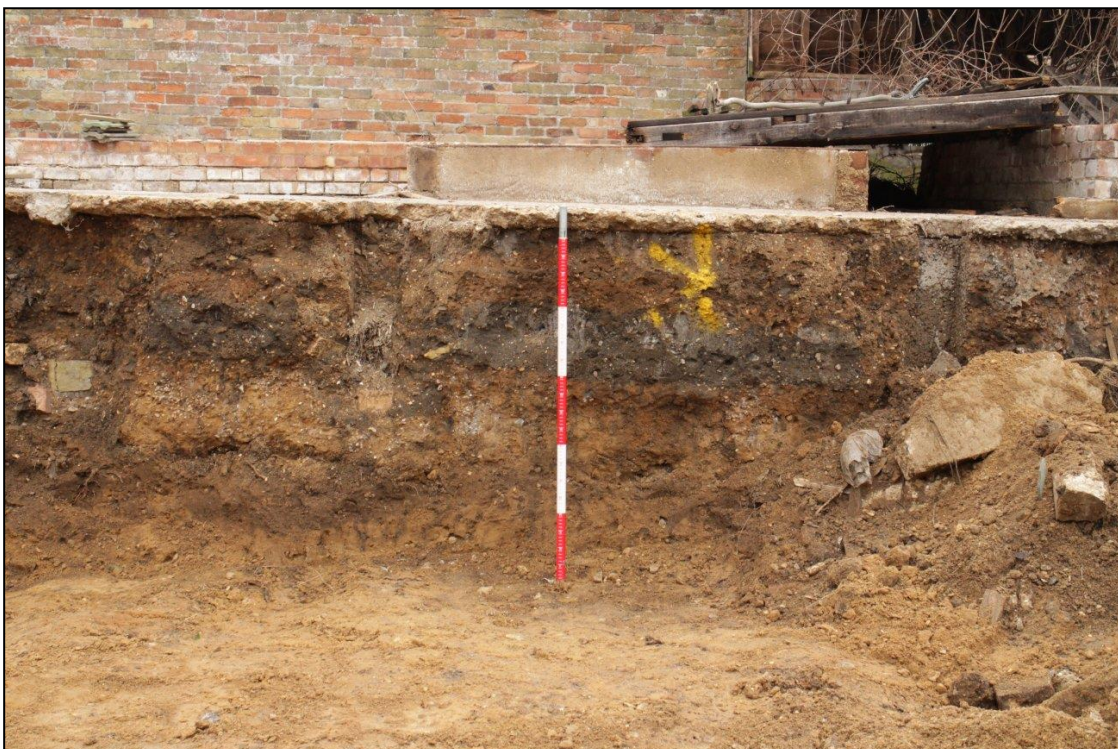
Image 2: Trench 1, Section 1

Shows dark grey buried topsoil layer (104) below a levelling layer (103) of re-deposited sand, used to form a level base for a timber building. The light yellow-brown sand layer (106) in the lower part of the section is the undisturbed geological stratum.

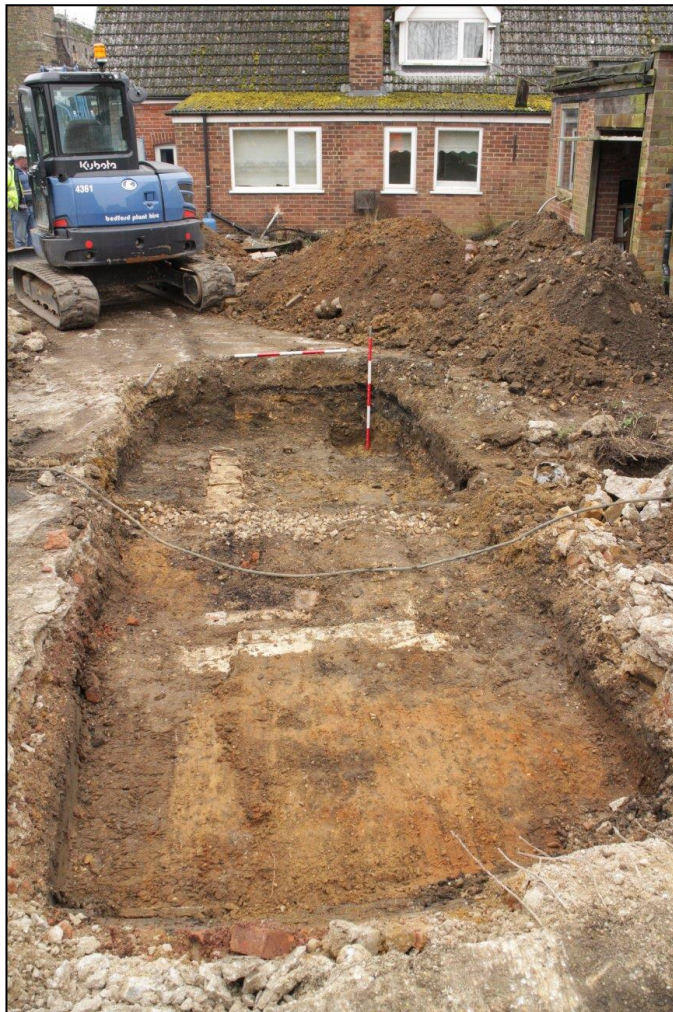
Two brick walls were found in Trench 2 (Figure 7 and Image 3). Wall (212) was L-shaped in plan, extending for at least 5m from east to west before turning southwards for 1.5m. It was constructed from plain red bricks (dimensions 230mm x 110mm x 60mm) bonded with cream-coloured mortar. Another, shorter section of wall (213) was only partially exposed. It was a half-brick wall (i.e. 110mm wide) made from similar bricks to wall (212), which it appeared to abut at its north end.

Image 3: Trench 2, looking east
Showing remains of 19th-century brick
walls (212) and (214). Scale 1m

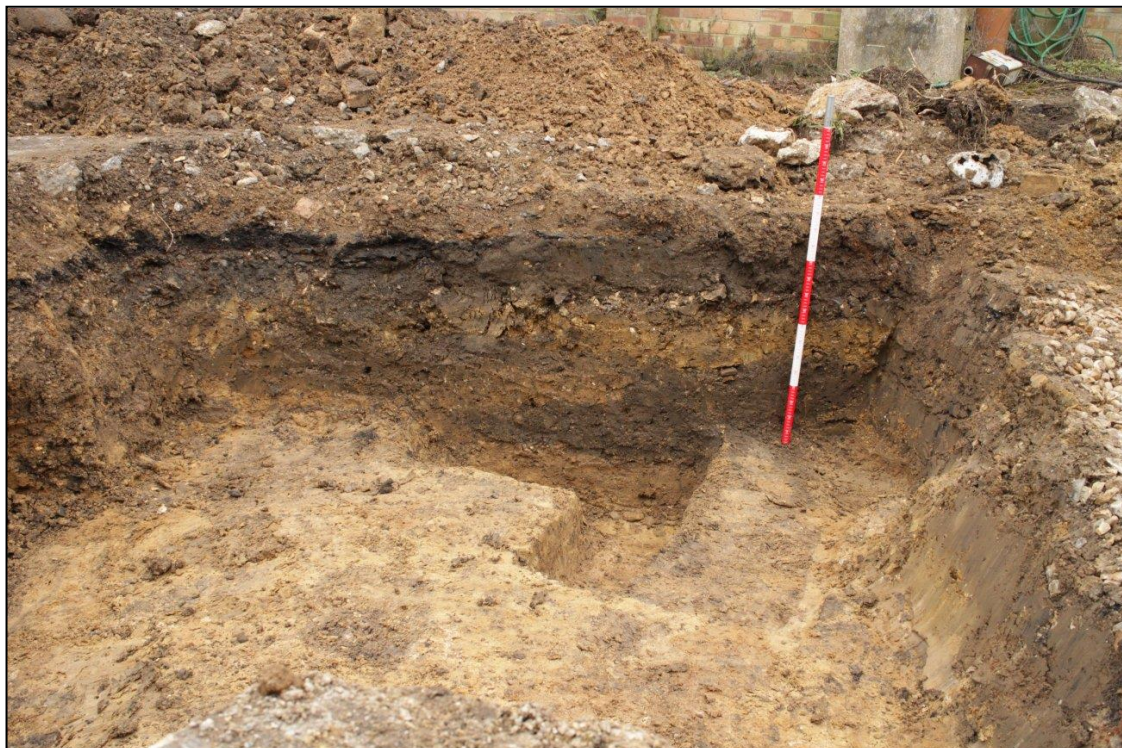
Image 4: Trench 2, Section 2

Two intercutting pits were found below the late 19th-century layers in Trench 2. They produced a very sparse artefact assemblage, including a single sherd of 17th/18th-century pottery (fabric type P01).

Looking south, showing east end of trench after it was machined down to the underlying sand geology, exposing two intercutting pits [206] and [208]. Scale 1m

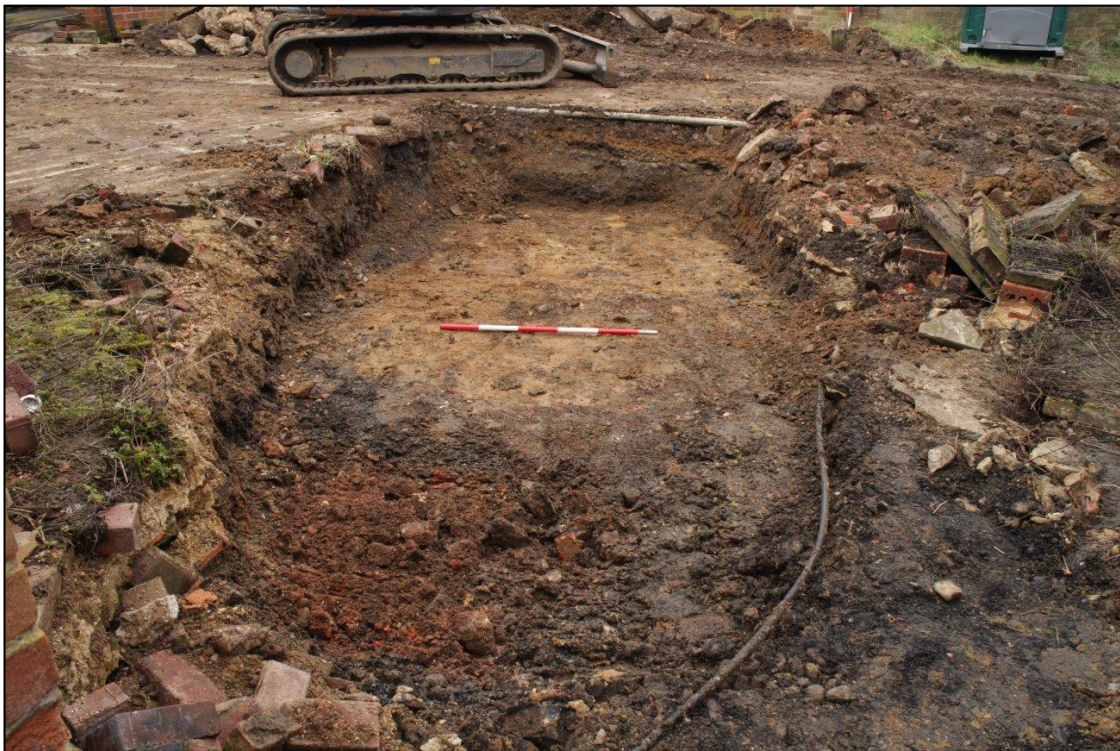
Image 5: Trench 3, looking north-west

A dark layer (309) was noted in plan, when machining the base of the trench; some of this material was left *in situ* at the south end of the trench, where this deposit filled a shallow depression in the top of the underlying geological strata (Image 5). Two sherds of 'Blue Willow' pattern transfer-printed earthenware (21g) were collected from this deposit. A discrete layer of brick rubble (308) was recorded in the south end of the trench, filling a hollow in layer (309). The rubble consisted of a mixture of red and Gault brick.

Shows the natural sand (307) with layers (308) and (309) in the foreground. Scale 1m

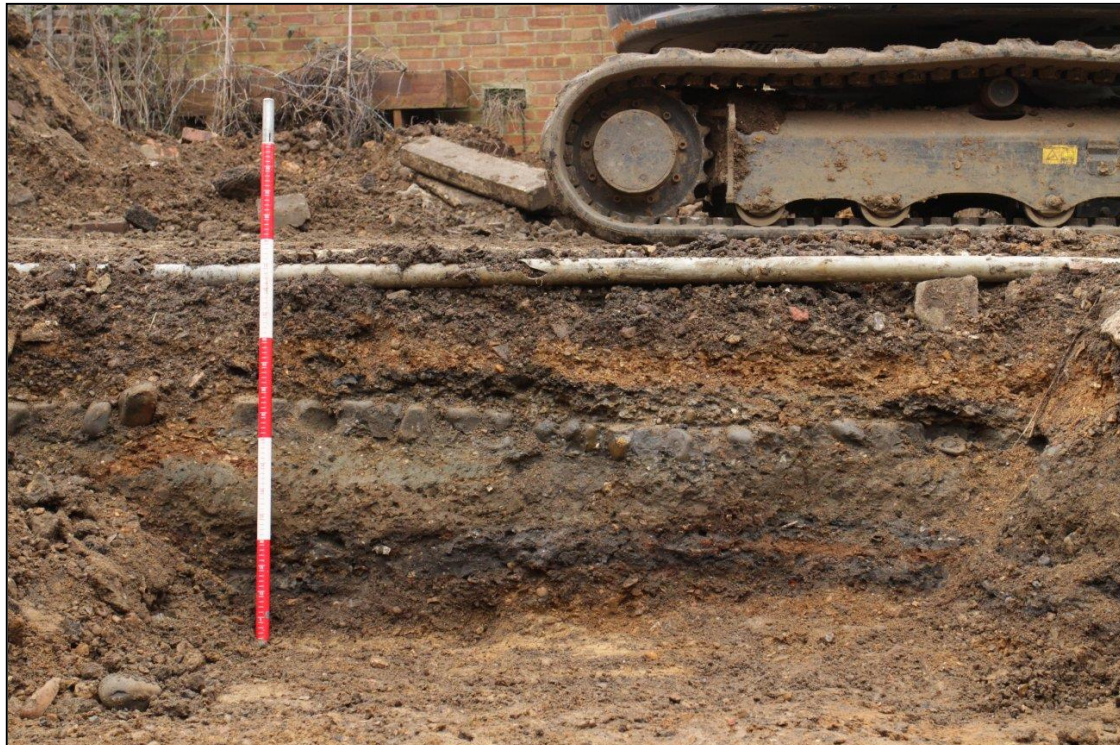
Image 6: Trench 3, Section 3

A well-made cobbled surface (302) was found in Trench 3, directly below modern made-ground deposits (Figure 7, Section 3 and Image 6). The cobbled surface was constructed from a single layer of closely packed pebbles. Layers of blue-grey (303) and yellow-brown sandy silt beneath the pebbles appear to be associated deposits used to raise the ground level and form bedding for the cobbled surface.

The section recorded at the north end of the trench shows a dark soil layer (305) near the base of the trench (Figure 7, Section 3 and Images 5 and 6). This consisted of dark grey or black silt with a few fragments of tile and a piece of clay pipe stem noted in section. Below this was a layer (306) of mid grey-brown sandy gravel immediately above the undisturbed geological strata (307), which consisting of light yellow sand.

Shows modern surface and make-up layers above cobbled surface (302) with a dark, buried soil layer (305) at the base of the trench. Scale 1m

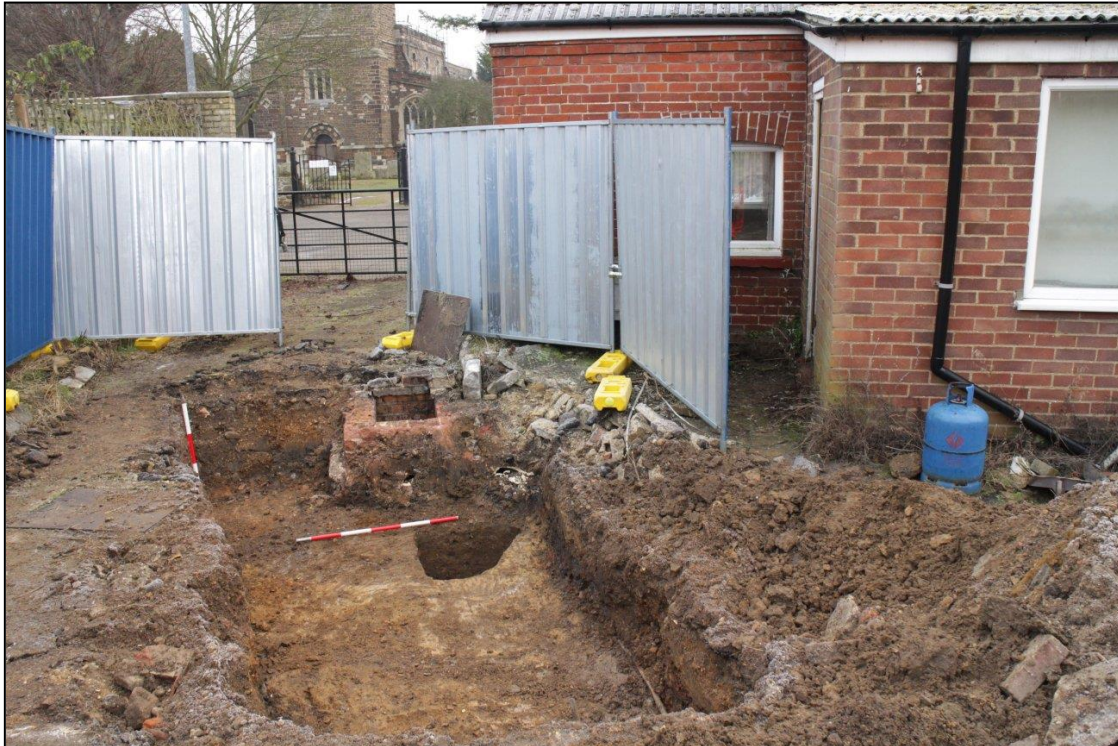
Image 7: Trench 4, looking east

Shows possible well [405] in eastern half of trench. Scale 1m

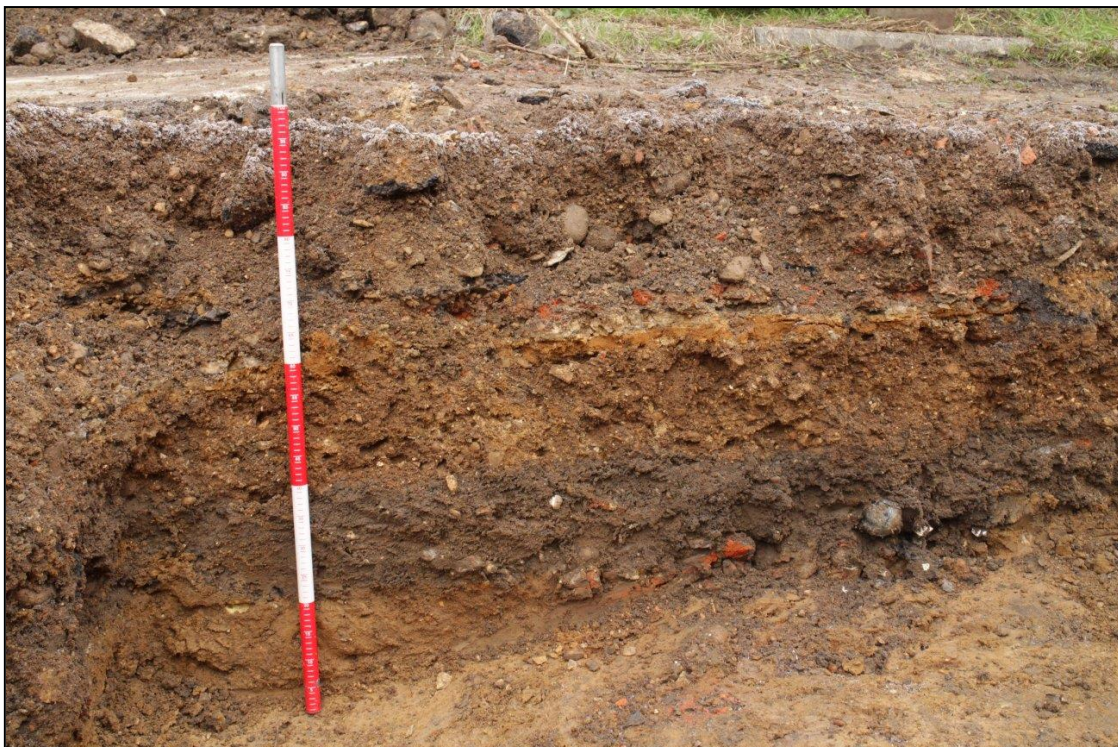
Image 8: Trench 4, Section 4

This trench contained a dark soil layer (403) immediately above the undisturbed geological strata (Figure 7, Section 4 and Image 8). This consisted of dark grey slightly sandy silt with occasional small stones and charcoal with some fragments of brick and bottle glass noted in section.

Shows north side of trench with modern surfaces and make-up layers above a buried soil layer (403) in the base of the trench. Scale 1m

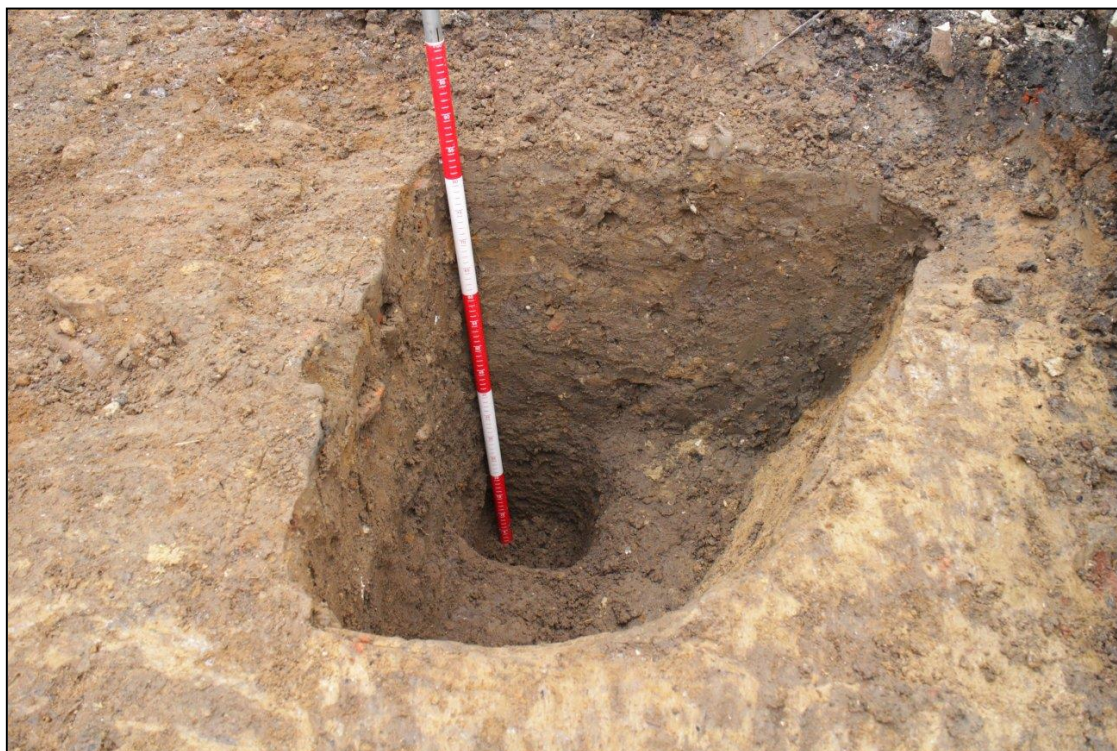
Image 9: Trench 4, showing feature [405]

The south-west quadrant of possible well [405], was excavated to depth of 0.8m below the base of the trench. Scale 1m
