**BEDFORD COLLEGE
TECHNOLOGY BUILDING
BEDFORD**

**ARCHAEOLOGICAL MONITORING
AND RECORDING**

Project: BC2184
Museum accession no.: BEDFM 2013.35
OASIS no.: albionar1-257743

Document: 2017/185
Version 1.0

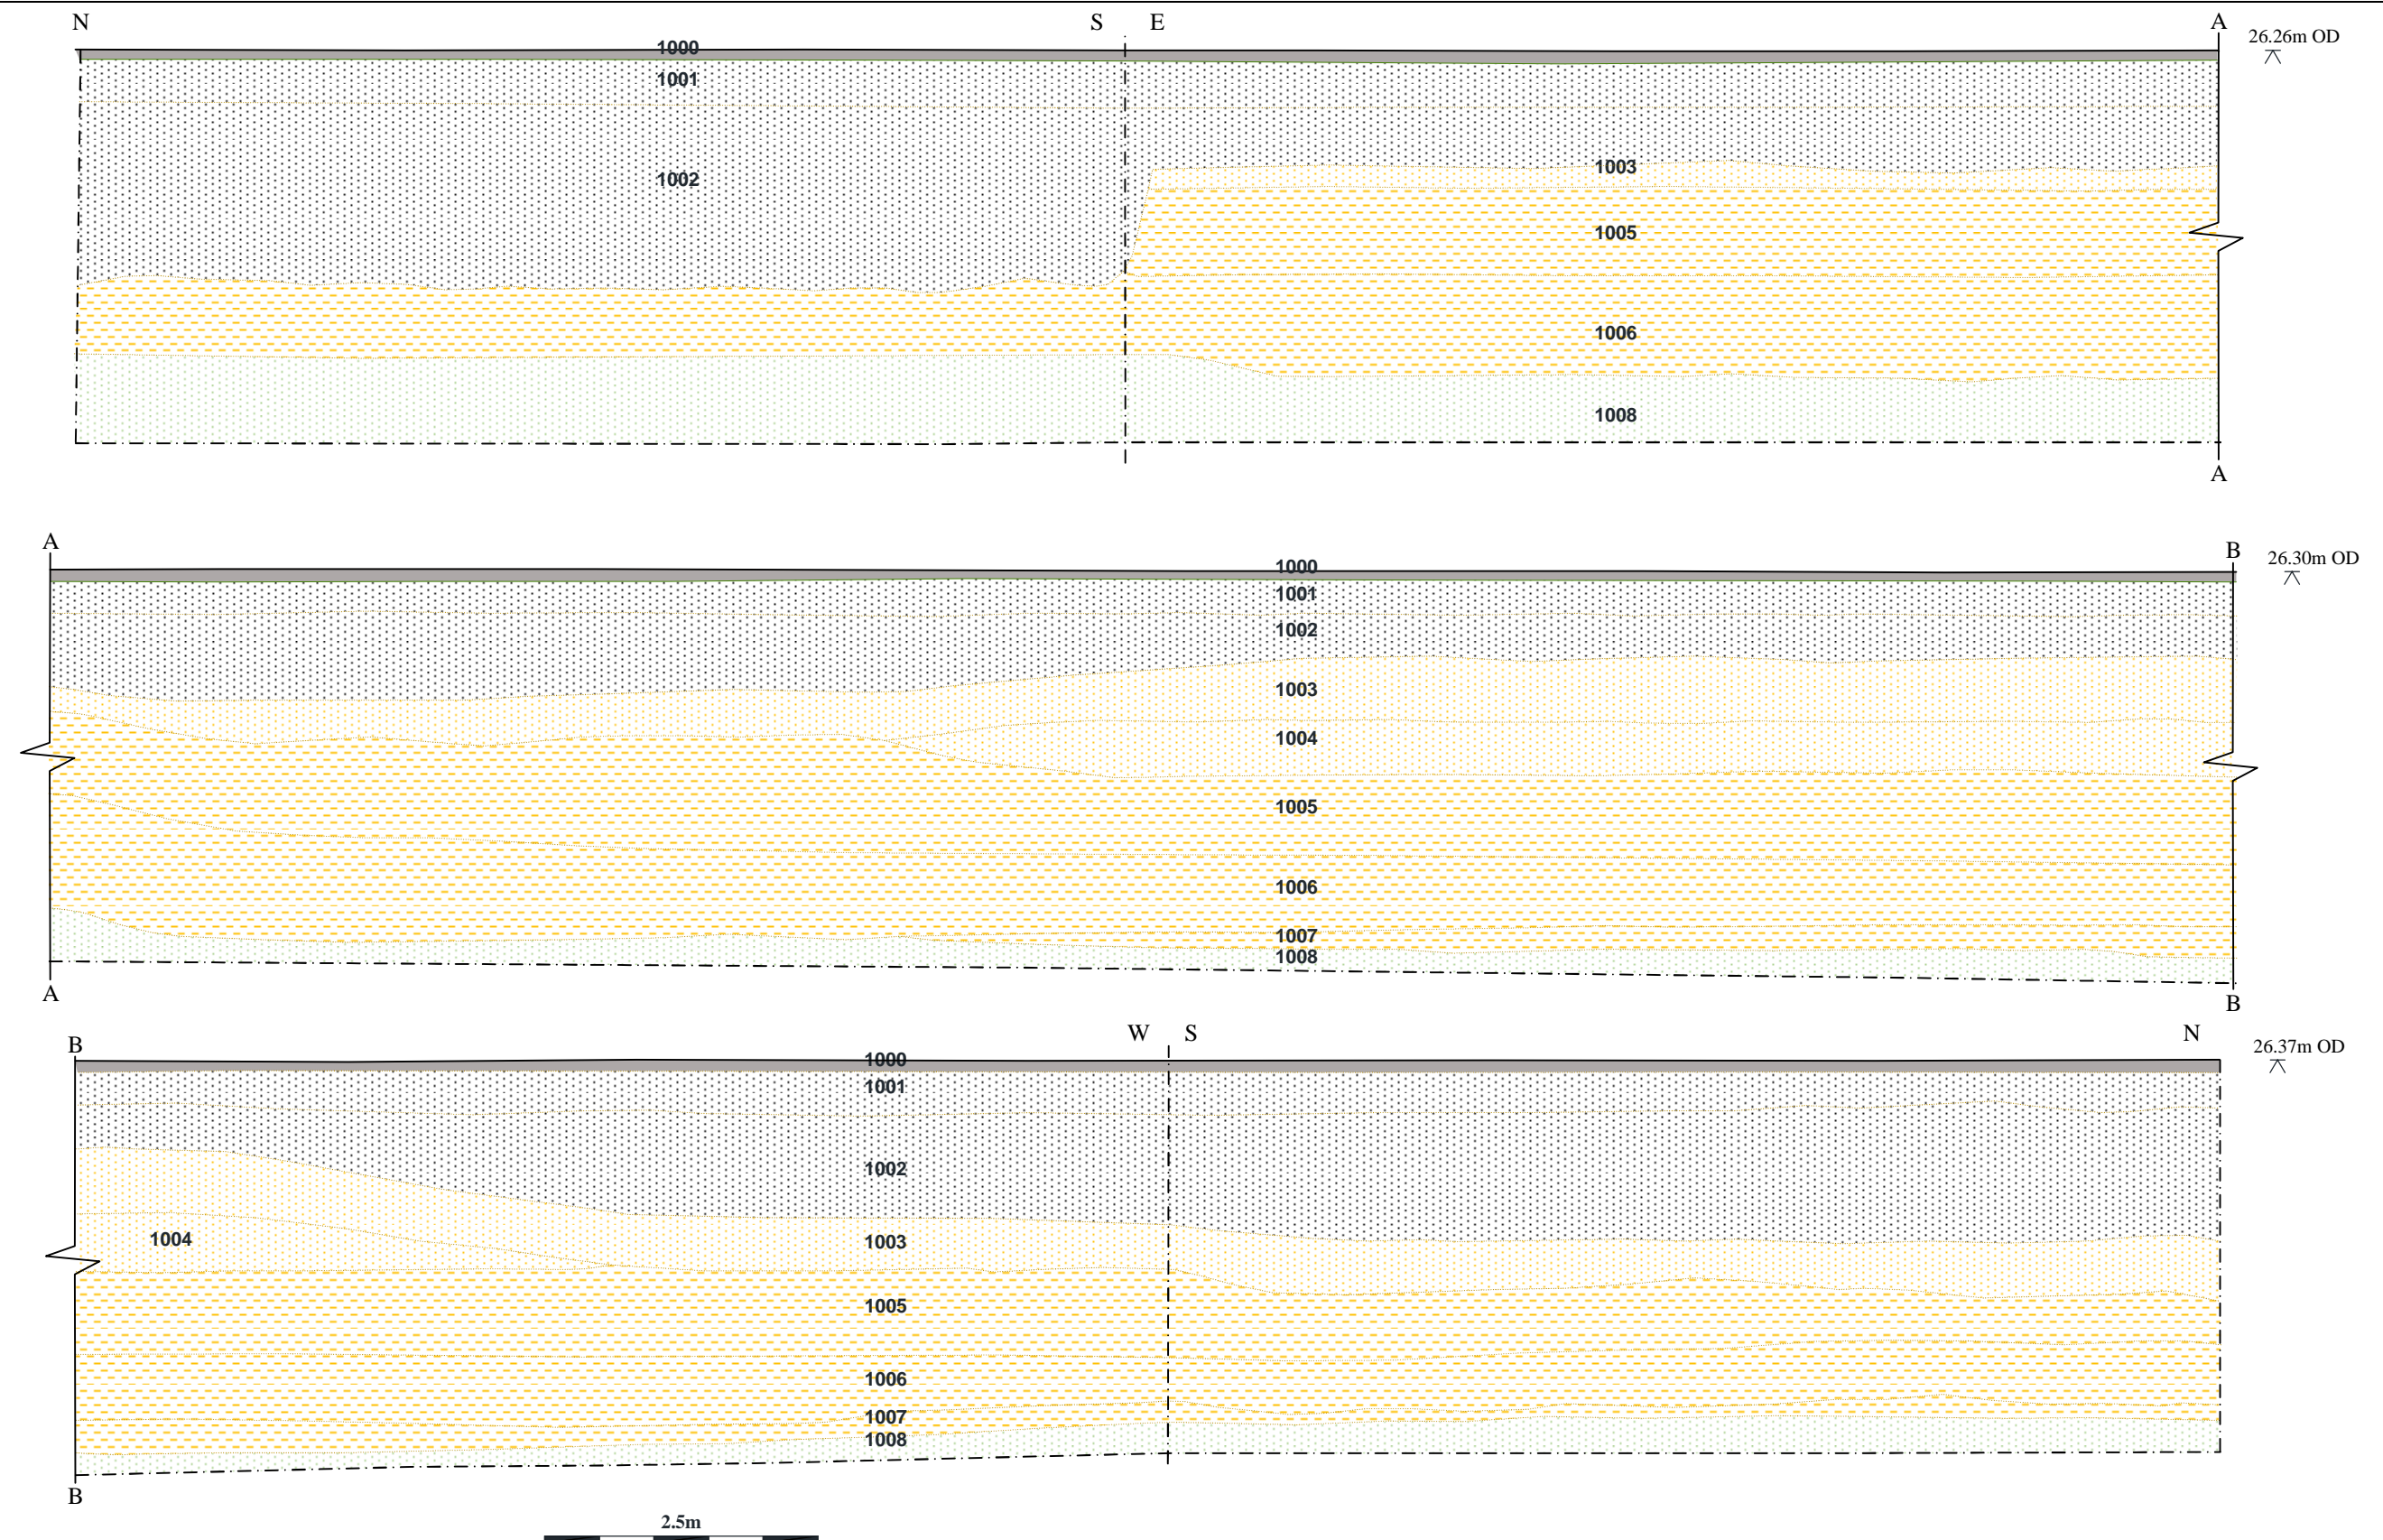
Figure 3: Soakaway trench, Section 3

Beneath the “garden” deposits a homogenous soil (1005) representing an extensive cultivation deposit was identified (Section 3 and Images 7 and 8). It consisted of brown-grey clay, up to 0.54m thick; it was identified in the building footprint, soakaway and service trench excavations. It contained post-medieval and modern CBM, including brick fragments (not collected). Three sand-tempered late medieval pottery body sherds (35g: fabric E02¹) were hand-collected from the deposit. Two abraded 12th–13th-century pottery sherds (13g: fabric C59B), a piece of late medieval roof tile (8g) and five animal bone fragments (34g: limb bones; vertebra, astragalus) derived from the sieved residue

Directly below (1005) an earlier soil (1006) was identified. It comprised a mid-grey-brown silt clay up to 0.48m thick that was observed during the excavation of the soakaway pit. It contained two residual late Saxon shell-tempered St Neots-type ware pottery sherds (5g: B01C).

Underlying geological deposits comprised yellow-green clay (1008), generally encountered *c.* 1.65m below ground level and only identified in the soakaway pit excavation (Images 6–8). This is a superficial geological deposit — alluvial clays and silts formed up to 2 million years ago in the Quaternary Period.

Immediately above (1008) a layer of dark silty clay (1007), approximately 0.14m thick, was seen towards the south-west end of the soakaway pit. This could have formed under marshy conditions on the margins of the river.

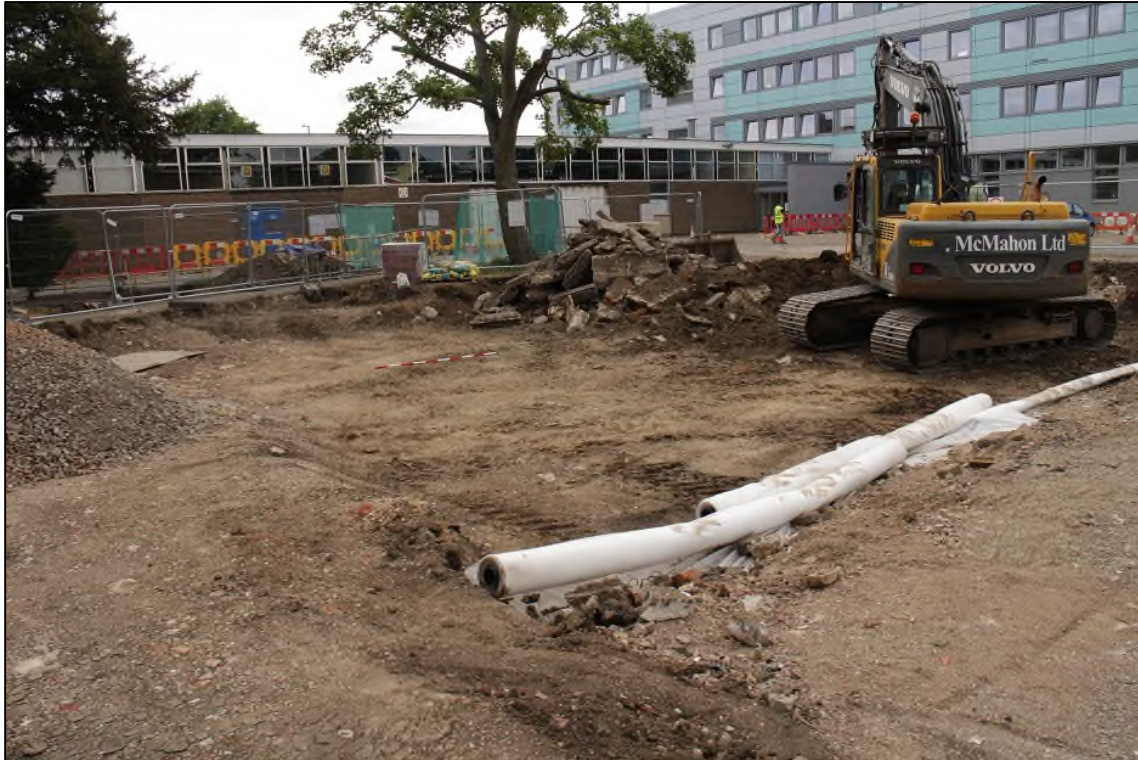
Image 1: General view of development area, looking south-west

Shows south-east corner of site at formation level for piling mat (scale 2m)

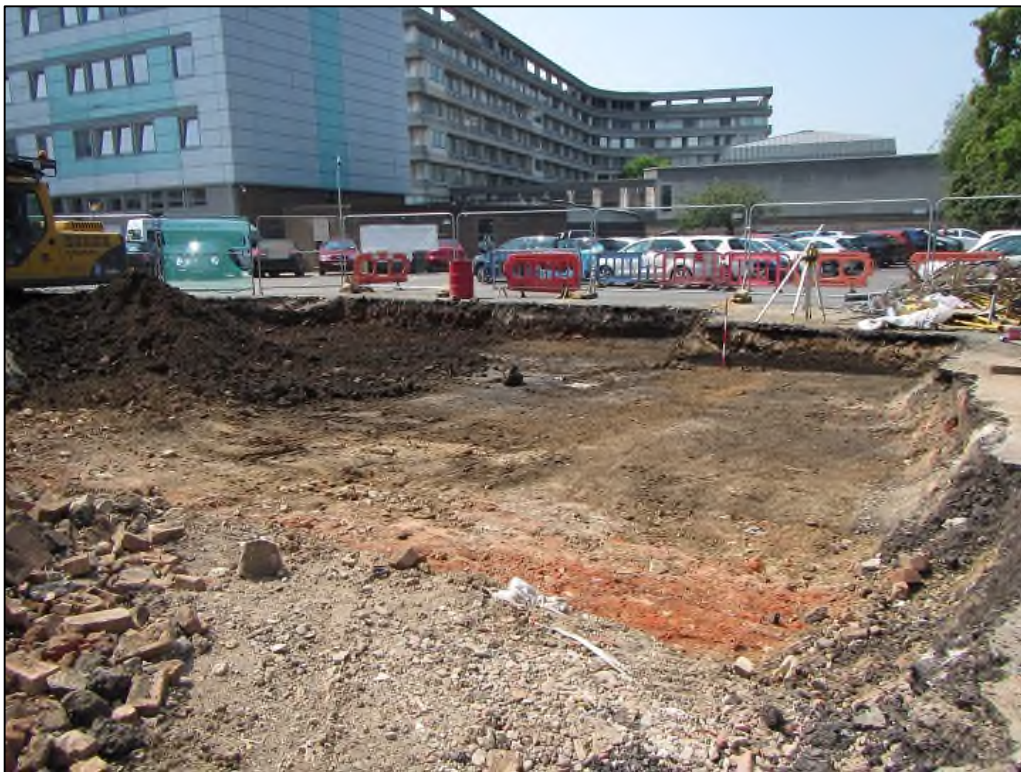
Image 2: General view of development area, looking west

Shows north-west corner of site at formation level for piling mat (scale 1m)

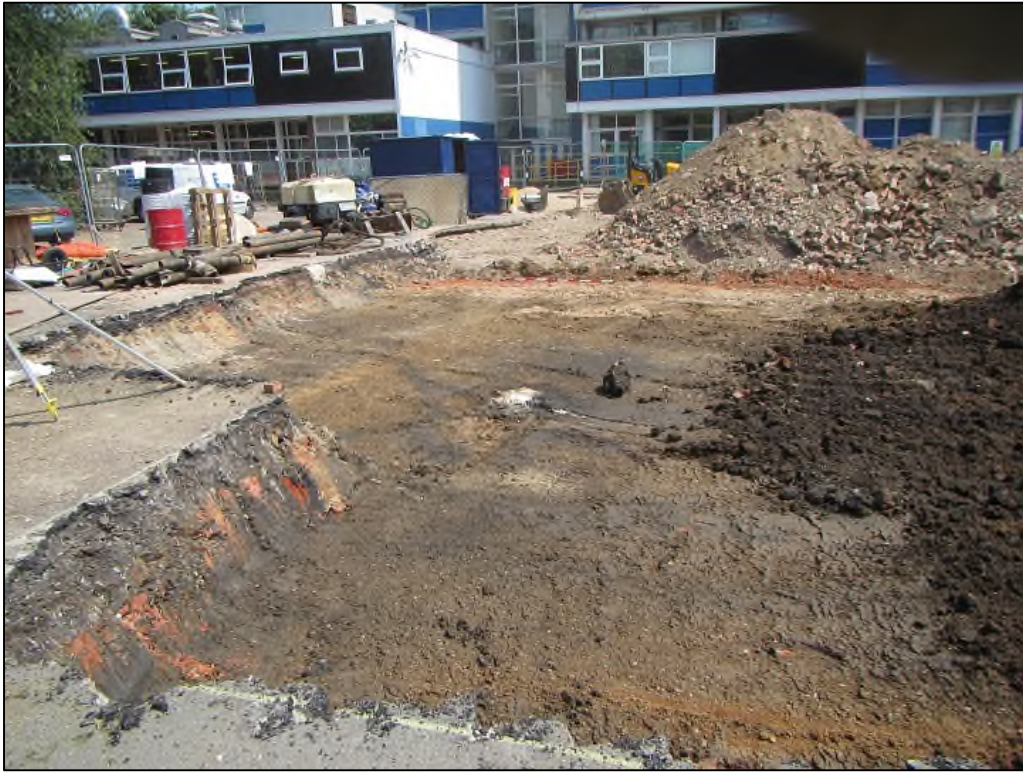
Image 3: General view of development area, looking east

Shows north-west corner of site at formation level for piling mat with Tower building in background

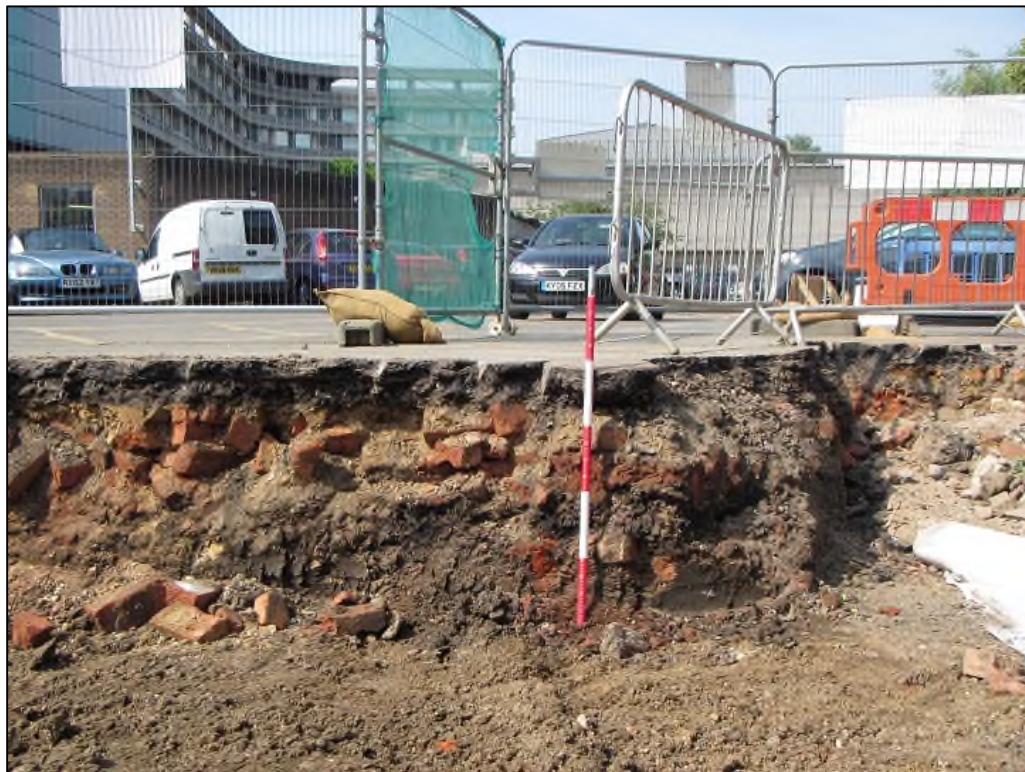
Image 4: Section 1

Overburden generally comprised *c.* 0.24m of tarmac (1000) and (1001), overlying a layered deposit of brick rubble and coarse sand and gravel (1002), representing demolition material and modern construction make-up, 0.32–0.84m thick. These deposits were identified in the building footprint, soakaway pit and service trench (Images 4, 5, 7 and 8).

Looking south-west (scale 1m)

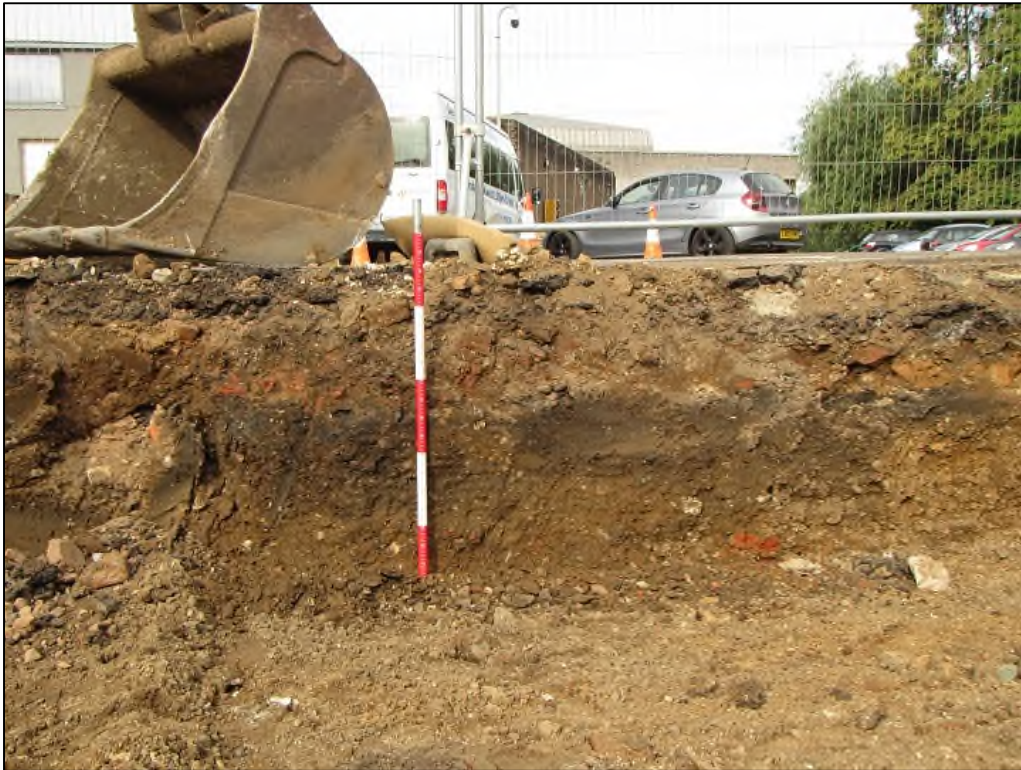
Image 5: Section 2
Looking south-west (scale 1m)

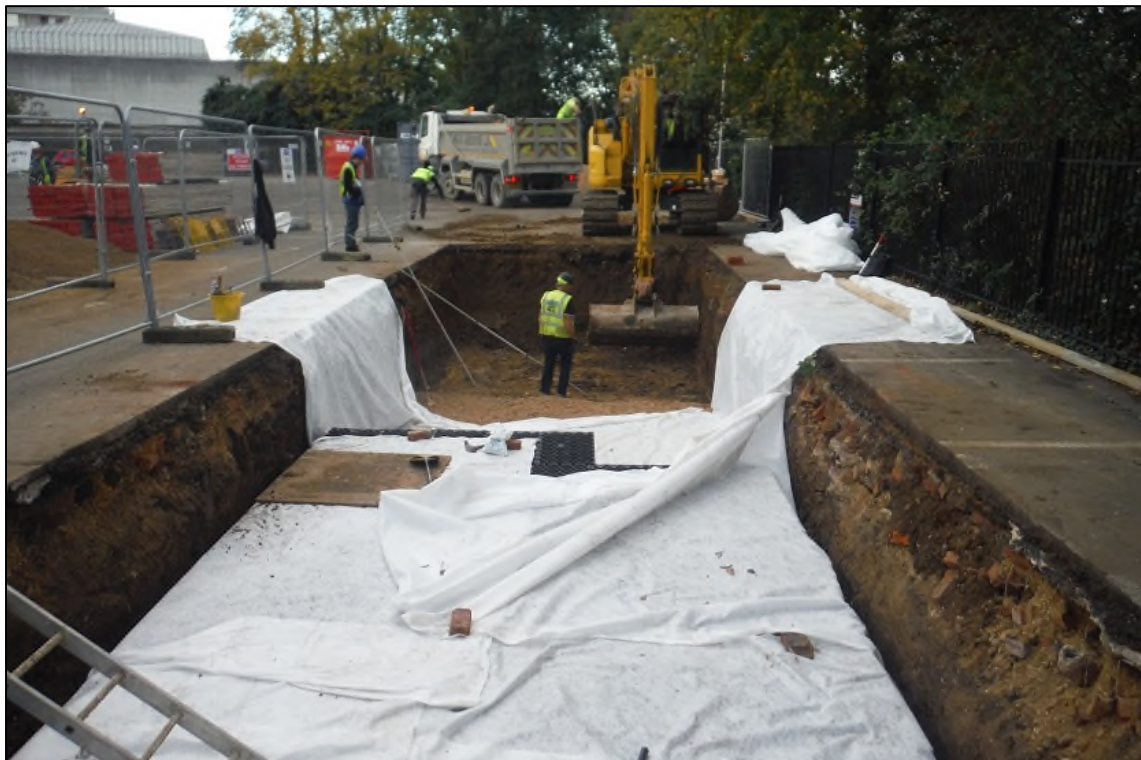
Image 6: Soakaway drainage under construction
Looking west-south-west

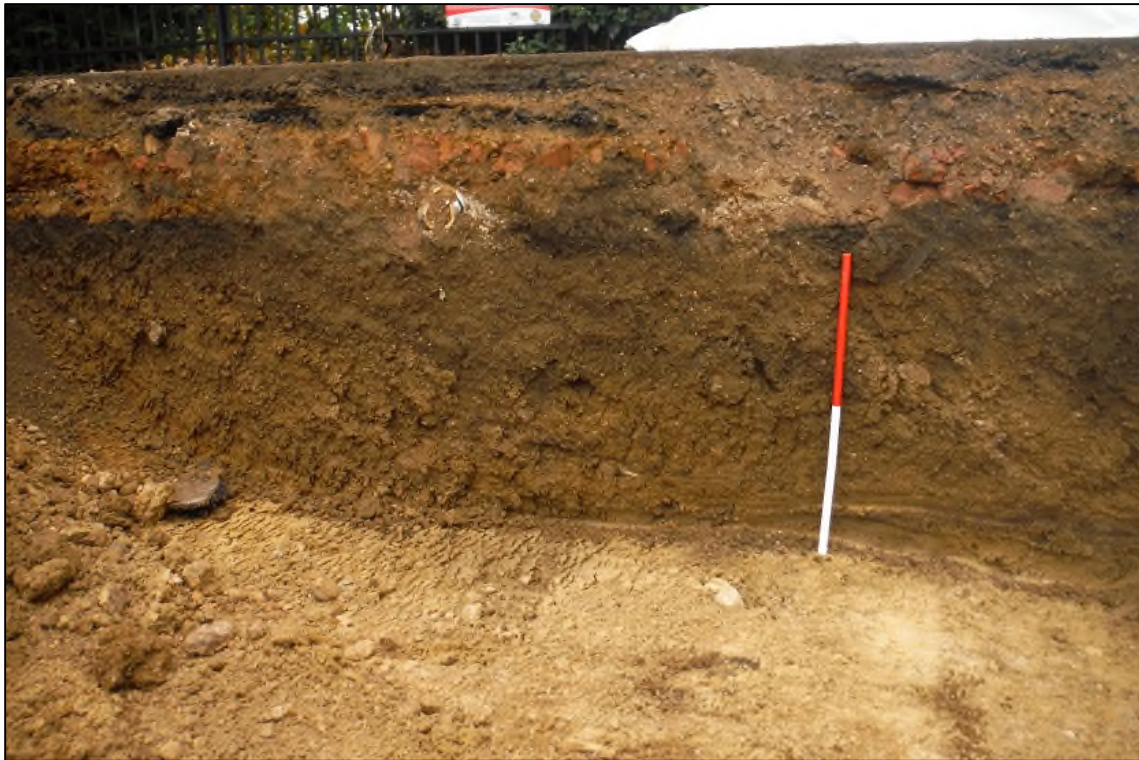
Image 7: Soakaway trench, north side

Looking north (scale 1m)

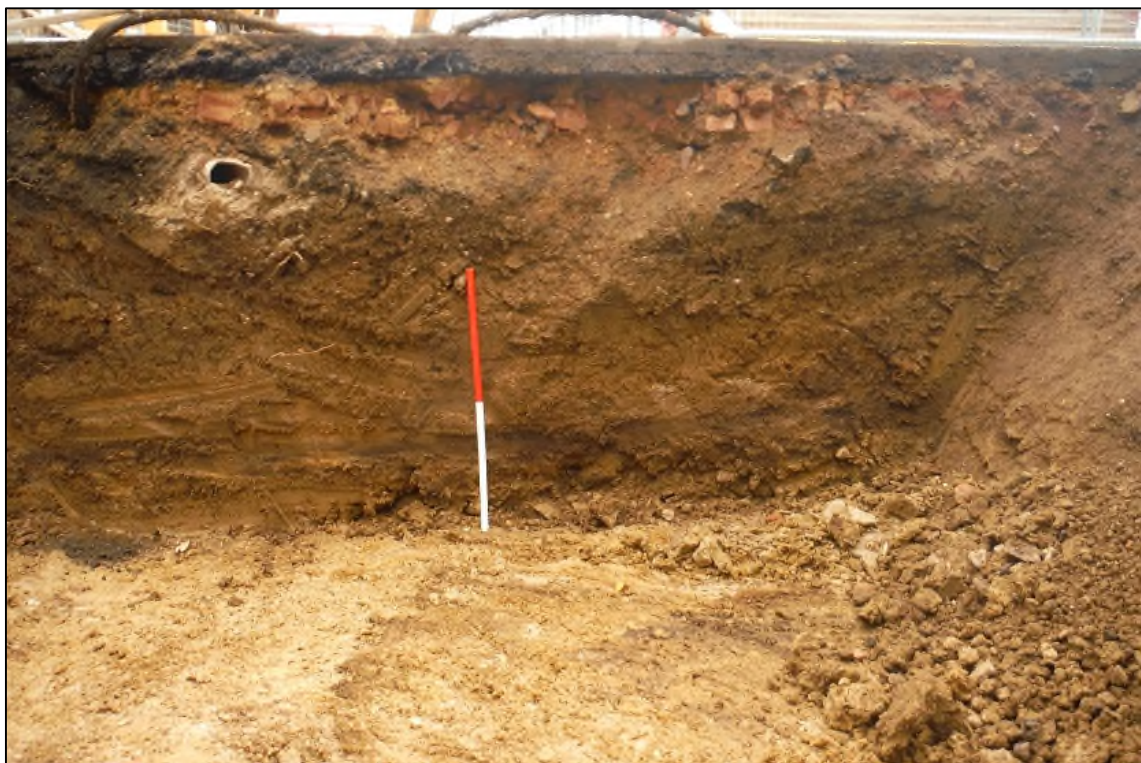
Image 8: Soakaway trench, south side

Looking south (scale 1m)
