**LYNCH FARM  
KENSWORTH  
BEDFORDSHIRE**

**ARCHAEOLOGICAL OBSERVATION,  
INVESTIGATION, RECORDING, ANALYSIS AND  
PUBLICATION**

Document: 2016/146  
Version: 1.0

Project Code: LF2106  
Luton Culture Accession no.: LUTNM: 2017/9  
OASIS ID: albionar1-albionar1-259907

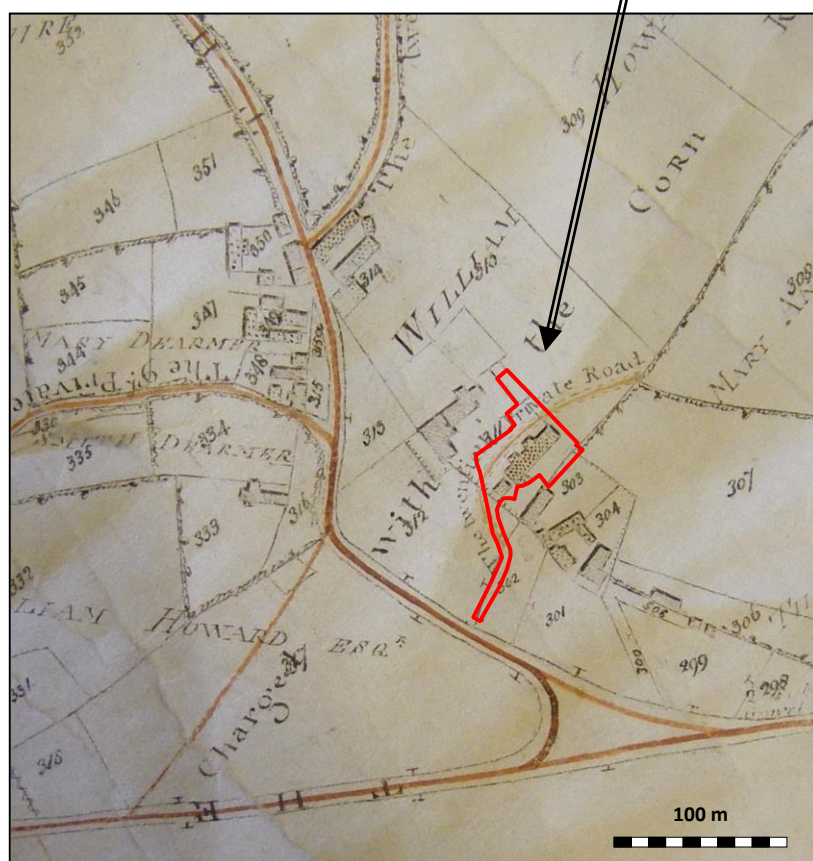
**Figure 2:** 1798 Enclosure map

The Kensworth enclosure map 1798 (BLARS ref MA 18/1) shows Kensworth Lynch with its surrounding property plots and fields. Most of the development area falls within a property plot numbered 311 belonging to Kensworth House. The plot contains two buildings that comprise what is now Lynch House on one side and a long building on the other side that is no longer present. The map uses a shading convention such that the buildings of Lynch House are hatched and those of the long building on the other side are stippled. From other buildings shown within the hamlet, this convention appears to suggest that the long building was an outbuilding rather than a dwelling. None of the buildings affected by the development are shown on this map.

(The development area is outlined in red. Scale is approximate. Map held by Bedfordshire and Luton Archives and Records Service)

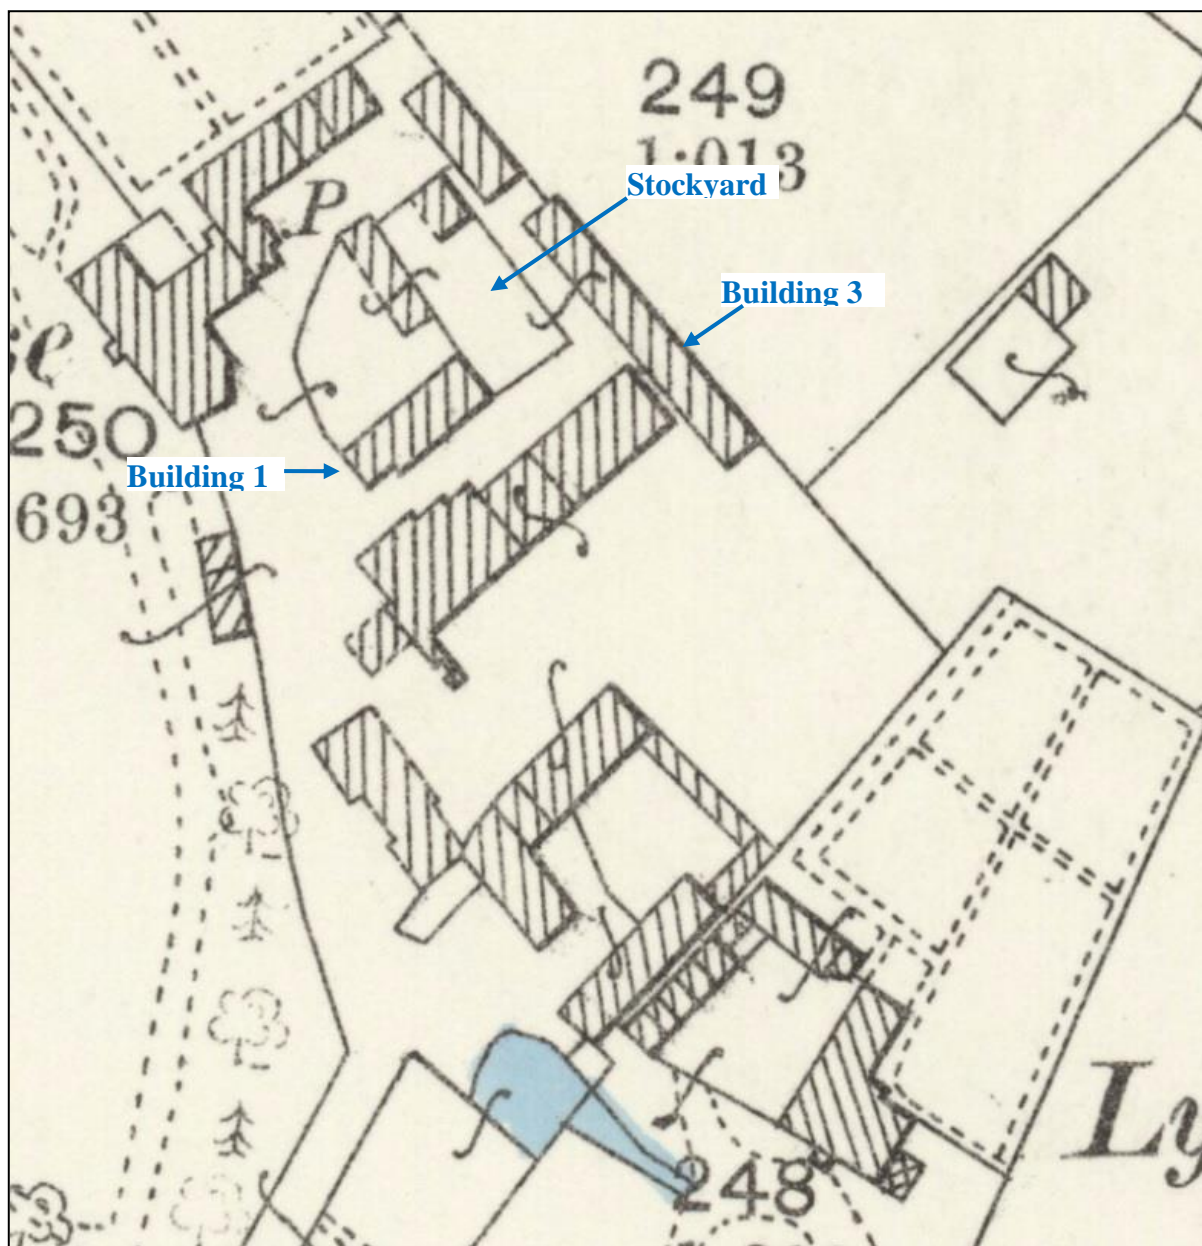
**Figure 3:** 1898 Ordnance Survey map

The map illustrated in Figure 4 is the map forming part of the Hertfordshire series. It was surveyed in 1879, revised in 1897 and published in 1898. An earlier edition published in 1880 shows no differences in the details of the Lynch Farm buildings.

This map shows a number of changes from the Enclosure map (Figure 3). It shows that Buildings 1 and 3 and the stockyard existed by this time. Building 2 was not present; instead a slightly smaller building with an open-front (denoted by a dashed line) is shown in the north-east corner of the stockyard. Another stockyard with an open-fronted shed lay on the south-west of the first, at the back of Lynch House.

The 1898 map shows another open-fronted building to the east of Lynch House. Other buildings not appearing on the earlier map are shown next to Lynch Farm Cottage. A building corresponding to the large barn-like building noted on the earlier map is shown between Lynch Farm Cottage and Building 1. It appears different from the building shown in 1798, lacking the two projections (possible porches) on its north-west side. Instead it is shown divided along its length into three sections and has a small open-sided building attached to its south-west end. Evidence from 1896 sales particulars and later rating records indicate that there was a brick engine house attached to the large barn like building. During the late 1890s it contained a steam engine which was used to power a corn mill with two sets of stones.

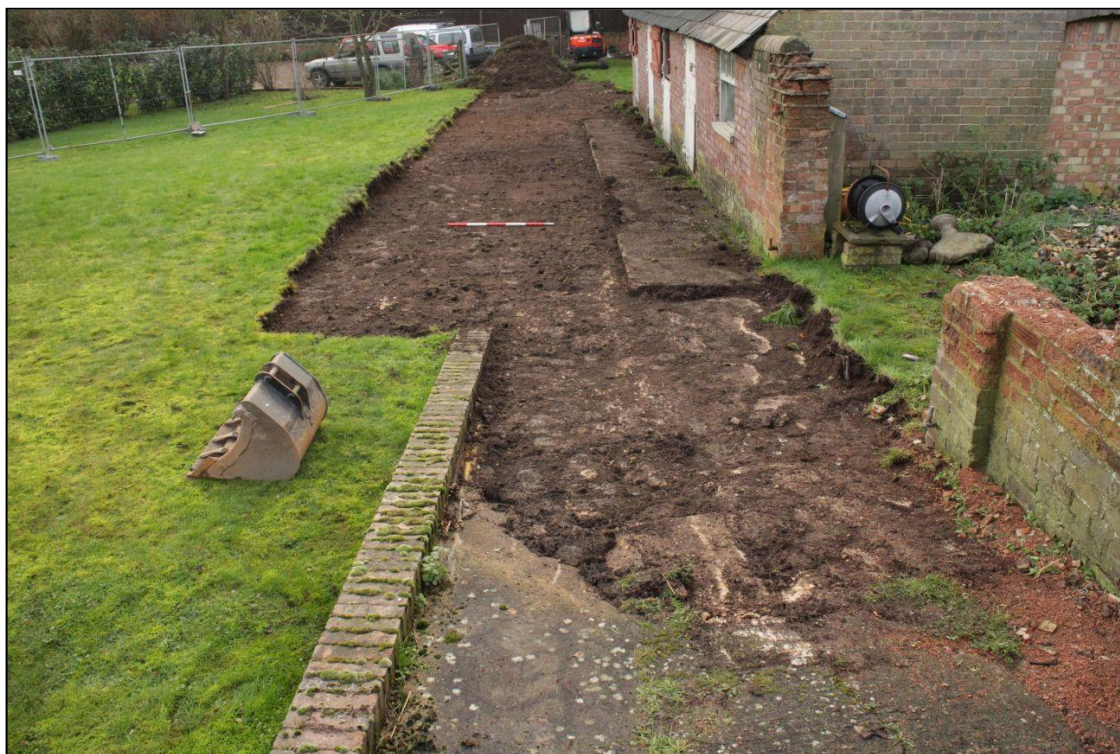
**Image 1:** Groundworks in front of Building 1

The initial groundworks consisted of a linear strip in the grassed area in front of Building 1 to form a site access (Image 1). It was up to 4m wide and c. 200mm deep. The soil (1) exposed across most of the area was dark grey-brown topsoil, containing brick rubble with some fragments of glass and slate. A smaller area of lighter soil (2), also containing brick fragments, was uncovered near the southern end of Building 1. These deposits were probably formed during landscaping of the site following the removal of farm buildings to the west of Building 1.

(Showing area of shallow ground reduction to form site access, looking south-west.  
Scale 1m.)

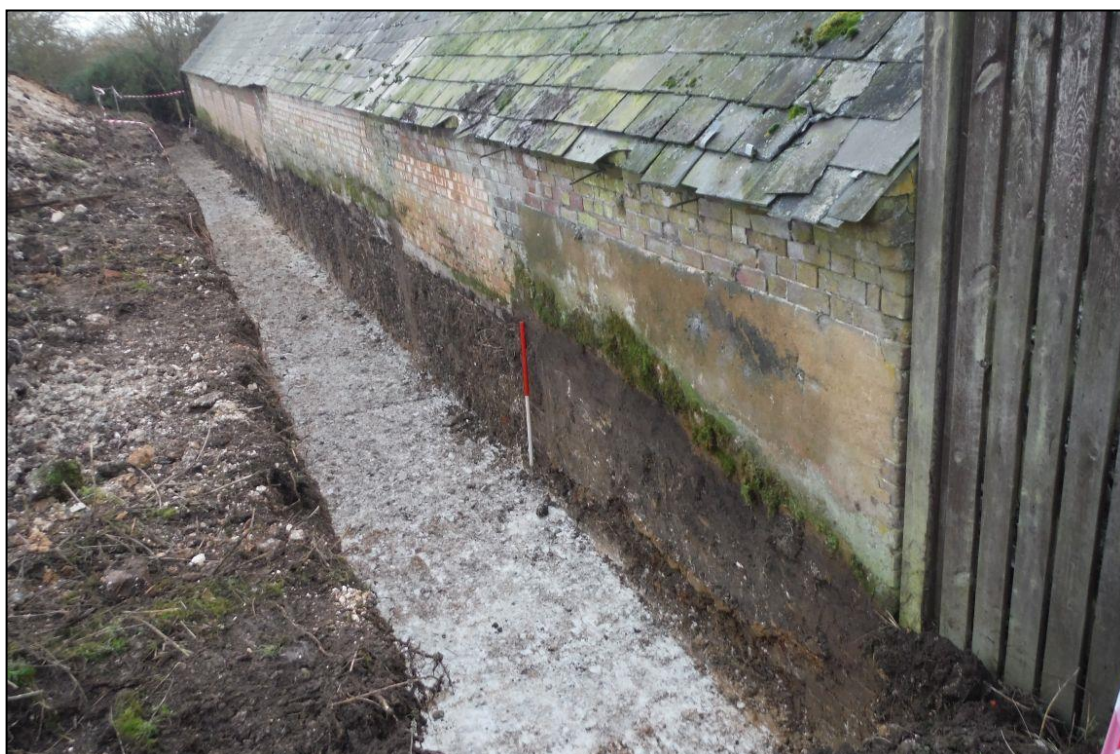
**Image 2:** Groundworks to rear of Building 3

Groundworks at the rear of Building 3 involved the removal of soil that had built up against the back wall of the building (Images 2 and 3). A 1.5m-wide trench was excavated down to the base of the wall. Building 3 stands on a terrace cut into the natural slope of the ground. The back edge of the terrace is a steep-sided cut [6] into the chalk bedrock (8). At the top of the terrace cut was a plough soil layer (9). A fill of loose, dark brown soil (7) with brick and concrete debris had accumulated against the back wall of the building. It appears to have formed as a result of a combination of soil creep from the cultivated field, decayed leaf litter and disposal of rubble waste.

(Showing trench excavated to remove soil build-up against back wall, looking south-east.  
Scale 1m.)

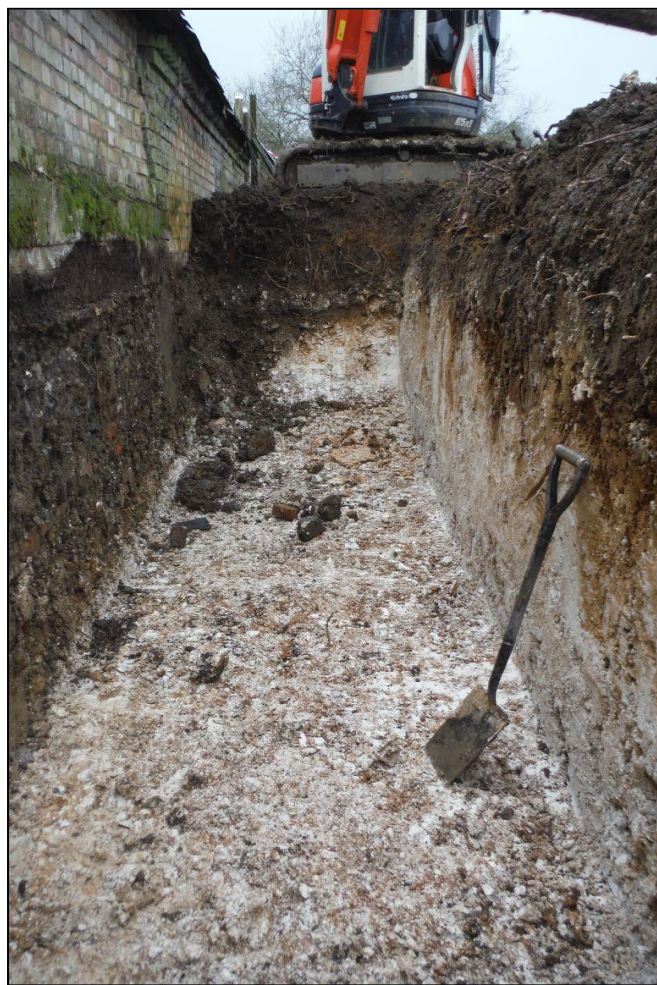
**Image 3:** Groundworks to rear of Building 3

(The exposed section below the machine shows where a terrace was cut into the chalk bedrock for the construction of Building 3, looking north-west.)

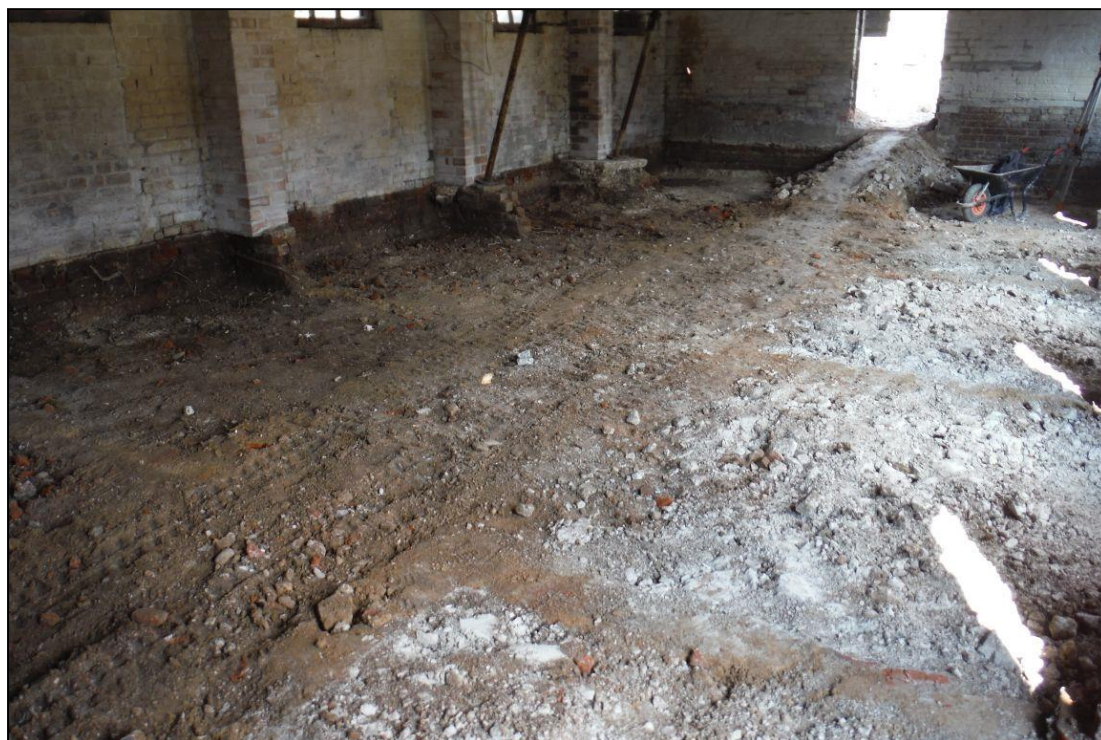
**Image 4:** Building 1, interior of main compartment

Evidence for the original arrangement of the piggery was found in the main compartment of the building (Image 4). The bases of demolished brick walls survived beneath the modern concrete floor. These formed a central corridor

(Showing bases of brick walls that formed a central corridor with pigsties to either side, looking north-east towards door in end wall.)

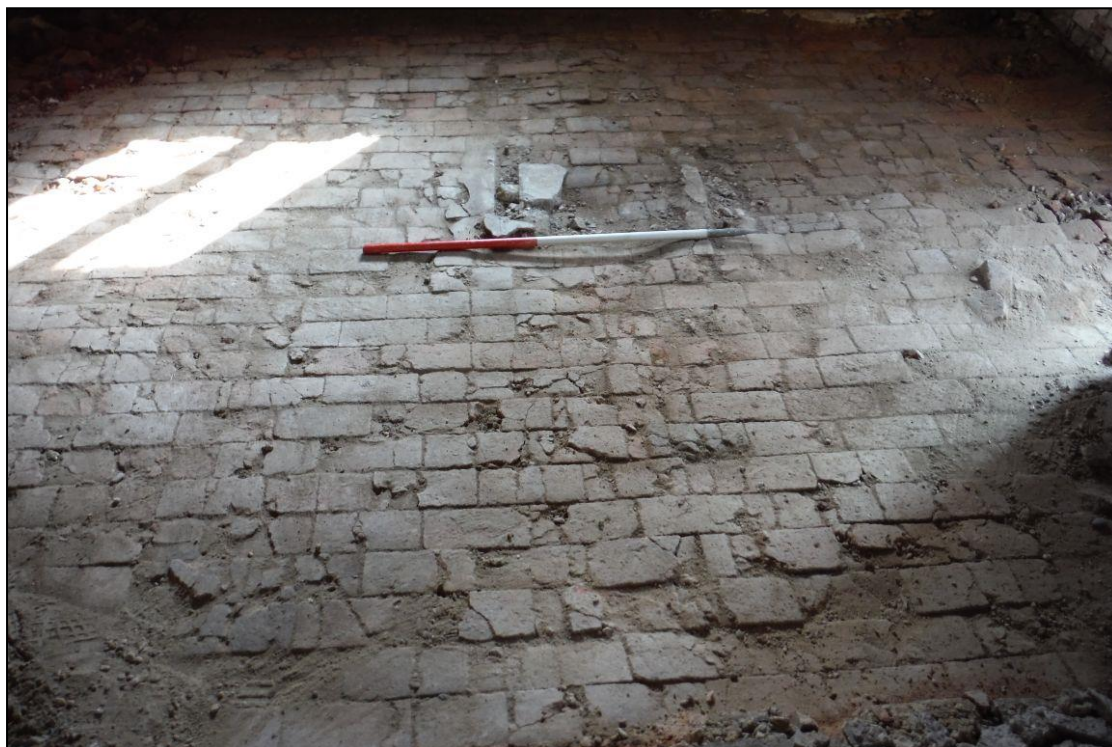
**Image 5:** Building 1, interior of south-west compartment

(Showing brick floor with rectangular machine base adjacent to the 1m scale, looking south-east.)

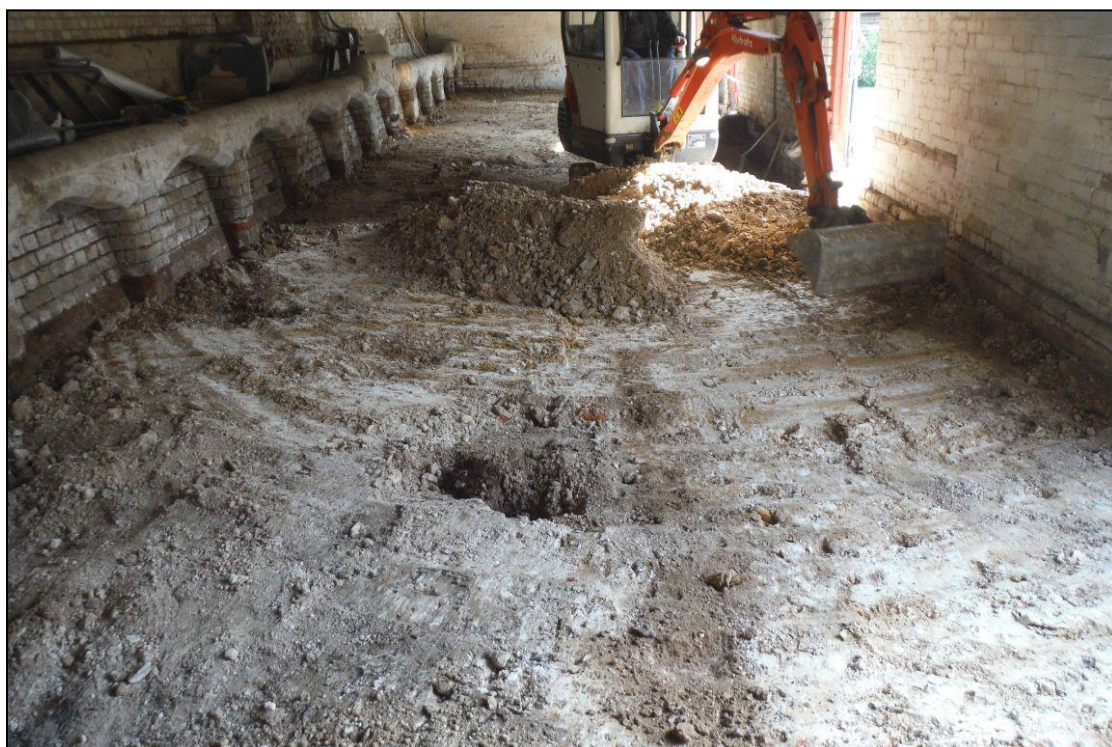
**Image 6:** Building 3 interior during groundworks

The main (north-western) compartment in this building contained a brick feed trough along the back wall, indicating that this was the stable. Ground reduction inside this compartment involved the removal of the modern concrete floor (15) and the brick rubble sub-base (17) for the floor (Image 6). Within layer (17) a drain capped with modern frogged bricks extended along the length of the stable. Also visible within this layer were the foundations for two brick cross-walls made of Fletton brick. These modern partition walls were still standing at the time of the historic building survey (Albion 2016, 23–4).

(Looking south-east in main compartment with brick feeding trough at left. Showing chalk bedrock beneath modern floor make-up with a central brick drain visible as the darker line in the centre of the image.)

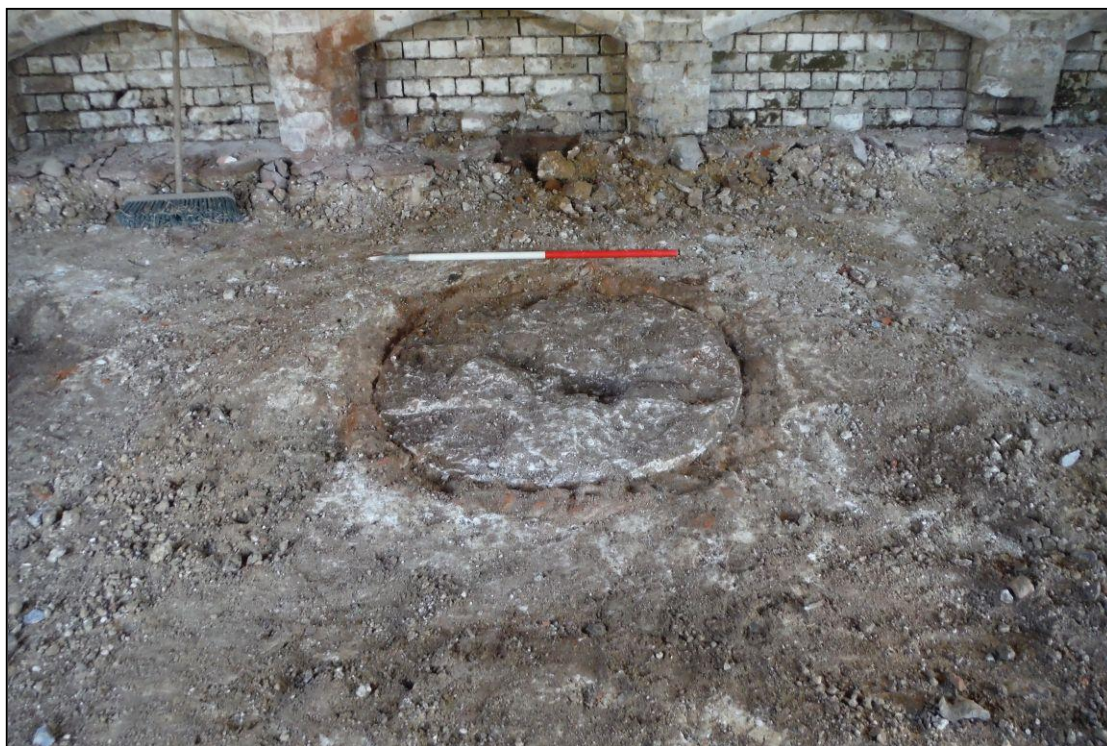
**Image 7:** Building 3 interior, Feature [10]

Beneath the modern floor levels the fragmentary remains of a former cobbled floor (16) were identified as patches of rounded pebbles in the south-eastern end of the compartment. Towards the middle part of the compartment two features [10] and [13] were identified, cut into the underlying chalk bedrock. Feature [10] was a shallow circular cut, 1.3m in diameter (Image 7). Its outer edge was lined with loose fragmented brick and mortar (11) whilst the middle was filled with hard packed chalk (12). The function of this feature is uncertain. Feature [13] was a rectangular pit, 1.9m long, 0.8m wide and 0.35m deep, located against the south-western side of the building (Image 7). It had been filled with chalky clay with brick rubble and scrap metal debris. The pit probably marks the location of a former drinking trough, a suggestion reinforced by the presence of cut-off steel pipe that was attached to the wall above.

(Showing circle of brick and mortar with central fill of chalk, looking north-east. Scale 1m.)

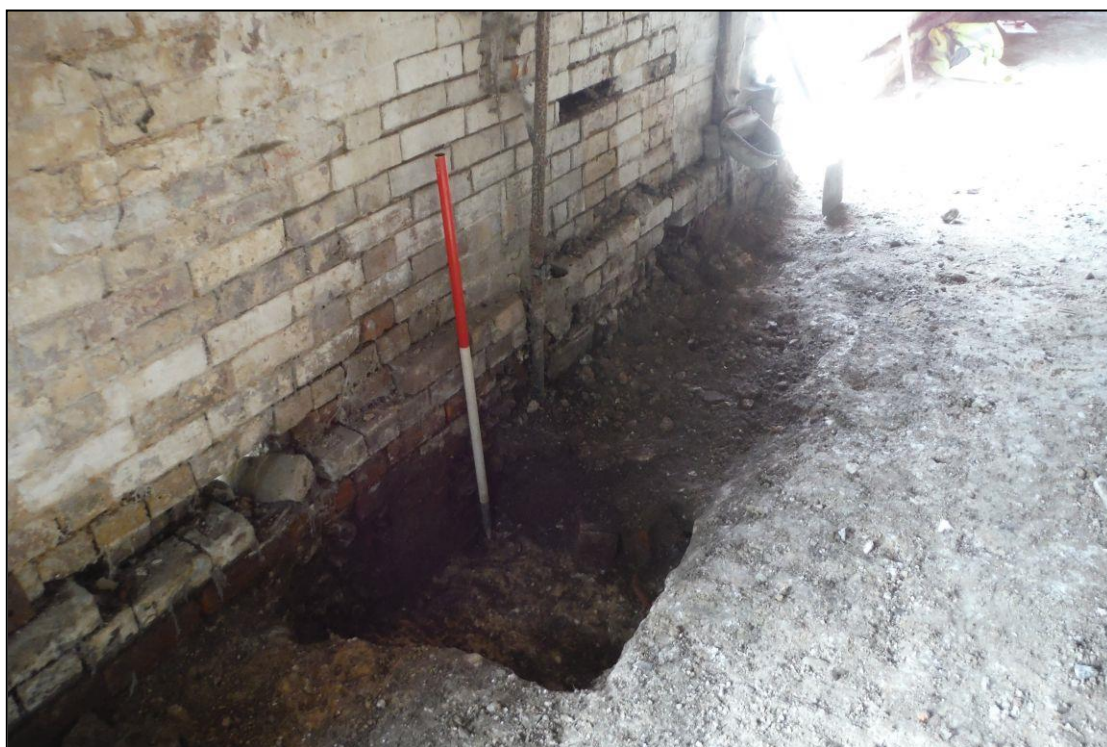
**Image 8:** Building 3 interior, Feature [13]

12	Fill	Hard-packed white chalk in feature [10].	<input checked="" type="checkbox"/>	<input type="checkbox"/>
13	Pit	Rectangular NW-SE sides: steep dimensions: max breadth 0.8m, max depth 0.35m, max length 1.9m. Located against southern wall in main compartment of Building 3 (stables).	<input checked="" type="checkbox"/>	<input type="checkbox"/>
14	Backfill	Loose dark grey chalky clay frequent small-large CBM. Contained scrap metal debris.	<input checked="" type="checkbox"/>	<input type="checkbox"/>
15	Internal surface	Concrete floor inside main compartment of Building 3 (stables).	<input checked="" type="checkbox"/>	<input type="checkbox"/>
16	Internal surface	Dark grey . Clay and chalk with frequent medium pebbles, remant cobbled floor in main compartment of Building 3 (stables).	<input type="checkbox"/>	<input type="checkbox"/>
17	Make up layer	Compact light grey clay chalk moderate medium CBM. In main compartment of Building 3 (stables).	<input type="checkbox"/>	<input type="checkbox"/>

(Showing rectangular cut against front wall with dark fill, looking west. Scale 1m.)
