**THE OLD POLICE STATION
EATON BRAY
BEDFORDSHIRE**

**ARCHAEOLOGICAL OBSERVATION,
INVESTIGATION, RECORDING, ANALYSIS
AND PUBLICATION**

Document: 2017/15
Version 1.0

Project: EB2914
Luton Culture entry no.: LTNMG 1257
OASIS ref. no.: albionar1-260103
HER search reference no.: 201516/127

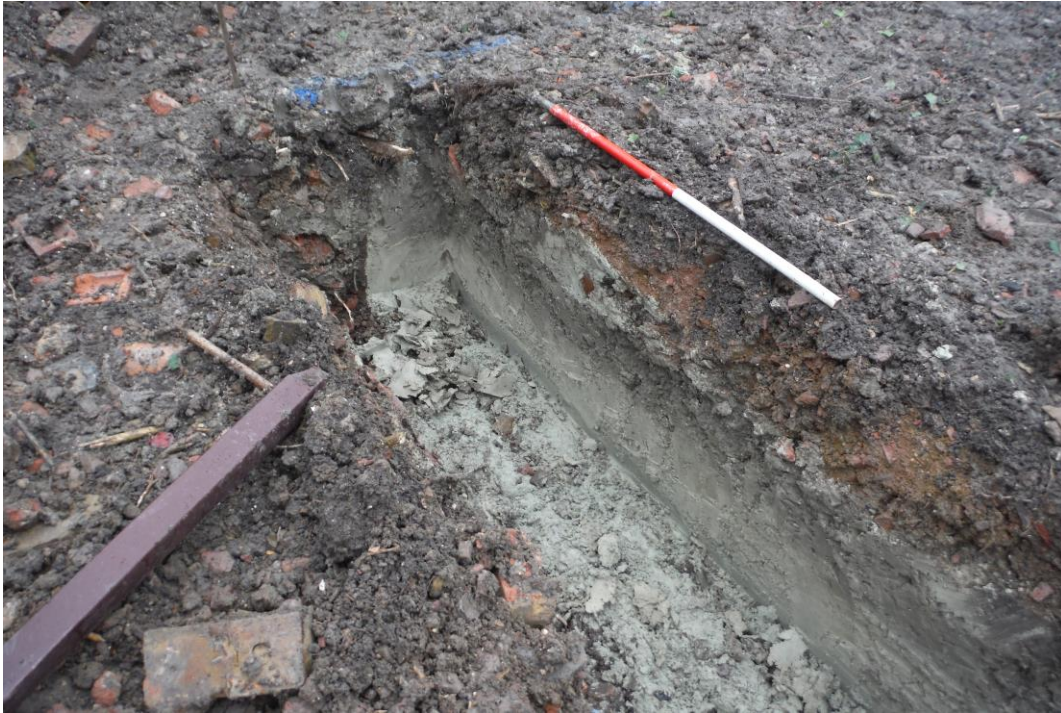
WNW-ESE aligned ditch [4/9] was intermittently traced across the footings for a length of some 13m. In section the ditch was over 1.5m wide and up to 0.16m deep, with shallow concave sides and a flat base (Figure 3: sections 1 and 2 and Figure 4: images 1 and 2). It was filled with friable mid-brown-grey silty clay. The ditch is interpreted as a former field boundary situated some distance from any focus of contemporary human activity. The relatively dark fill would indicate material derived from an unstable upper soil profile — possibly ploughsoil from an adjacent arable field.

Image 1: General view of ditch [4] revealed at the NE corner of the footing trenches for the new buildings. The dark fill of the ditch is truncated by disturbance associated with the former Police Station. Scale 1m in 50cm divisions.

The ditch does not correspond to any boundaries on the available historical maps, suggesting that it may be of some antiquity. The lack of associated features and artefacts within its fill suggests that the ditch was located in an agricultural area, situated some distance from any focus of human activity. The layer in the south-east part of the site may represent a former ploughsoil.

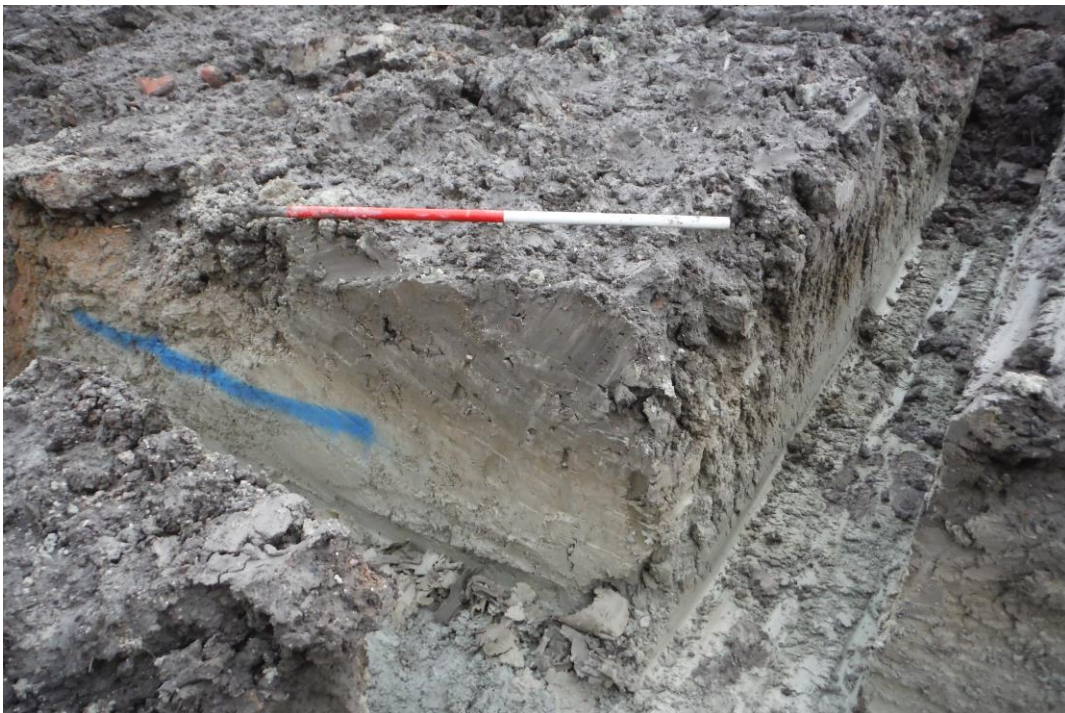
Image 2: General view of western continuation of the ditch [9] revealed at intersection of two footing trenches. The ditch was truncated by disturbance associated with the former Police Station. Scale 1m in 50cm divisions.

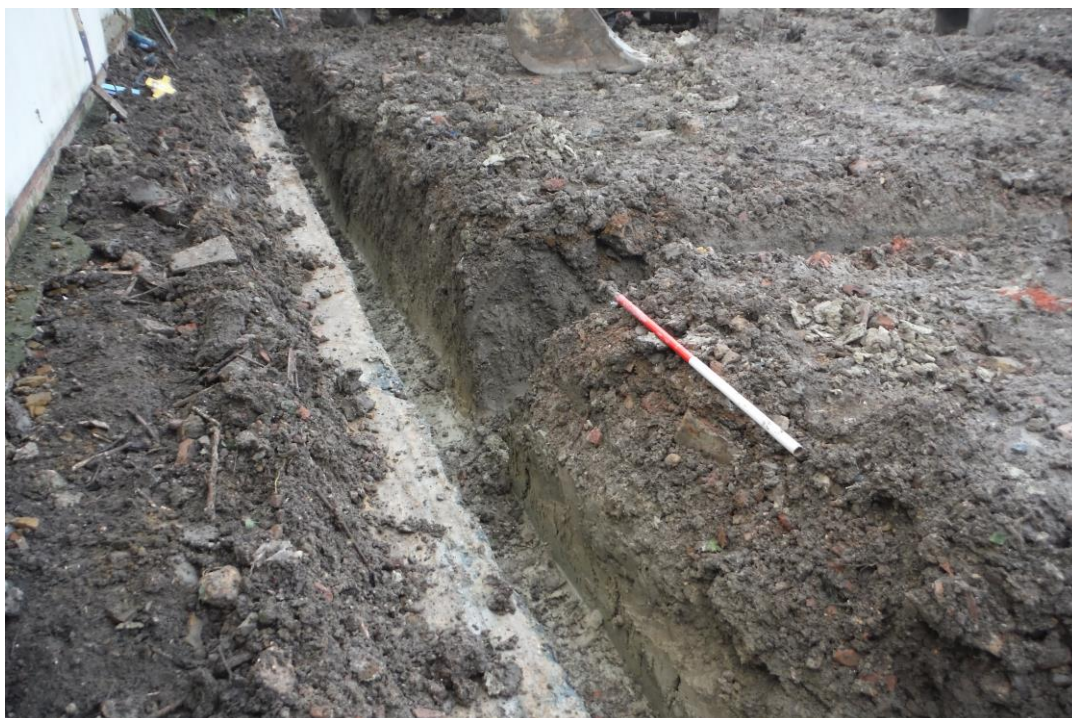
Mid-brown-grey silty clay deposit (8) was revealed in the south-east part of the DA (Figure 3); it was up to 0.4m thick at the south-east margin. It was obscured on the surface by modern deposits, although it was traced in three footings trenches (Figure 5: images 3 and 4). The thickness and colour of the deposit suggest a former ploughsoil, possibly incorporating a colluvial element due to downslope soil movement.

Image 3: Looking southwards along the eastern wall footing trench, which shows extensive dark layer (8) getting thicker to the south, away from the camera. Scale 1m in 50cm divisions.

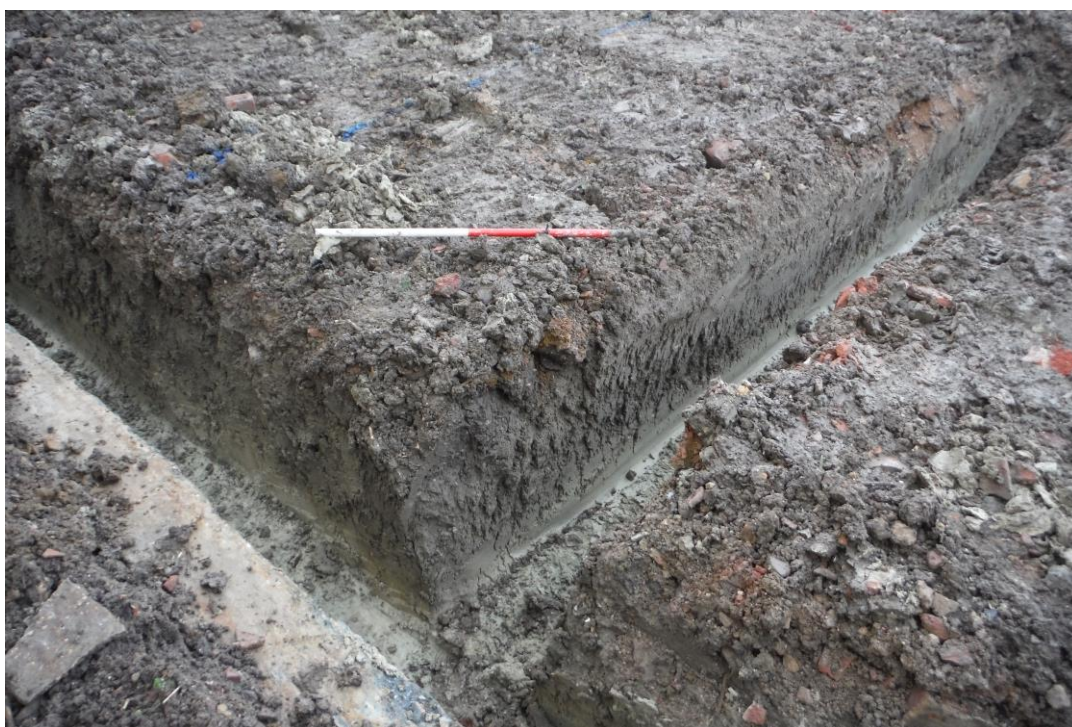
Image 4: Continuation of extensive layer (8) revealed at the junction of intersecting wall footings trenches. The deposit survives below later disturbance. Scale 1m in 50cm divisions.
