**ST PETER'S CHURCH  
WRESTLINGWORTH  
BEDFORDSHIRE**

**ARCHAEOLOGICAL WATCHING BRIEF**

Project: WC 1264

Document: 2007/50  
Version 1.0

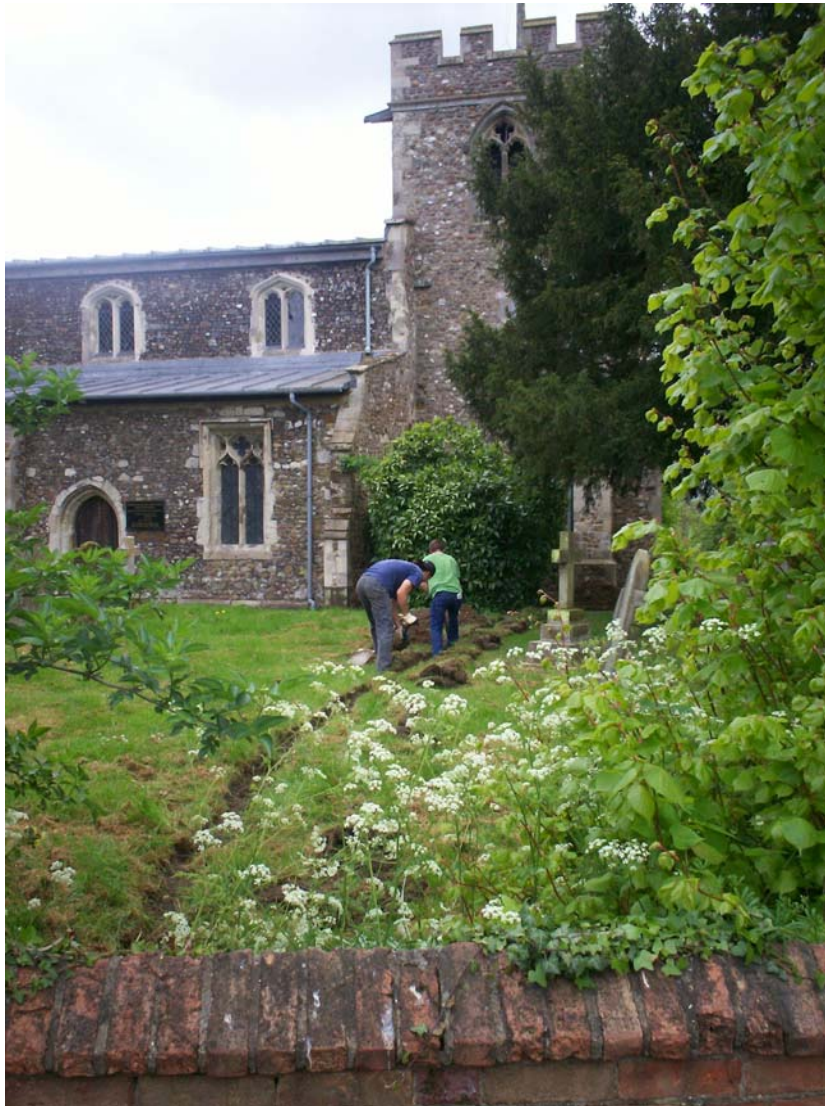
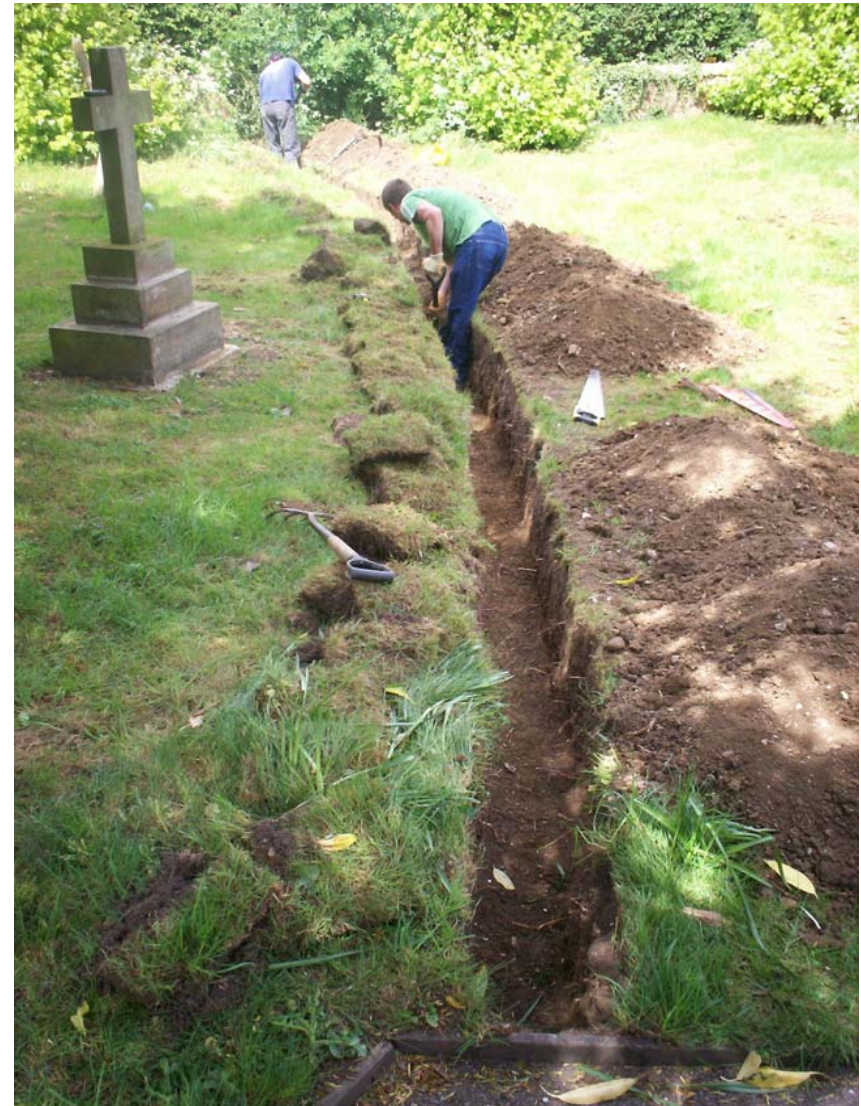
**Figure 2:** Excavation of the service trench

No significant archaeological features were revealed within the service trench. A 0.1-0.15m thick layer of topsoil (100) was recorded, overlying a layer of mid greyish-brown sandy-silt subsoil (101) throughout the trench. The trench was not deep enough to reveal any undisturbed geological deposits.
