**OLD GORHAMBURY
BACON'S HOUSE
ST ALBANS
HERTFORDSHIRE**

ARCHAEOLOGICAL WATCHING BRIEF

Document: 2010/51
Project: OG1392

Produced for:
English Heritage

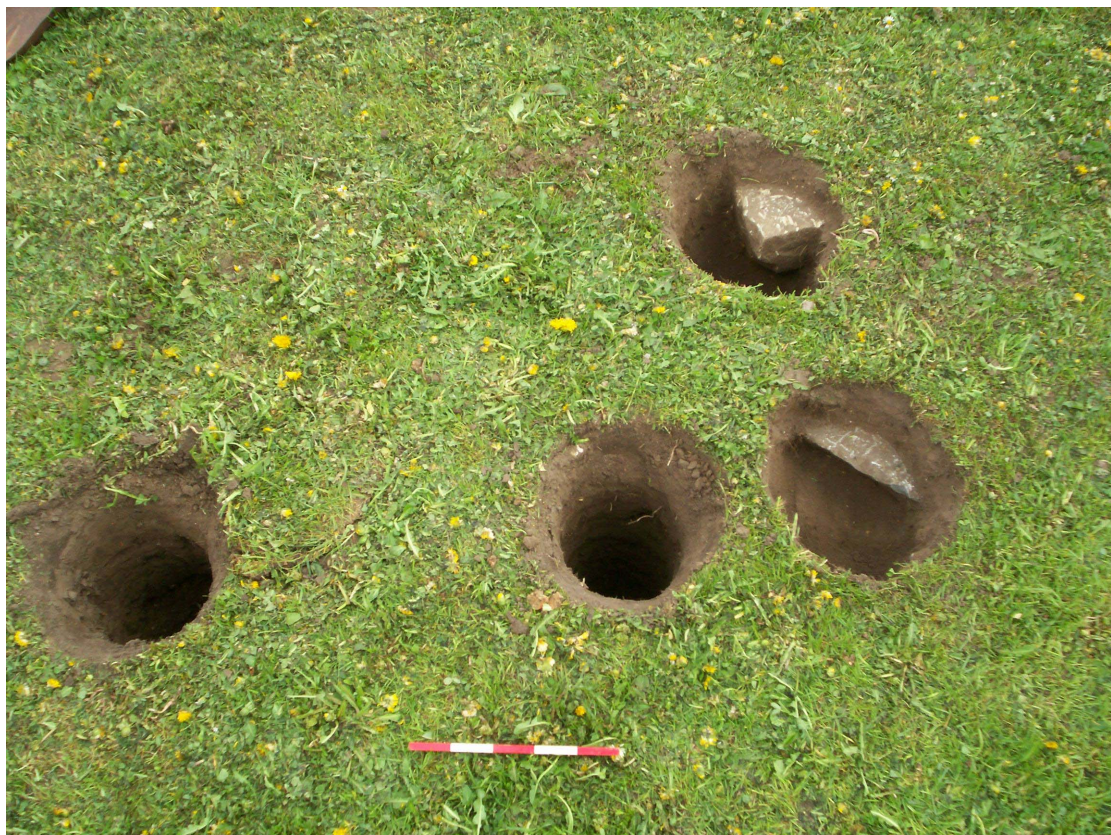
Plate 2: Panel 1 – masonry and adjusted position of postholes

The location of Panel 1 within the former main court was altered twice because large angular stones were encountered within the first 0.1m of excavation. There was no evidence that the stones were part of an *in situ* structure, although they were large and angular enough for them to have been shaped for use as masonry. It is possible that they were part of collapsed masonry or demolition rubble. The postholes for the panel were moved c.0.2m to the side and rotated around 90 degrees (Plate 2).

The remaining deposits exposed represent accumulation of soil over the ruined building remains. The two larger stone blocks, visible in the original postholes for Panel 1, and the flint, brick and mortar inclusions in the deposits removed for the postholes of both panels, probably originate from the nearby building walls after their destruction and/or collapse.

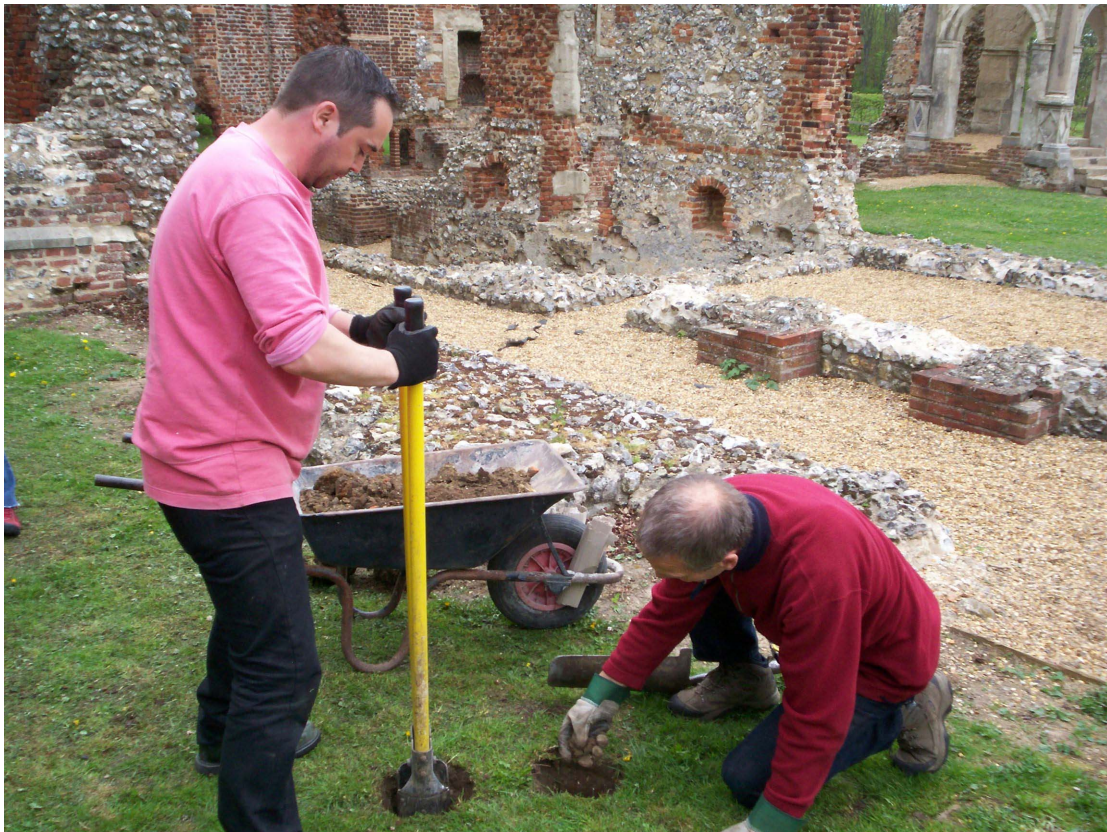
Plate 3: Panel 2 - excavation of postholes

One of the postholes of Panel 2 (Plates 3 and 4) outside the former building was excavated to a reduced depth of 0.44m because a piece of brick was encountered in the base. The brick was horizontal and had traces of mortar on its upper surface. This may have been part of an *in situ* structure, a brick rubble surface, or debris from the collapse of the building.

In situ archaeological deposits exposed during the watching brief consisted of one horizontal brick found at a depth of 0.44m in one of the postholes of Panel 2 which may or may not have been part of a brick-built structure. It was left undisturbed at that depth with the concrete and panel post placed on top.
