**FORMER DAIRY CREST SITE
FENSTANTON
CAMBRIDGESHIRE**

**ARCHAEOLOGICAL WATCHING BRIEF AND
MONITORING OF GEOTECHNICAL TEST PITS**

Project: DC3112
CHER event no.: ECB5002
OASIS ref: albionar1-278059

Document: 2017/163
Version 1.1

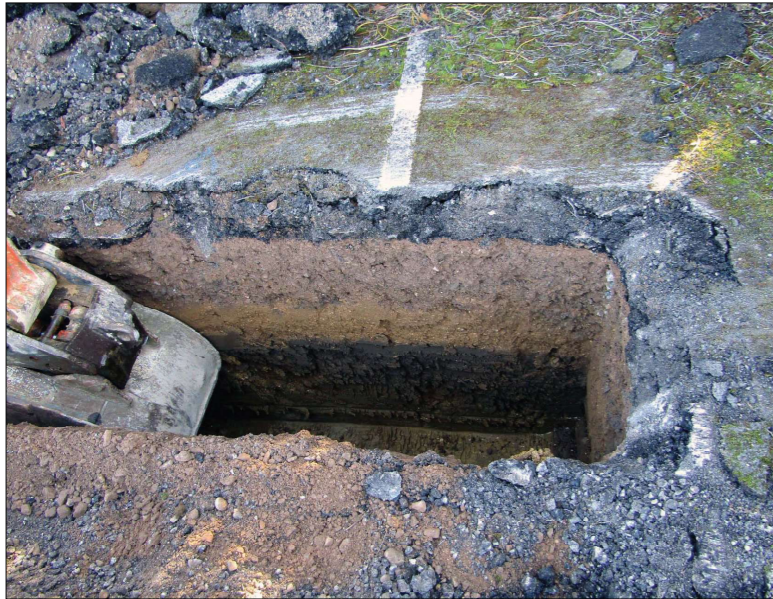
Photograph 1 on Figure 4 shows a broadly representative profile for most of the test

pits. Deposits associated with the construction of the dairy directly overlay geological deposits in just five test pits (TP13–14, TP24 and TP36–37).

Photograph 1: TP1, looking east

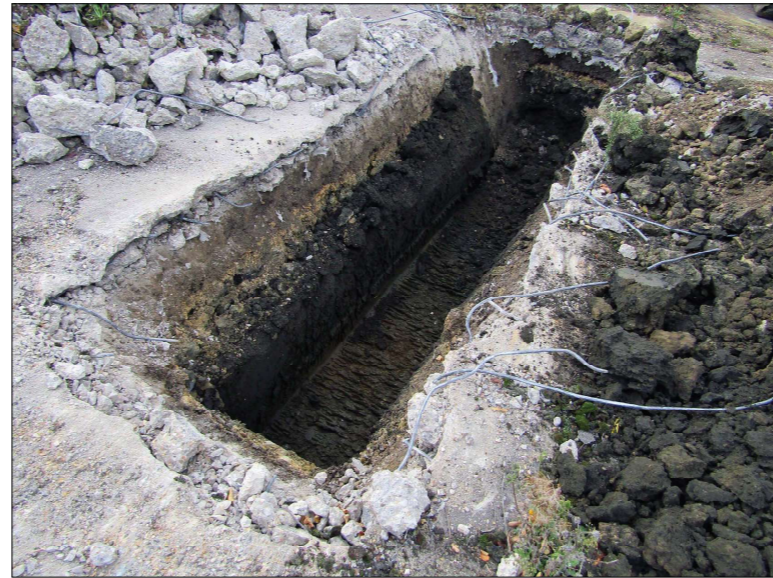
Two features were observed that appeared to be sealed by the subsoil: one in TP7, which was at least 0.6m deep; and a similar one in TP6 (Fig. 4: Photograph 2). Both contained dark deposits, but no artefacts were recovered from either to suggest their date. Two further features were observed in TP24, one >1.2m deep; no pre-dairy soils survived to give a stratigraphic clue as to their date, but their infill was similar to the deposits seen in TP6 and TP7.

Photograph 2: TP6, looking south-west

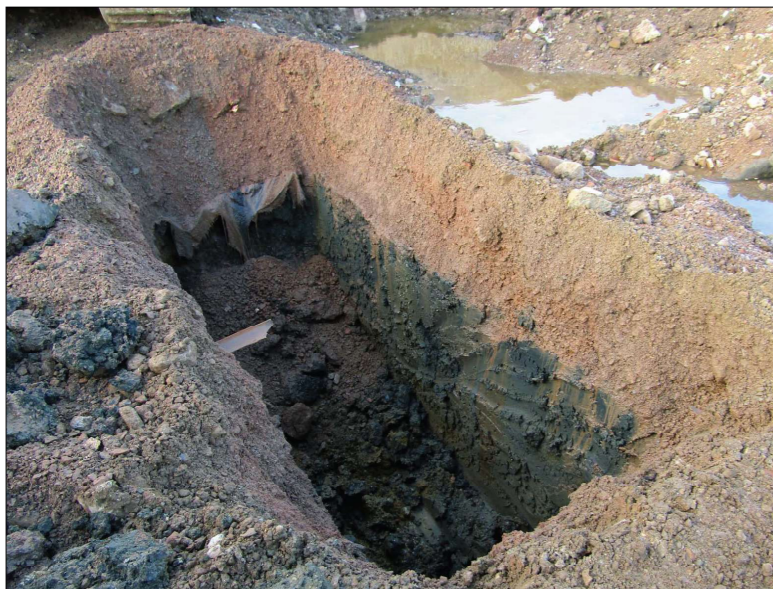
Test pits TP32 (Fig. 4: Photograph 4) and TP36–37 were not excavated deeply enough to reach undisturbed geological deposits, but the dark soils revealed in their lower extents appeared to be the infill of archaeological features rather than layers of overburden.

Photograph 4: TP32, looking north-east

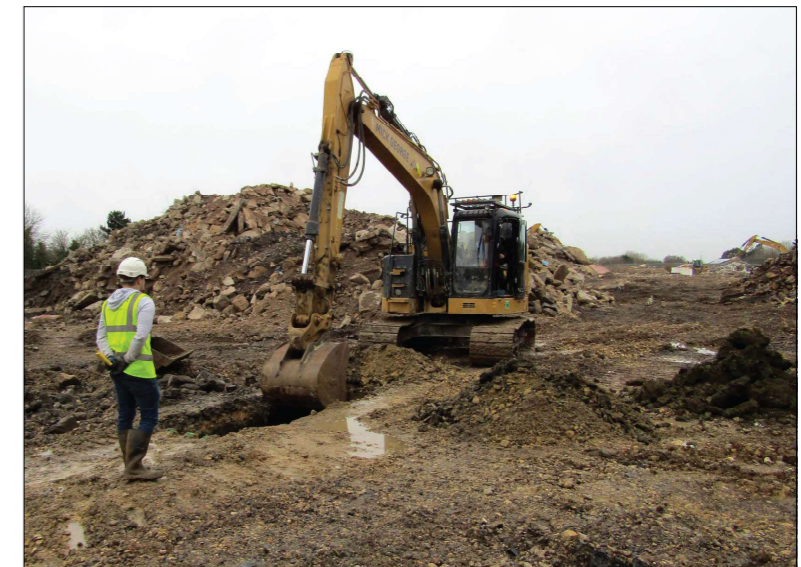
Test pits TP22–32 and TP36–39 were excavated in areas where ground levels had been disturbed by demolition work (*cf.* Fig. 4: Photograph 6), and the depth of overburden recorded is likely to have been less than was originally present before demolition began. Machining of TP25 was abandoned due to the presence of excessive groundwater, while TP26 ceased when it reached a modern service. Groundwater also obscured visibility in TP 38, while TP32, TP36 and TP37 were only excavated to a sufficient depth to confirm the absence of any significant contamination, meaning that the full archaeological profile was not visible.

Photograph 6: General photo, looking south-west across TP23

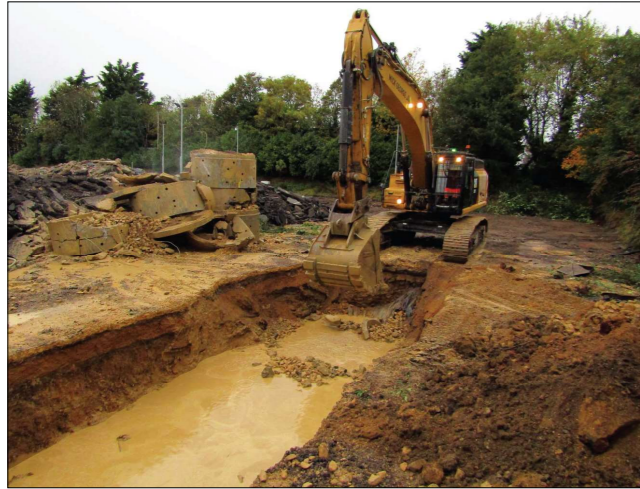
The large post-medieval or modern feature first seen in TP2 was revealed more extensively in area A, but no other archaeological features were identified during the watching brief. Machining associated with the removal of the concrete pads and tanks was largely constrained within areas of ground that had already been disturbed during the dairy's construction. Possible features were observed in the edge of the trench in area C, but there was no opportunity to safely investigate these (cf. Fig. 5: Photograph 2). Excessive groundwater obscured visibility in areas A and H (Fig. 5: Photographs 1 and 5), but the depth of modern disturbance makes it unlikely that any pre-modern archaeological features would have survived in these areas.

Photograph 1: Removal of drainage tanks (area A)

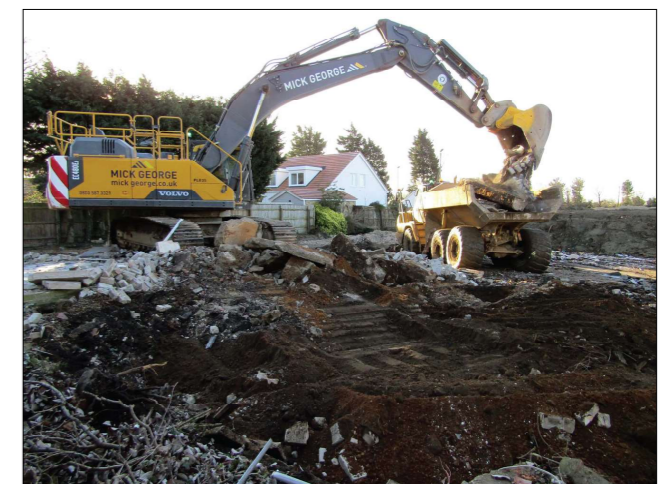
Observation of the removal of building footings was similarly unrevealing. Excavation of those in areas F and G was confined essentially to ground that had been disturbed during construction, although this disturbance appears not to have extended significantly below the subsoil, while the bungalow footings in area D were only within the topsoil (Fig. 5: Photograph 9).

Photograph 9: Removal of building footings (area D)
