**STEM BUILDING
UNIVERSITY OF BEDFORDSHIRE
LUTON**

**ARCHAEOLOGICAL OBSERVATION,
INVESTIGATION, RECORDING, ANALYSIS AND
PUBLICATION**

Project: UB3047
Luton Culture entry no: LTNMG 1272
OASIS no: albionar1-278113
HER search reference: 201617/326

Document: 2017/177
Version 1.0

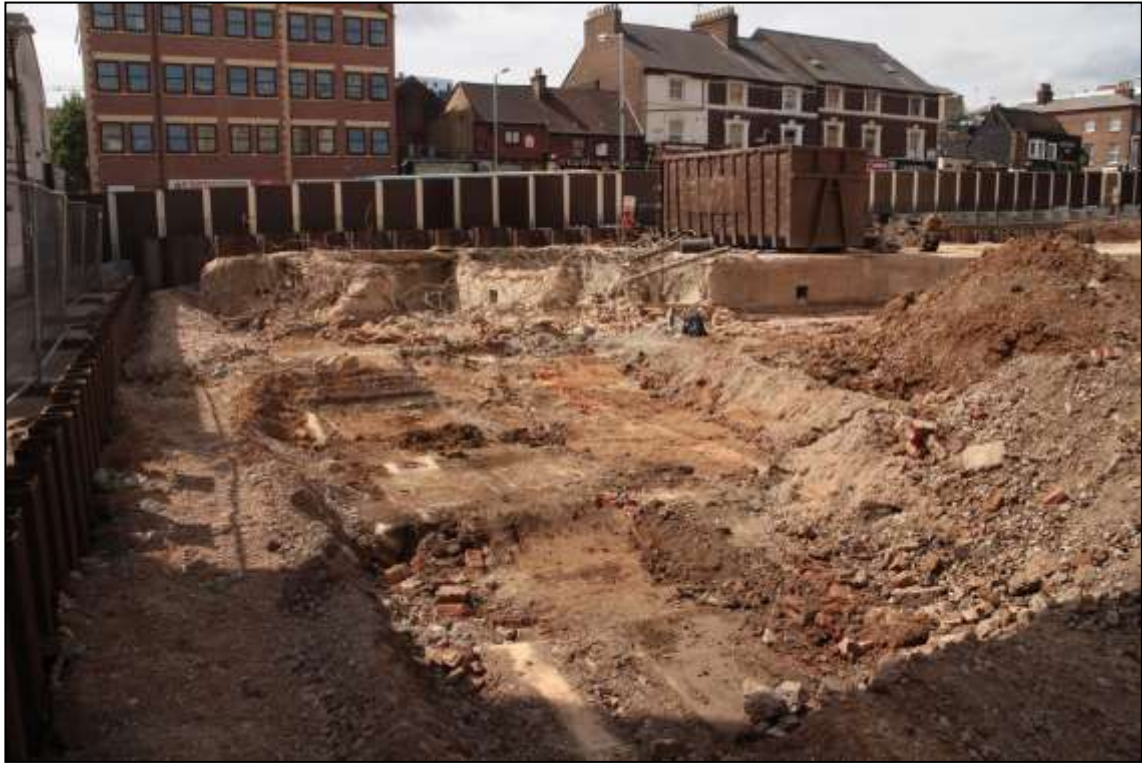
Image 1: General view of Area 1 looking towards Park Street

Sub-surface structural remains (9) associated with the recently demolished buildings consisted of substantial concrete foundation pads in the main part of the site and a basement along the Park Street frontage constructed in concrete (Image 1).

Southern corner of site, looking south-west. The partially demolished basement walls of the 1990s building are visible in the background, on the Park Street frontage.

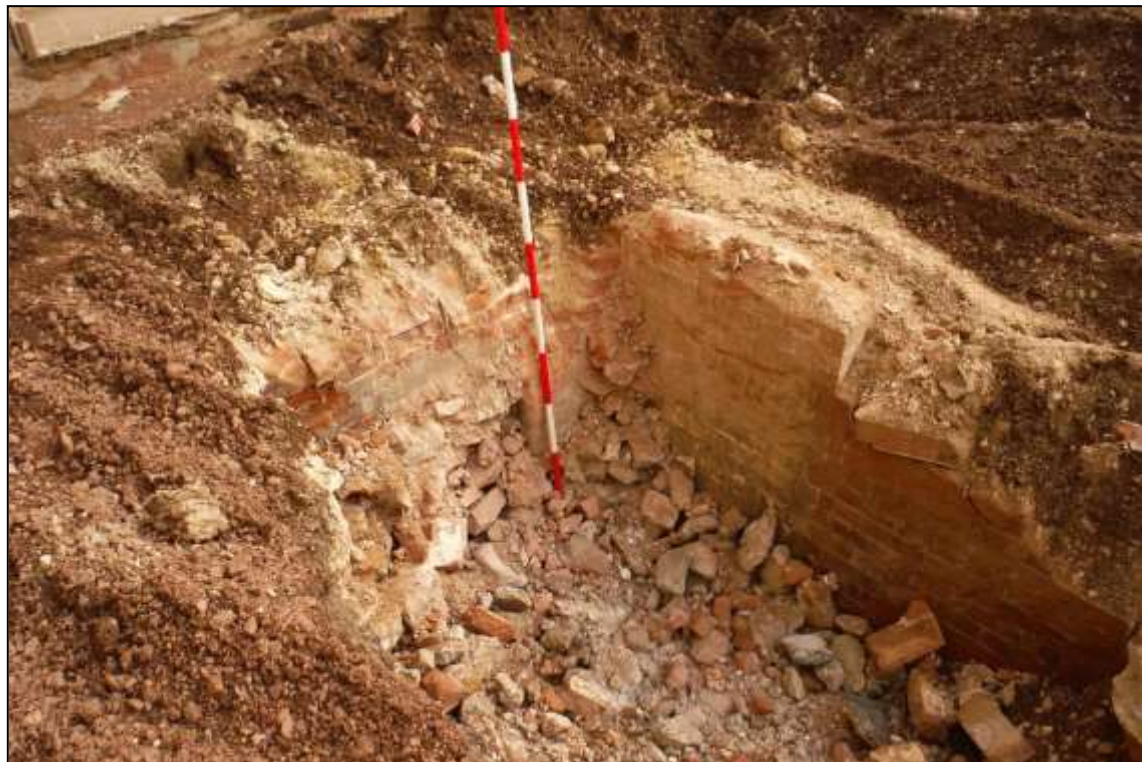
Image 2: Area 1, 1950s basement walls

A series of test pits excavated along the north-east edge and the central part of the site uncovered remains of a basement constructed during the 1950s. The structural remains (11) comprised brick walls, a concrete floor slab and foundations (Images 2 and 3). The walls were made with pressed bricks with

Brick basement walls (11) exposed in northern corner of site. Looking east (scale 2m).

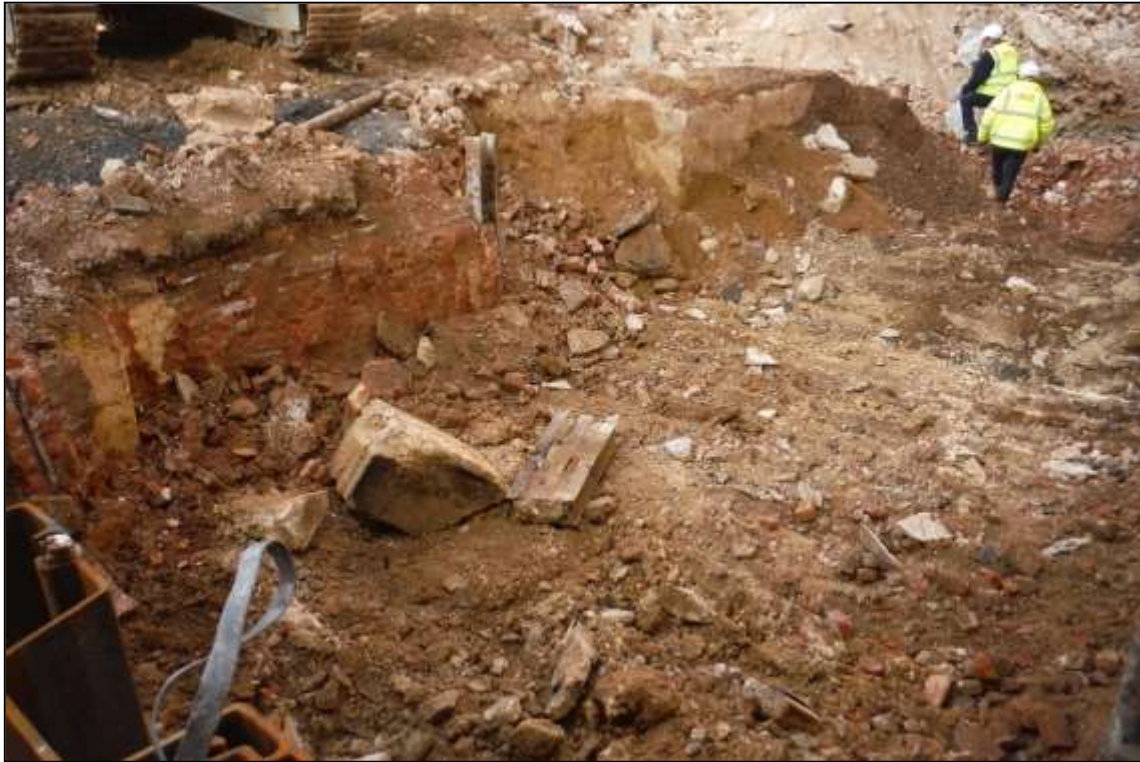
Image 3: Area 1, 1950s basement walls

Part of basement walls (11) exposed in eastern corner of site. Looking west (scale 2m).

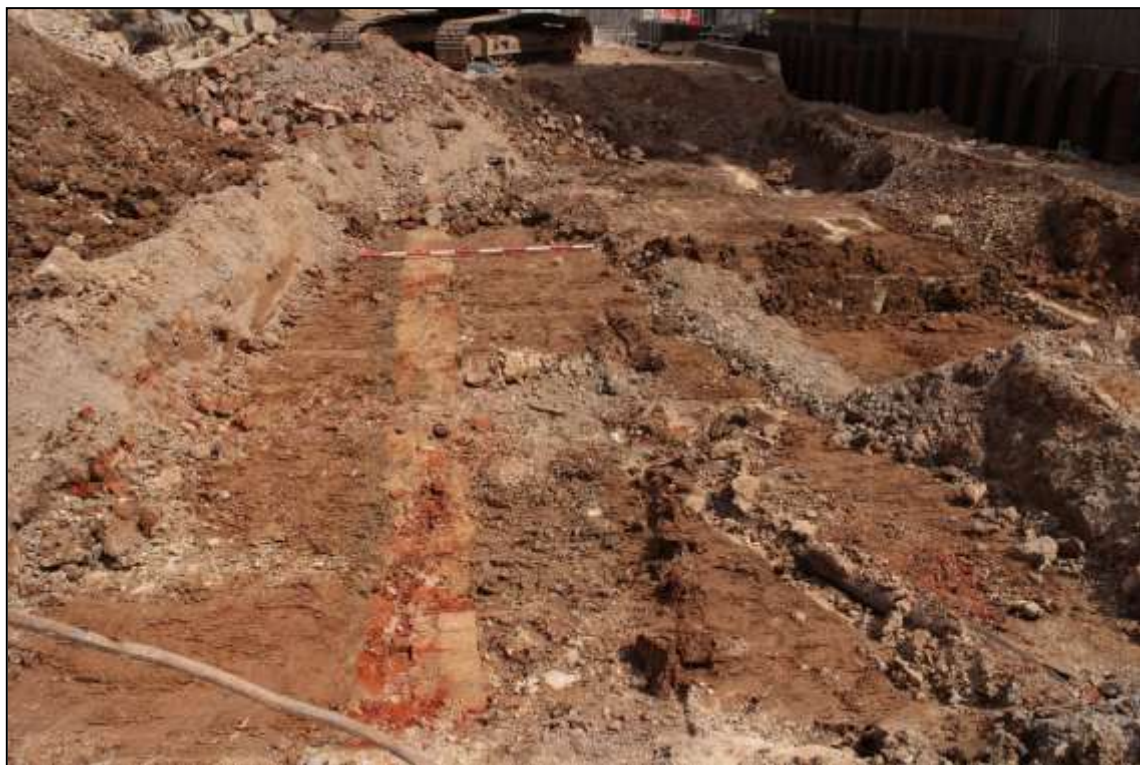
Image 4: Area 1, brick foundation (4)

A brick wall (4) was found in the south-eastern part of Area 1 (Image 4). It was c. 400mm wide, aligned north-east to south-west and made from plain mid-red brick bonded with light yellowish mortar. A narrow construction cut [3] was visible along its north-west side, filled with a mid-grey clay (5) construction backfill. No construction cut was visible on the south-east side of the wall where a layer (6) of mid yellowish brown silty-clay is interpreted as construction make-up for the floor of the building.

Comparison with historical maps suggests that the wall was a longitudinal internal wall of a building that is labelled on the 1884 Ordnance Survey map as brewery (disused at that time) (Figure 3). Layer (6) was observed in what would have been the interior of this building.

Looking north-east showing 18th- or 19th-century brick foundation (4) associated with former brewery (scale 2m).

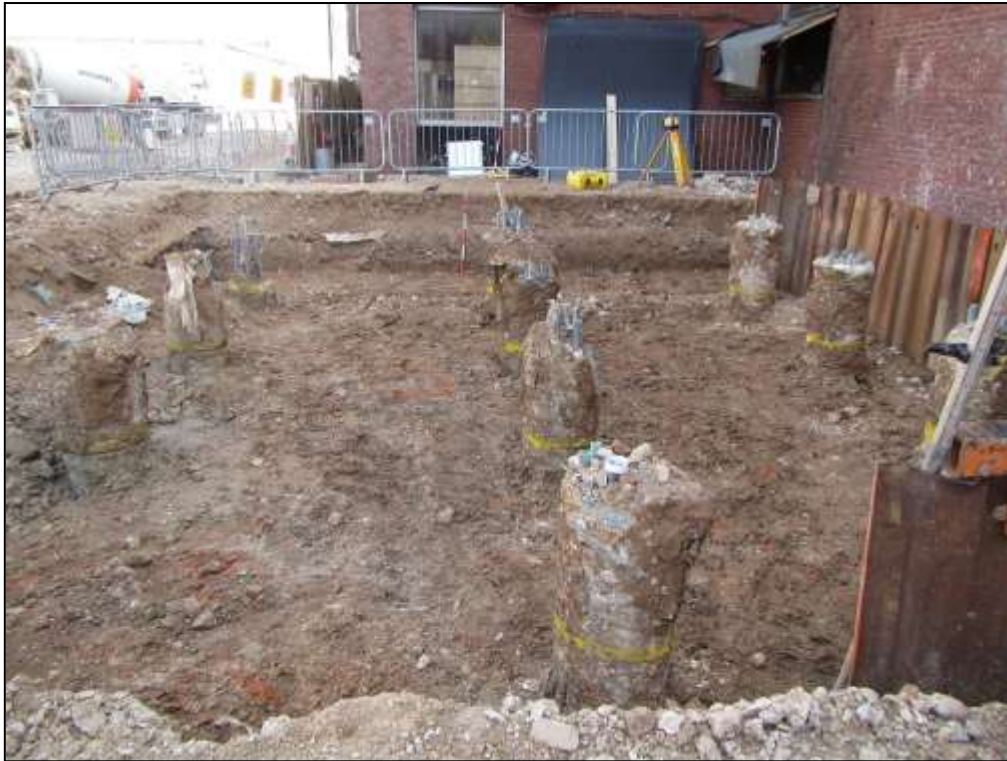
Image 5: Area 2, showing backfilled quarry pit [13]

A large, steep-sided pit [13] was observed in Area 2. One edge of the pit was visible along the western side of the trench but elsewhere it extended beyond the limit of excavation, measuring at least 7.5m wide and 9m long. The base of the pit lay at a depth of c. 1.9m below the level of St Ann's Lane. It contained a fill (14) of mixed dark grey and mid red-brown clay, containing fragments of plain red brick (Image 5). The same fill was observed throughout the full depth of the feature.

This large pit was located along the eastern edge of St Ann's Lane, possibly respecting an historical boundary or plot. The feature is interpreted as a quarry. It is cut into the glaciofluvial clay, sand and gravel deposit beneath this part of Luton. It is possible that this material was extracted for brick-making. The nature of the fill indicates that the pit was deliberately filled in a single phase, rather than by gradual silting or episodic filling. The type of plain red brick, c. 70mm thick, in the fill indicates a probable 18th- or 19th-century date for the filling of the pit. Historical maps show this area was covered by buildings by the late 19th century (Figure 3).

Looking north-east, showing trench reduced to depth of 1m, exposing the backfill material within quarry pit [13] (scale 1m).

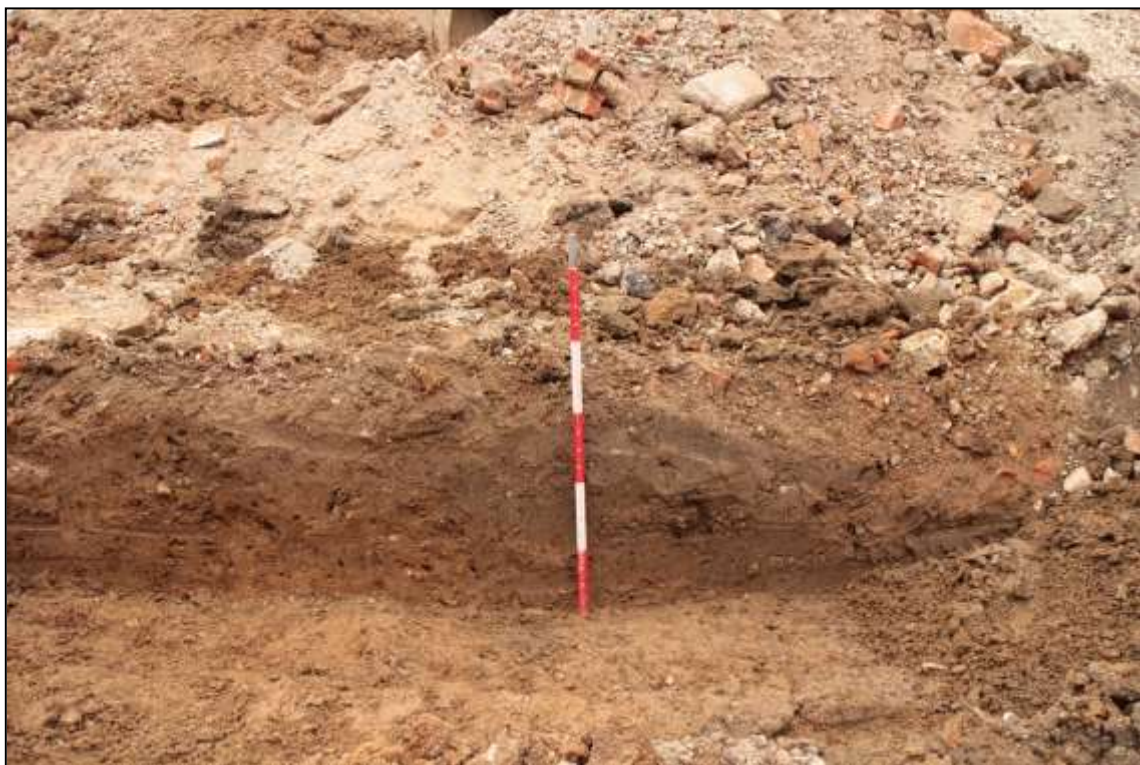
Image 6: Area 1, pit [7]

Within the area covered by the former brewery building a section was cut to examine the ground below layer (6). This uncovered the southern edge of a feature [7] interpreted as a pit (Image 6 and Figure 1: Section 1). Its fill (8) consisted of mid-grey silty clay with frequent green-yellow mottles and

occasional small stones. Six highly abraded indeterminate animal bone pelvis fragments (82g) (not retained) were recovered from the fill but no pottery or any other dateable artefacts were identified.

The green-yellow mottled appearance of the fill is commonly associated with the decay of organic material and could indicate that the feature was used as a cess pit or that it contained other organic material.

Looking north-west with pit [7] showing in section as a darker soil compared to the reddish-brown glaciofluvial deposit (1) visible at left (scale 1m).
