**GOLDINGTON GREEN LOWER SCHOOL
GOLDINGTON ROAD
BEDFORD**

**ARCHAEOLOGICAL OBSERVATION,
INVESTIGATION, RECORDING, ANALYSIS AND
PUBLICATION**

Project: GG3117
Museum accession no.: BEDFM: 2017.28
OASIS ref.: albionar1-280875

Document: 2017/114
Version 1.0

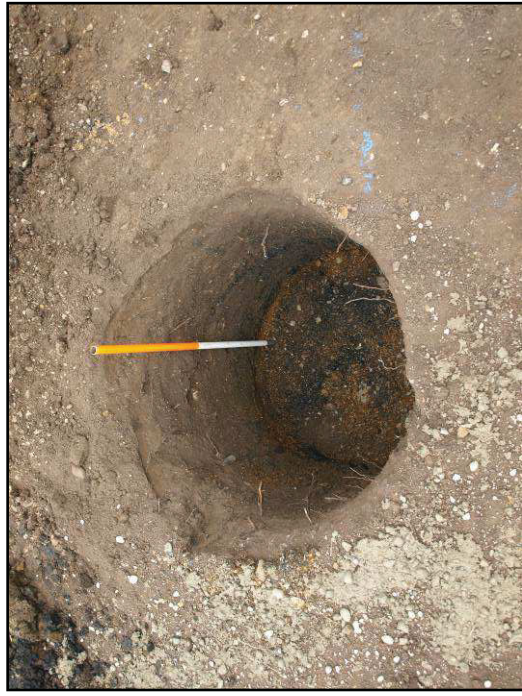
Typical augered pad pit (no. A10)

The pits were generally 0.75m wide by 0.75m long where excavated by machine bucket, or 1m in diameter where excavated by the auger. The depths were largely determined by the geology encountered, but were all a minimum of 0.7m deep and were specified to extend a minimum of 0.15m into undisturbed geology or solid ground. All pits were examined by a building inspector prior to filling with concrete.

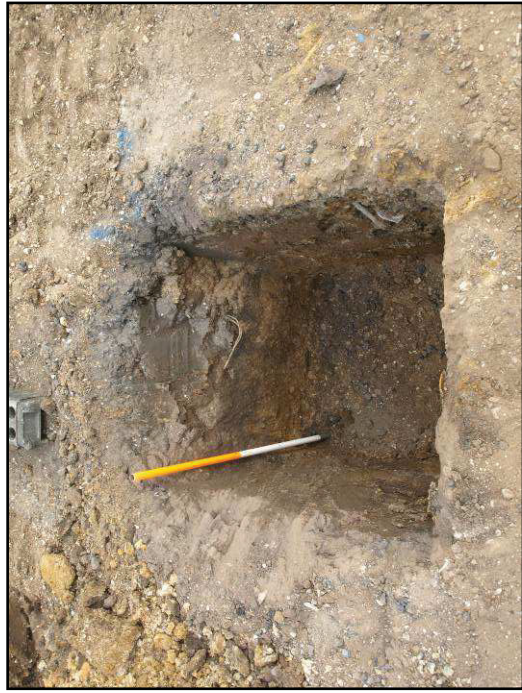
Typical square pad pit (no. E5)

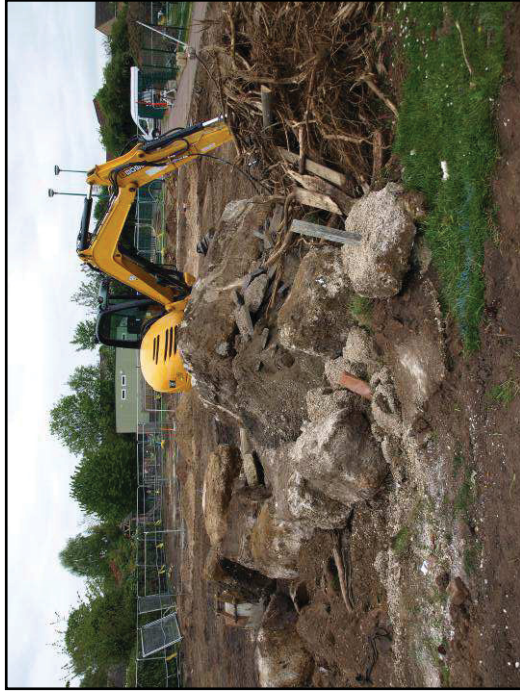
The greatest impact of the former swimming pool was the presence of eight large c. 1m square cubes of concrete, plus one large L-shaped mass that was c. 3m in

length. These were not removed under archaeological supervision; however the disturbance appeared to be localised to the area of the former swimming pool. There was no evidence of a large hole left by the former pool — it would appear most likely that the swimming pool was free-standing and not sunk into the ground. Despite this, there had been a significant impact in this area by disturbance associated with the foundations and associated services.

Former swimming pool/mobile classroom foundations (looking SE)
