**CHURCH OF ST MARY AND ST ANDREW
GRANTCHESTER
CAMBRIDGESHIRE**

ARCHAEOLOGICAL WATCHING BRIEF

Project: GC2665
CHER event no.: ECB5112
OASIS ref.: albionar1-283680

Document: 2017/131
Version 1.0

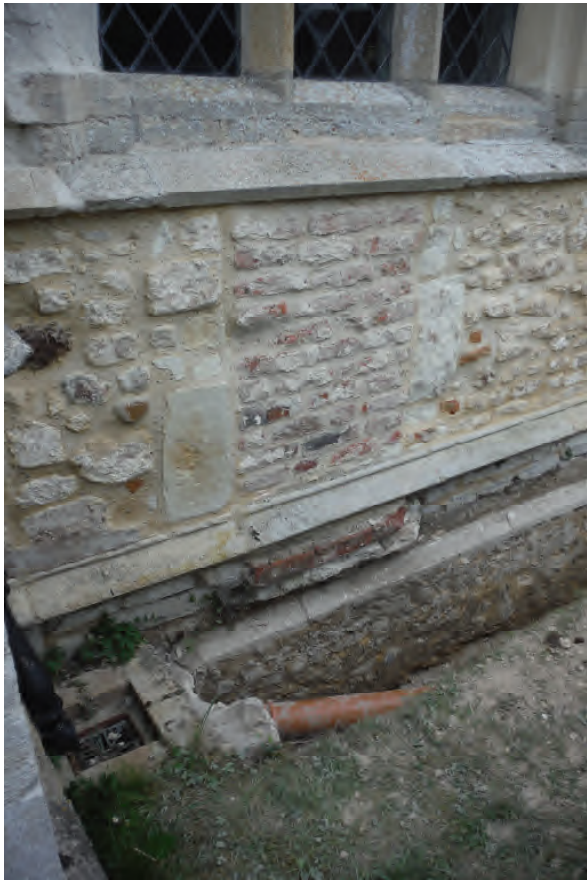
The inside vertical face of the trench exposed the chancel foundation, which continued below the base of the trench. It comprised light grey-yellow sandy mortar with frequent flint and sandstone cobbles, *c.* 150mm x 60mm (102) (Plate 1). This material is interpreted as the ‘outer edge’ of a deposit placed within a foundation trench and tamped down to form a construction base. Above this, the chancel wall construction comprised roughly hewn, squared sandstone and clunch blocks, random and uncoursed, to a height of *c.* 1m, above which the wall fabric is squared clunch blocks in an ashlar construction.

Beneath the east window a rectangular clunch block-edged opening that had been infilled with bricks was observed (Plate 1). The opening was probably a doorway that predates the extant window.

Plate 1: Trench 1 – chancel foundation (102) and bricked-up opening

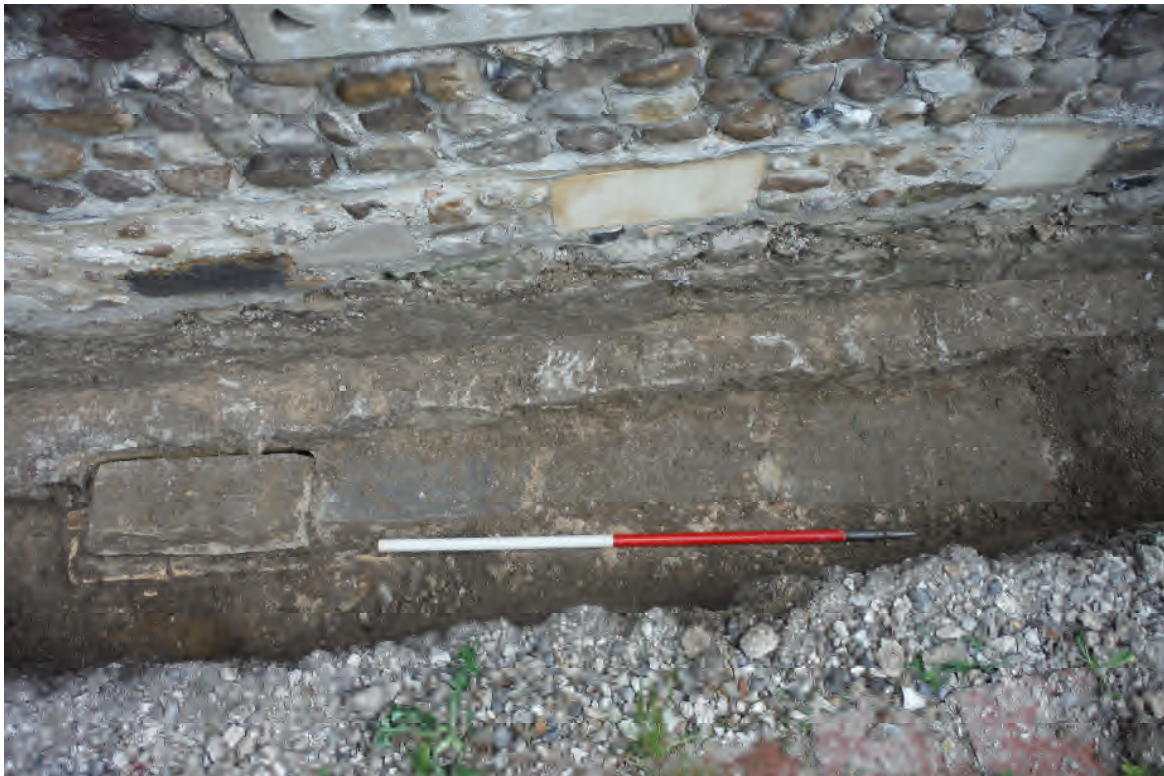
At the base of Trench 2, towards its eastern limit, a burial vault (204) was present (Figure 2; Plate 2). It was capped with a 73mm-thick light grey sandstone slab (205), which was fractured at the west end of the vault. The foundations of the south aisle, the orientation of which were at odds with the alignment of the vault, had been sympathetically constructed around and above the vault capstone, clearly indicating that the vault predated the construction of the south aisle.

Vault (204) was a rectangular brick construction, measuring *c.* 2.4m long. The interior was 0.82m wide and at least 1.1m deep. It was constructed of light grey-yellow unfrosted bricks that measured *c.* 223mm x 108mm x 53mm. The interior brick face of the vault had been painted with whitewash. Three iron bars, which were triangular in section, were present, crossing the width of the vault at an approximately half-height position. They had been inserted through pre-formed holes in the brickwork (after the coffin had been inserted) and then cemented in place.

Plate 2: Trench 2 – burial vault (204) with stone capping (205) (1m scale)

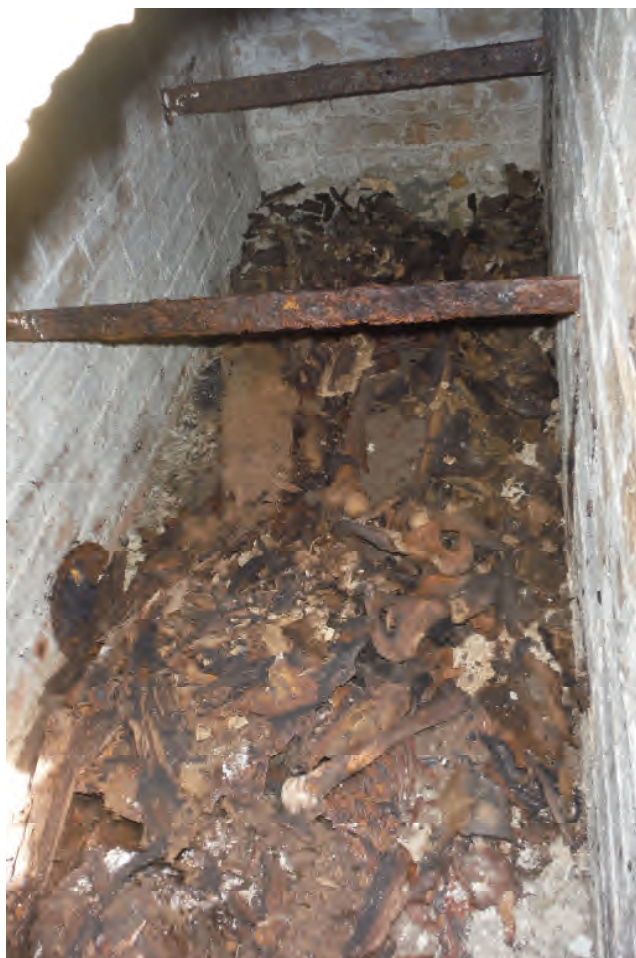
The capstone fragment was temporarily removed to expose the burial, which was photographed but not otherwise disturbed in any way (Plate 3).

The human remains comprised a complete skeleton, which appeared to be in good condition with the bones retaining locations close to the positions of their original articulation. A large number of timber coffin fragments and some metal studs were also present in the base of the vault. The vault is of probable 18th- to 19th-century date.

The iron bars were probably fitted to prevent the possible opening of the coffin and the 'theft' of the body. During the 18th and 19th centuries, the expansion of the medical schools, such as the anatomy school at Cambridge, increased the need for human cadavers for dissection. Removal of recently interred bodies was prevalent during this period, aided by the fact that bodies were not legally anyone's property, which allowed grave robbers to operate in a legal grey area.

Plate 3: Trench 2 – iron bars within burial vault (204)

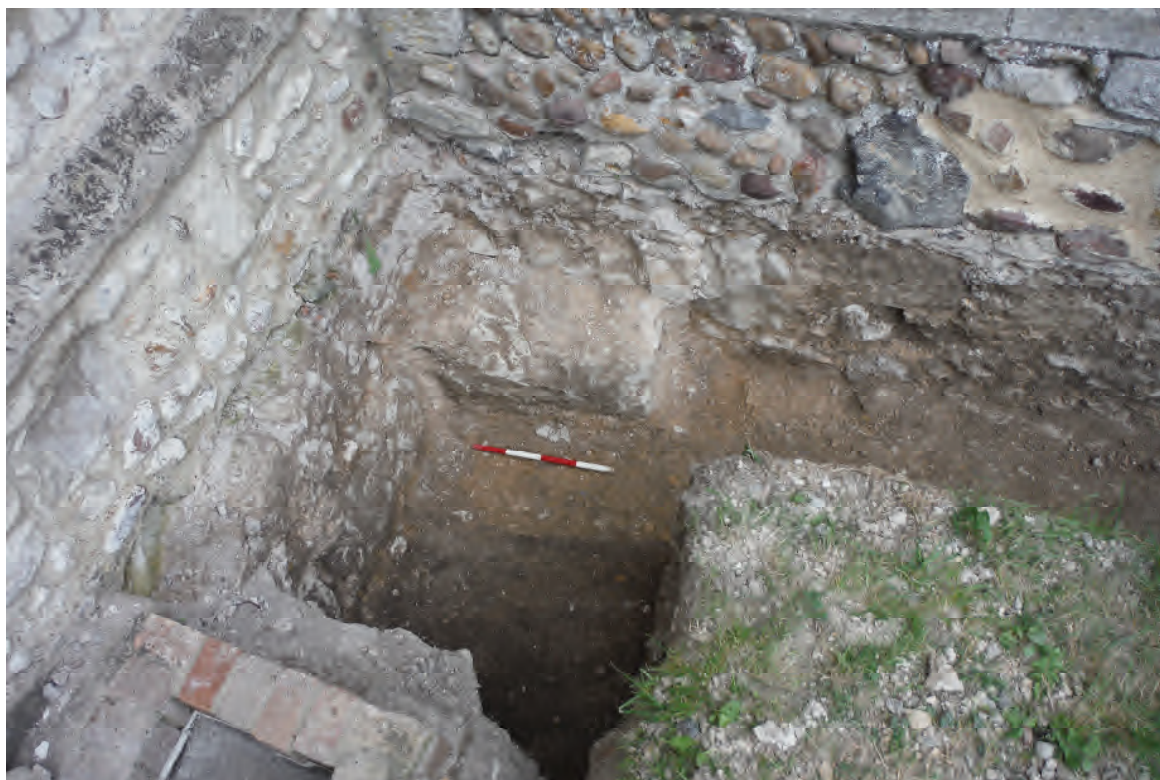
In the corner of Trench 3, where the south aisle adjoins the tower, a rectangular deposit of light orange-grey sandy silt with small fragments of mortar (304) was visible in the base of the trench (Figure 2; Plate 4). This is interpreted as the location of part of the base of the tower buttress, the base of which is now masked by the west end of the south aisle as it wraps around and encompasses the buttress — probably in a slightly width-reduced form but consolidated by the wall of the south aisle.

Plate 4: Trench 3 – reduced buttress (304) where west end of south aisle abuts tower (0.40m scale)

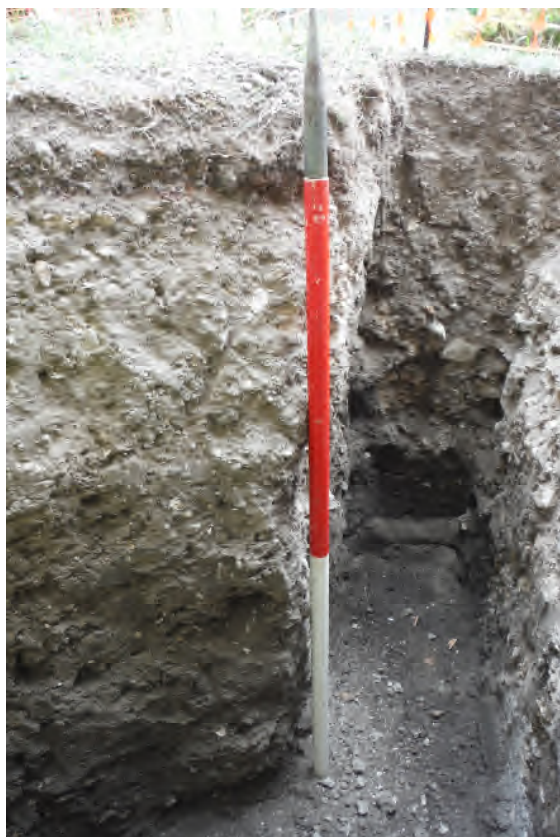
The outside vertical face of the trench (Plate 5) exposed a 0.1m-thick layer of mid-orange-grey sandy silt, the modern turfed surface (400). Below this was a 0.45m-thick layer of light brown-grey sandy silt with occasional stones, an upper graveyard soil (401). Below this was a 0.60m+-thick layer of dark brown-grey sandy silt with occasional stones, a lower graveyard soil (402), which contained a well-preserved sherd of late Saxon (850–1150) St Neots-type ware (16g).

Plate 5: Trench 4 – graveyard soil layers (400), (401), (402) (1m scale)

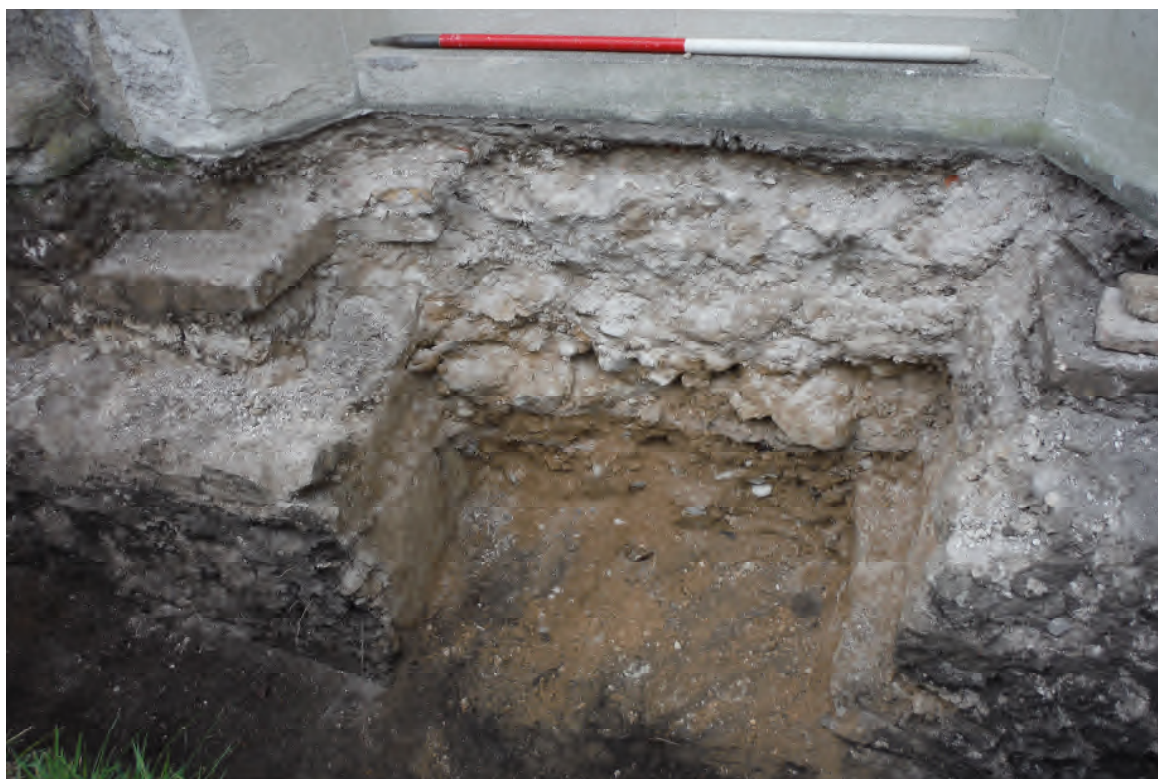
A gap in the foundations was present in a position central to the west side of the tower below the extant window (Plate 6). The gap probably represents the original position of a west door (as suggested by the Historic England assessment) that would have stepped down to a lower internal floor level within the tower.

Plate 6: Trench 5 – tower foundation (503) with gap indicating location of former west door (1m scale)

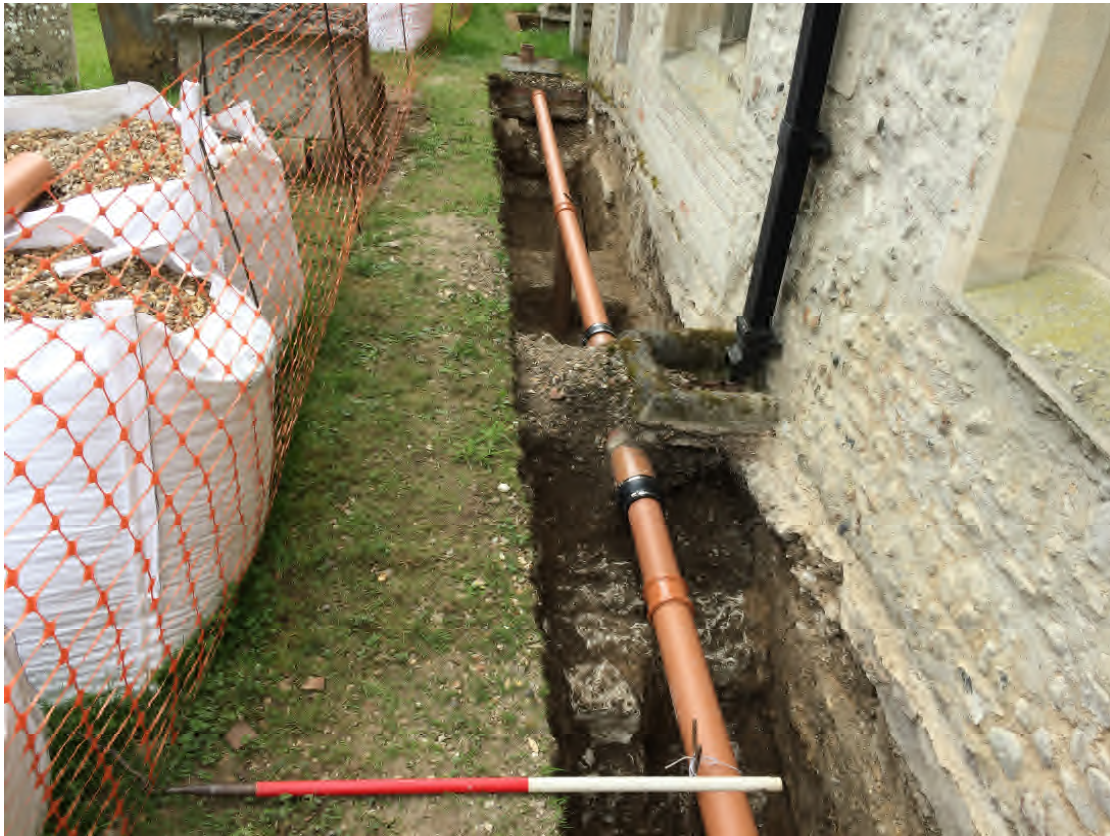
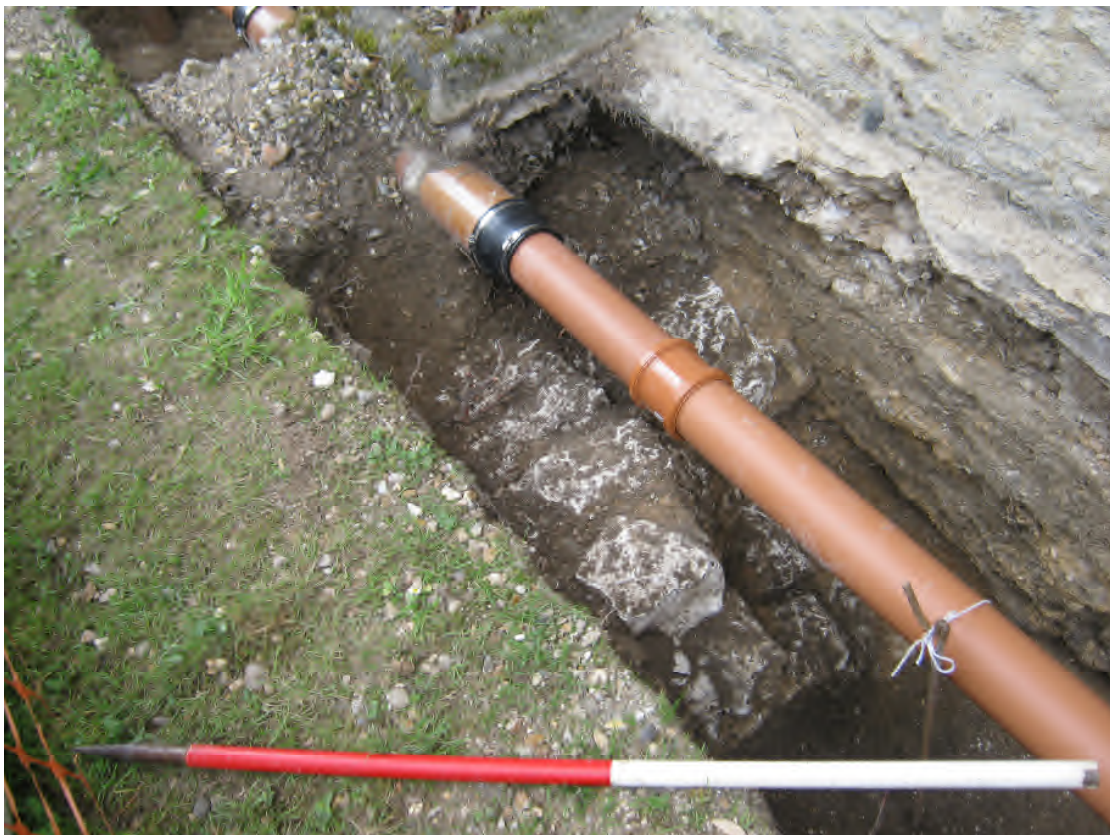
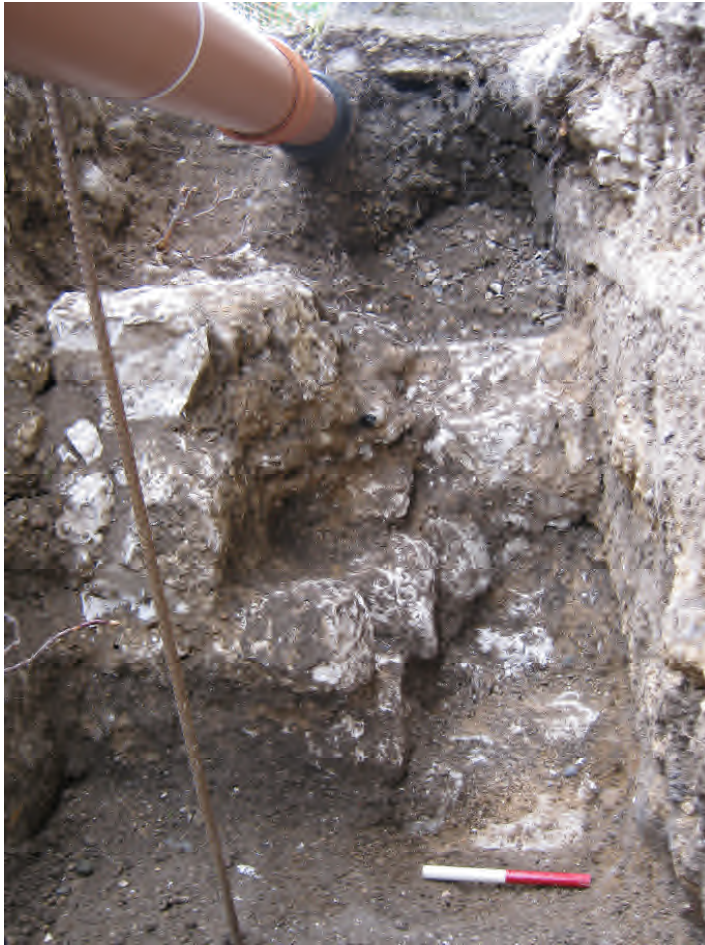
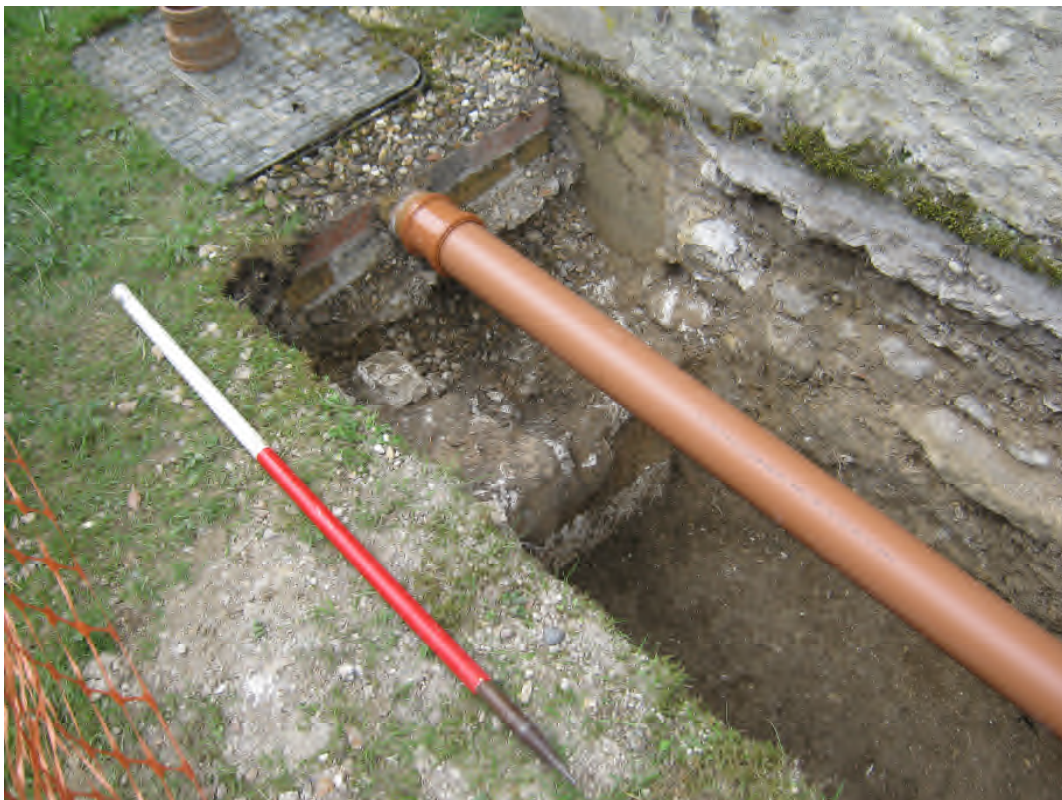
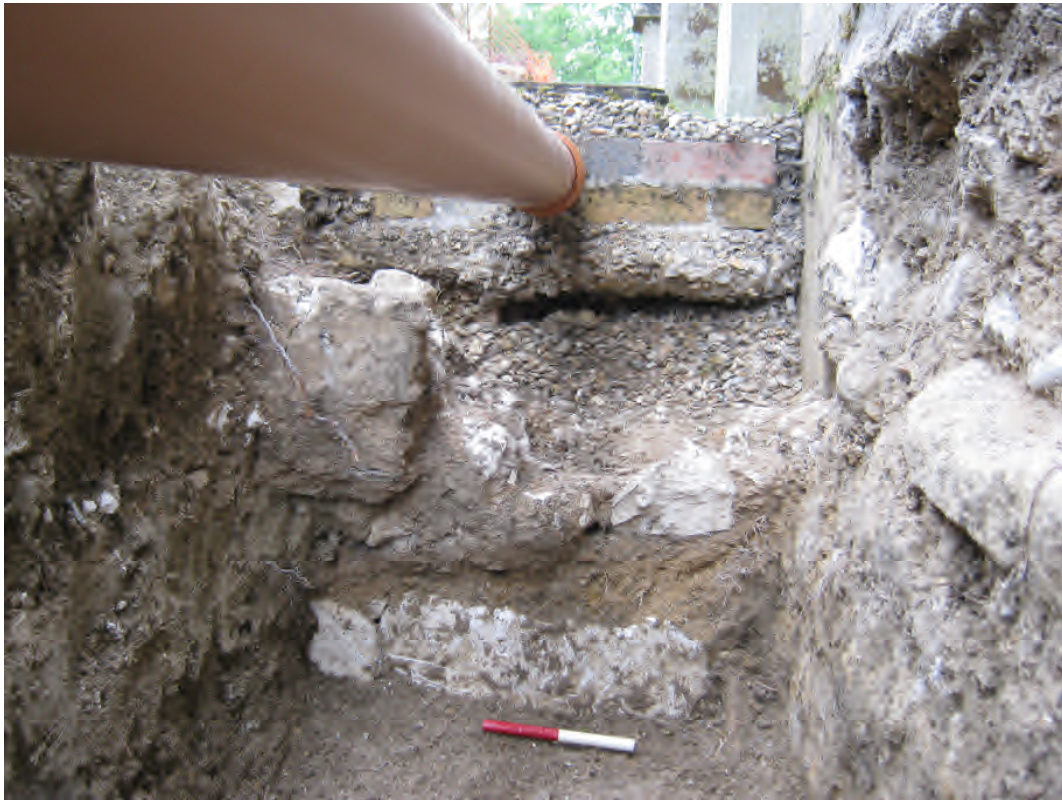
Large clunch stone foundations were revealed at two locations towards the east end of Trench 6 (Figure 2; Plates 7–11). They were set on a north-south alignment, running perpendicular to the nave. The foundations corresponded with the location of a blocked former stone arch opening set into the north wall of the nave and surface depressions in the wider cobblestone wall surface indicating the position of a formerly attached structure that had been ‘cut away’ and removed.

The foundations were set *c.* 5.3m apart, were at least 0.7m wide and continued below the base of the trench at a depth of 1m. They comprised large roughly hewn, squared, light grey-white clunch blocks (611), ranging in size from 50mm x 50mm x 80mm to 350mm x 240mm x 120mm. They were tightly fitting random uncoursed in construction and bonded with light grey-yellow sandy mortar, which was in moderate condition.

Plate 7: Trench 6 – demolished chapel foundations (611) in foreground and at end of trench. Stone floor remnant (612) towards centre. (1m scale)

Plate 8: Trench 6 – western arm of demolished chapel foundations (611)
(1m scale)

Plate 9: Trench 6 – side view of western arm of demolished chapel foundations (611)
(20cm scale)

Plate 10: Trench 6 – eastern arm of demolished chapel foundations (611)
(1m scale)

Plate 11: Trench 6 – side view of eastern arm of demolished chapel foundations (611)
(20cm scale)

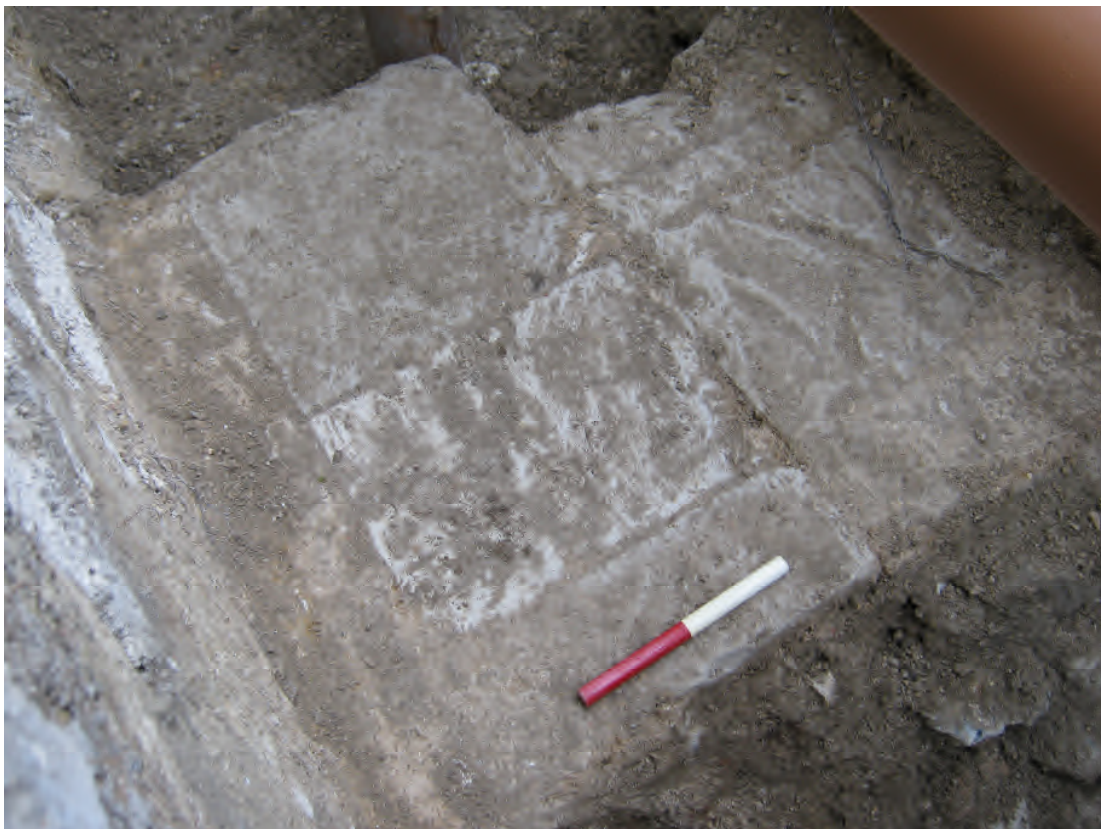
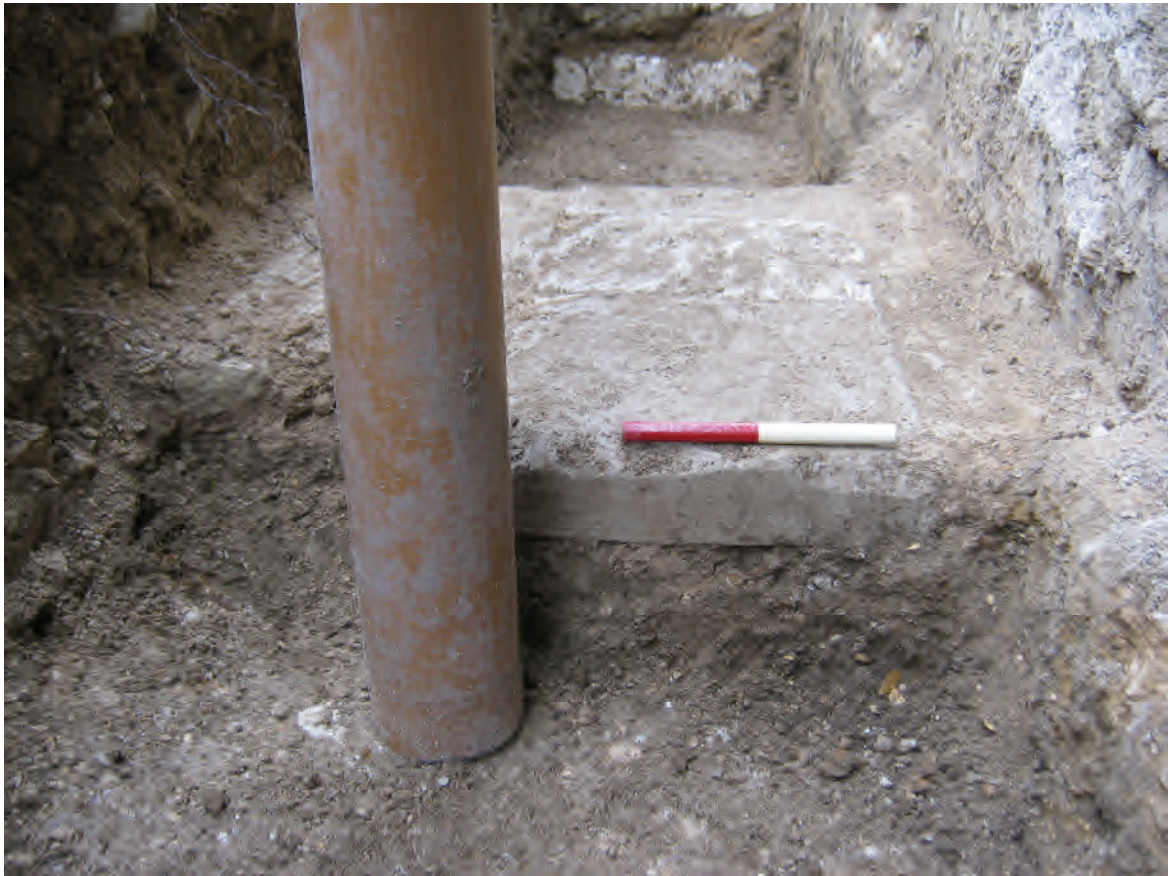
Between the foundations a small area of flat, smooth-faced, squared and finely abutted clunch ‘flagstones’ (612) were present (Figure 2; Plates 12 and 13). The stones were 280–400mm long, 340mm wide and *c.* 80mm thick. The stonework is interpreted as a surviving section of the former floor of the building defined by the foundations. The surface level was a good match for the extant nave interior floor.

Plate 12: Trench 6 – remnant of clunch stone floor (613) of demolished chapel
(20cm scale)

Plate 13: Trench 6 – side view of remnant of clunch stone floor (613) of demolished chapel (20cm scale)

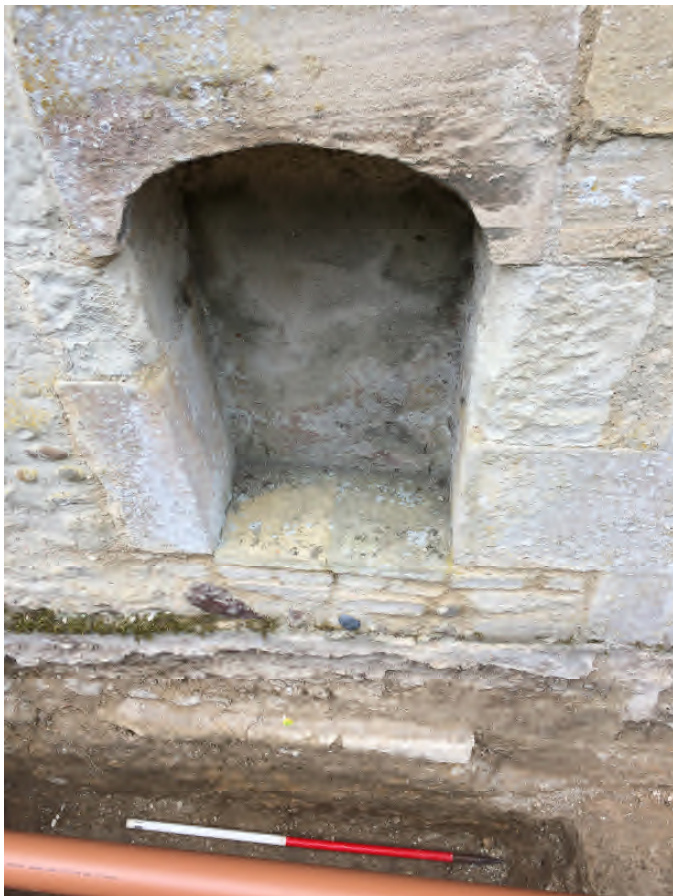
A small arched recess is present in the north wall immediately east of the blocked opening, suggesting that it would have been a feature within the demolished chapel (Figure 3 and Plate 14). The recess was also blocked at the back and for part of its lower drop. Its purpose is uncertain. It may have been associated with an internal nave stair to a lost rood screen or it may have been a piscina.

Plate 14: Recess in nave north wall, formerly within now-demolished chapel (1m scale)

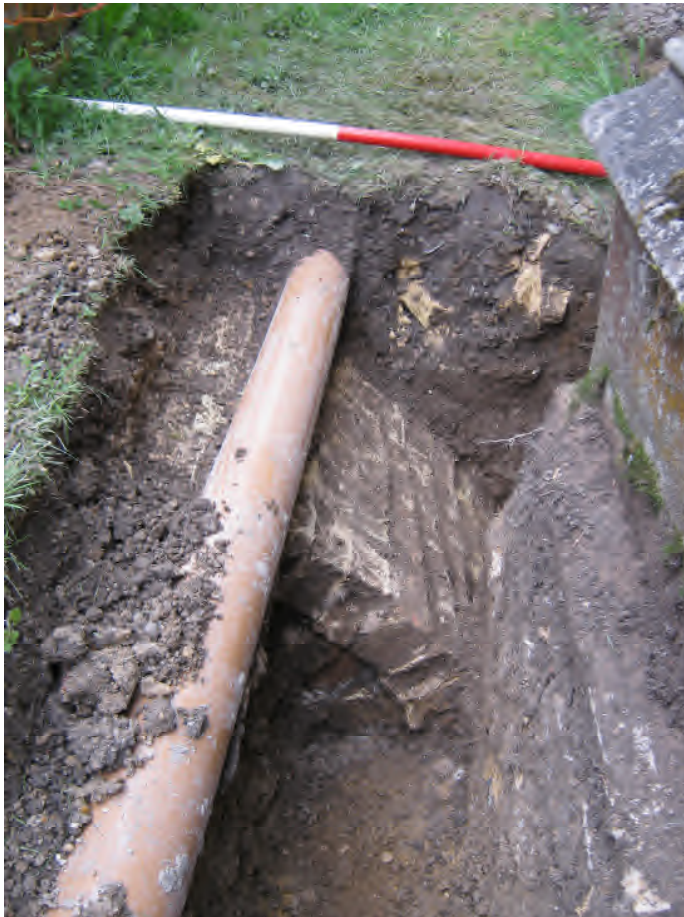
Part of a burial vault was exposed within the trench excavated around the centre buttress on the north side of the chancel (Figure 2; Plate 15).

The exposed convex ‘roof’ of the vault (703) was constructed of bricks. The vault was 1.7m wide. The unfrogged bricks were light grey-yellow, measuring *c.* 220mm x 108mm and bonded with a light grey-white sandy mortar that was in good condition. The south-west corner of the vault had been constructed around the base of the buttress. The vault is of probable 18th- to 19th-century date.

Plate 15: Trench 7 – brick burial vault (703) north of the chancel (1m scale)

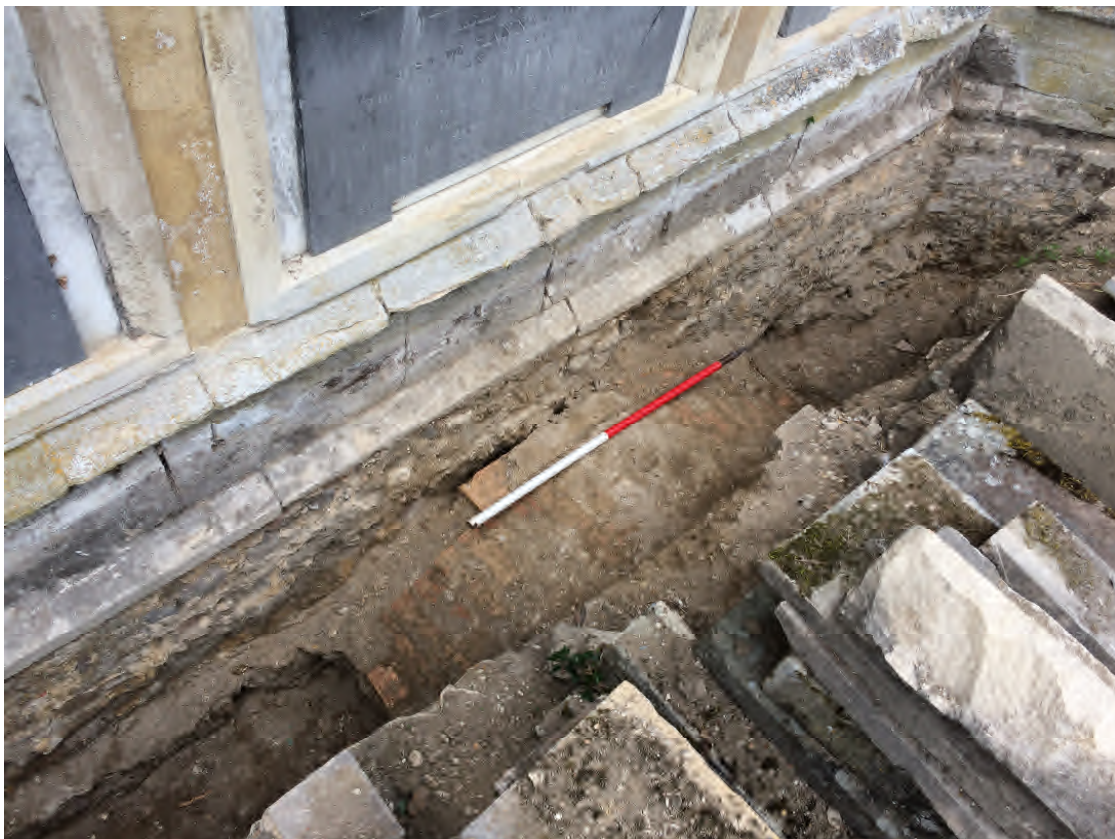
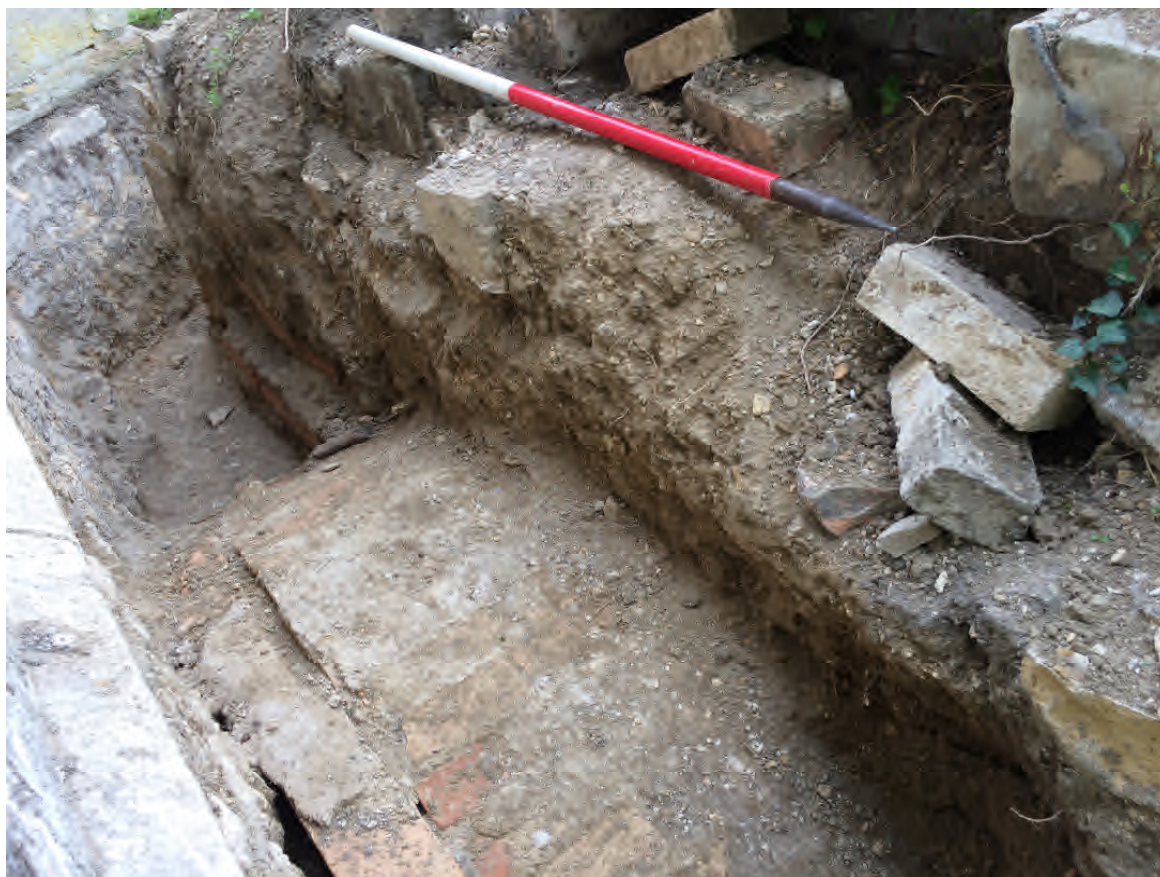
Two brick burial vaults were revealed, which aligned with the partially removed marker plinths (Figure 2; Plates 16 and 17). The most prominent was the centre vault (803), the exposed 'roof' of which was constructed of bricks. The vault was 1.7m wide and abutted the eastern end of the chancel foundations. The unfrosted bricks were light pinkish red or grey-yellow, measuring c. 223mm x 105mm. They were bonded with a light grey-white sandy mortar, which was in good condition.

Plate 16: Trench 8 – brick burial vault (803) at east end of chancel (1m scale)

Plate 17: Trench 8 – brick burial vaults (803) and (804) at east end of chancel (1m scale)
