**12 MANOR LANE
WYMINGTON
BEDFORDSHIRE**

**ARCHAEOLOGICAL OBSERVATION,
INVESTIGATION,
RECORDING, ANALYSIS
AND PUBLICATION**

Document: 2017/125
Version 1.0

Project: ML3170
Museum accession no.: BEDFM 2017.55
OASIS no.: albionar1-285612

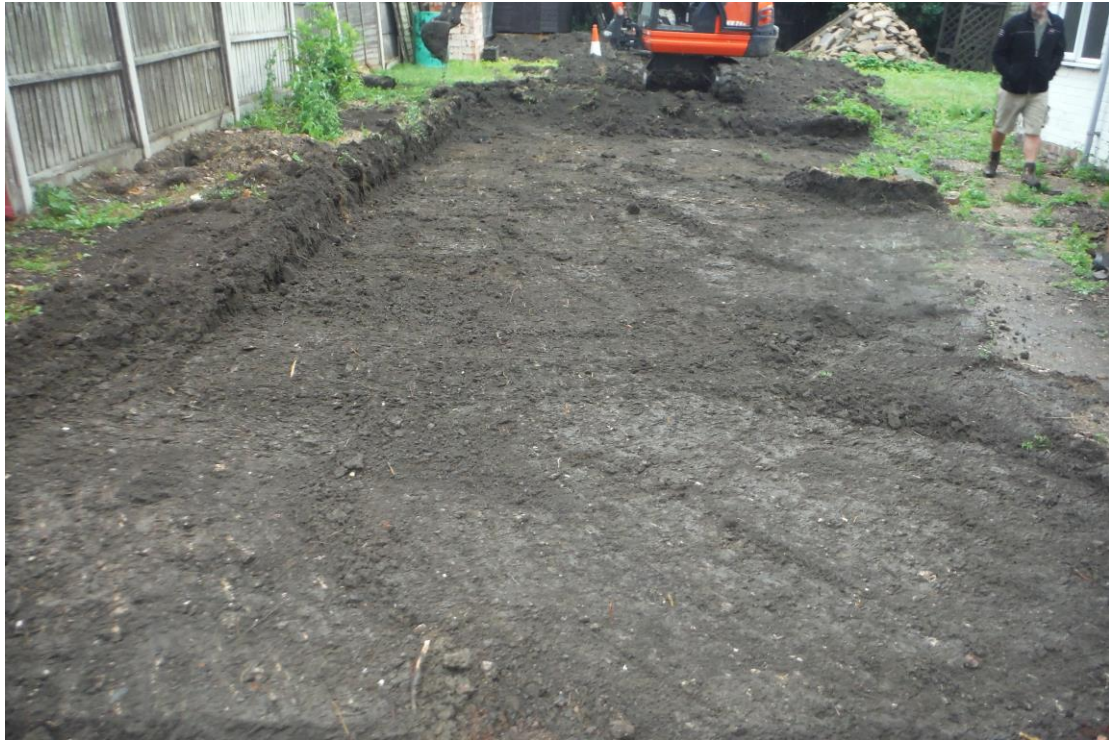
The topsoil (01) comprised firm dark black, clay silt, up to 0.25m thick, with occasional small fragments of brick and slate (Figure 3: image 1). The thickness of the deposit suggests a former cultivation soil, probably a garden soil, though it may have originally been an arable cultivation soil.

Image 1: General view of area looking northwards, during initial strip of topsoil (01)

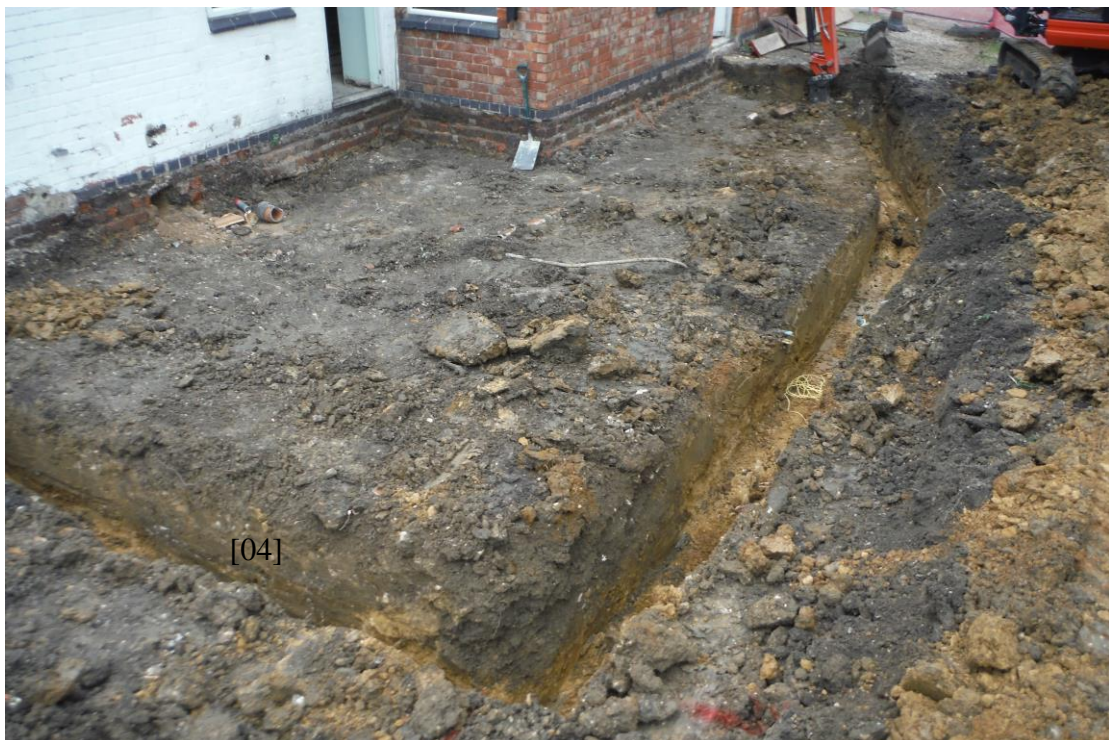
Figure 3: Selected images 1 and 2

The sole feature revealed was pit [04] located at the SE corner of the new footings (Figure 2 and Figure 3: image 2). The pit was apparent in both footing trench edges. The base tapered markedly to the south, whilst continuing below the bottom of the footing trench (Figure 4: image 4). The pit was 1.88m long, at least 0.6m wide and 0.75m deep with an asymmetrical profile (Figure 2: section 2; Figure 4: image 4; and Figure 5: image 5). The single firm mid orange-grey clay fill (05) contained no finds.

Image 2: General view of area looking from the SE, after the footing trenches had been excavated to formation level. Pit [04] is visible in the foreground (labelled).

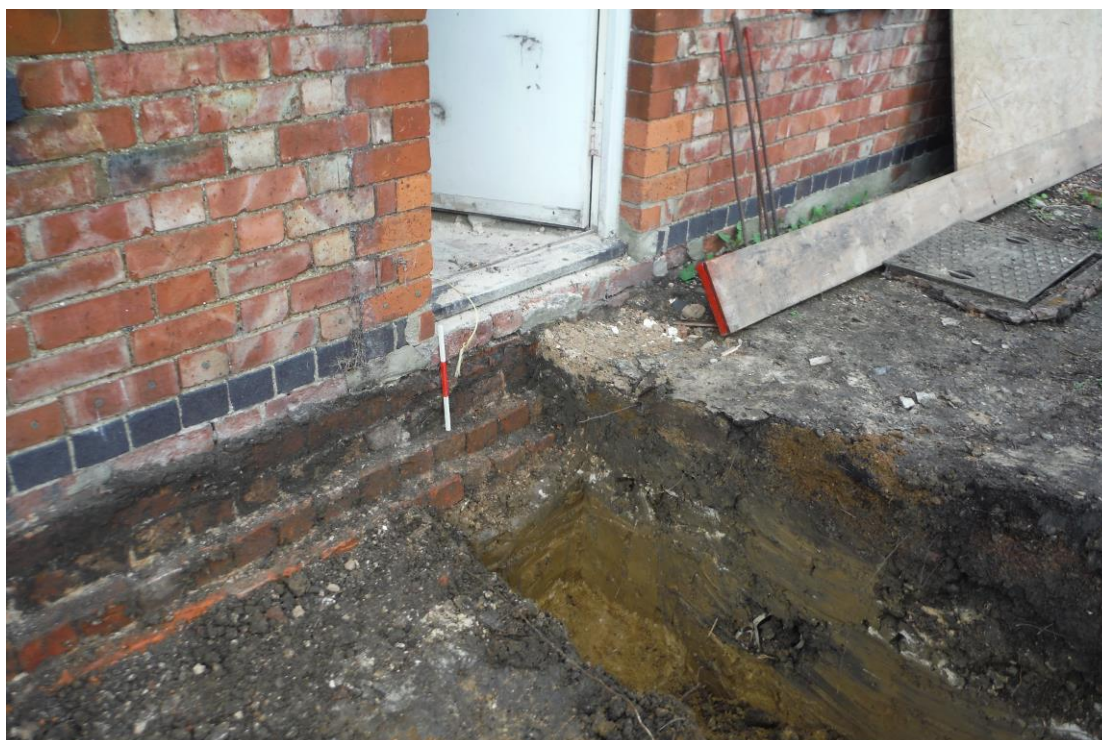
The footing trenches revealed sequential drains associated with the house, with an early drain [06] extending eastwards from the building. This had been recently replaced by a new drain [08], aligned parallel to the eastern wall of the building (Figure 2: section 1 and Figure 4: image 3).

Image 3: NW area of footing trench showing the two sequential drains, with the earlier example [06] parallel to the northern edge of the footing trench, whilst the later example [08] crosses the earlier drain at right angles, truncating it. Scale 0.3m in 10cm divisions.

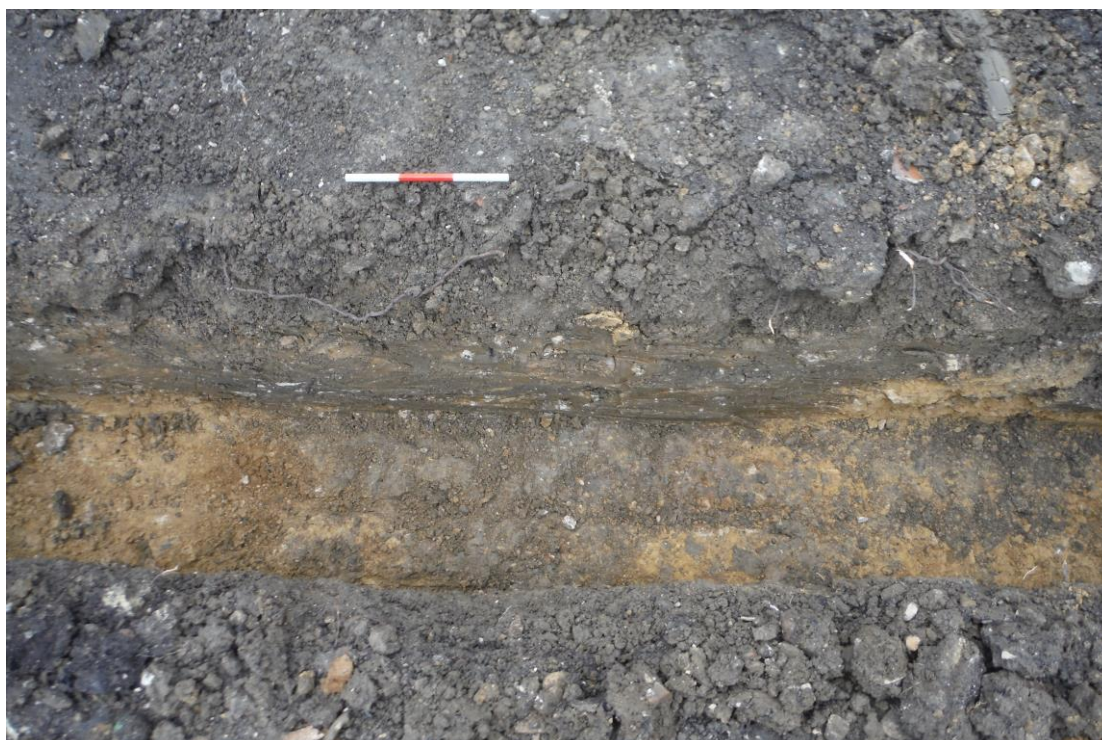
Figure 4: Selected images 3 and 4

Image 4: Overhead view of pit [04], showing wider northern profiles, and fill (05) in the base of the trench. Scale 0.3m in 10cm divisions.

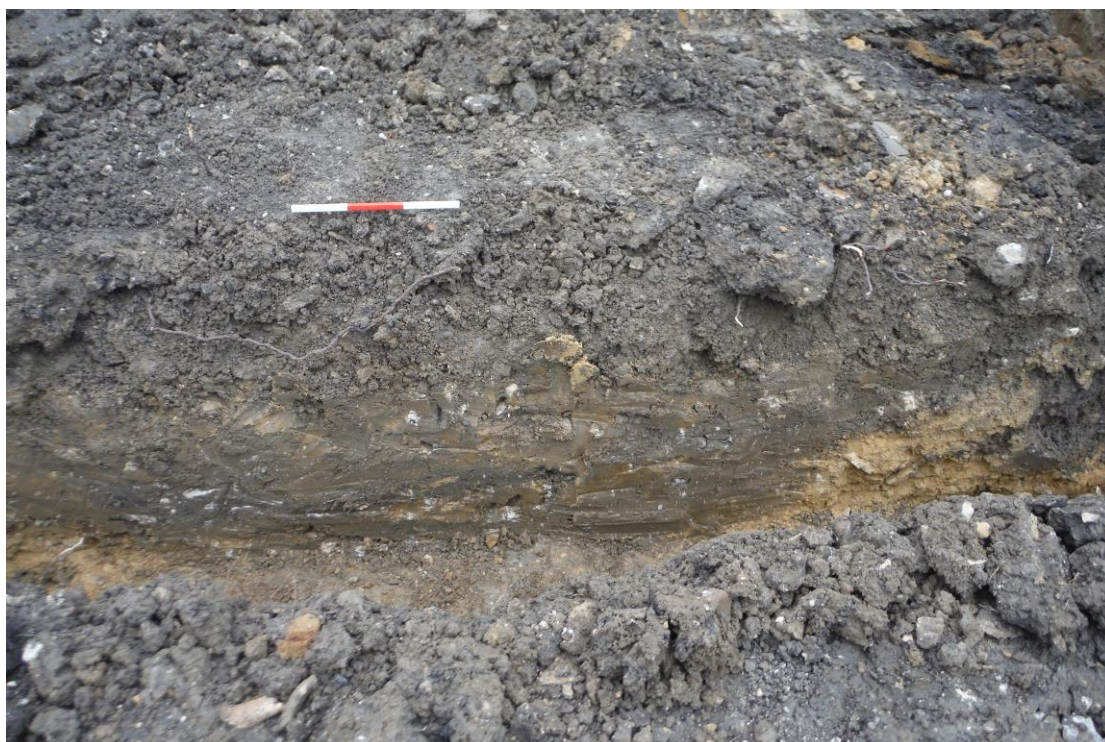
Figure 5: Selected image 5

No significant archaeological features were encountered during the investigation. The topsoil and subsoil had been subject to a moderate amount of disturbance. This is likely to be associated with the construction of the existing building in the late Victorian period, as well as backyard activity. The sole feature, pit [04], is likely to be modern in date but is of uncertain function.

Image 5: Northern section of pit [04]. Scale 0.3m in 10cm divisions.
