**JOHN O'GAUNT GOLF COURSE
SUTTON PARK
SUTTON
SANDY
BEDFORDSHIRE**

**ARCHAEOLOGICAL STRIP, MAP
AND RECORD EXCAVATION,
ANALYSIS AND PUBLICATION**

Document: 2017/150
Version 1.0

Project: JG3145
Museum Accession no: BEDFM 2017.66
OASIS no: albionar1-291805

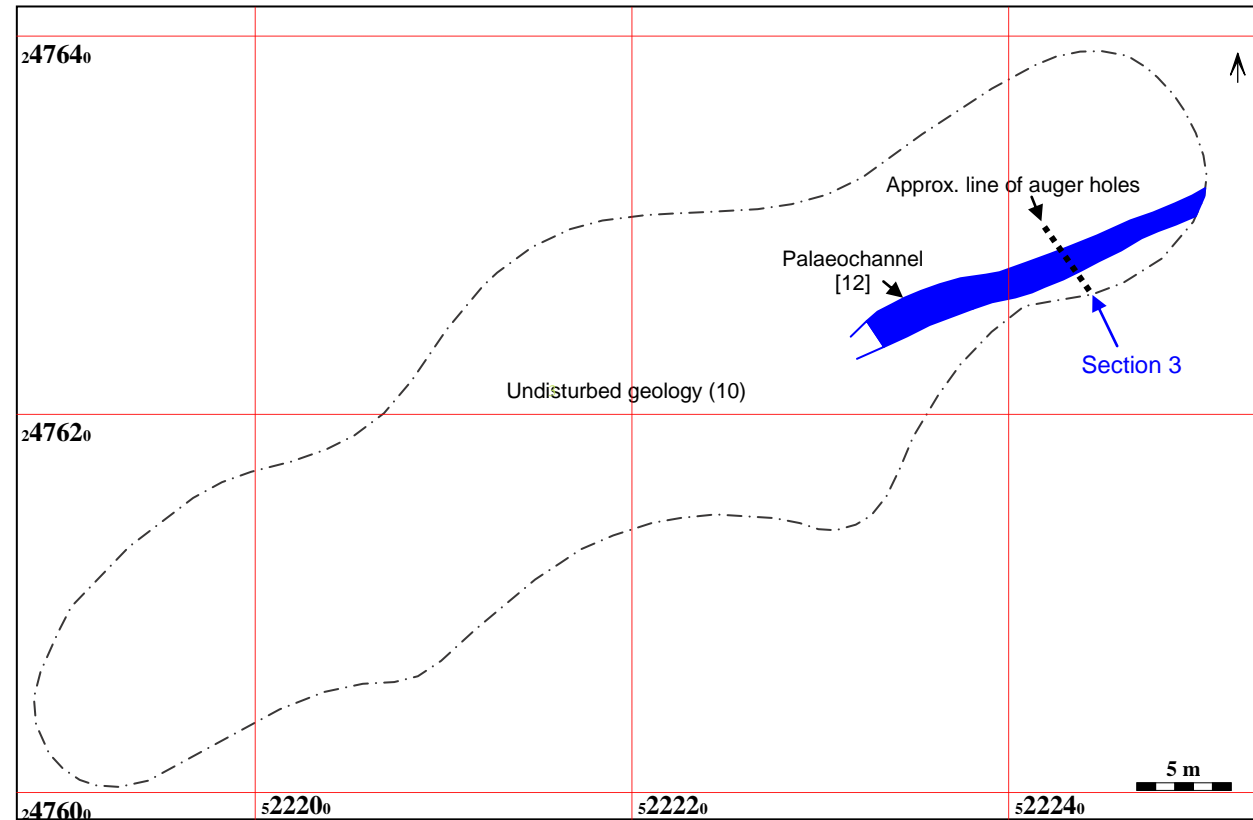
Plan of the new pond after the removal of peat

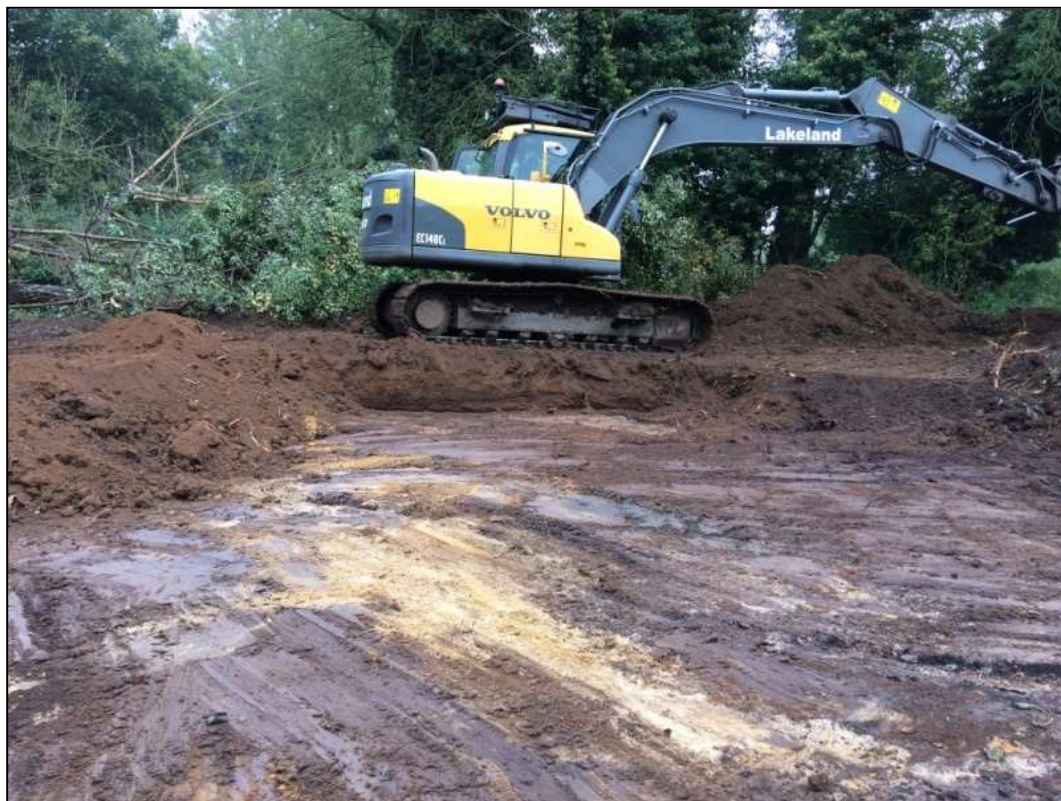
Plate 1: Removal of overburden and exposure of peat (17) in Area A, looking north

Following scrub clearance, three layers were observed during the removal of overburden: topsoil (14) and two make-up layers (15) and (16) (Plate 1).

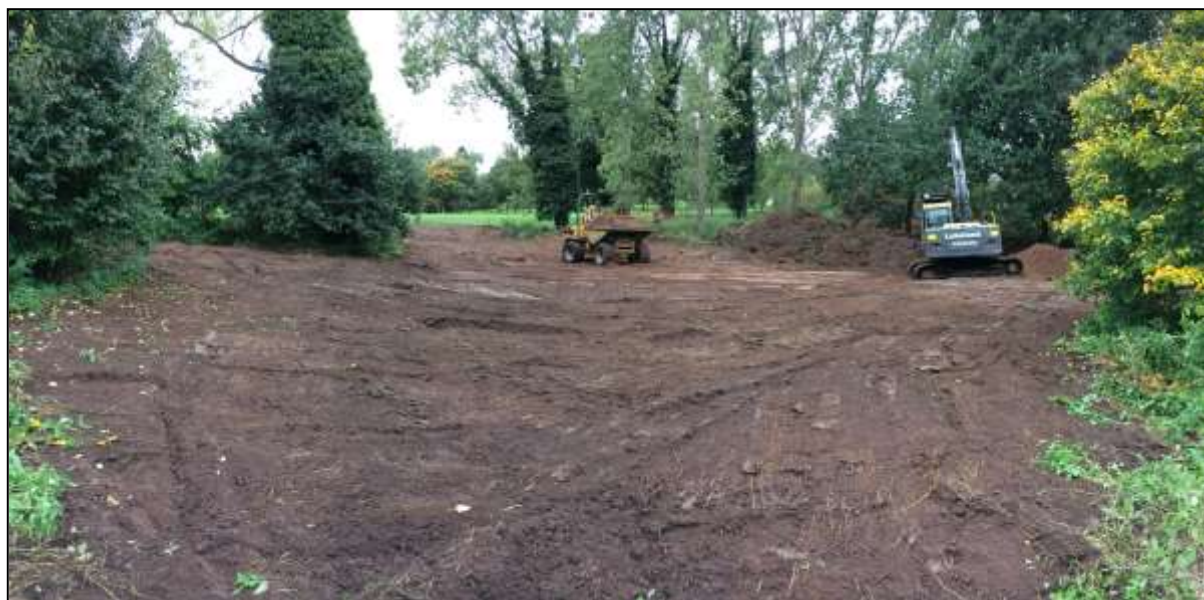
Plate 2: Area A after the removal of overburden, looking south-west

Below these layers a dark greyish brown peat layer (17) was observed (Plate 2). No archaeological features were identified within this peat deposit and it was left *in situ*.

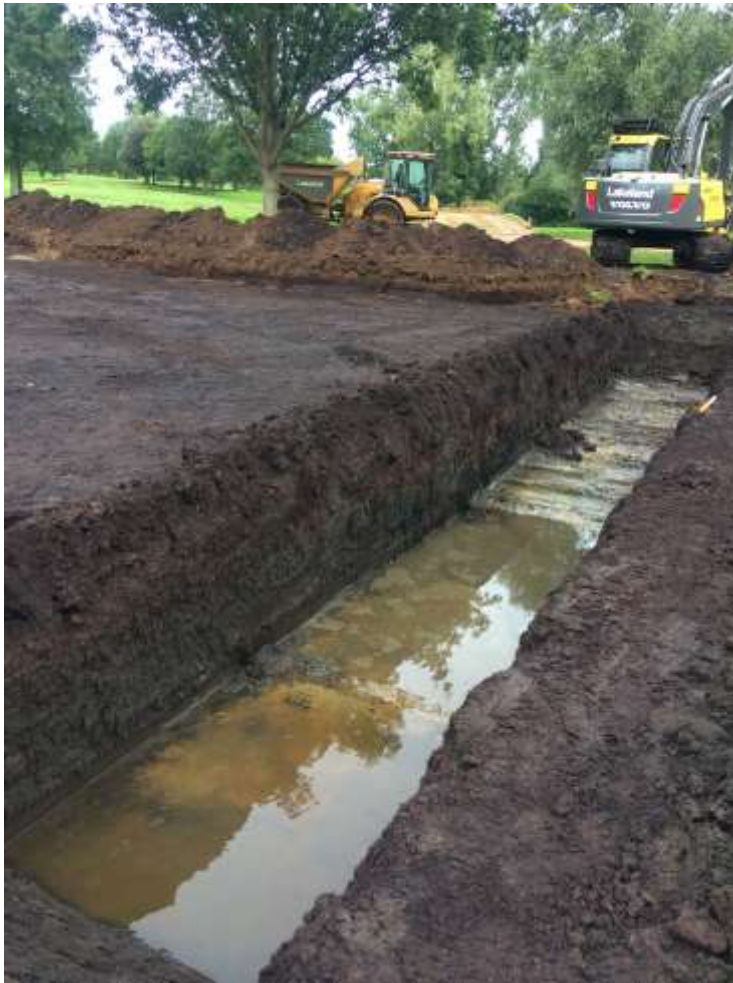
Plate 3:
Machine-dug trench through peat
(3, 4, 9 and 10) in Area B,
looking west

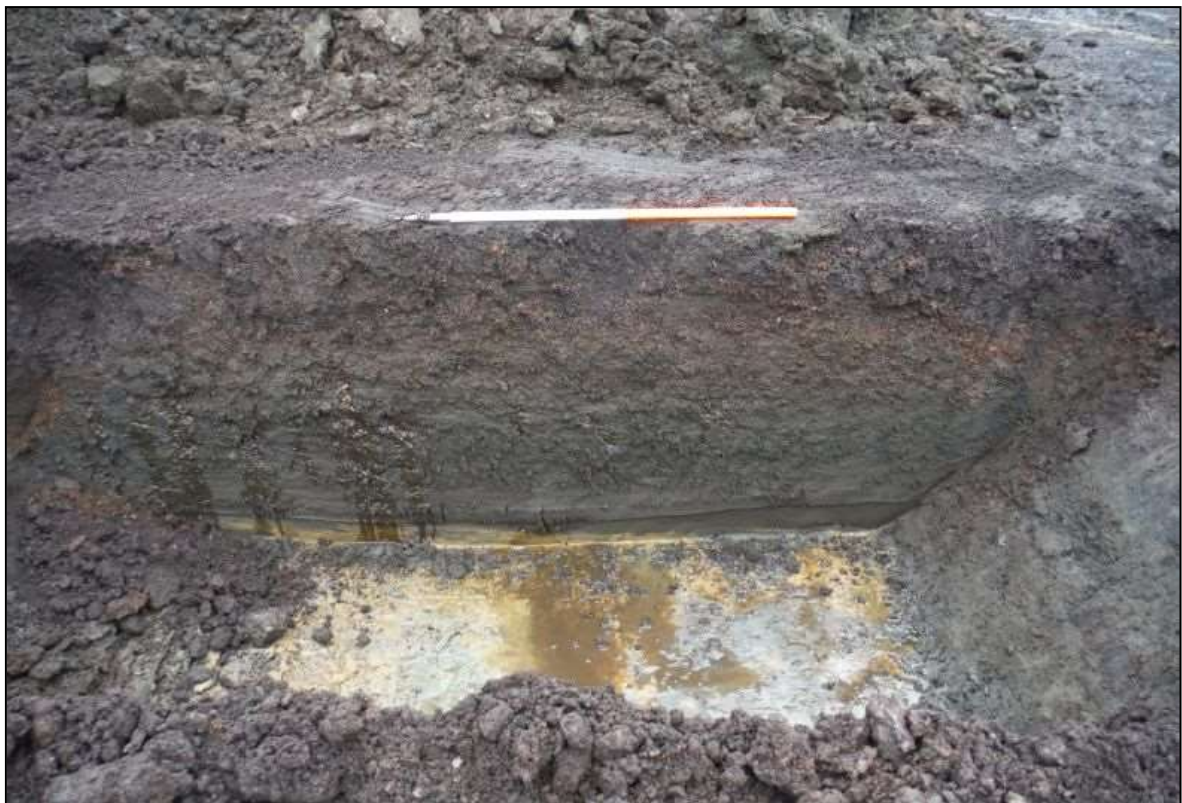
Plate 4: Representative section of machine-dug trench in Area B,
showing peat layers within the new pond footprint

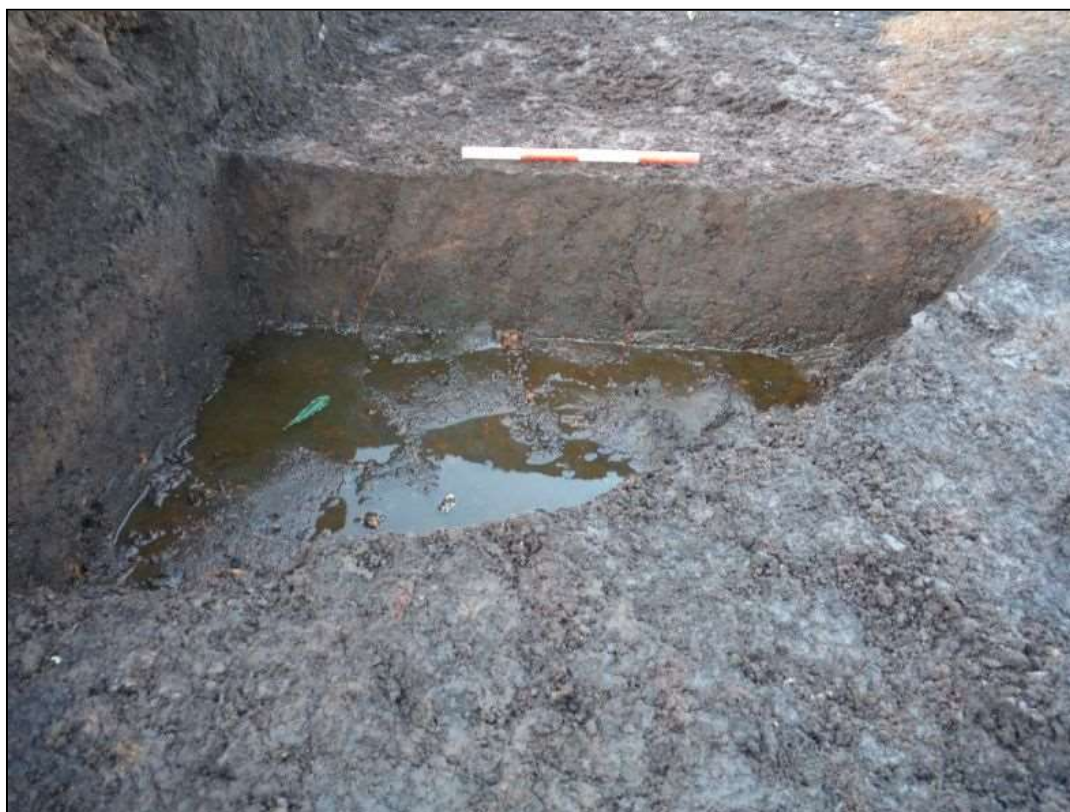
Plate 5: Hand-dug segment of tree-throw [5],
looking south-west

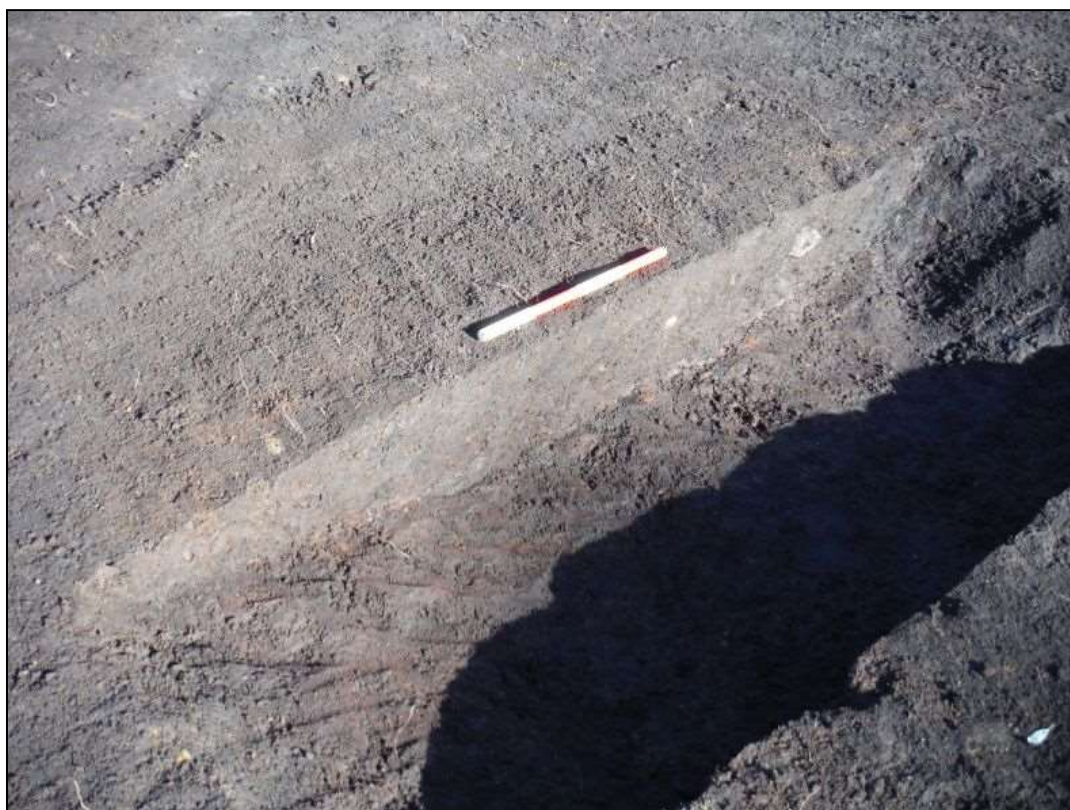
Plate 6: Hand-dug segment of ditch [7],
looking north-east

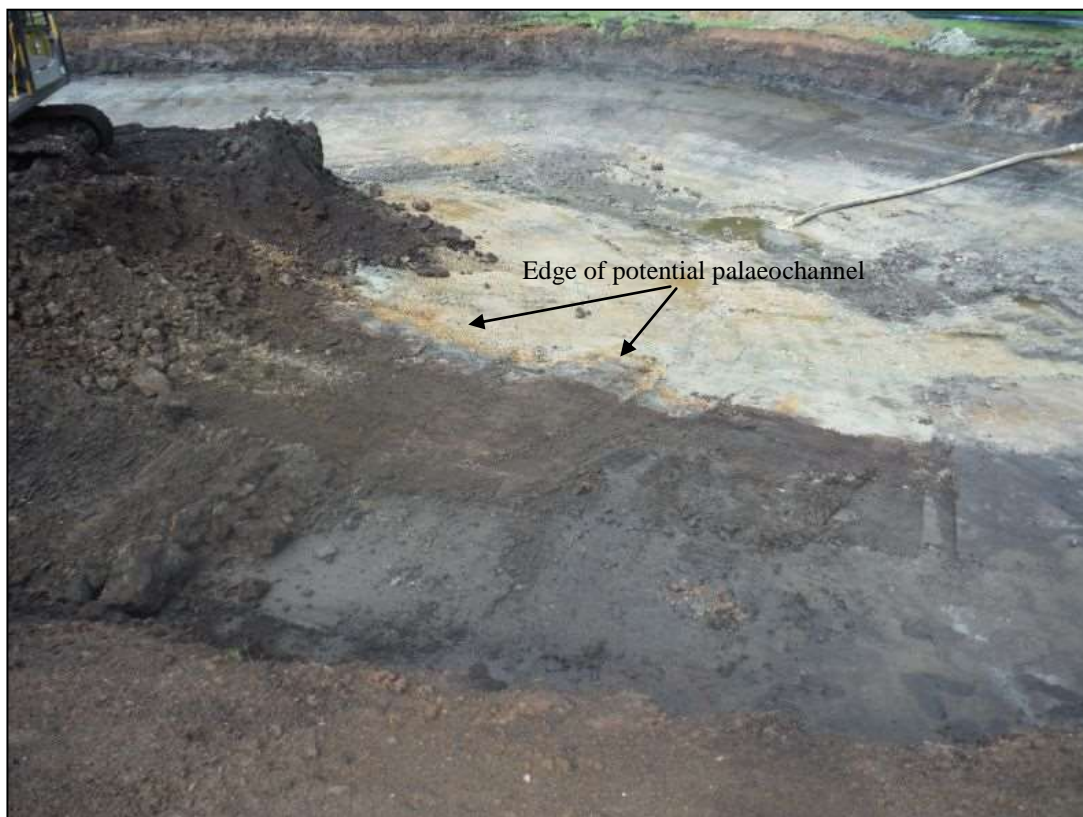
Plate 8: Edge of the potential palaeochannel, looking north

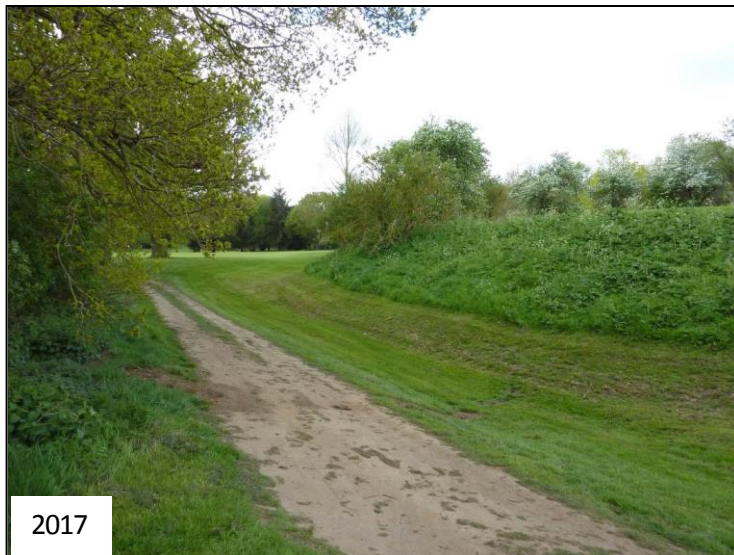
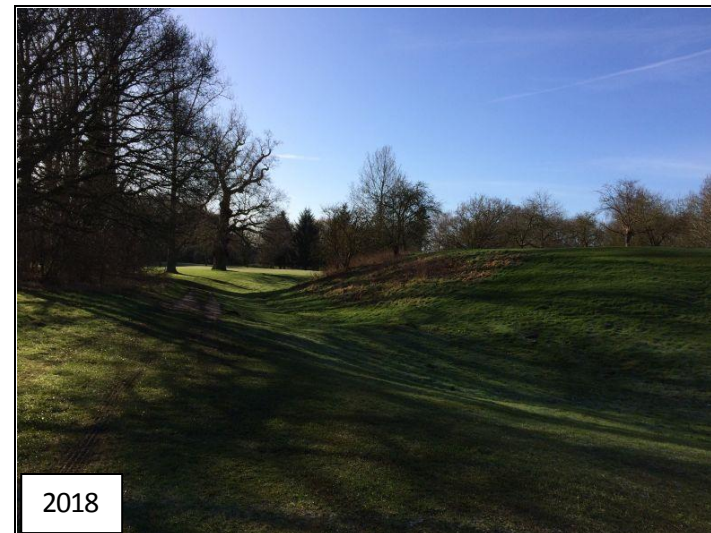
Plate 19: View of the eastern side of John O'Gaunt's Hill, from the north-west

Early indications (Plate 19) suggest that there has been a considerable improvement in the condition of the north-eastern edge of the monument. Here the development has allowed for redirection of golf course vehicles away from the outer edge of the moat, allowing turf cover to regenerate and reducing the potential for erosion of the earthwork.
