**CHURCH OF ST MARY THE VIRGIN
BOZEAT
NORTHAMPTONSHIRE
ARCHAEOLOGICAL WATCHING BRIEF**

ARCHAEOLOGICAL WATCHING BRIEF

Project: BC3131
HER event no.: ENN108812
OASIS ref.: albionar1- 292322

Document: 2017/148
Version 1.0

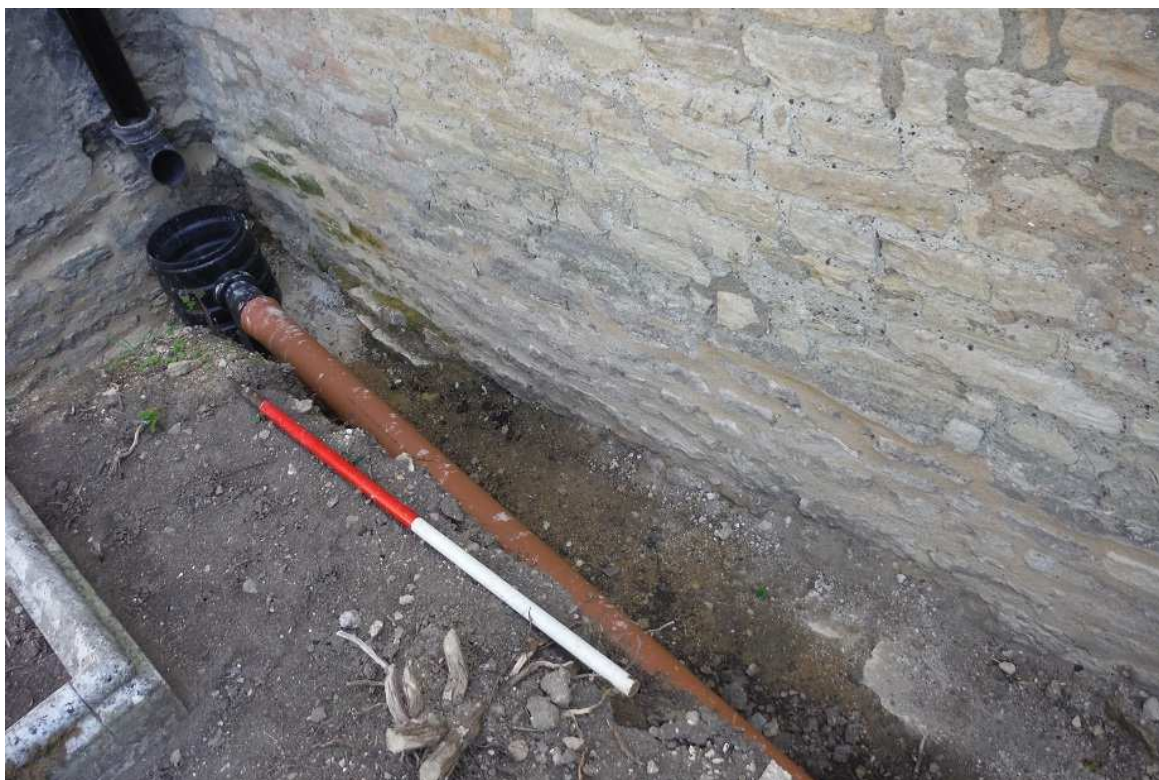
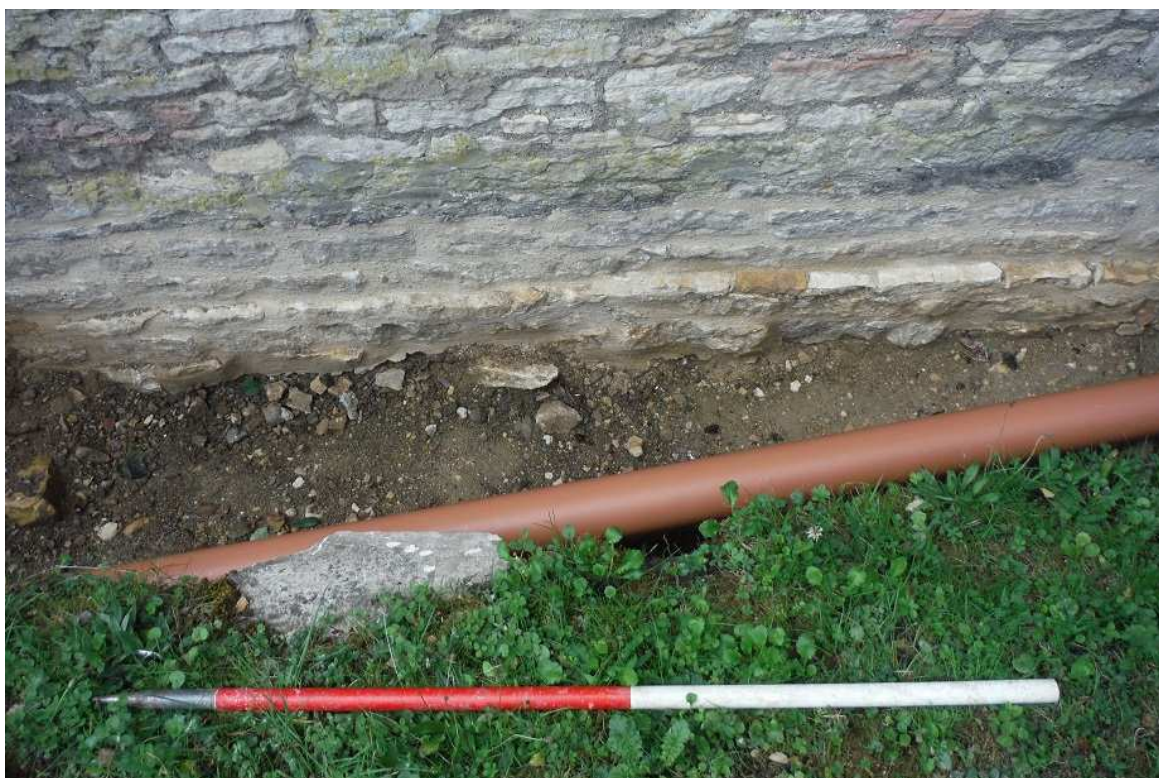
The inside vertical face of the trench exposed the top of the porch foundations, which continued below the base of the trench and were 0.05–0.18m wider than the porch wall. As with the chancel, it is assumed that the foundation was constructed within a trench (see Section 3.3.1 below).

The foundations comprised roughly hewn limestone blocks, which ranged from 100mm x 120mm to 100mm x 200mm. They were random-coursed and had recently been repointed with light yellow-grey sandy mortar (104) (Plates 1 and 2). The wall itself comprised, light white-grey, squared limestone blocks, measuring 20mm x 80mm to 110mm x 250mm. It was random-coursed with some areas uncoursed and had been repointed with light grey sandy mortar.

Plate 1: Trench 1 – south porch, west-facing foundation (104) (1m scale)

Plate 2: Trench 1 – south porch, west-facing foundation (104) (1m scale)

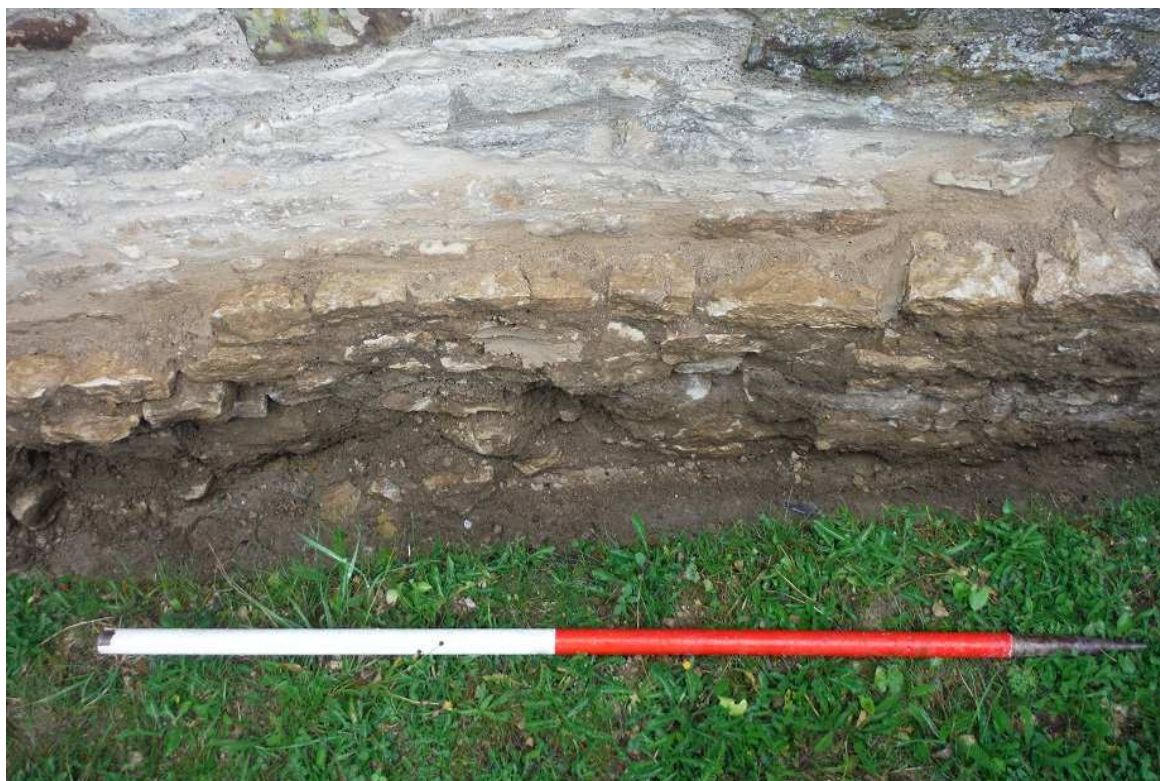
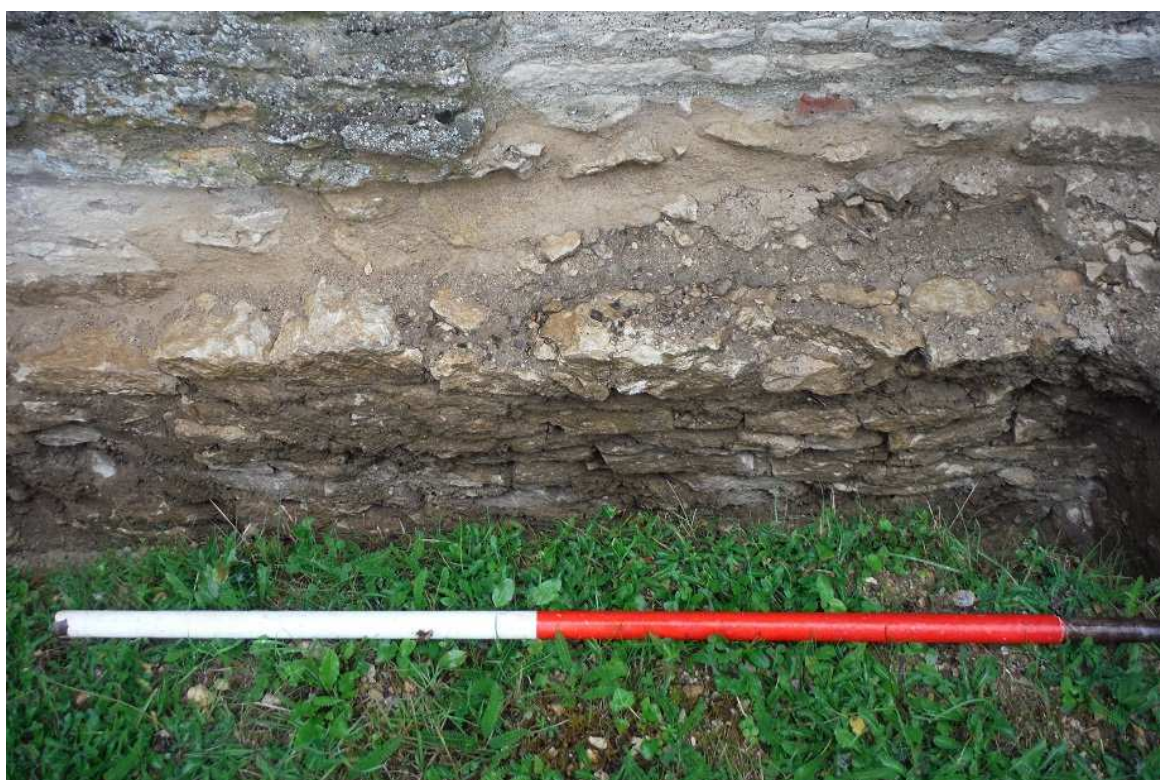
The inside vertical face of the trench exposed the south aisle foundation and buttress fabric, which continued below the bottom of the trench. The exposed stonework comprised the upper part of a foundation ‘plinth’ that was 0.05–0.20m wider than the wall. As with the chancel, it is assumed that the foundation was constructed within a trench (see Section 3.3.1 below).

The foundation was constructed of roughly hewn limestone blocks, which ranged from 50mm x 130mm to 100mm x 190mm. It was built to courses and infilled with light grey orange silt (204) (Plates 3 and 4). The top of the foundation was capped with one or two courses of slightly larger squared limestone blocks (205), measuring *c.* 100mm x 210mm, which formed a level surface for the wall construction.

Plate 3: Trench 2 – south aisle, south-facing foundation (204) (1m scale)

Plate 4: Trench 2 – south aisle, south-facing foundation (204), further to the east (1m scale)

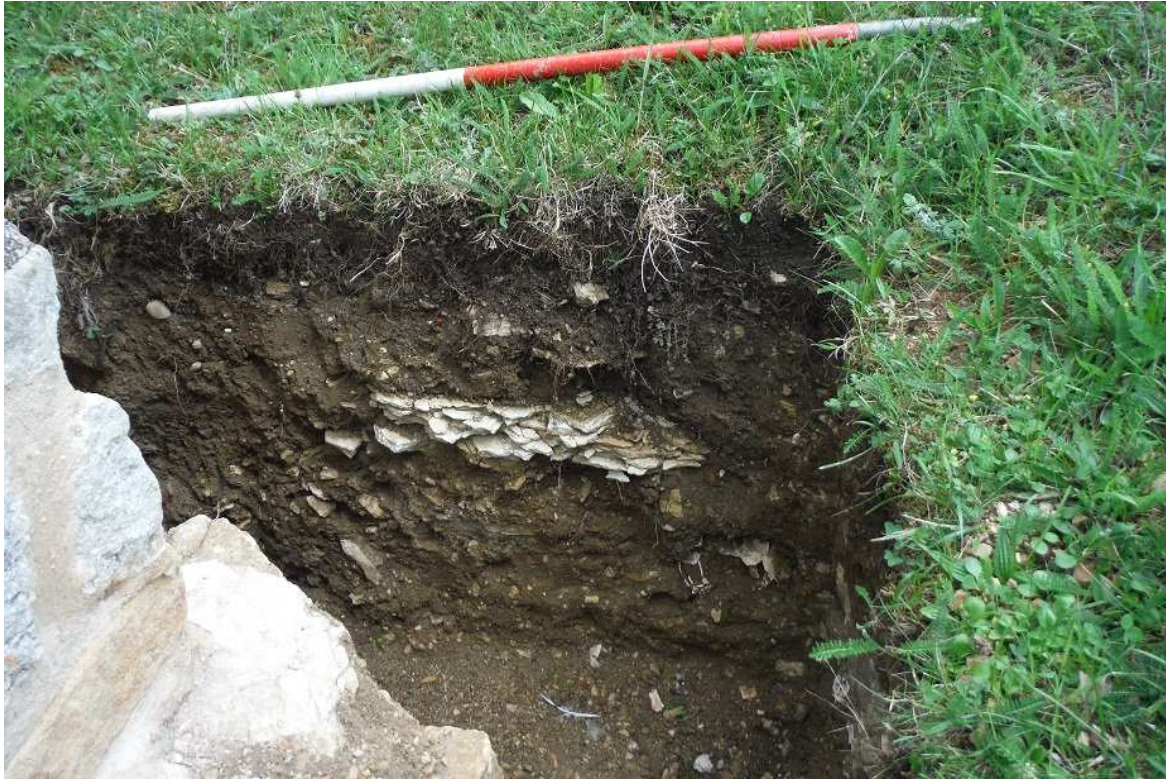
The outside vertical face of the trench (Plate 5) revealed similar layers to those recorded around the chancel (see Trench 3 below): topsoil (200) (as (300)), upper cemetery soil (201) (as (301)), second cemetery soil (202) (as (302)), lowest cemetery soil (203) (as (303)).

Plate 5: Trench 2 – south aisle layers (200), (201), (202), (203) (1m scale)

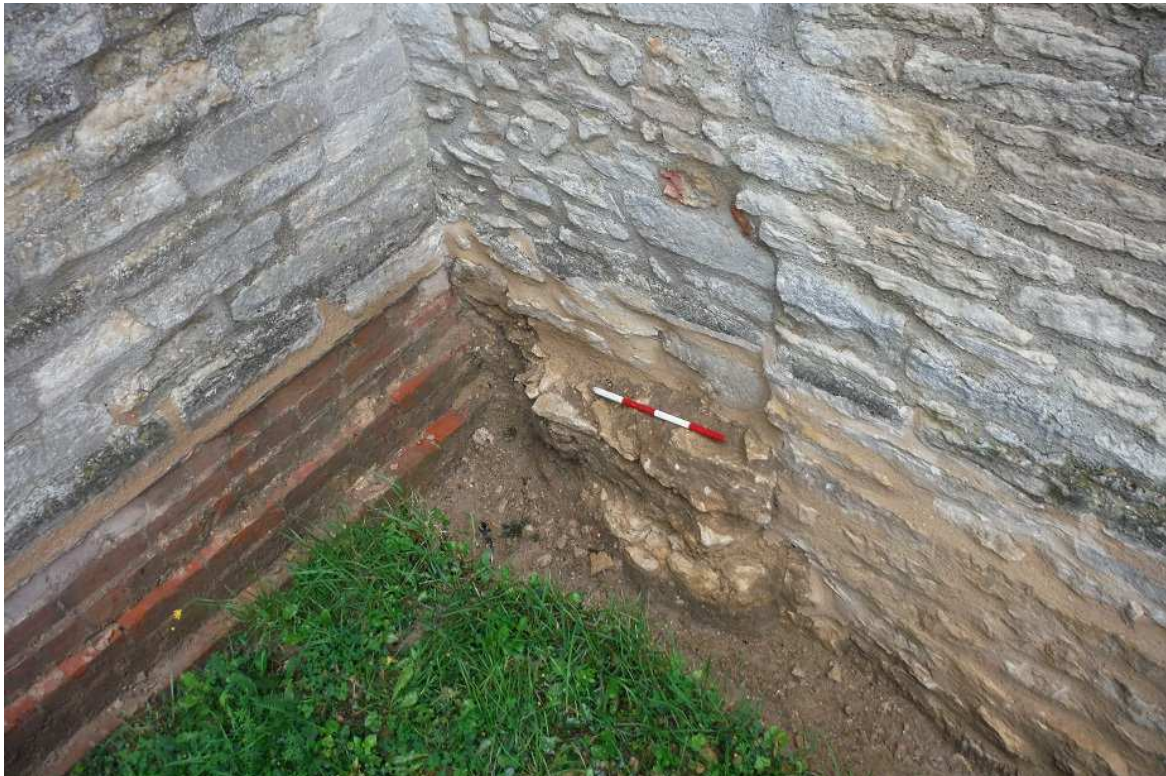
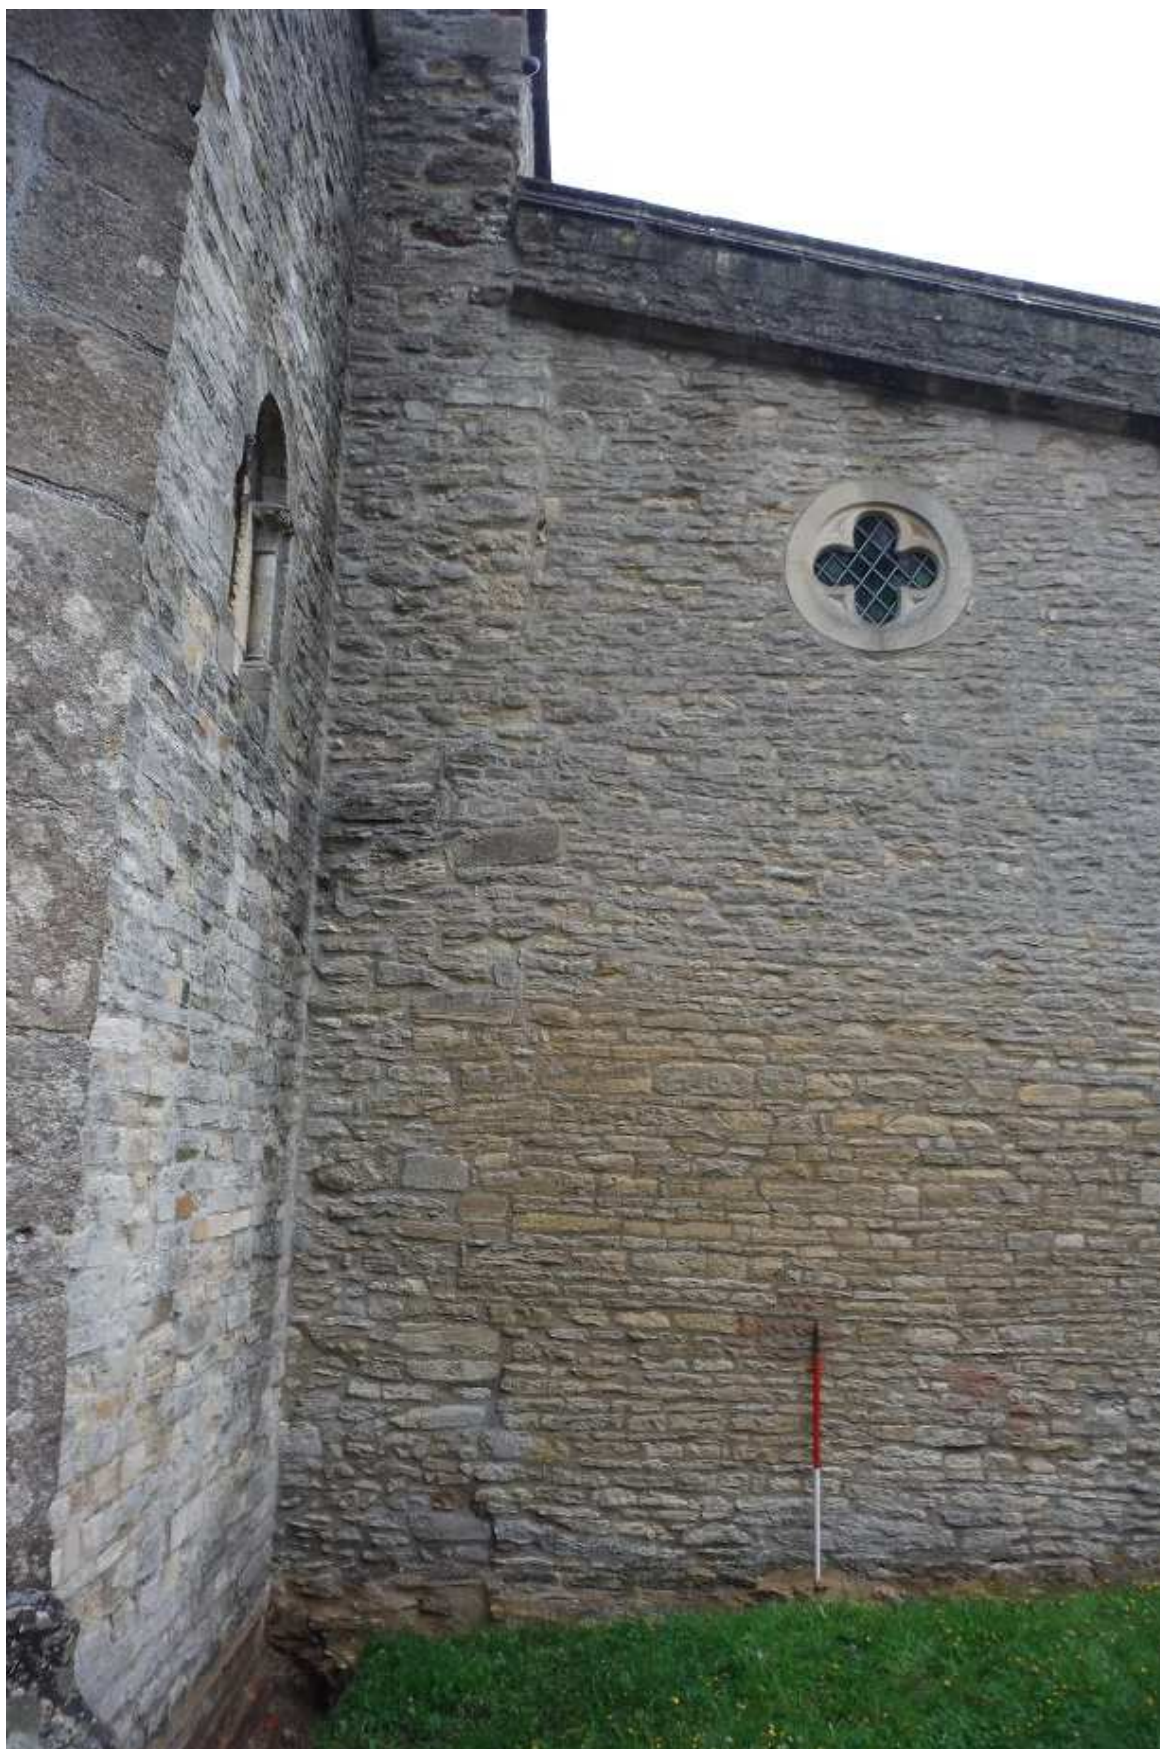
At the junction of the south aisle and the tower, a surviving remnant of the original nave wall was visible both as an area of jutting foundation and as a vertical variation in the outer skin of the building's stonework (Plates 6 and 7). As with the chancel, it is assumed that the foundation was constructed within a trench.

The exposed foundation was 0.15m wider than the wall. It was constructed of roughly hewn limestone blocks, which ranged from 30mm x 200mm to 120mm x 380mm; they were tightly packed, random uncoursed and infilled with light grey orange silt (207). Above this the surviving wall segment comprised, light white-grey, limestone fragments or squared blocks, which varied widely from 15mm x 70mm to 100mm to 480mm. The blocks were random-coursed and bonded with hard mid-grey sandy mortar that is probably repointing of 20th-century date.

Plate 6: Trench 2 – south aisle, nave foundation remnant (207) (40cm scale)

Plate 7: Trench 2 – south aisle with surviving nave wall segment (scale 1m)

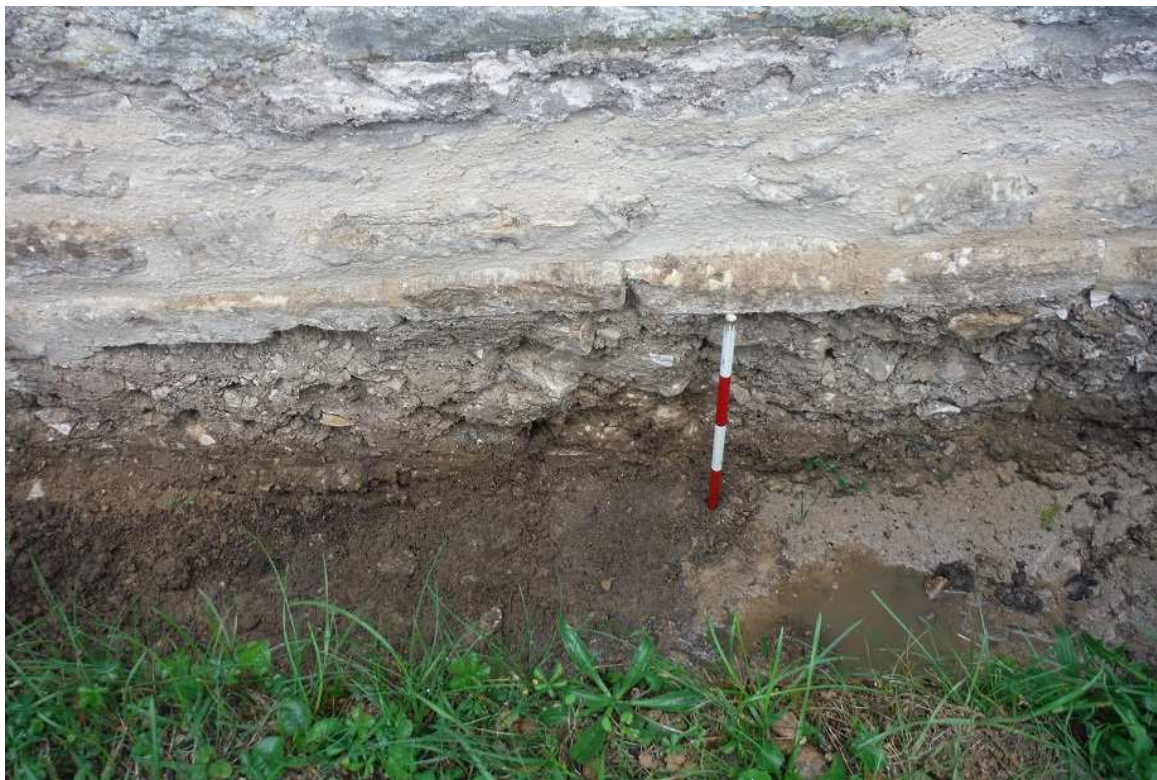
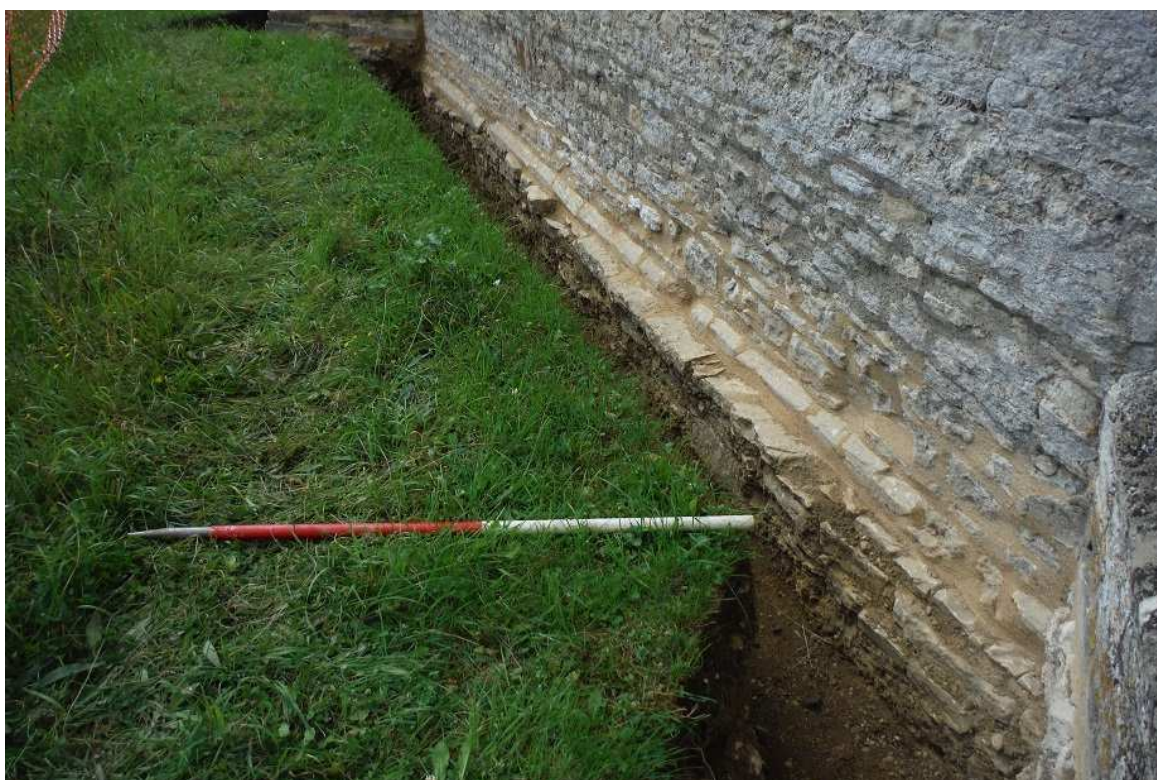
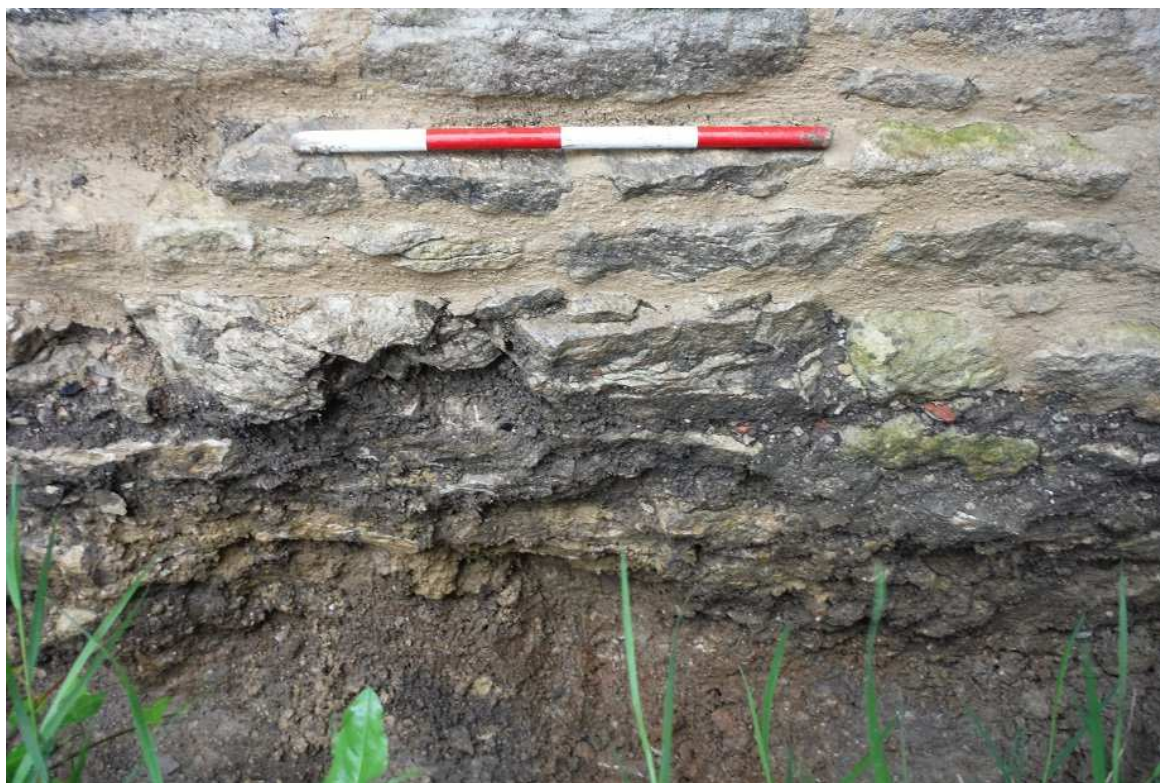
The inside vertical face of the trench exposed the chancel foundation and buttress fabric, which continued below the bottom of the trench. The exposed stonework comprised the upper part of a foundation 'plinth' that was 0.04–0.20m wider than the wall. The foundation appeared to be constructed within a continuous trench of unknown depth with the limestone blocks being arranged in a fitted, drystone-wall fashion with gaps infilled with silt as construction progressed.

The foundation comprised roughly hewn limestone blocks, which ranged from 50mm x 100mm to 80mm x 340mm. They were tightly packed, uncoursed and infilled with light grey-orange silt (304). The top of the foundation was capped with one or two courses of larger, squared, limestone blocks (305), measuring 50mm x 130mm to 100mm x 190mm, which formed a level surface for the wall

construction (Plates 8–10). This arrangement was best exemplified in the east-facing wall (Plate 9).

Plate 8: Trench 3 – south-facing chancel foundation (304) (40cm scale)

Plate 9: Trench 3 – east-facing chancel foundation (304) (1m scale)

Plate 10: Trench 3 – north-facing chancel foundation (304) (40cm scale)

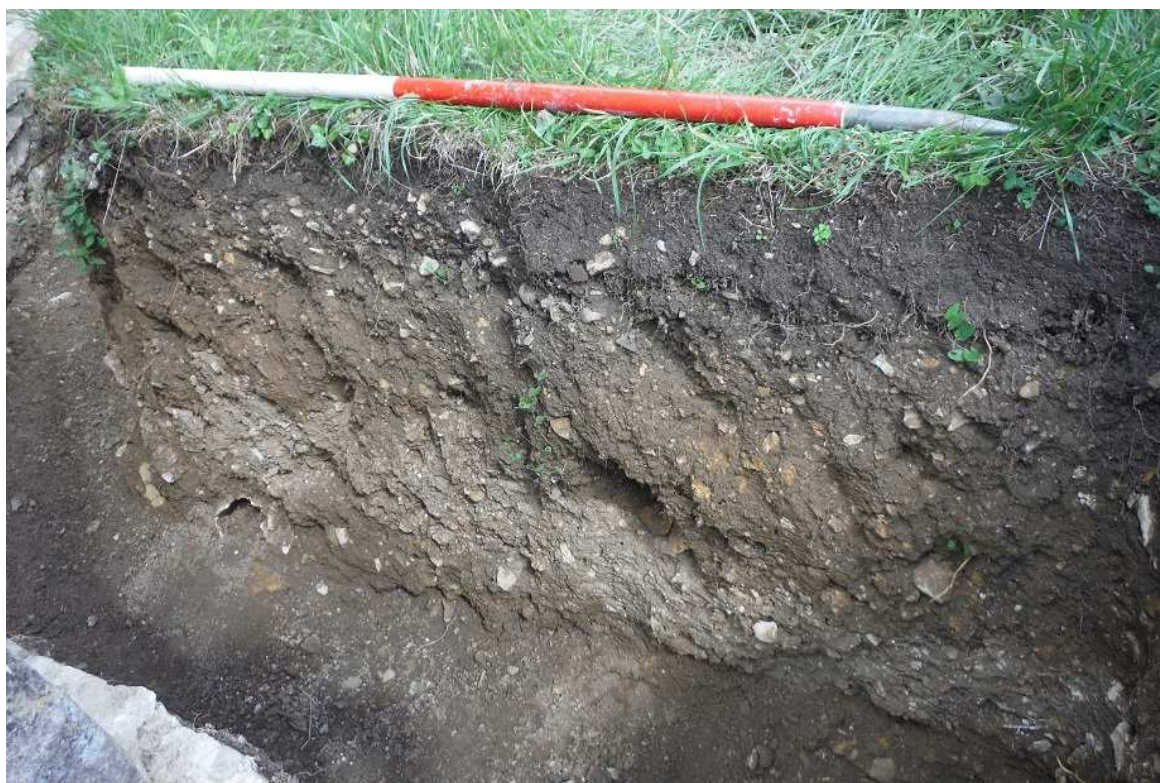
The outside vertical face of the trench (Plate 11) revealed layers that comprised, from top to bottom: 0.15m of dark grey-brown clay silt with moderate small limestone fragments, the modern ‘turf’ surface (300); a 0.20m-thick layer of mid-grey-brown clay silt with frequent small limestone fragments, an upper graveyard soil (301); a 0.22m-thick layer of light brown-grey sandy silt with moderate small and occasional large limestone fragments, patches of mortar and occasional fragments of human bone, a cemetery soil with debris from maintenance of the church (302); a 0.2m+ thick layer of mid-orange-brown clay silt with occasional small limestone fragments and occasional fragments of human bone, a lower cemetery soil (303).

Plate 11: Trench 3 – chancel layers (300), (301), (302), (303) (1m scale)

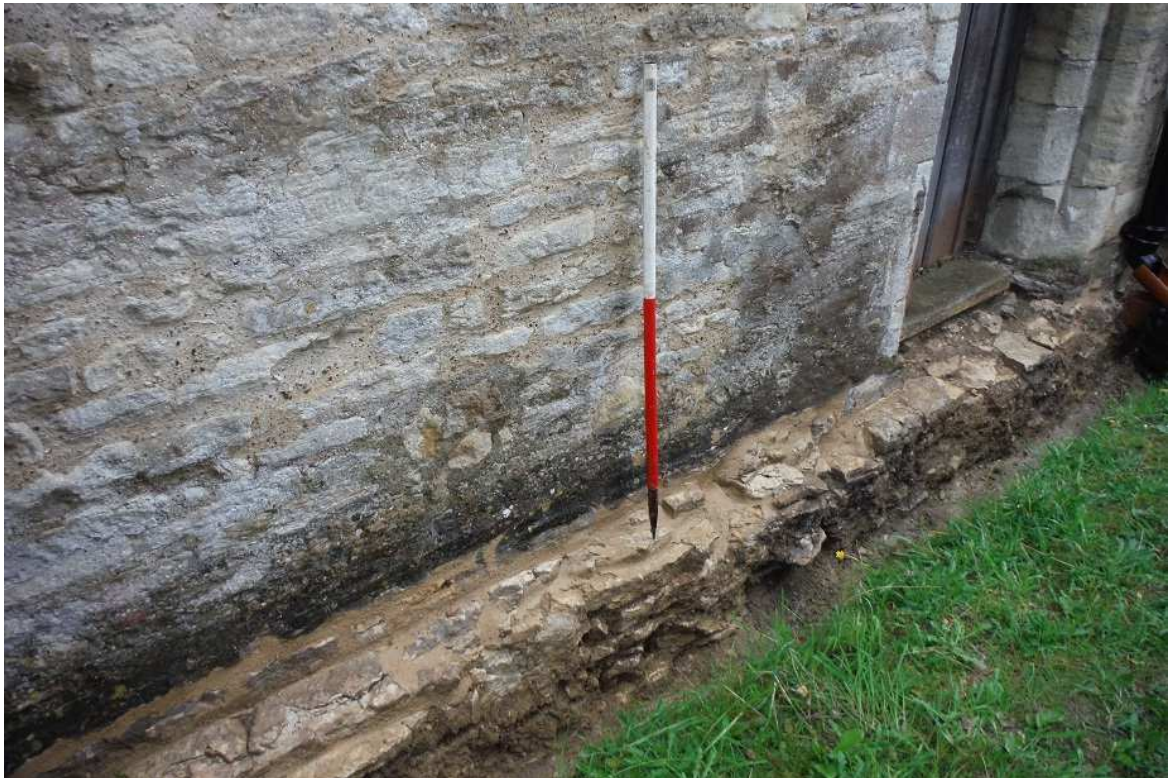
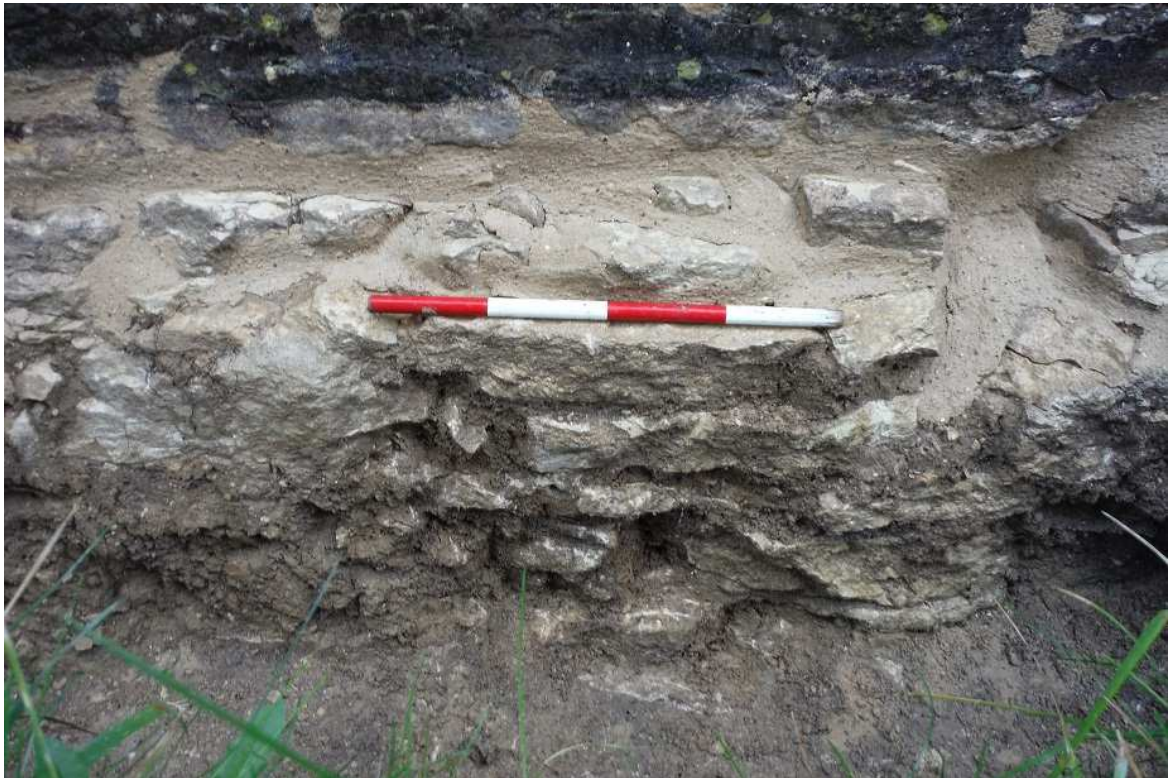
The inside vertical face of the trench exposed the north aisle foundation fabric, which continued below the base of the trench and were 0.12m to 0.2m wider than the north aisle wall. It is assumed that the foundation was constructed within a trench.

The foundation comprised roughly hewn limestone blocks, which ranged from 60mm x 80mm to 100mm x 280mm. They were random-coursed and infilled with light grey-brown sandy silt (405) (Plates 12 and 13). The top of the foundation was capped with two courses of larger, squared, limestone blocks (305), measuring 50mm x 200mm to 140mm x 340mm, which formed a level surface for the wall construction.

Plate 12: Trench 4 – north-facing north aisle foundation (405) (1m scale)

Plate 13: Trench 4 – close-up of north-facing north aisle foundation (405) (40cm scale)

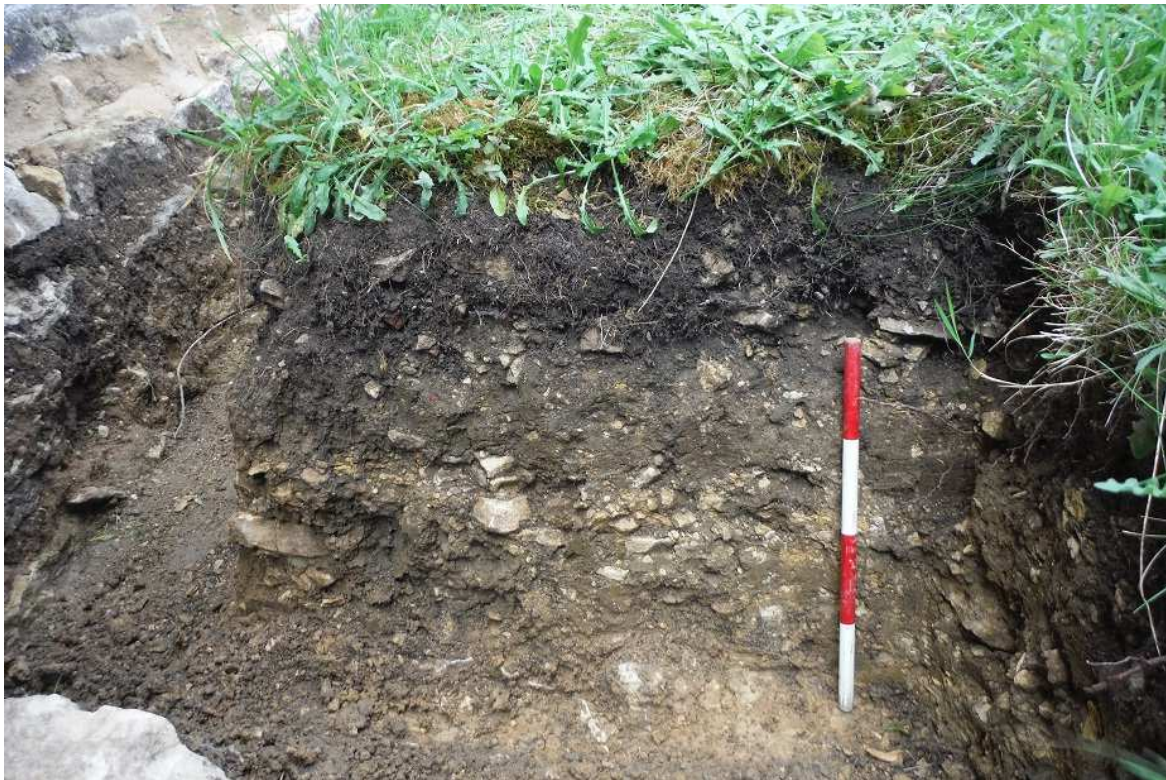
The outside vertical face of the trench (Plate 14) exposed: a 0.25m-thick dark grey-brown clay silt, the modern turfed surface (400); a *c.* 0.1m-thick mid-grey-brown clay silt with moderate limestone fragments, an upper graveyard soil (401); a 0.1m-thick layer of frequent medium limestone fragments infilled with mid-grey-

brown clay silt, a disturbed lower cemetery layer (402); a 0.10m+ thick mid-orange-brown clay silt with moderate small limestone fragments, a probable subsoil remnant (403); and a 0.02m+ thick layer of light grey-orange clay with moderate limestone fragments, the undisturbed geological deposit (only exposed in two small areas) (404).

Plate 14: Trench 4 – layers (400), (401), (402), (403), (404) (40cm scale)

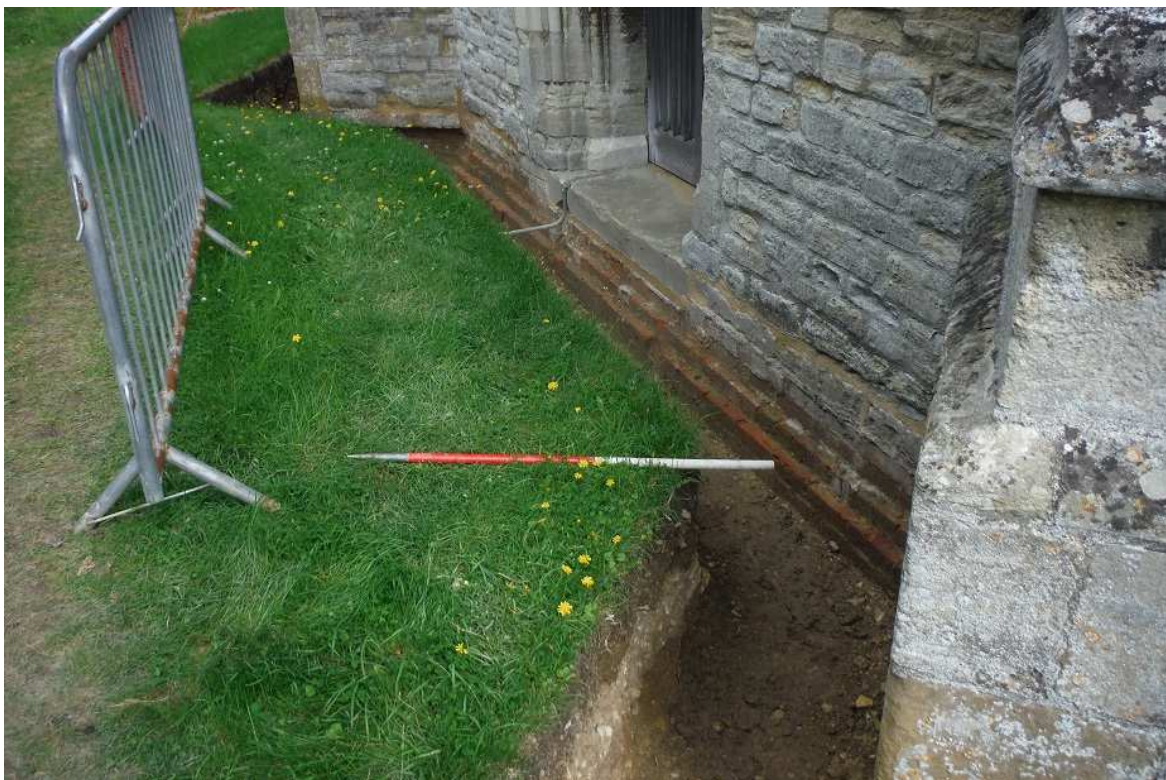
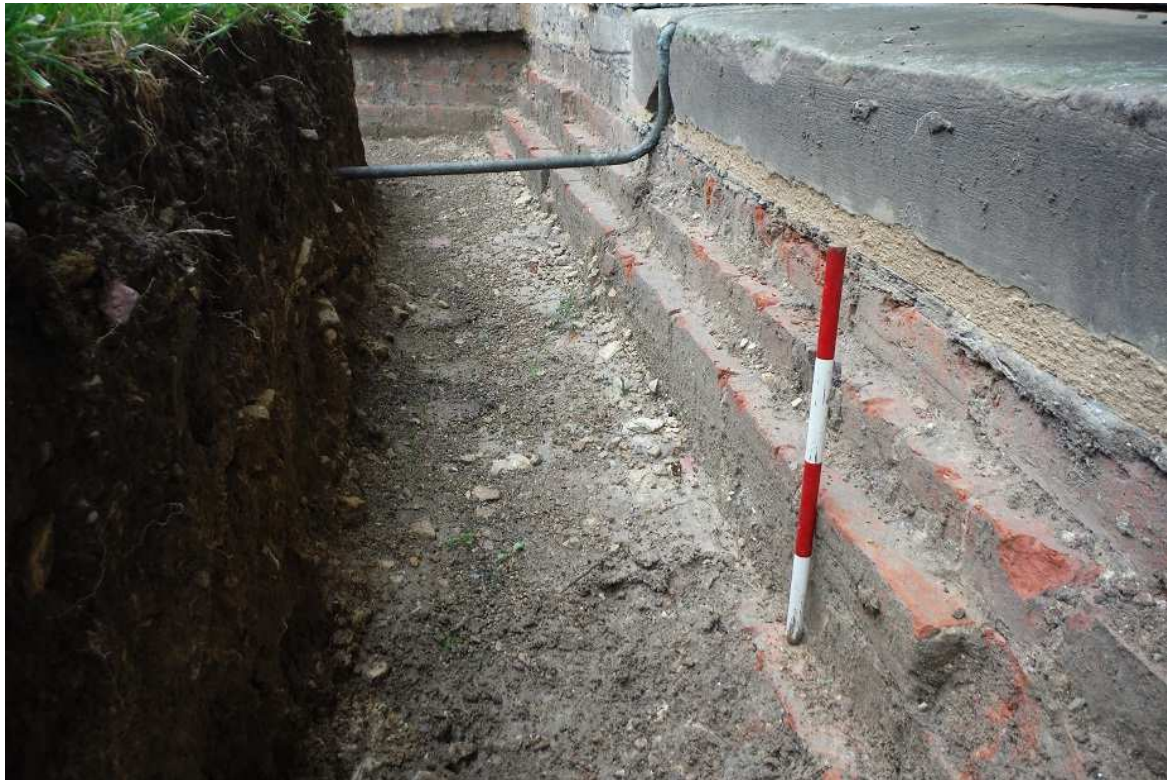
The inside vertical face of the western trench exposed the tower foundation fabric, which continued below the trench. It comprised dark red, unfrogged bricks (Plates 15 and 16), which were stepped out wider than the tower wall by 0.2m. The bricks were *c.* 234mm long x 67mm high, bonded with mid-grey-yellow sandy mortar in good condition (504). The bricks are judged to be an outer lining, covering more substantial stone foundations beneath the tower. This interpretation is supported by the presence of a thin layer of slate and mortar (505) between the brick and the stone blocks of the tower walls — a typical method of space filling at the (never exact) join where a brick construction is butted up to an existing structure.

Plate 15: Trench 5 – west-facing tower foundation (504) (1m scale)

Plate 16: Trench 5 – close-up of west-facing tower foundation (504) (40cm scale)

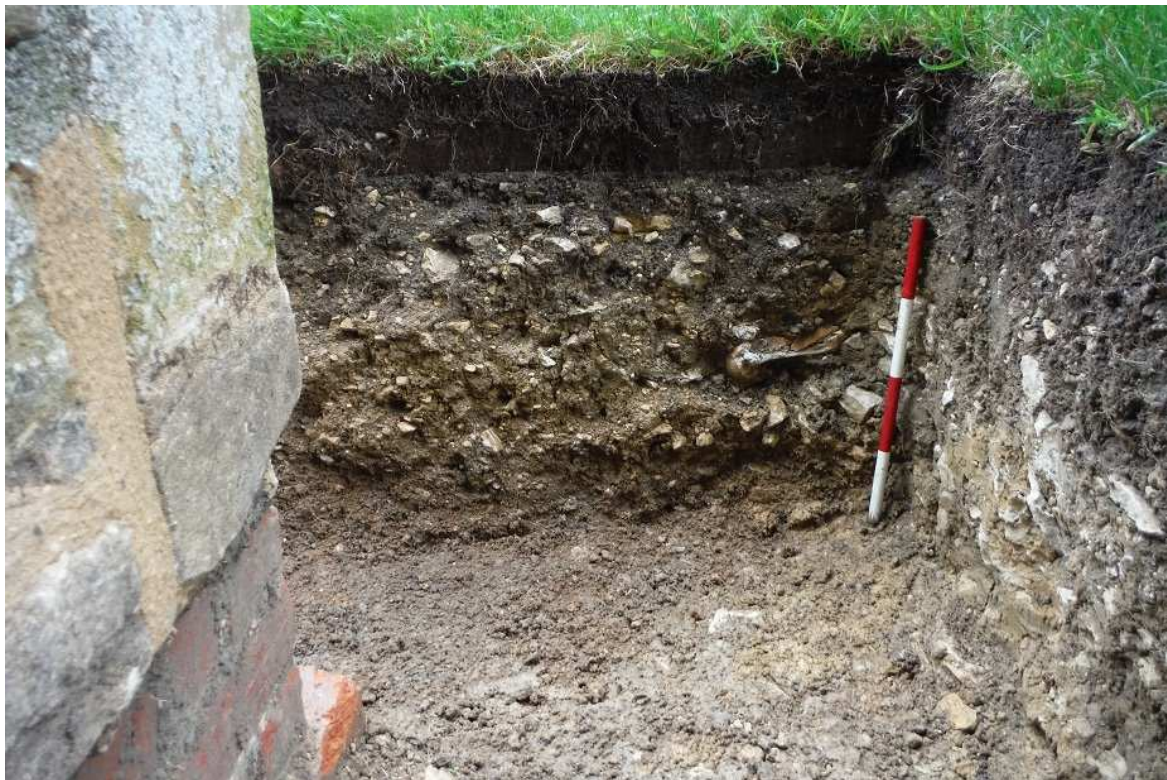
The outside vertical face of the trench (Plate 17) exposed: a 0.15m-thick layer of topsoil (500) (as (300)), a 0.2–0.3m-thick mid-grey-brown clay silt with moderate limestone fragments (a cemetery soil (501)), a 0.08–0.2m-thick layer of light orange-brown clay silt with frequent small and moderate medium limestone fragments (502), a 0.1m+ thick layer of light grey-brown clay with frequent small and medium limestone fragments (undisturbed geology (503)).

Plate 17: Trench 5 – layers (500), (501), (502), (503) (40cm scale)

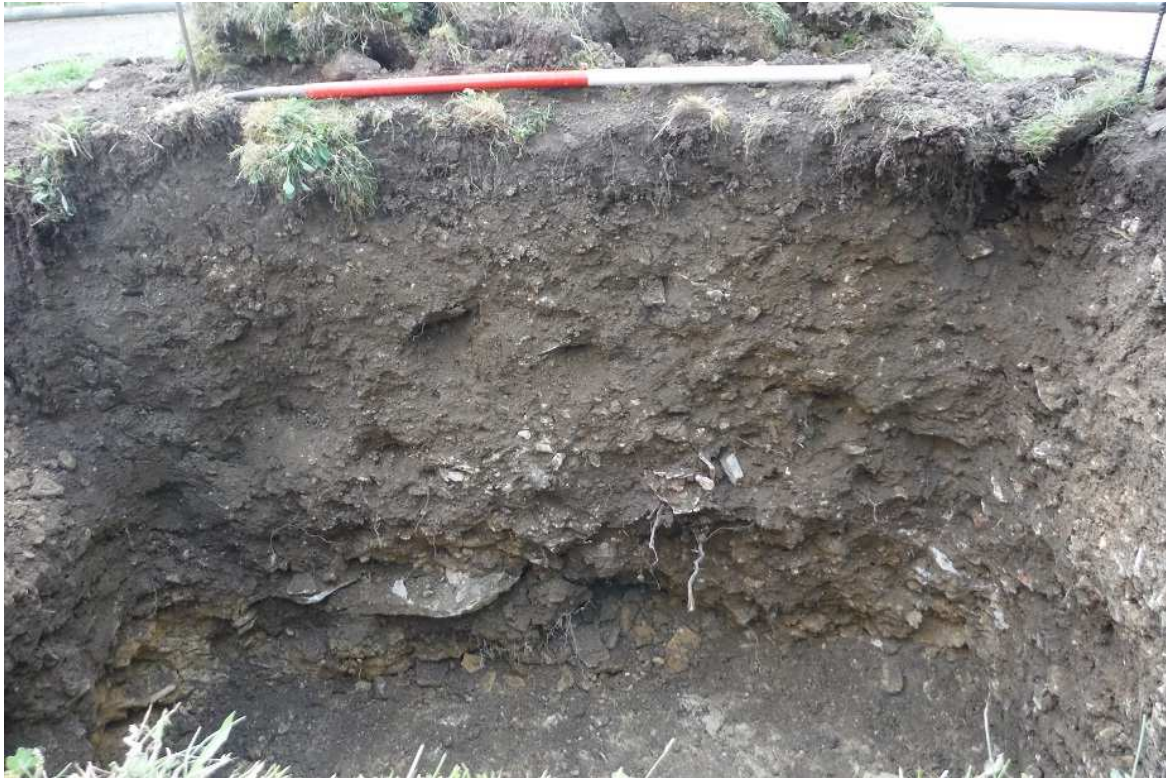
The vertical faces of the trench exposed differing deposits with steep-edged, flat-based profiles that defined at least ten separate grave cuts: [603], [605], [607], [609], [611], [613], [615], [617], [619] and [621] (Figure 3; Plates 18–20). The lowest, earliest grave cuts reached the base of the trench at a depth of *c.* 1.5m below the current cemetery ground level; the later burials were sequentially cut to lower depths.

Plate 18: Trench 6 – north-facing soakaway pit section with grave cuts [605], [609], [619]
(1m scale)

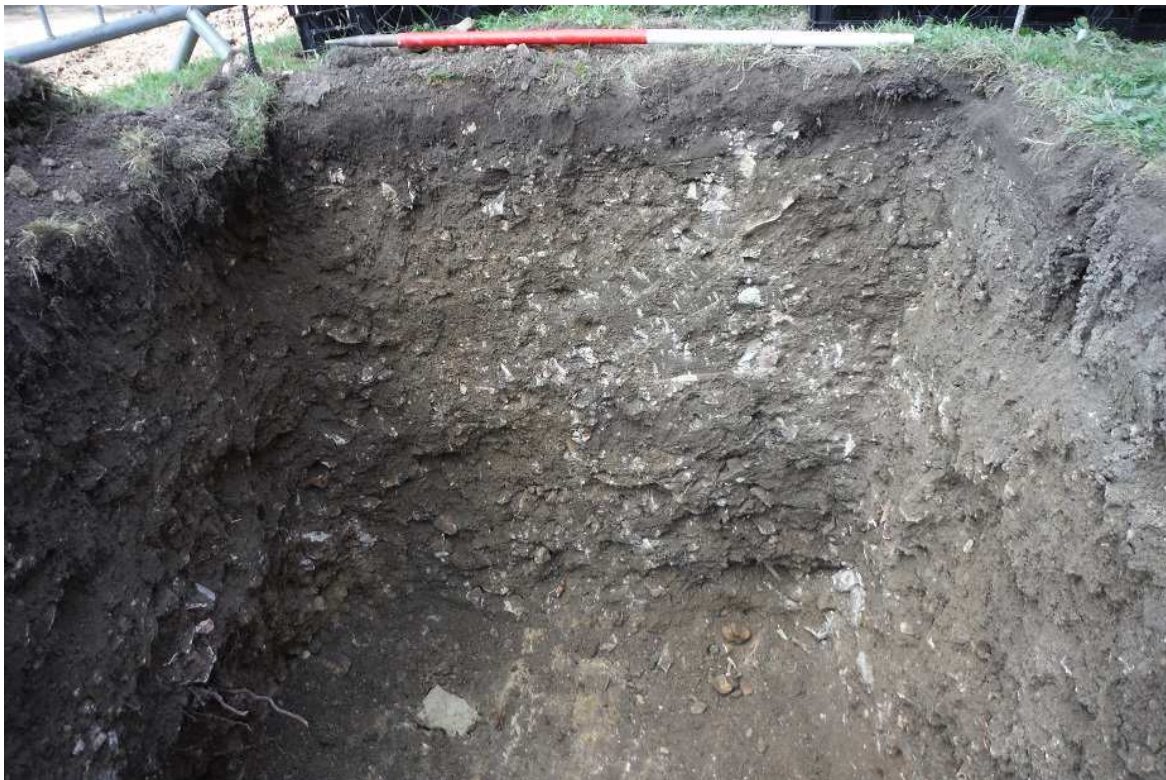
Plate 19: Trench 6 – east-facing soakaway pit section with grave cuts [603], [609], [613] [617], [619]
(1m scale)

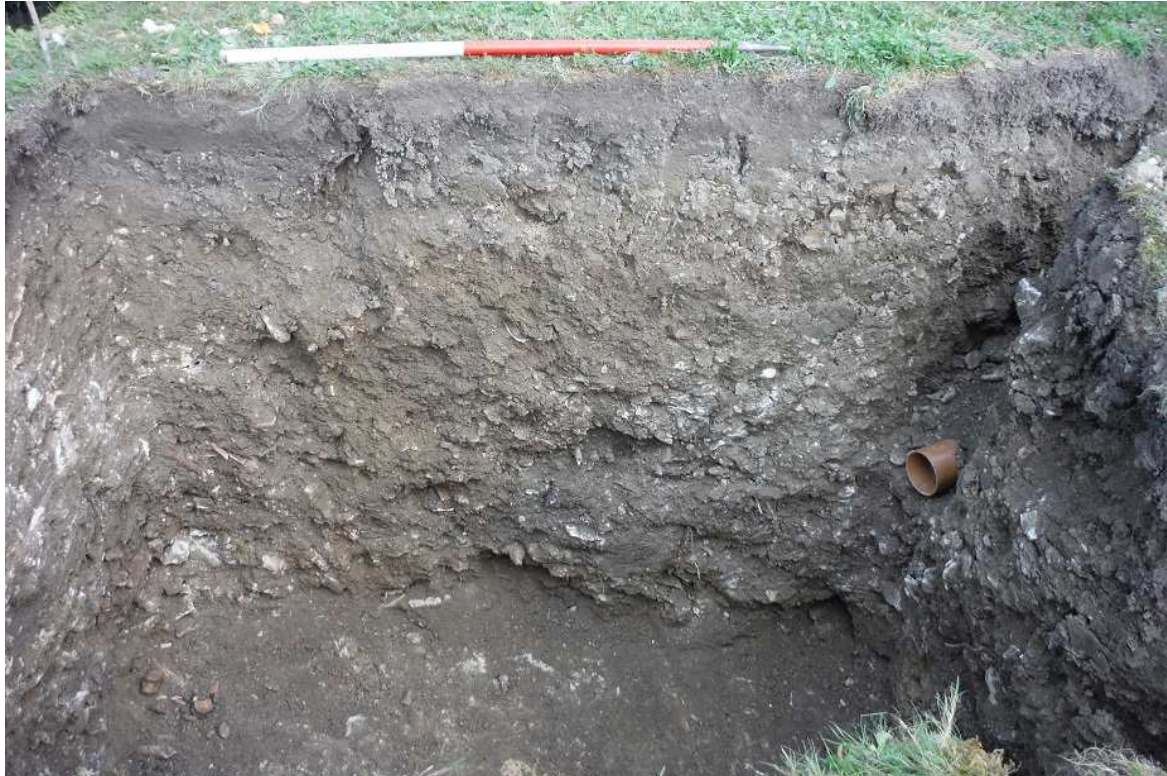
Plate 20: Trench 6 – south-facing soakaway pit section with grave cuts [603], [607], [611] [613], [615], [617], [621] (1m scale)
