**LAND AT 1 DOVE LANE
HARROLD
BEDFORDSHIRE**

ARCHAEOLOGICAL FIELD EVALUATION

Project: DL1270

Document: 2007/65
Version 1.0

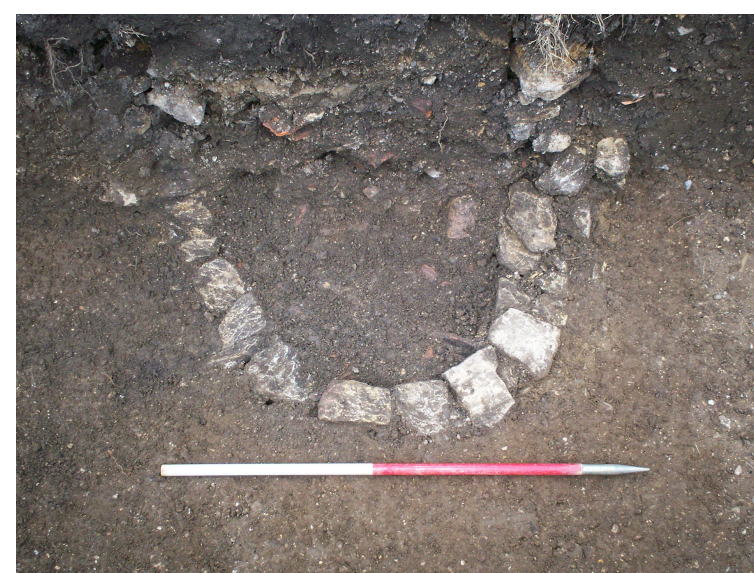
Well [112], looking east, scale 1m

Within Trench 1 the well cut measured 1.52m diameter, with a central stone structure, of single coursed stones, 1.25m diameter and a shaft recess of 0.8m. The structure was packed into the well cut using dark brown/black clay silt (113). The well contained post-medieval and modern pottery amongst other debris.

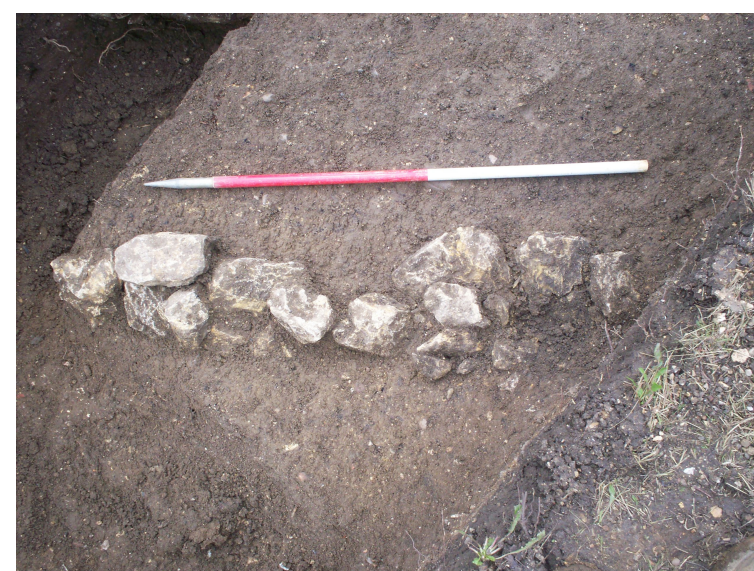
Wall [105], looking north-west, scale 1m

Running parallel to the structure at its southern edge was a drain [105]. Resembling a wall, the drain comprised roughly hewn limestone blocks laid over a recess with near vertical sides and a concave base. Dateable artefactual material was recovered from deposit (106) within the drain and comprised small quantities of post-medieval pottery (Appendix 5.1, Table 2).

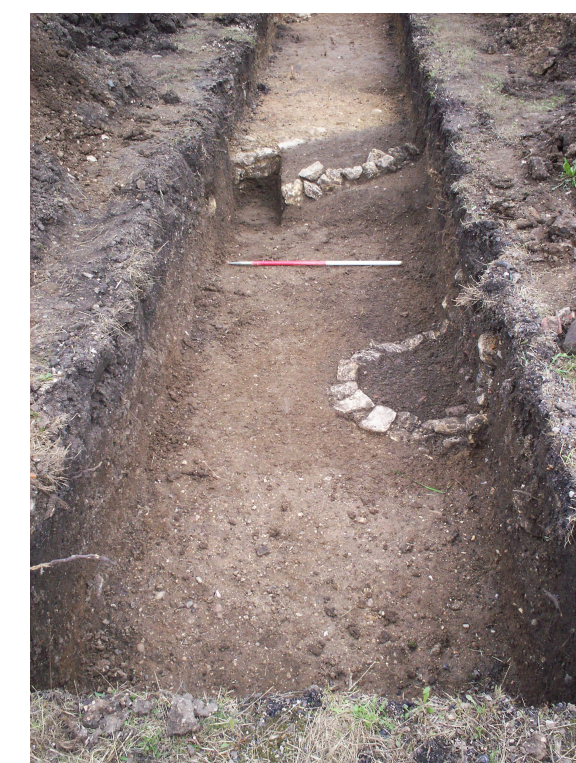
Well [112], drain [105] and wall [108], looking north, scale 1m
