**CHAWSTON CROSS ROADS
CHAWSTON
BEDFORDSHIRE**

**ARCHAEOLOGICAL OBSERVATION
INVESTIGATION, RECORDING, ANALYSIS AND
PUBLICATION**

Project: CC3091
Document: 2018/85
Version 1.0

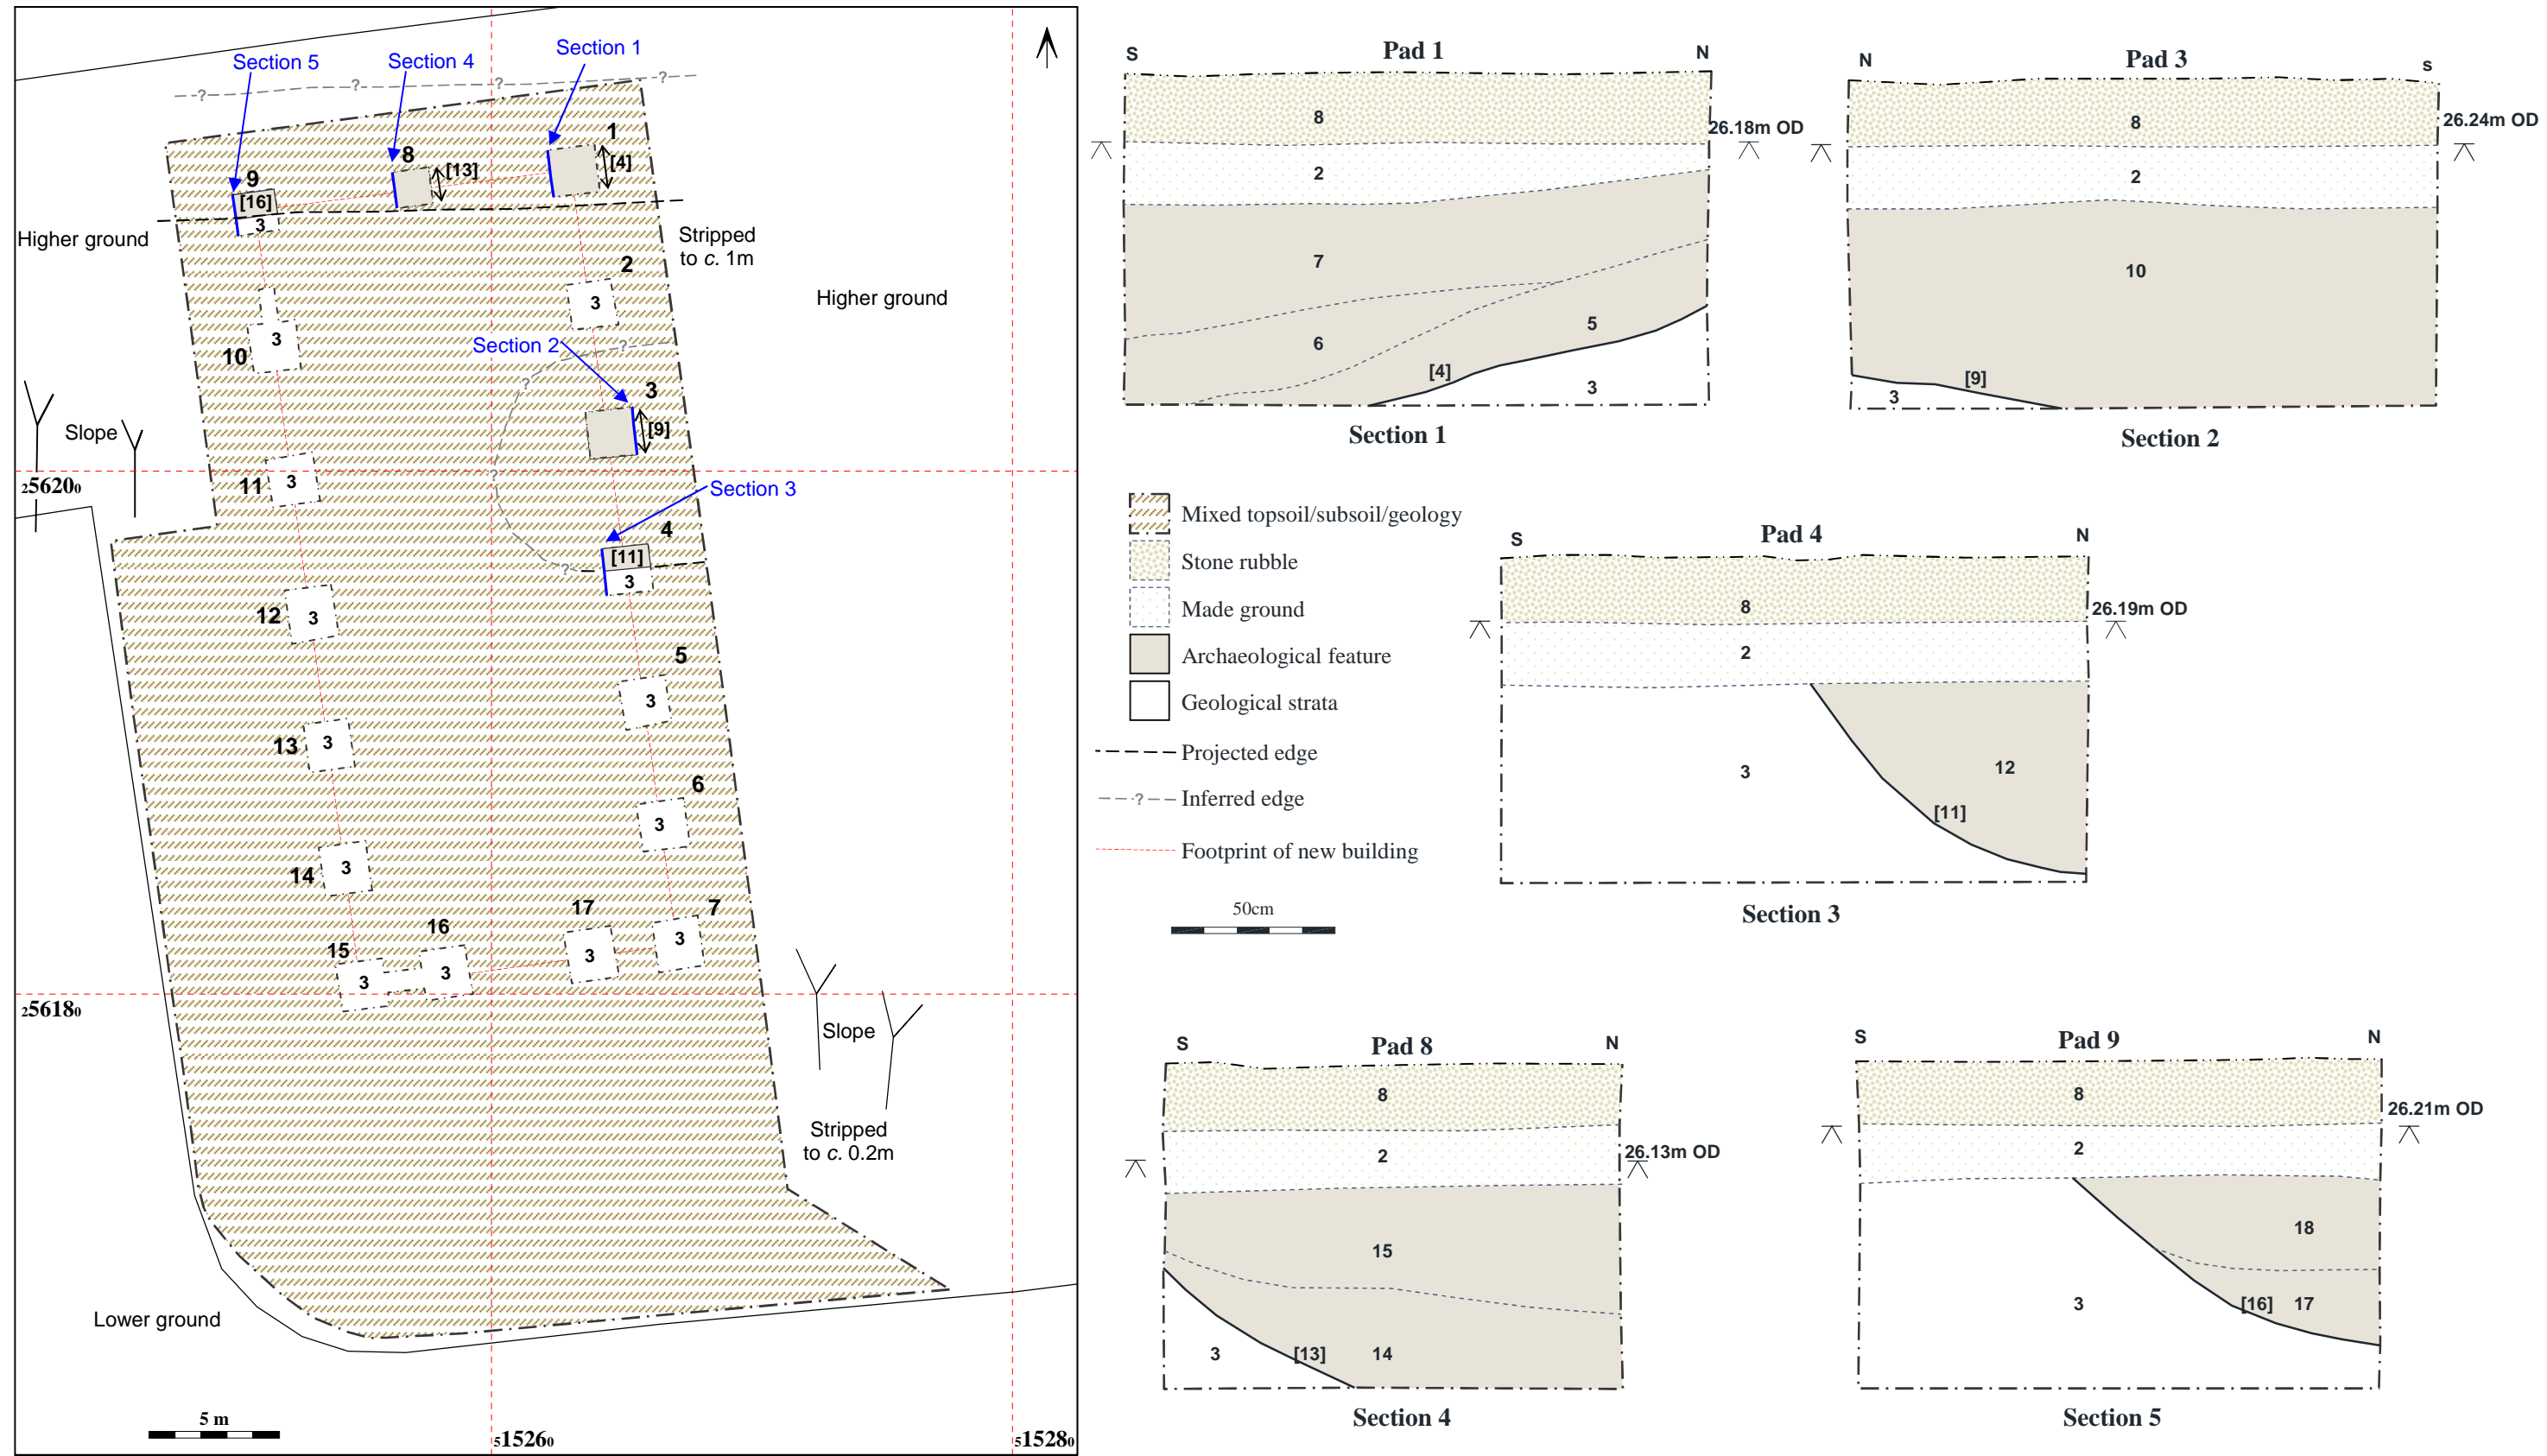
Figure 2: All-features plan and selected sections

An E-W aligned linear feature [4], [13] and [16] was revealed towards the northern extent of the PDA in Pads 1, 8 and 9 respectively (Figure 2). These probably formed parts of the same substantial ditch, which was in excess of 1.8m wide and had a gradually sloping U-shaped profile that was at least 0.6m deep (Figure 2; sections 1, 4 and 5; Figure 5: images 5 and 6). Initial fill (5) comprised a mid-grey silty clay deposit, whereas the intermediate deposit (6/14/17) comprised mid grey-blue clay with small amount of stone inclusions. The upper fill (7/15/18) comprised dark brown-grey silty clay — peat-like material that yielded an abraded Gault clay stock moulded brick fragment (64g) of post-medieval date (not retained). All the deposits infilling the ditch seem to have formed in wet conditions, suggesting poorly drained land.

Archaeological deposits [9] and [11] were revealed in Pads 3 and 4 respectively; they are thought to have possibly formed parts of the same substantial feature. The feature was 1.8m+ wide with a length greater than 6m; its gradual concave profile measured in excess of 0.6m in depth (Figure 2: sections 2 and 3; Figure 6: image 8). Its sole fill (10/12) comprised mid brown-grey silty clay that produced

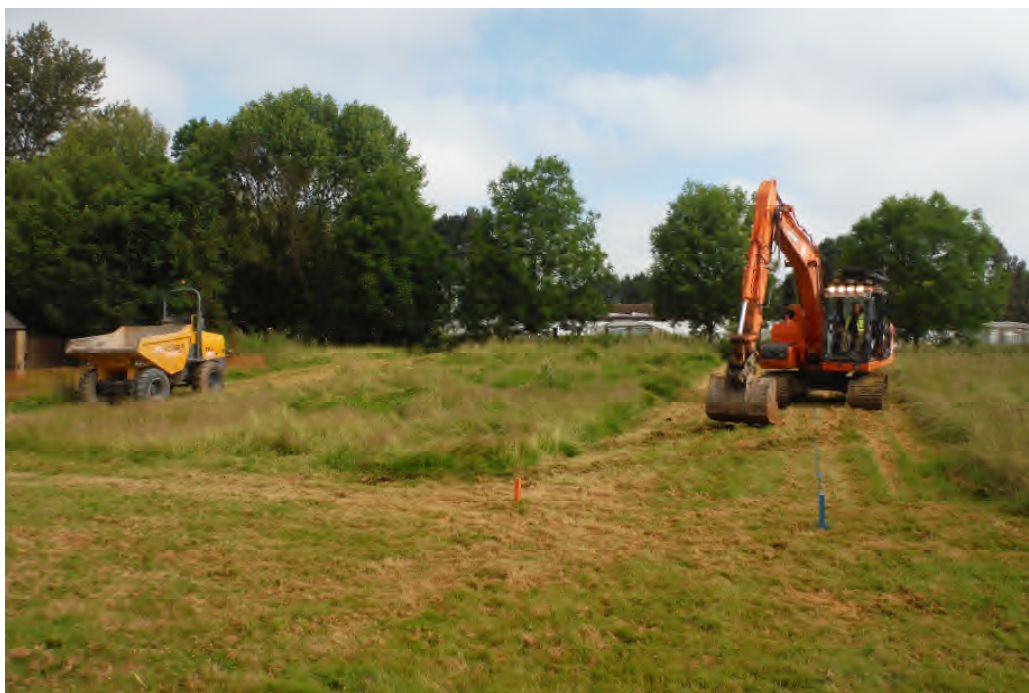
Image 1: General view of the site prior to stripping, looking north with the ground sloping down to the south and west

The new building with associated car parking and hard standing will be set back from the road (Figure 1). Prior to the commencement of the groundworks the terrain was gently sloping down to the south and also to the west (Figure 3: image 1).

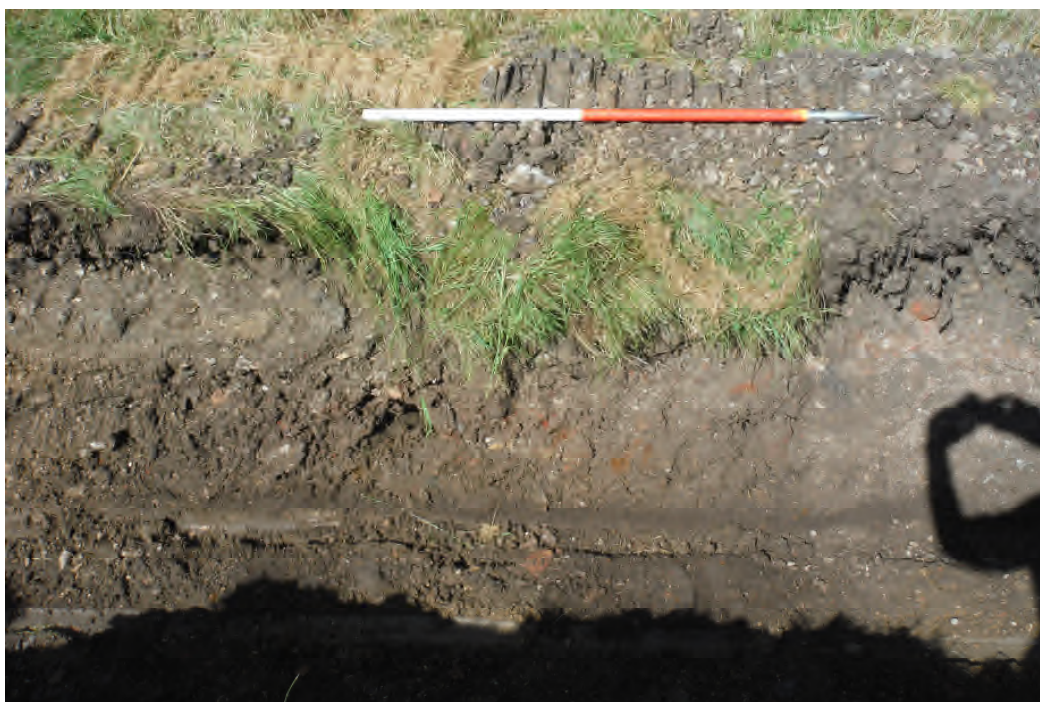
Image 2: Deep section of made-ground (2) containing modern building materials (scale 1m in 50cm divisions)

Topsoil/turf-line (1) comprised dark brown-grey sandy silt up to 0.15m thick. This overlay a c .0.4–1.1m thick modern deposit of made-ground (2), that comprised mixed material of mid to dark grey-brown to orange-brown clayey silt and sand, with inclusions of modern building material fragments, plastic and concrete (Figure 3: image 2). The lower part of this deposit was still present at the formation level after the initial ground reduction works (Figure 4: image 3). Stone rubble layer (8) was laid onto it to create a level surface (Figure 4: image 4).

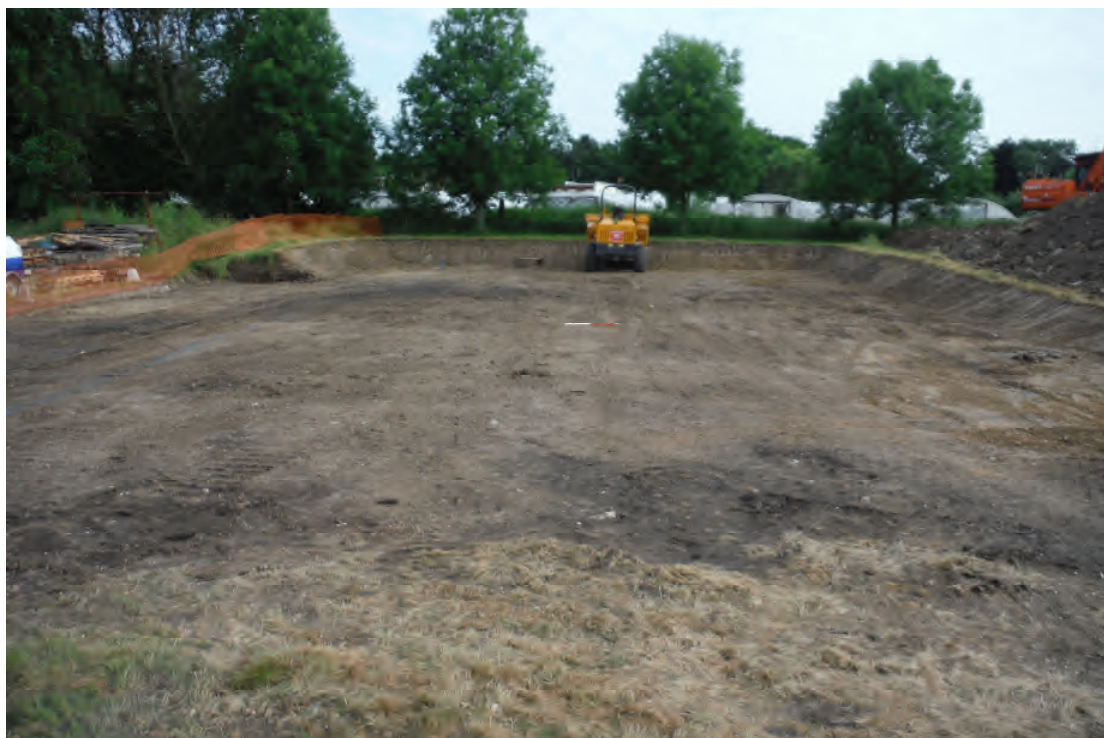
Image 3: General view of the building footprint stripped to the formation level, which is within made-ground deposit (2) (scale 1m in 50cm divisions)

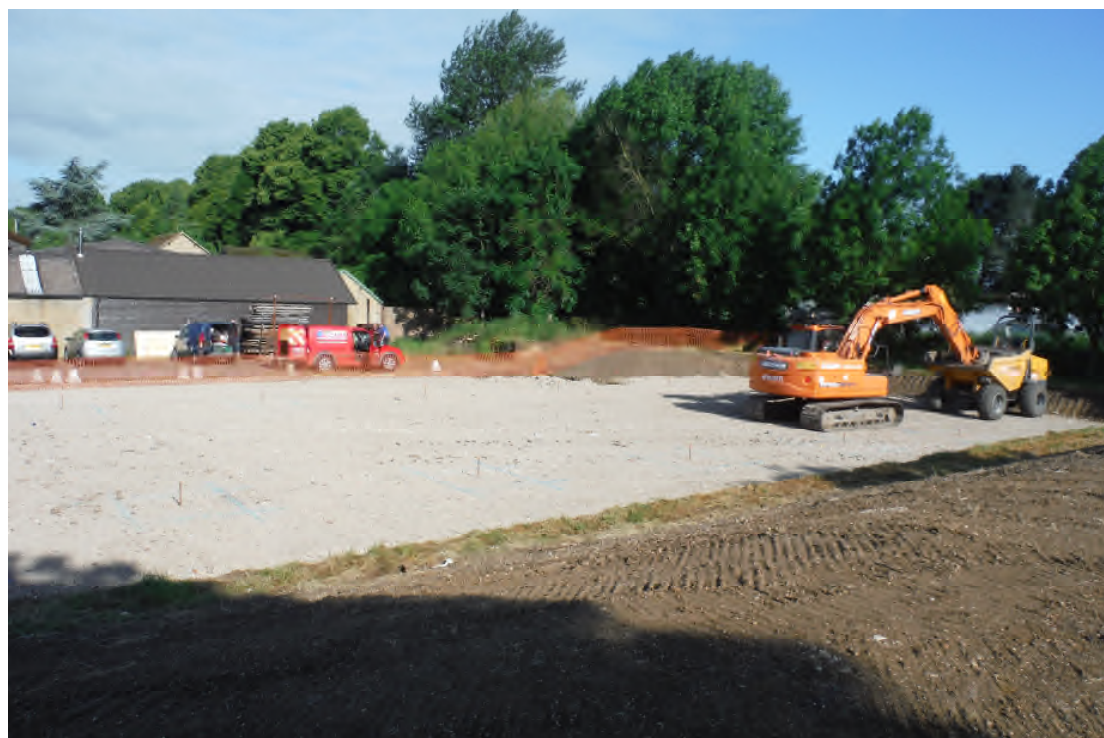
Image 4: Stone spread (8) within the building footprint

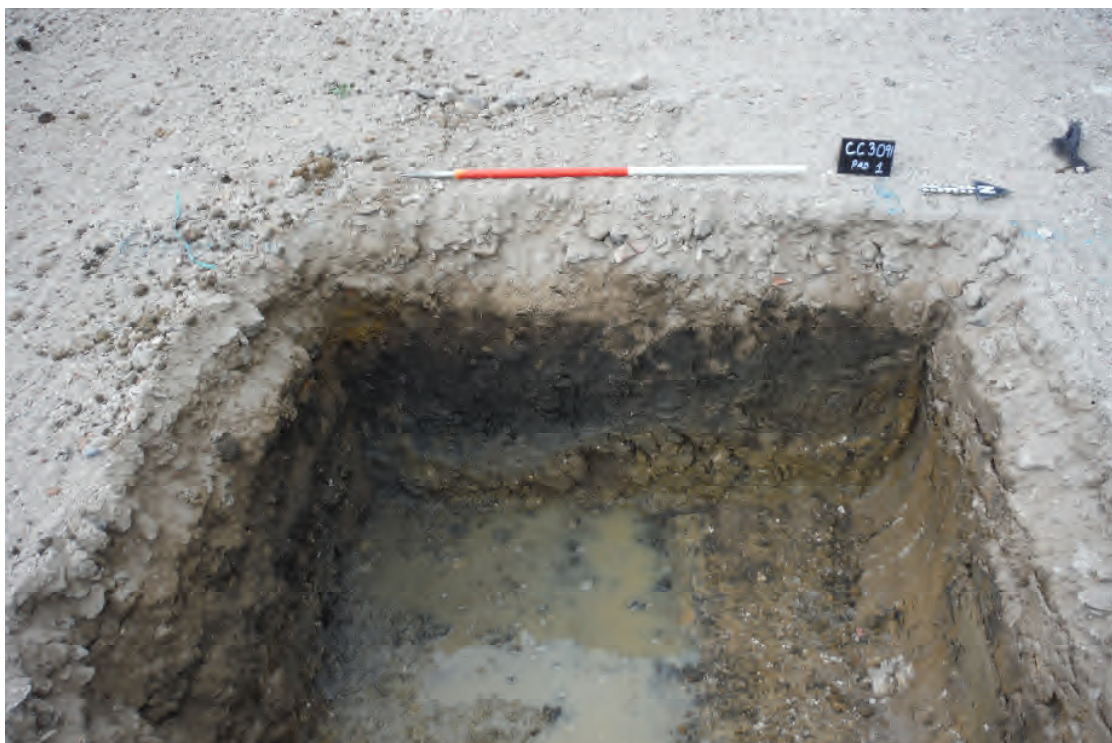
Image 5: Ditch [4] in Pad 1 (scale 1m in 50cm divisions)

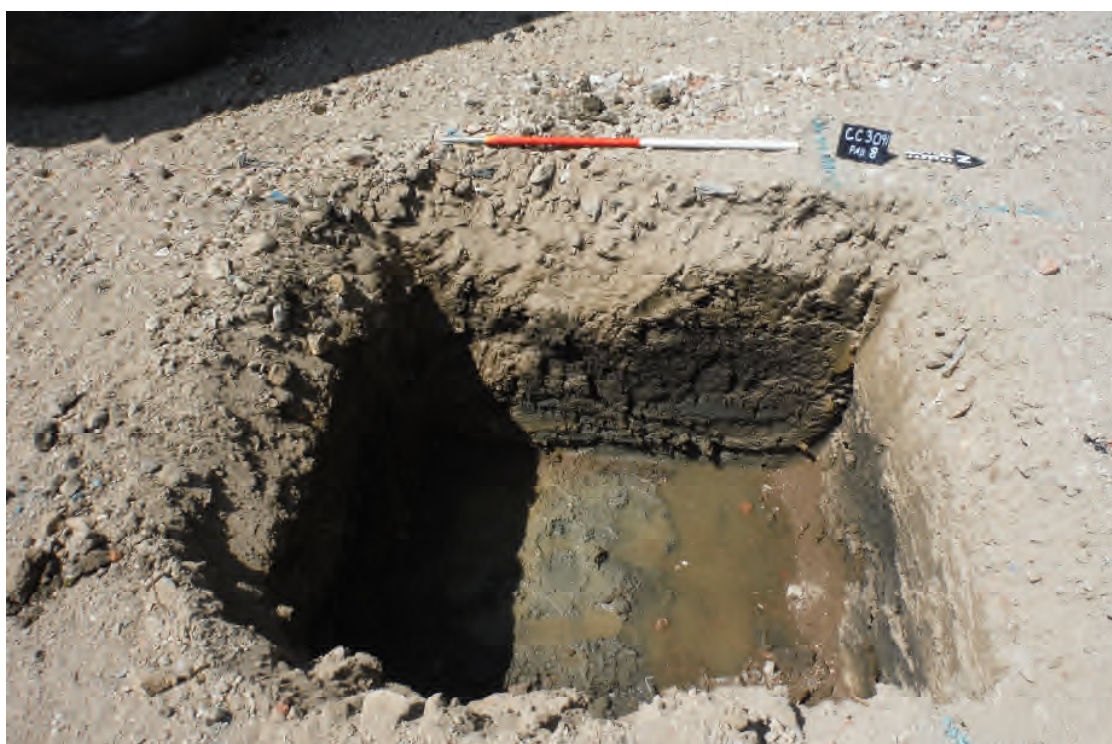
Image 6: Ditch [13] in Pad 8 (scale 1m in 50cm divisions)

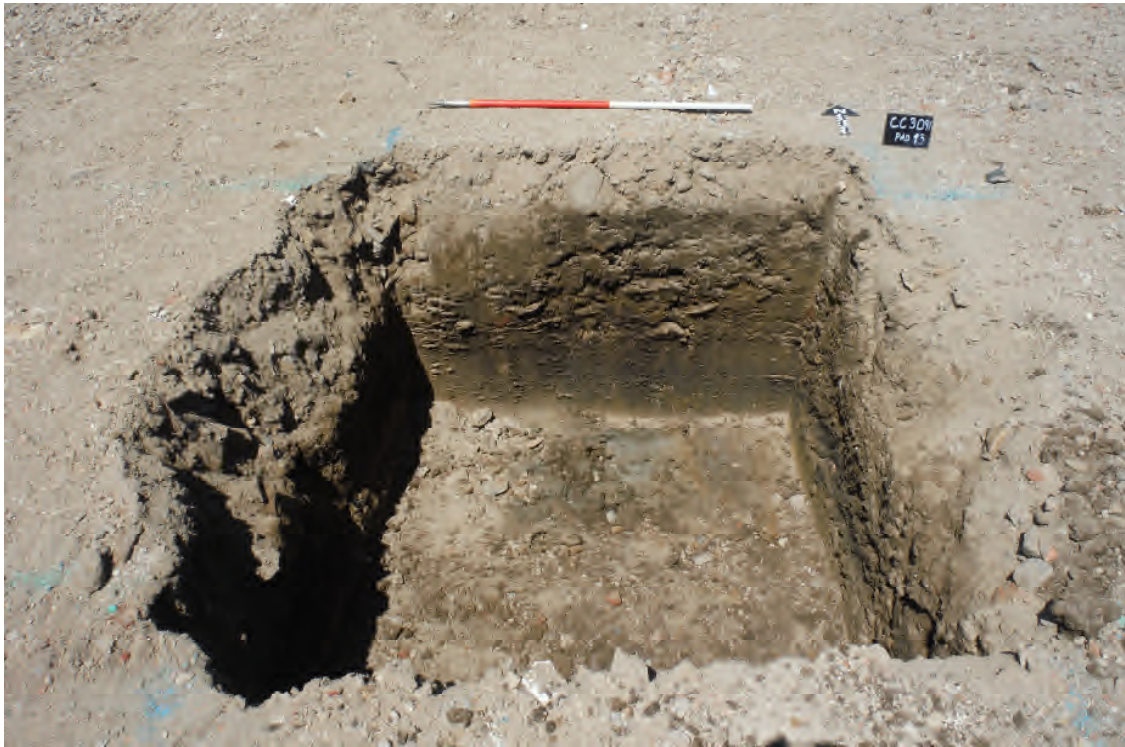
A 0.4m thick deposit (19) was recorded beneath layer (2) in Pad 13 (Figure 6: image 7). It consisted of dark brown-grey silty clay with pockets of yellow-grey sandy clay; it contained a sand-tempered post-medieval stock moulded brick fragment (375g: depth 70mm) and a piece of coarse lime mortar (17g). Neither was retained. The mixed nature of the layer may suggest the deliberate deposition of this material in an attempt to raise the level of the ground, possibly in response to wet ground conditions. This activity may relate to the 19th-century Chawston Manor Farm.

Image 7: Made-ground layer (19); the more friable deposit is visible in the upper part of the section in Pad 13, having a more open soil structure (scale 1m in 50cm divisions)

The substantial ditch would appear to have been dug in wet conditions, as indicated by the character of its fills. It does not appear on available historical maps of the area. Layer (19) in Pad 13 may have been another attempt to utilise the wet ground, in this instance by raising the ground level.

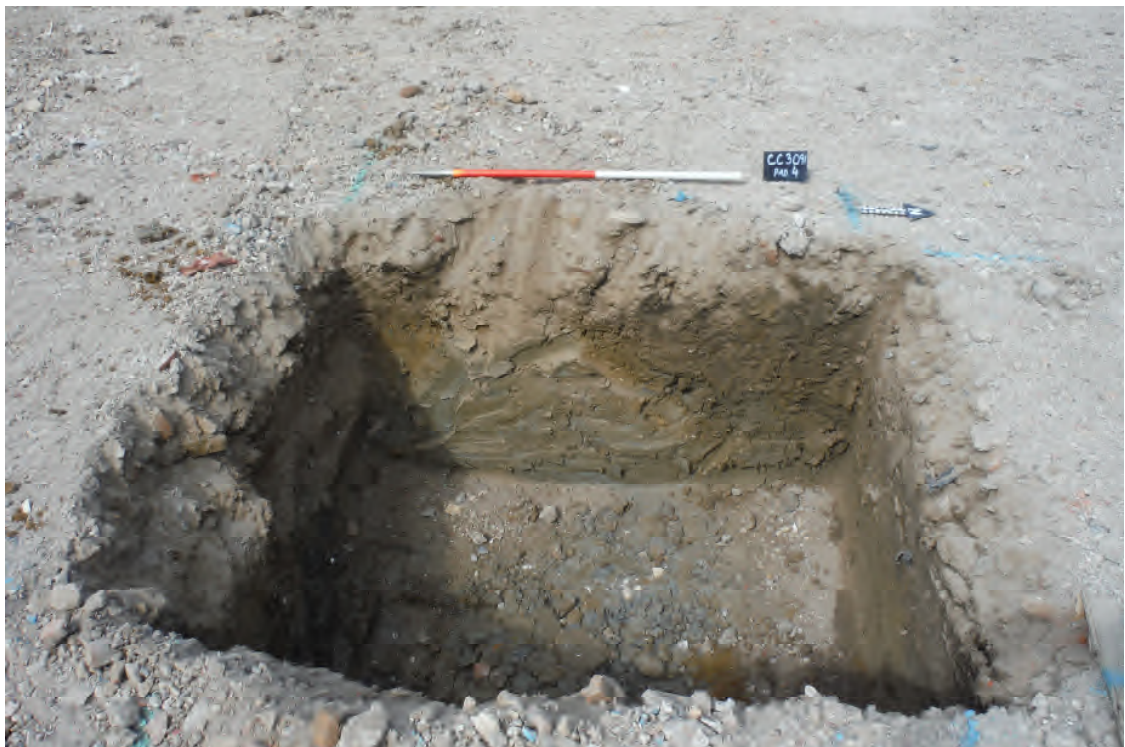
no dating evidence. Considering the size and shape of the possible pit it seems plausible to suggest it was dug to extract clay.

Image 8: The sloping edge of the possible quarry pit [11] in Pad 4, visible in the right side of the image, defined by the relatively dark fill (scale 1m in 50cm divisions)

Although undated, the large, possible quarry pit may also date to the post-medieval or later period, given its relatively dark fill, which lacked mineralisation.
