THE CHURCH OF ST MARY THE VIRGIN, HARLINGTON, BEDFORDSHIRE: Precautionary Archaeological Attendance and Reporting

Albion Archaeology Project No: SM1205

Report No: 2006/112, version 1.0

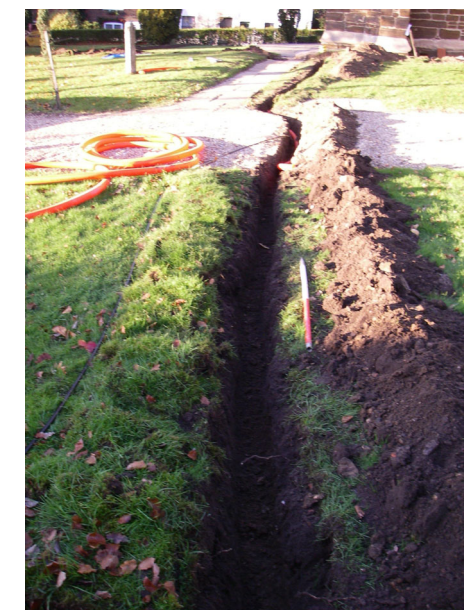
Three trenches were excavated in the western part of the churchyard. A central trench began at the southern wall of the tower and extended westwards. The other two trenches branched off from the central trench towards the north and south. The central trench was 21.4m long and 0.15m wide. The southern trench was 18.70m long and 0.20m wide. The northern trench was 25.6m long and 0.15m wide. All of the trenches were excavated to a depth of approximately 0.45m. The north and central trenches were excavated with a trenching machine and the southern trench was excavated by hand.

The overburden within the trenches was homogenous across the site and consisted of 0.15m-0.20m of topsoil (100), overlying 0.25-0.30m of sandy silt subsoil (101). The bottom of the trench never exceeded the depth of this deposit, which contained small quantities of disarticulated human bone, tile, brick and stone. The majority of the human bone recovered was from the southern trench.

Southern cable trench: looking north

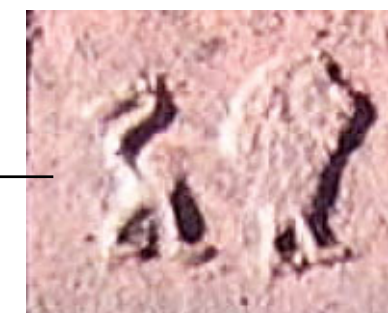
Towards the church wall in the northern trench, four tiles were recovered. These were of the type used to form garden borders or path edging, with a decorative, shaped upper edge. The tiles showed signs of wear and in some places were broken. The northern trench produced two pieces of disarticulated human bone, four impressed tiles and two pieces of modern pottery. The tiles were all of uniform size (0.15m by 0.15m) and were machine made. They were flat on one face with an impressed design on the other. Two of the tiles had a simple square in the centre of the tile; the other two were divided into 9 squares with a lion stamp in the centre square (see photo, Figure 2).

Lion detail
