ST MARY'S CHURCH, MARSTON MORETAINE, BEDFORDSHIRE

Precautionary Archaeological Attendance, Observation, Recording and Reporting

Albion Archaeology Project No: SM1141

Report No: 2005/73

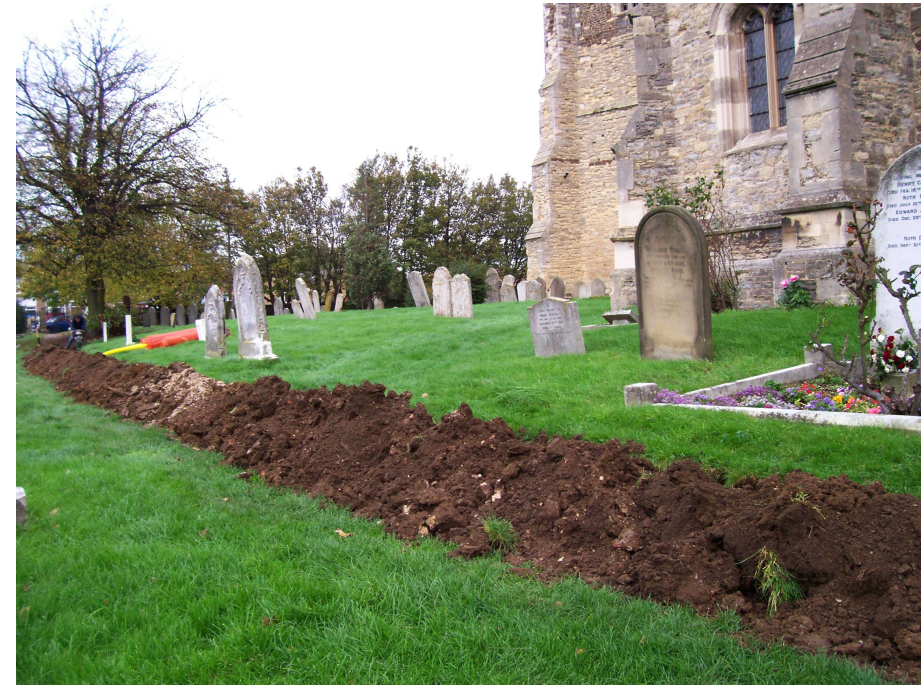
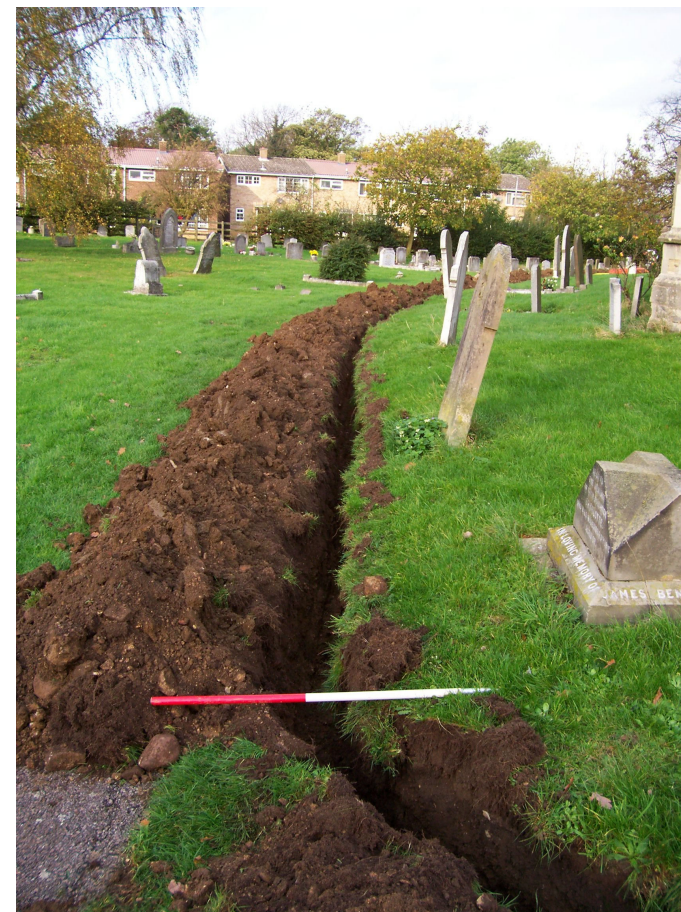
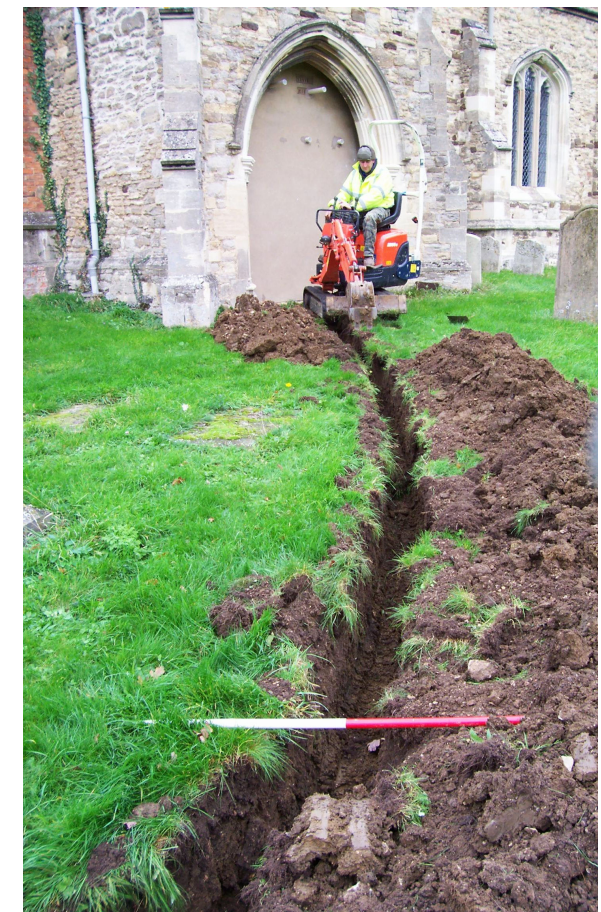
Figure 1: Site location map and all features
 Base map reproduced from the Ordnance Survey Map with the permission of the Controller of Her Majesty's Stationery Office, by Bedfordshire County Council, County Hall, Bedford. OS Licence No. 076465(LA). © Crown Copyright.

The pipe trench was approximately 85m long and 0.30m to 0.40m wide. After entering the churchyard at its northern entrance, the trench ran nearly due south as it traced the eastern edge of a small pathway. After c.50m it mirrored a slight south-easterly turn in the pathway. Thereafter, it left the course of the path and cut across the churchyard in a north-easterly direction, running for 12m to the church's now sealed south door. The trench was excavated using a mini-digger.

Throughout the first 15m of the northern end of the trench, the overburden consisted of 0.20m-0.25m of topsoil (100) (see Figure 1), overlying 0.30m of sandy, gravelly subsoil (101) which in turn sealed undisturbed orange/brown sandy gravel. Over the next 11m of the trench, a similar depth of topsoil overlay a firm brown/green clay. The bottom of the trench never exceeded the depth of this deposit, which contained no artefacts and is interpreted as an undisturbed geological deposit.

Beyond this point, there is a visible downwards slope to the path and the clay was sealed by a friable, grey/brown silty clay which had moderate inclusions of red brick and tile and was occasionally inter-mixed with a more loamy grave earth (102). This deposit was present throughout the remaining length of the trench; the undisturbed clay was never exposed again.
