**EDWORTH MANOR
CHURCH END
EDWORTH
BEDFORDSHIRE**

**ARCHAEOLOGICAL OBSERVATION
INVESTIGATION, RECORDING, ANALYSIS AND
PUBLICATION**

Project: EM3330
HER search no: 201819/059
Museum accession no.: BEDFM 2018.35
OASIS no.: albionar1-318896

Document: 2018/100
Version 1.1

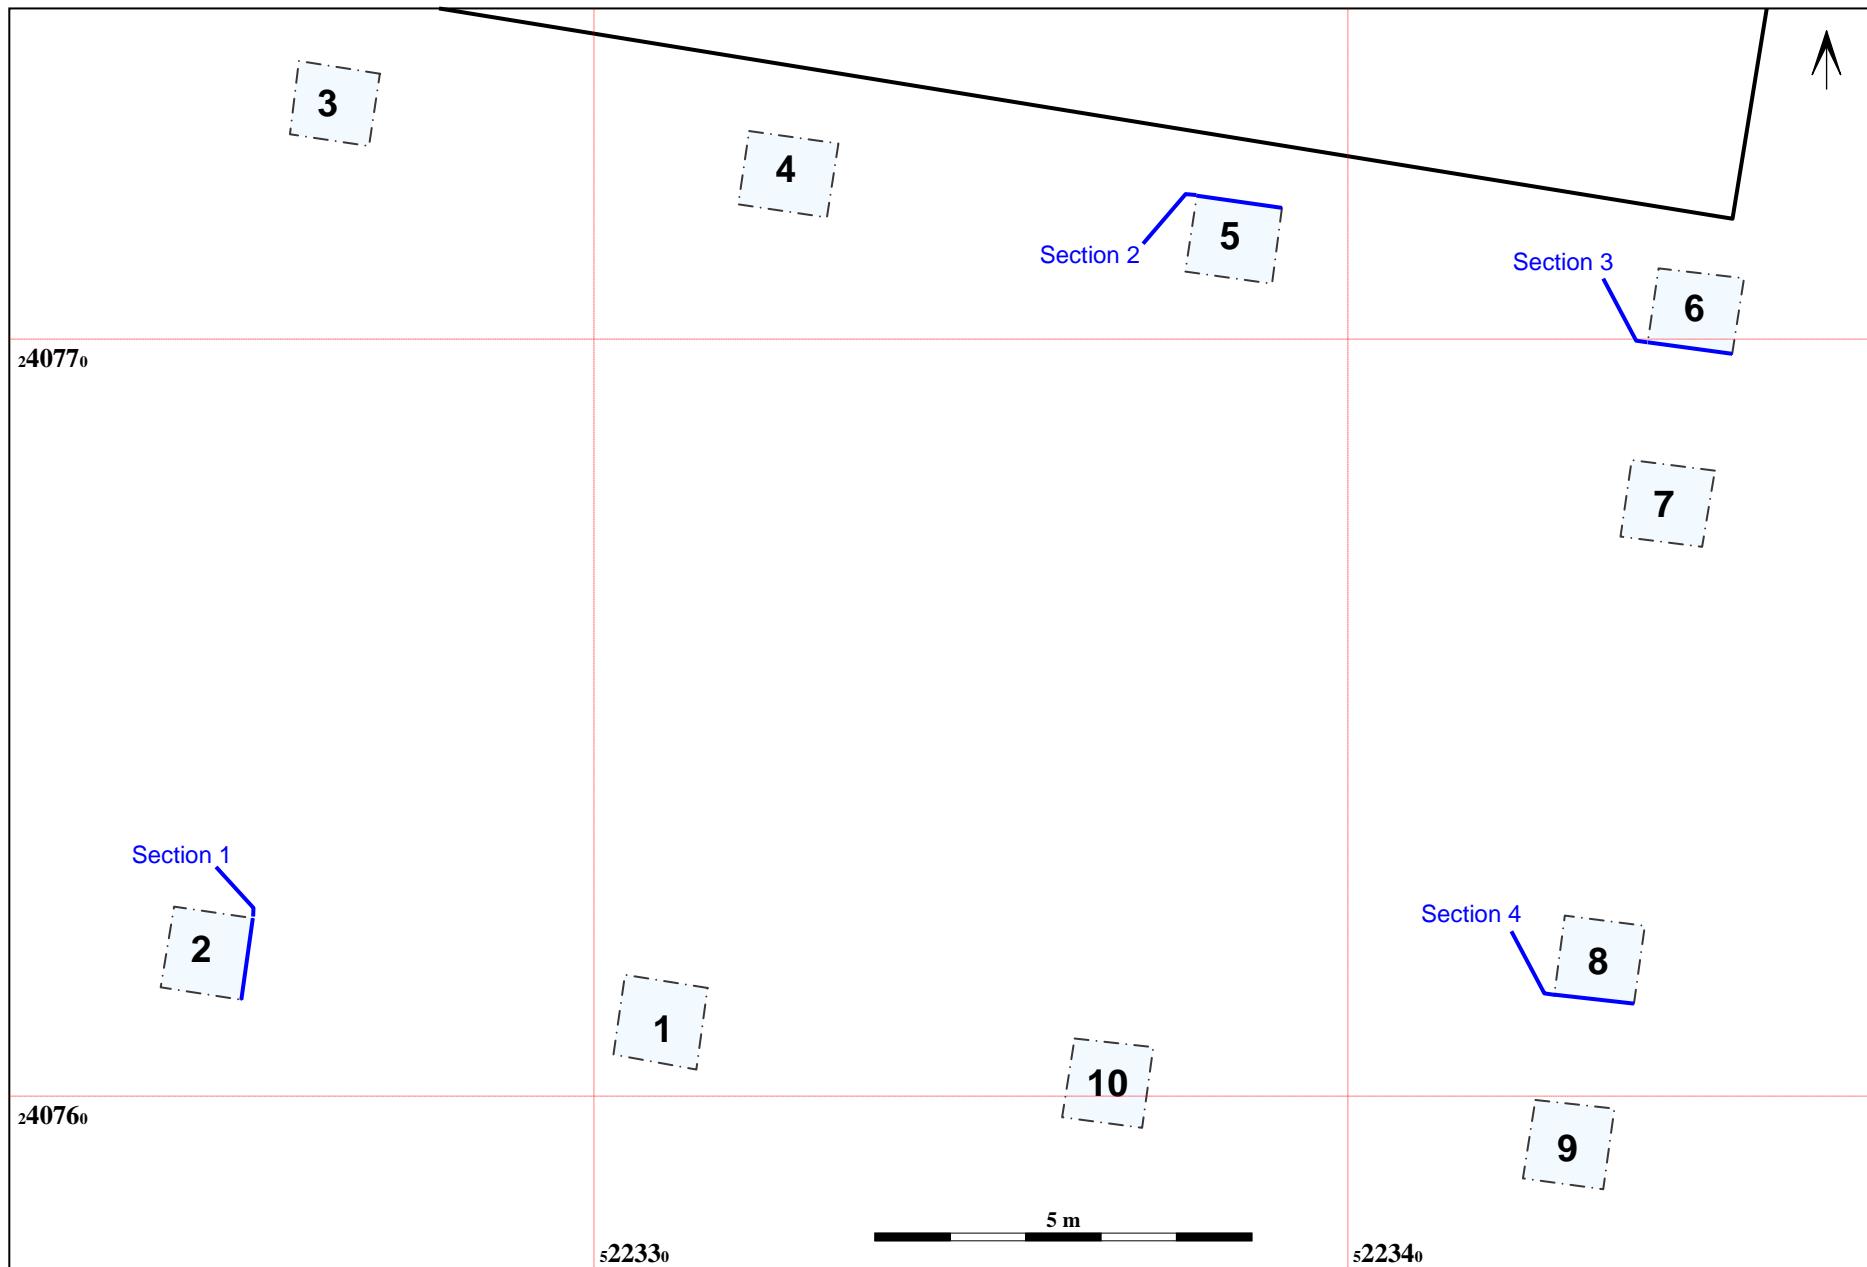
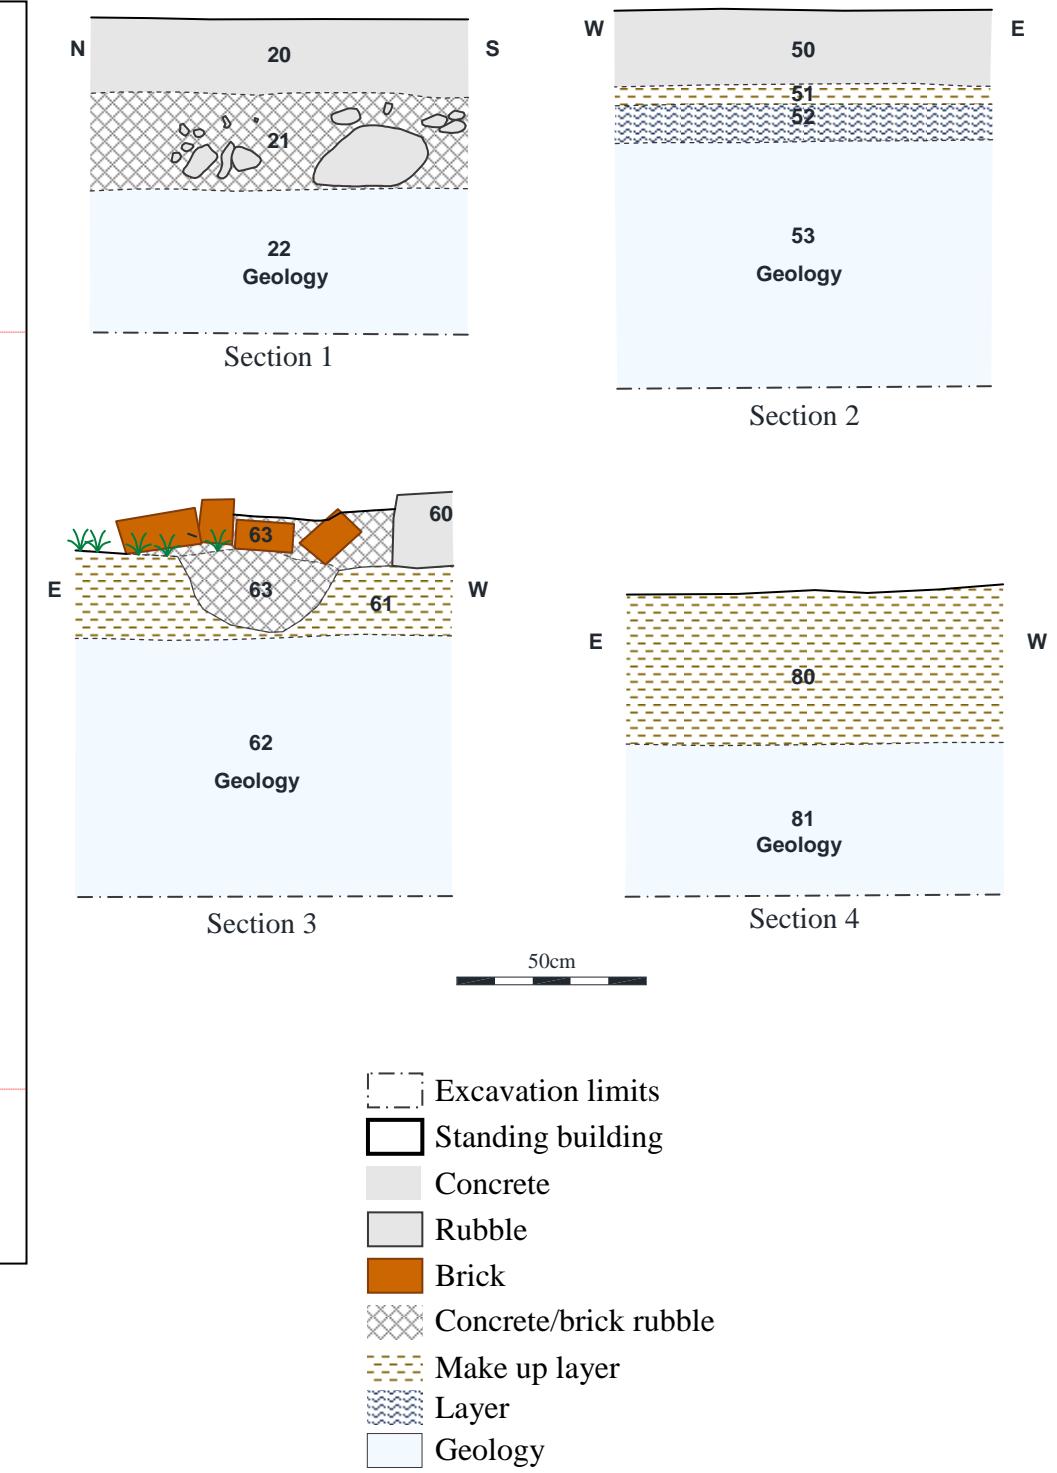
Figure 2: All-features plan and selected sections

- white concrete to a maximum thickness of 0.2m (10), (20), (30), (40), (60), (70) and (100);
- a rubble sub-stratum, comprising brick (mostly fragments) and stone in a variable soil matrix that ranged from reddish brown to dark brown silty clay. The deposit varied from 0.1–0.25m thick (11), (21), (31), (41) (61), (71) and (101) (Sections 1 and 3 on Figure 2; Figure 3: images 1 and 2; Figure 4: image 3), which lay directly above the geological stratum.

In Pit 5 the concrete (50) and rubble sub-stratum (51) sealed black, friable silt layer (52), up to 0.1m thick, which was directly above the geological stratum (Section 2 on Figure 2; Figure 4: image 4). Deposit (52) is difficult to characterise, given the limited extent of the pit; however, it appears to be modern disturbance associated with the creation of the former barn rather the remains of an archaeological feature.

Pits 8 and 9 showed a similar sequence, although there was no concrete above the rubble sub-stratum (80) and (90), which was up to 0.4m thick (Section 4 on Figure 2; Figure 5: image 5). It would appear that the footprint for the barn floor had been cut too wide in the east and the area beyond the concrete floor was infilled with available material — mostly rubble but also some soil.
