**HARE HOUSE
SCHOOL LANE
BOLNHURST
BEDFORDSHIRE**

**ARCHAEOLOGICAL OBSERVATION,
INVESTIGATION, RECORDING, ANALYSIS AND
PUBLICATION**

Project: HH3365
Document: 2018/155
Version: 1.0

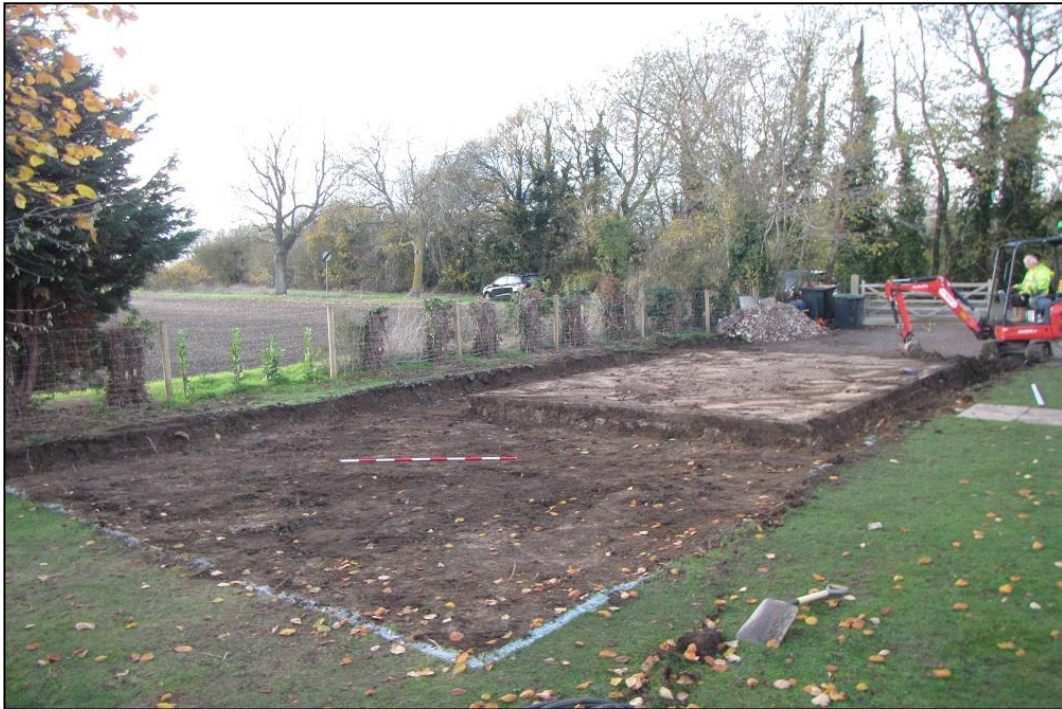
Image 1: View of the trench and retained slab, looking north-west
(Scale 2m)

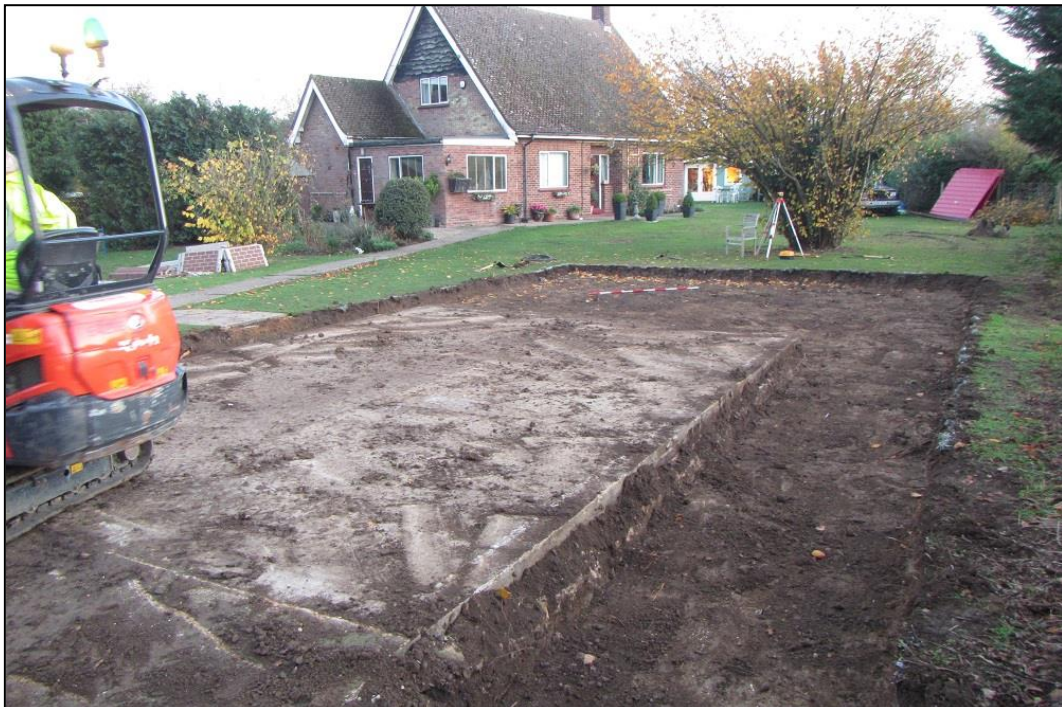
Image 2: View of trench and retained slab, looking south-east
(Scale 2m)

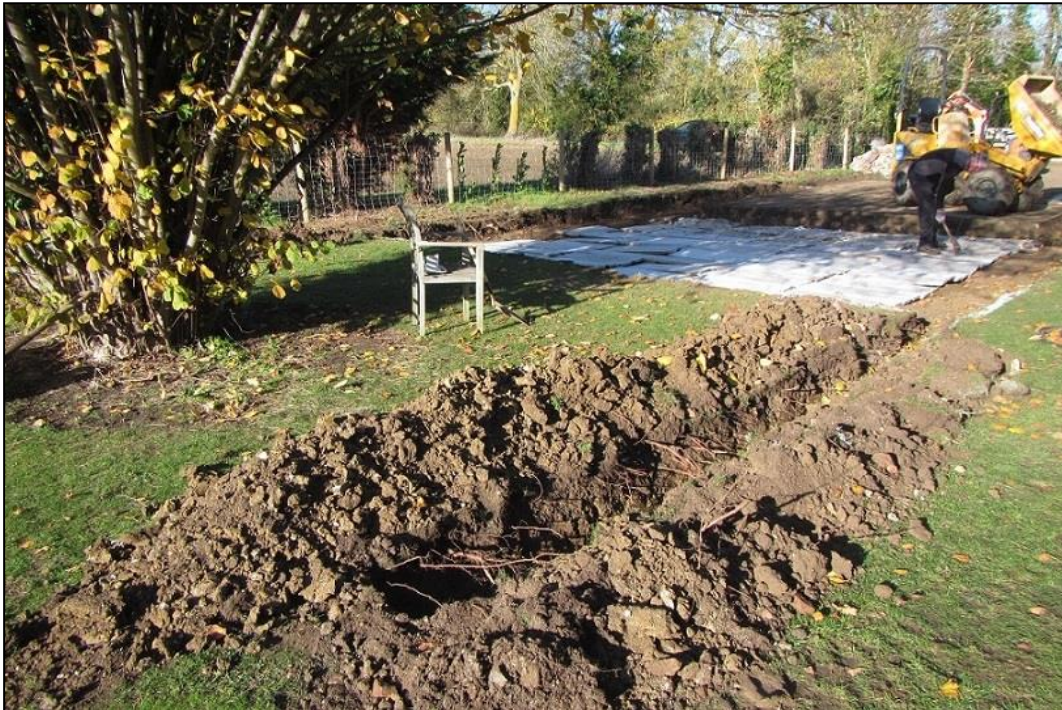
In addition to the trench for the foundation slab, two trenches were excavated for surface water drainage. They were 5.5m long, 400mm wide and 300–400mm deep, extending southwards from the south-east and south-west corners of the foundation trench for the installation of perforated pipe drainage.

Image 3: Drainage trench extending from south-east corner of foundation, looking north-west
