**LAND OFF WOBURN ROAD  
KEMPSTON HARDWICK  
BEDFORDSHIRE**

**ARCHAEOLOGICAL FIELD EVALUATION**

Project: WR3423  
Museum accession no.: BEDFM 2018.73  
OASIS no.: albionar1-329488

Document: 2018/159  
Version 1.0

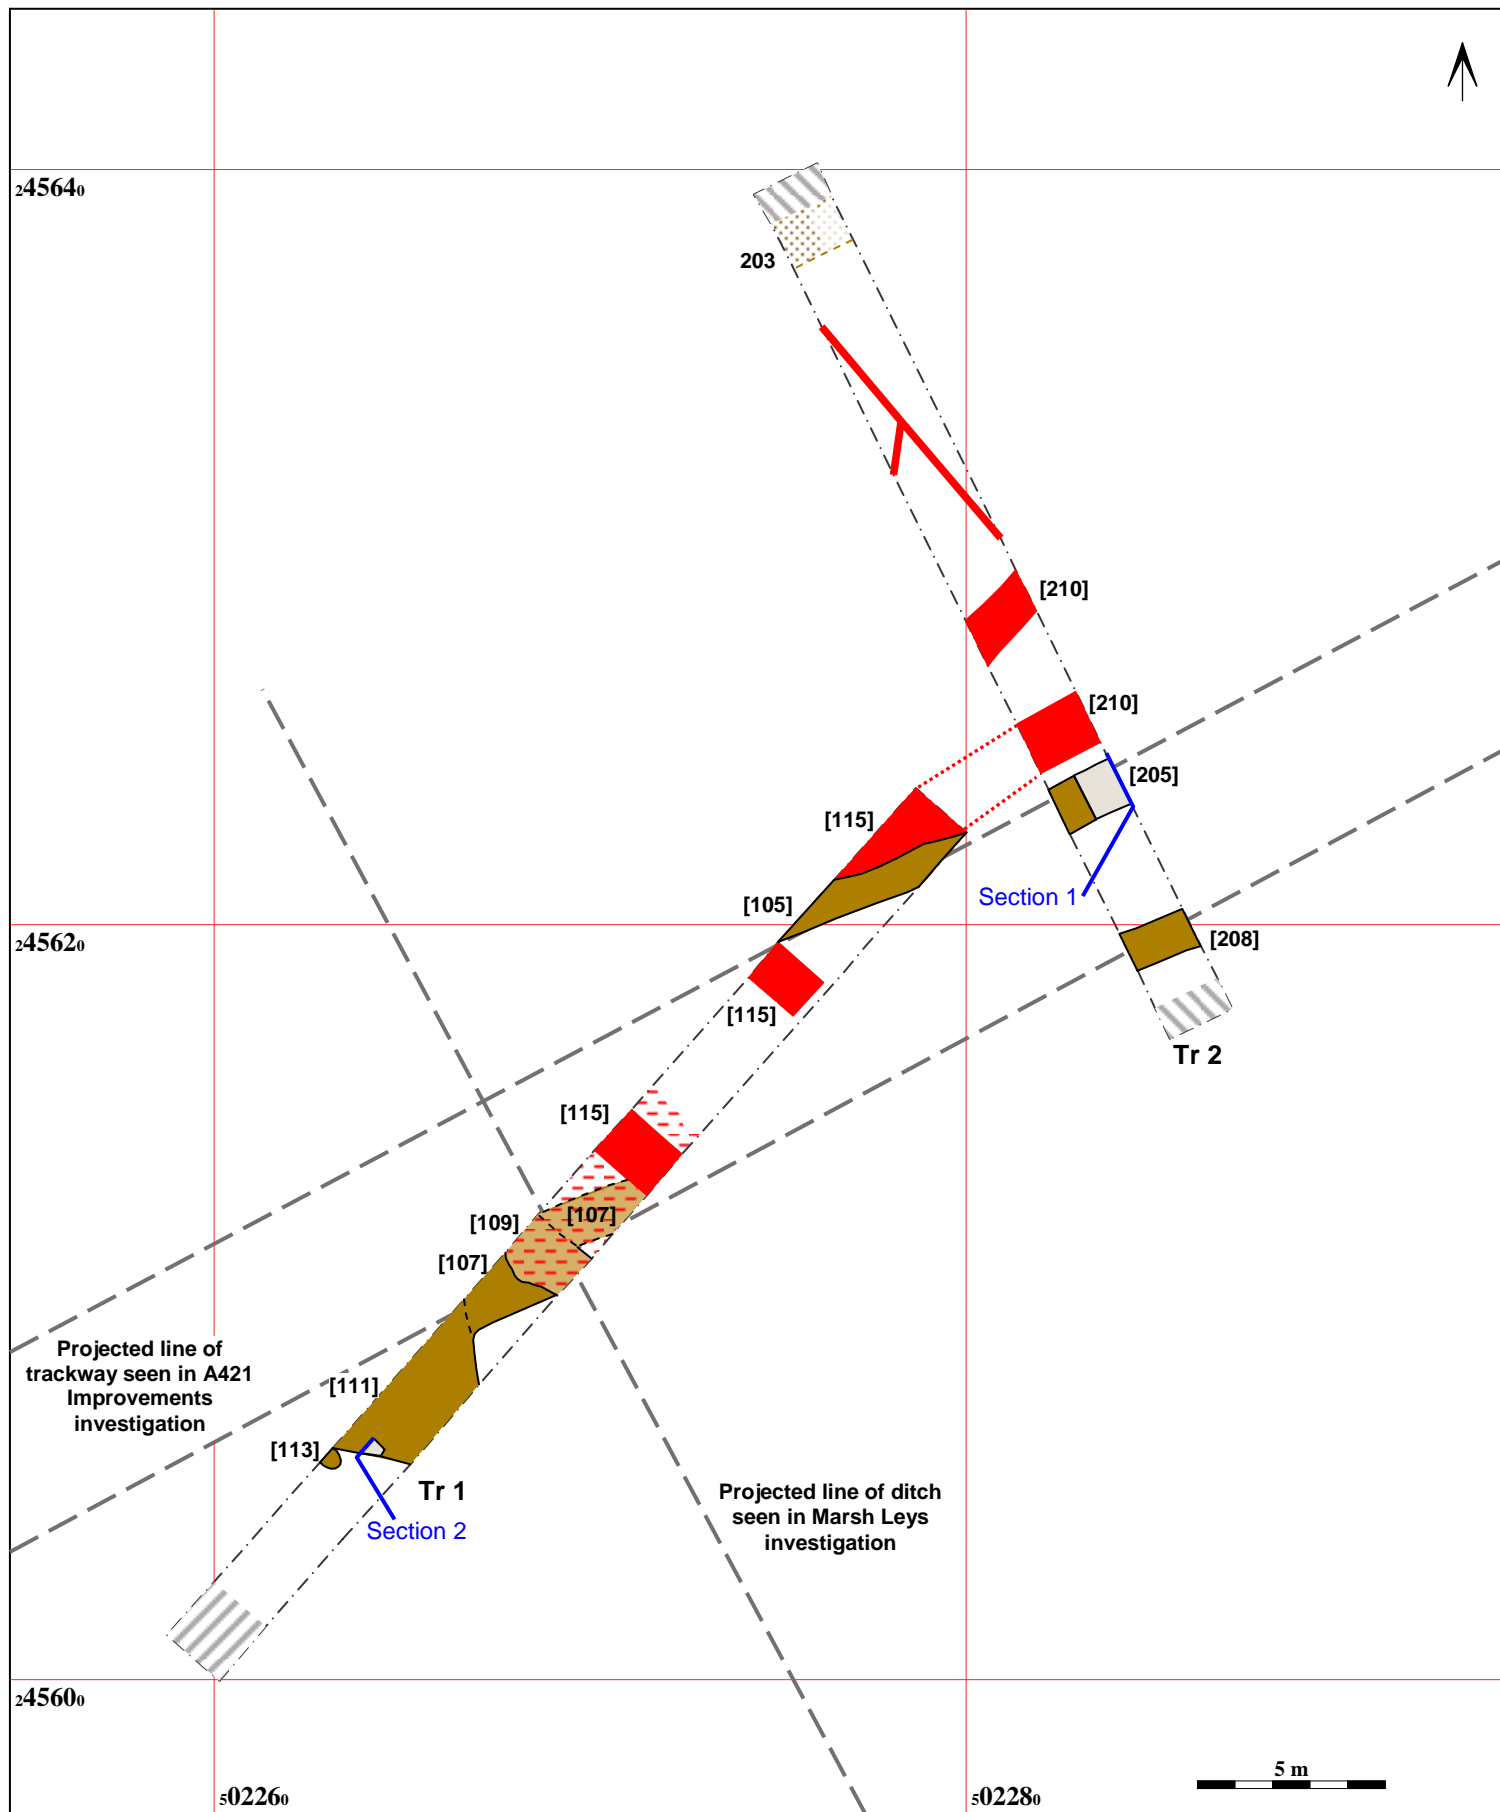
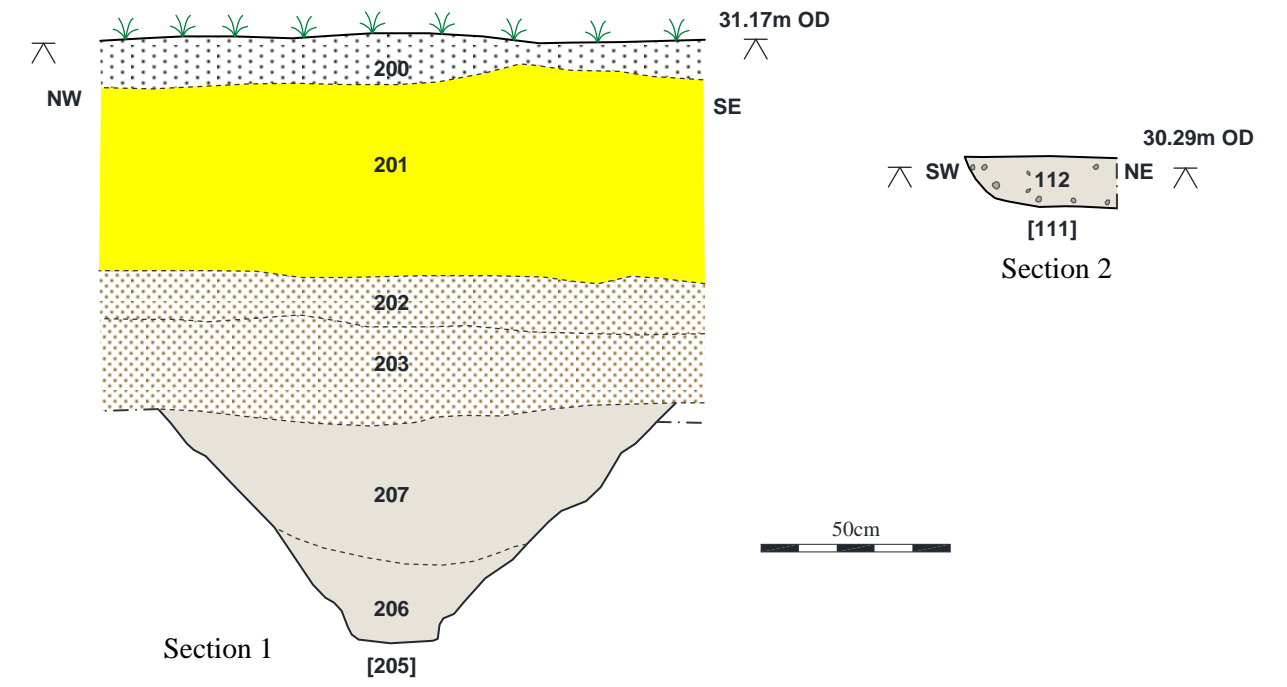
Figure 2: All-features plan with sections

Below the topsoil was an extensive spread of modern rubble (101) and (201) ranging from 0.15–0.5m thick, though generally around 0.5m thick (Figure 2: section 1 (yellow deposit); Figure 3: image 1). This was present throughout the whole length of Trench 2; it was thickest at the north-west end but only 0.2m thick at the south-east end. The continuation of the deposit extended for most of the length of Trench 1, apart from the south-western area. This material comprised large quantities of CBM, concrete, glass, metal and other demolition debris. Distinctive hydrocarbon odours were noticeable from these deposits.

The trenches revealed a total of four modern machine-dug trench-pits [115] and [210], one of which extended between the two trenches (red features on Figure 2). These trench-pits were sealed by the modern rubble spread (101) and (201) but cut through the subsoil and into the underlying geological strata. The trench-pits were 1–1.5m wide and of varying length. The backfills (116) and (211) comprised dark brown to black silt with CBM, concrete, modern refuse, burnt materials, glass, cables, plastic and paper (Figure 3: image 2). The deposits also smelt of hydrocarbons.

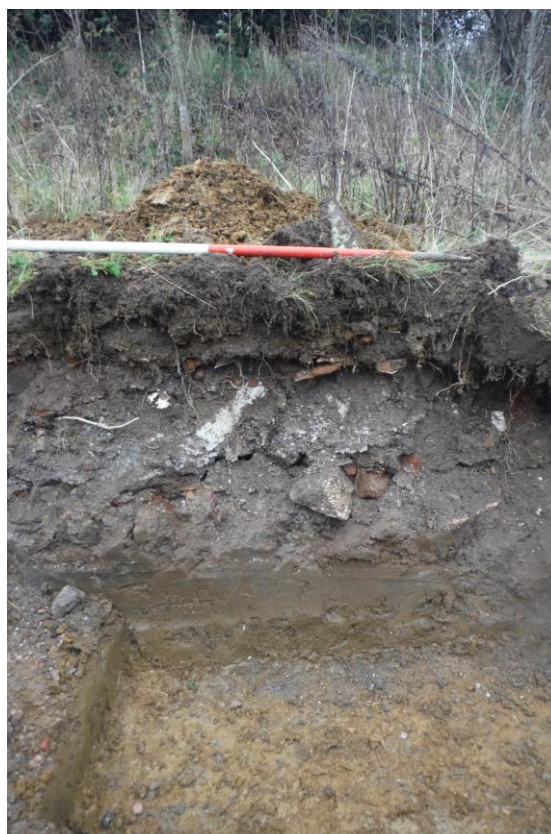
**Image 1:** Northern section of Trench 2, showing soil profile including extensive rubble deposit (201) (Scale 1m in 50cm divisions).

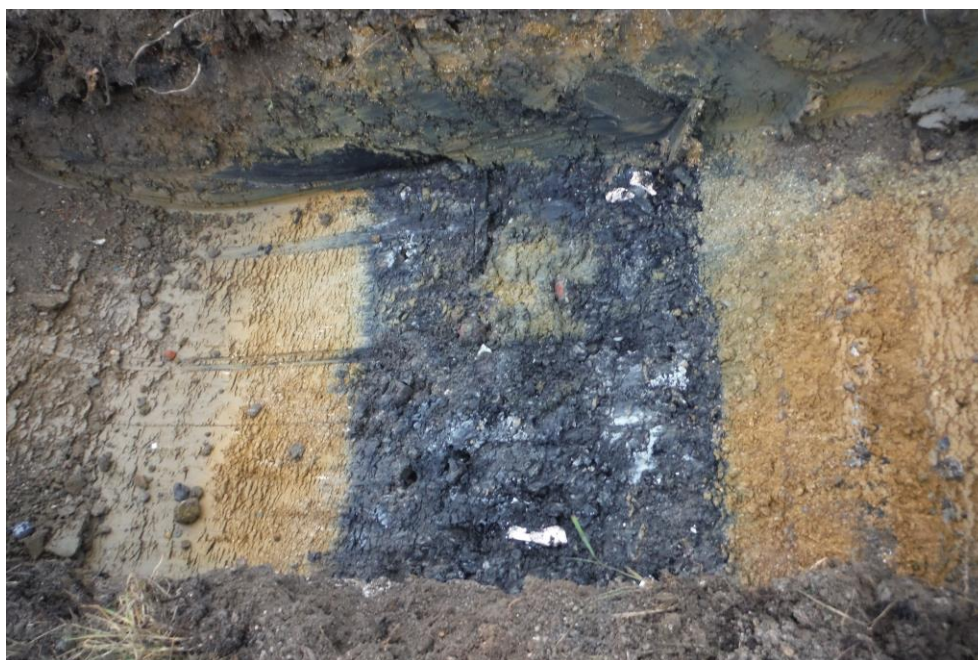
**Image 2:** Black fill of modern trench-pit [210]

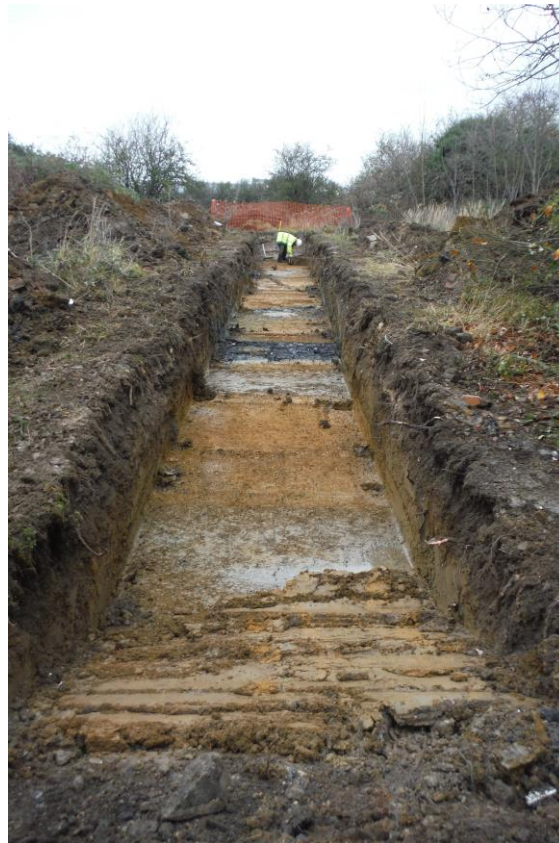
Sealed by undisturbed subsoil (103) / (203), linear features [105] and [205] appear to be parts of the same ditch (Figure 4: images 3 and 4). A section was excavated in Trench 2, revealing a roughly V-shaped stepped profile c.1.32m wide and c.0.6m deep, with a lower, squared element (Figure 2: section 1). The light brown-grey clayey silt lower fill (206) was c.0.22m thick. The upper, main fill (207) was darker, mid-grey-brown clayey silt, c.0.4m thick. No finds were recovered from the fills. Both deposits represent successive episodes of natural silting and erosion of the adjacent soil profile.

**Image 3:** General view of Trench 2 looking to the NW, showing the two ditches, with [208] in the foreground, partly capped with backfilled subsoil to reduce the flow of water from a partly exposed land drain. Ditch [205] is a short distance beyond, with the black fills of two modern trench-pits in the middle distance

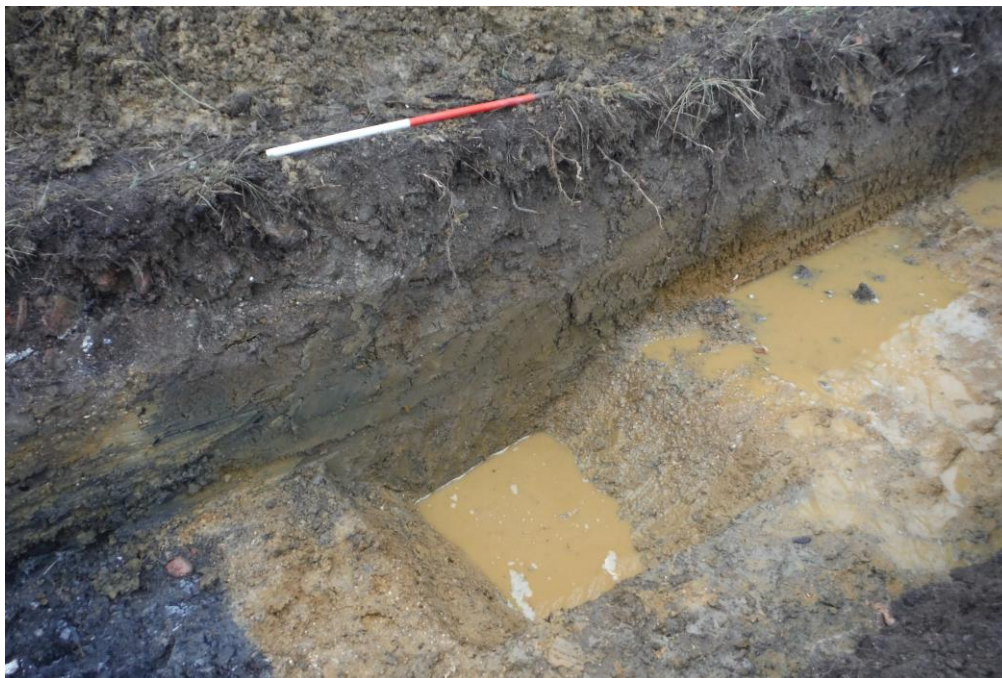
**Image 4:** Excavated segment through ditch [205], with the dark fill of a modern trench-pit a short distance to the west (Scale 1m in 50cm divisions)

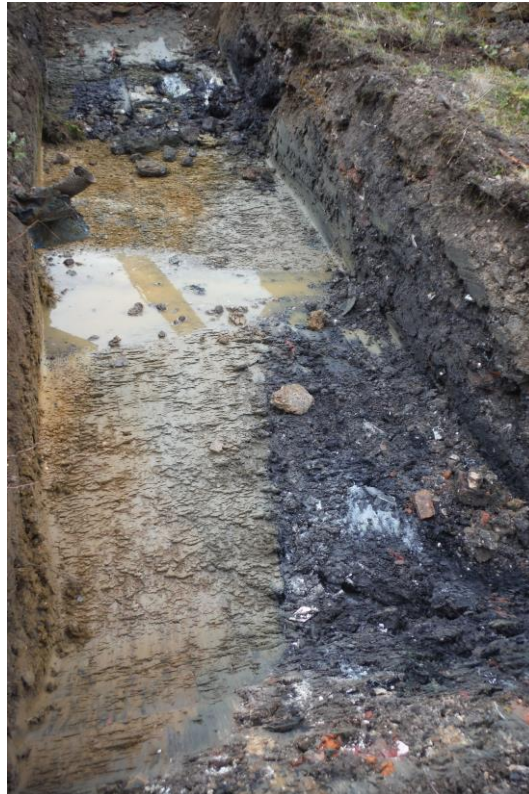
Ditch [107] was truncated by modern trench-pit [115] and showed signs of contamination from the modern feature (Figure 5: images 5 and 6). It appears to be a continuation of ditch [208] in Trench 2, running parallel to ditch [105] / [205], c.3.4m to the north. Its fills varied from mid-grey-brown to mid-brown-grey, though there was a distinct green hue in the fill of [107], probably derived from the leaching of the fill of the adjacent trench-pit (Figure 2 (pecked area); Figure 5: image 6). Ditch [107] appeared to be truncated by perpendicular ditch [109], although this may be misleading due to the discolouration of the deposits. Ditch [109] was up to 1.45m wide and correlated with the projected line of an enclosure ditch from the adjacent Marsh Leys investigation.

**Image 5:** Northern part of Trench 1, showing ditch [105], which continues into Trench 2 as [205] and is truncated by modern trench-pit [115] / [210]

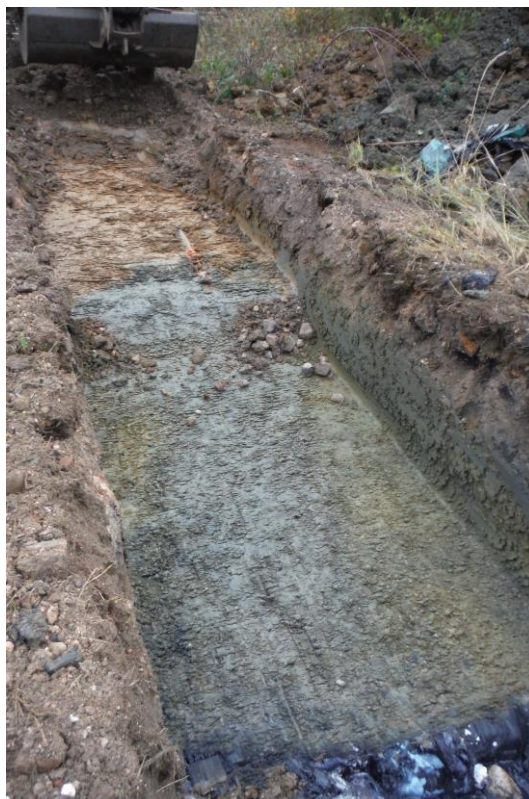
**Image 6:** Ditch [107] / [109] in the central part of Trench 1, showing discolouration of the fills, and a modern trench-pit at the bottom of the image
