St Peter's Church, Benington, Hertfordshire

Precautionary Archaeological Attendance, Observation, Recording, and Reporting

Albion Archaeology Project No: BE 1147

Report No: 2006/29

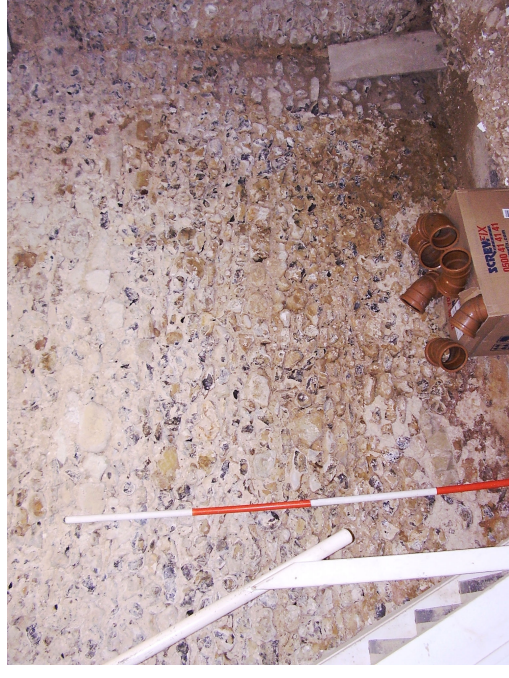
The exposed interior face of the tower.
Scale 2m in 0.50m divisions

It was noted that the appearance of the outer face of the tower (100) differed from the exposed inner face (105). The interior flints were undressed and more varied in size (see Figure 1 inset). The interior mortar was also slightly softer. This contrast may be due to post-medieval re-facing of the exterior of the tower.

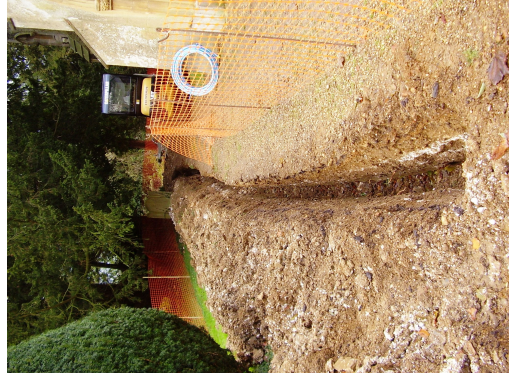
Trench 5, facing west.

Trench 5 was 63m long, 0.30m wide and ranged in depth from 0.75m to 1.50m (see Figure 1 inset).

At the south-western end of the trench the modern-day path and its levelling layer sealed layers of build up, which had presumably been laid to raise the ground level. These included re-deposited chalky boulder clay, e.g. (510), and re-deposited chalk, e.g. (505). Fragments of red brick in these layers suggest a post-medieval date. Similar deposits were recorded at the north-eastern end of the trench, although they increased in thickness towards the road.

Chalk bedrock, sealed by chalky boulder clay, was encountered at a depth of 0.68m in the south-western end of the trench. The same material was recorded at a depth of 1.45m in the north-eastern end of the trench, which presumably accounts for the greater thickness of build up / levelling in this part of the churchyard.
