**THE MANOR, CHURCH ROAD, MEPPERSHALL,
BEDFORDSHIRE**

**ARCHAEOLOGICAL WATCHING BRIEF
AND FIELD RECORDING**

Document: 2004/13
Project: CRM938

Produced for:
Bruce Deacon Ltd
on behalf of
Mr. T A Waldock

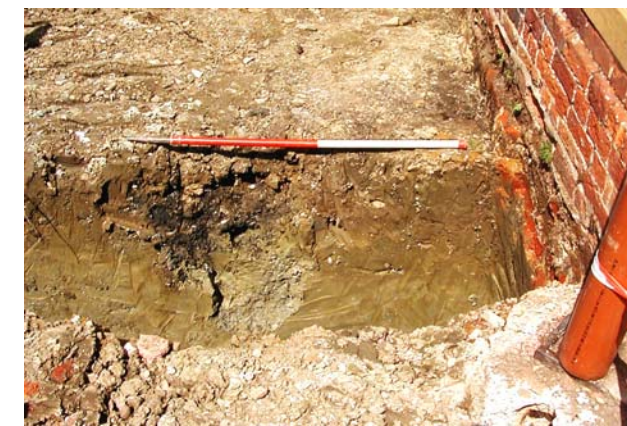
Figure 3:
Plan and section of Footing 1

In summary, a re-deposited layer of mixed building debris and clay (109) (Figure 3) overlay both the construction horizons of a modern drain, [107] / (108) and the putative construction cut and horizon of construction [103] / (104) of the Manor itself. Both of these features were cut into a putative subsoil deposit (100), comprised of mixed and dirty clay, which overlay a further soil horizon of yellow clay (101).

The levelling down of the interior of Footing 1 (Figure 3) confirmed in plan the sequence observed in the sections of the foundation trench. Recording in this area ceased on the 11th August. No finds were present.

Photograph showing drain [107] and foundation cut [103] (scale 1m)

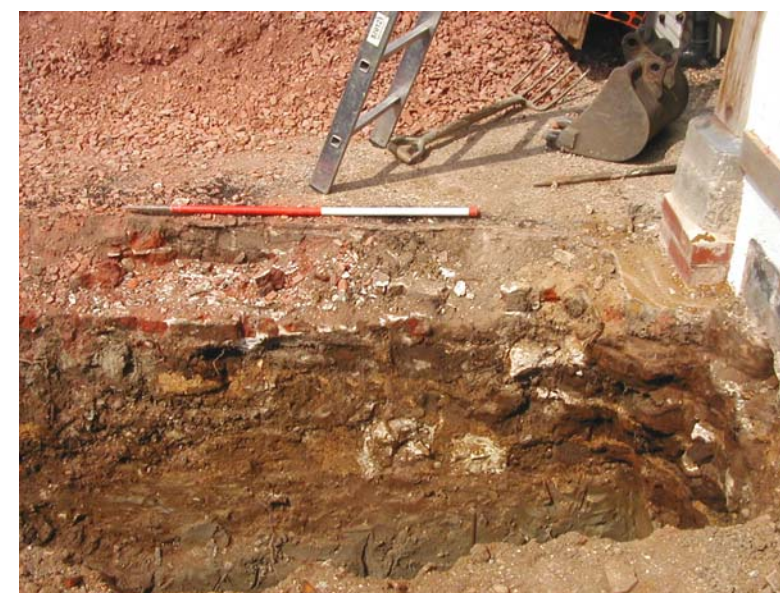
Figure 4: Plan and sections of Footing 2

A brick wall and its foundation [119] made of machine made bricks laid as stretchers in 'English Cross' bond stood to a total of three courses high and was associated with a rough external surface comprising brick rubble fragments (109) (Figure 4). To the north, layer (109) overlay a north-south aligned foundation which returned to the east at its northern and southern end to run beneath the revealed house foundations. This wall [117/122/123] was constructed of dressed, limestone and greensand blocks between 0.3m x 0.2m x 0.2m and 0.10m x 0.10m x 0.10m in size. It survived to five courses, 0.5m high. The wall courses appear to have been a random mixture of headers and stretchers in a matrix of sticky binding clay and weak lime mortar, charcoal-rich in places, which lay within a wide construction cut [116/124].

To the south of [117] and also directly beneath the insertion/construction cut for the building [114] lay the remnants of a horizontally truncated pit [112] and a possible ditch [110], which appear to have been open and in use at the same time. Both features were filled with a sticky silty clay with frequent small stone inclusions (113 and 111) respectively. No finds were present.

Photograph showing cut [116] and walls 117 and 119 (scale 1m)

Of the three areas investigated only one, Footing 2, demonstrated the preservation of any archaeological levels. It would appear that walls, [117, 122, 123] relate to the original build of the Manor and possibly represent, along with foundation trenches [116, 124] and their infilling (118, 125, 126), the construction of a chimney back or a small wing on the north-western side of the manor building. Earlier features from Footing 2 include a possible pit [112] and linear ?gully [110]. While it is possible that the latter formed part of a ditch, possibly associated with laying and marking out the land prior to the construction of the manor building the function and date of possible pit [112] are unknown. It may be the case that walls [117, 122] represent a garderobe or latrine shaft and that pit [112] represents an associated cleaning pit. However, evidence for cess, associated with the use of these features, was absent.
