VILLAGE FARM
HIGH STREET
SUTTON
BEDFORDSHIRE

ARCHAEOLOGICAL OBSERVATION,
INVESTIGATION, RECORDING, ANALYSIS
AND PUBLICATION

Project: VF3441
Document: 2019/126
Version: 1.0

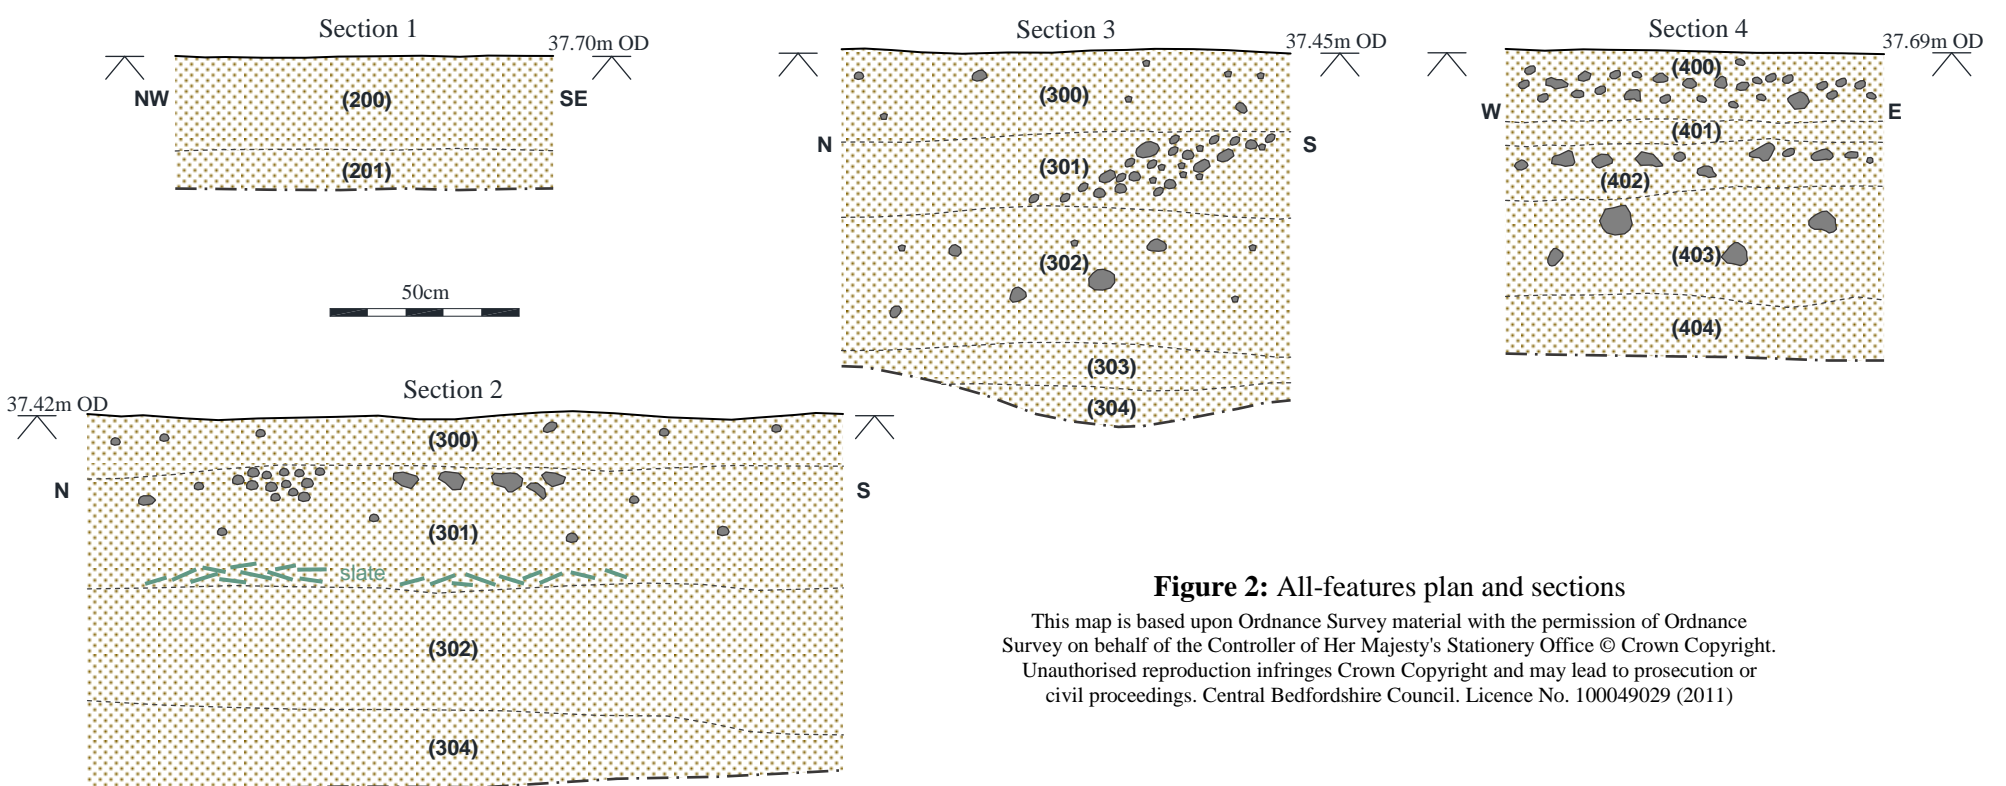
Figure 2: All-features plan and sections

The deposits recorded on site were assigned context numbers by trench number, with Trench 1 beginning at context (100), Trench 2 (200), etc. All of the deposits identified were layers. See Figure 2 for plans and sections illustrating the deposits; selected images are included at the back of the report. Information on the individual archaeological contexts for each trench is tabulated in Appendix 1.

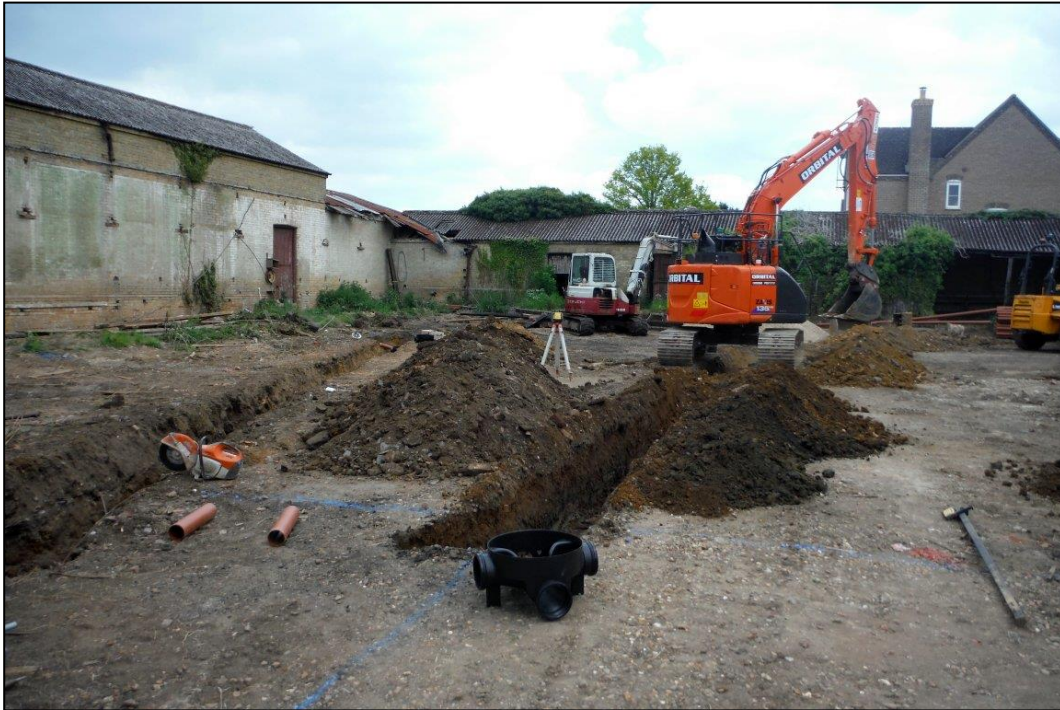
Image 1: Trenches 1 and 2

Looking east from west side of farmyard showing trenches under excavation

The deposits were examined in a series of narrow service trenches (Trenches 1 to 3) excavated in the yard surrounded by the former farm buildings. The deepest of the trenches was dug along the western side of the courtyard, and in this trench undisturbed geological deposits were observed in the base of the trench. In the eastern part of the courtyard the trenches were shallow, limiting the potential for archaeological observations to the upper deposits.

The next layer down (contexts 100, 200 and 301) was found in all of the farmyard trenches and was quite similar in colour and composition to (300). It was, however, a mixed deposit with patches of gravel/uneven distribution of stones and with fragments of roofing, slate which in some places was concentrated at the base of the deposit (Figure 2, Section 2). The uneven nature of this deposit suggests that it may be a dump deposit or a deliberately imported layer. The concentrations of shattered roofing slate suggest a possible event relating to the repair of the surrounding farm buildings or possibly it represents imported topsoil that also contained some building debris.

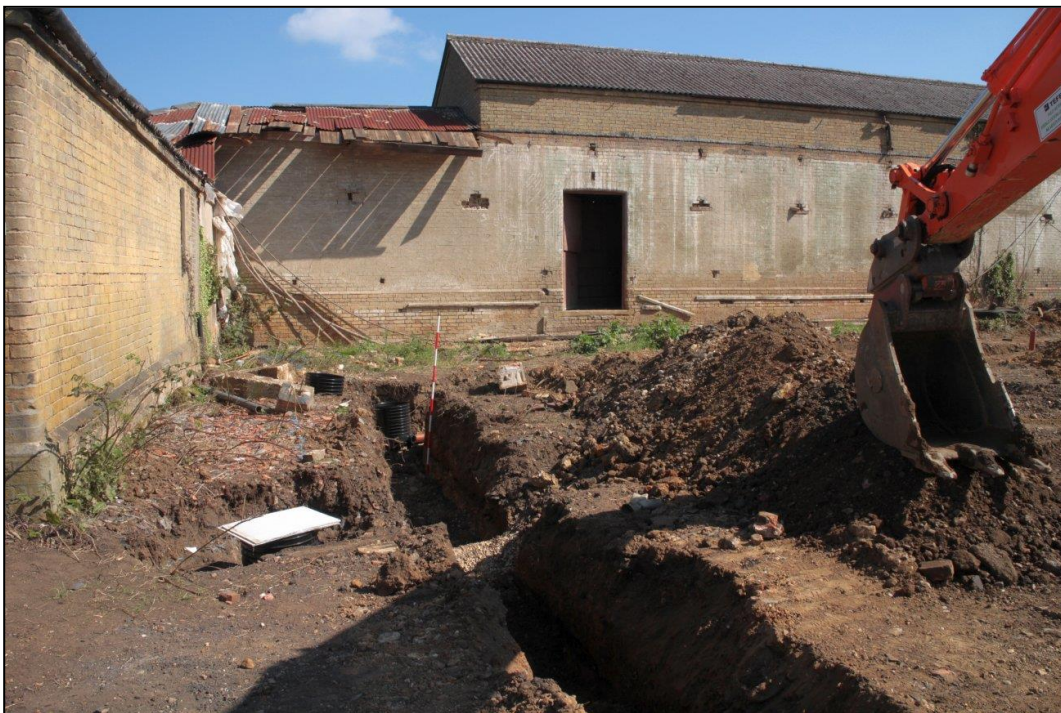
Image 2: Trench 3

Looking north showing western arm of Trench 3 (Scale 2m)

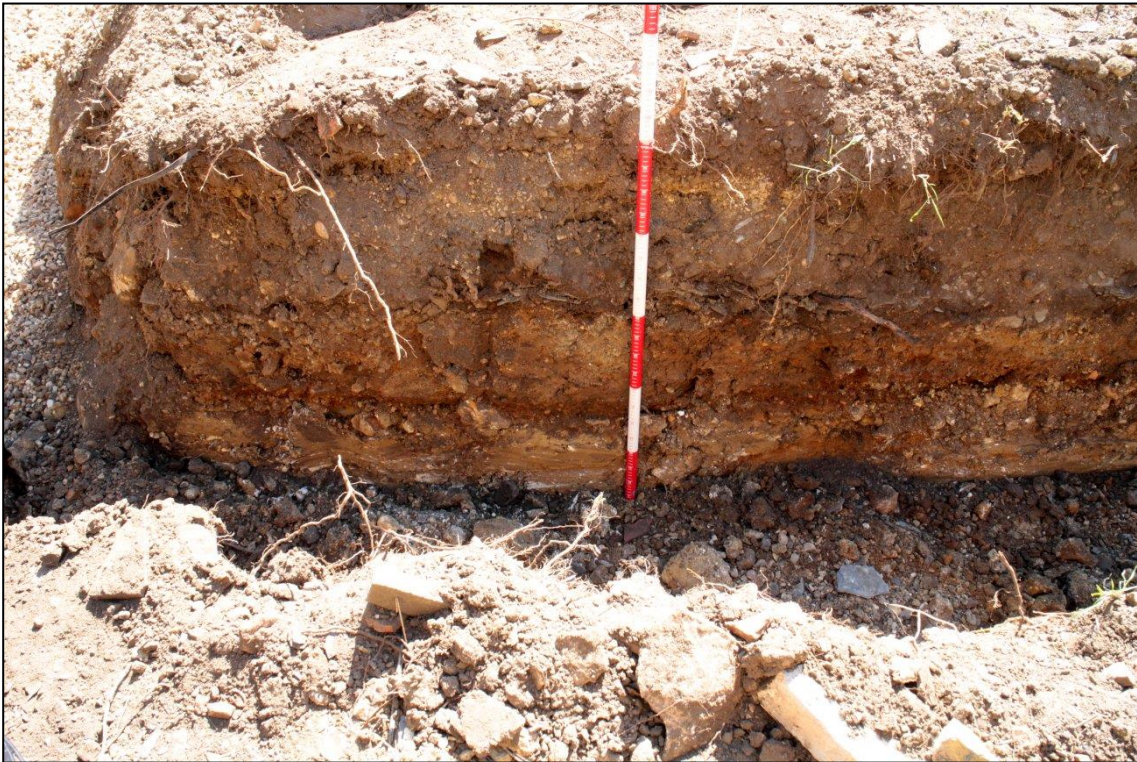
Image 3: Section 2, Trench 3

Looking east showing deposits, including roofing slate debris at base of grey upper layers
(Scale in 200mm divisions)

This slightly undulating layer (303) of black, probably organic, sandy silt with a maximum thickness of 110mm was seen in Section 3 but was not present a short distance further north in Section 2.

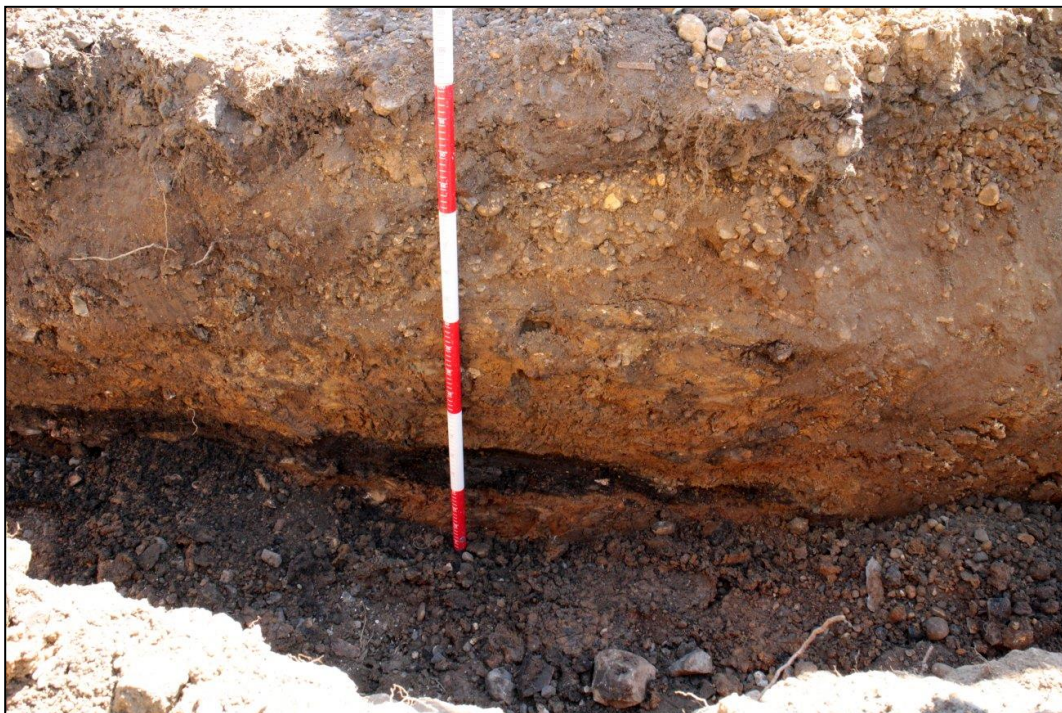
Image 4: Section 3, Trench 3

Looking east showing deposits, including black sandy silt layer (303) near base of trench
(Scale in 200mm divisions)

The nature of the deposit and its location within a farmyard could indicate an origin as a farmyard manure or animal trample in an area formerly used for animal stockyards. It was, however, found at some depth below the present ground surface (*c.*770mm).

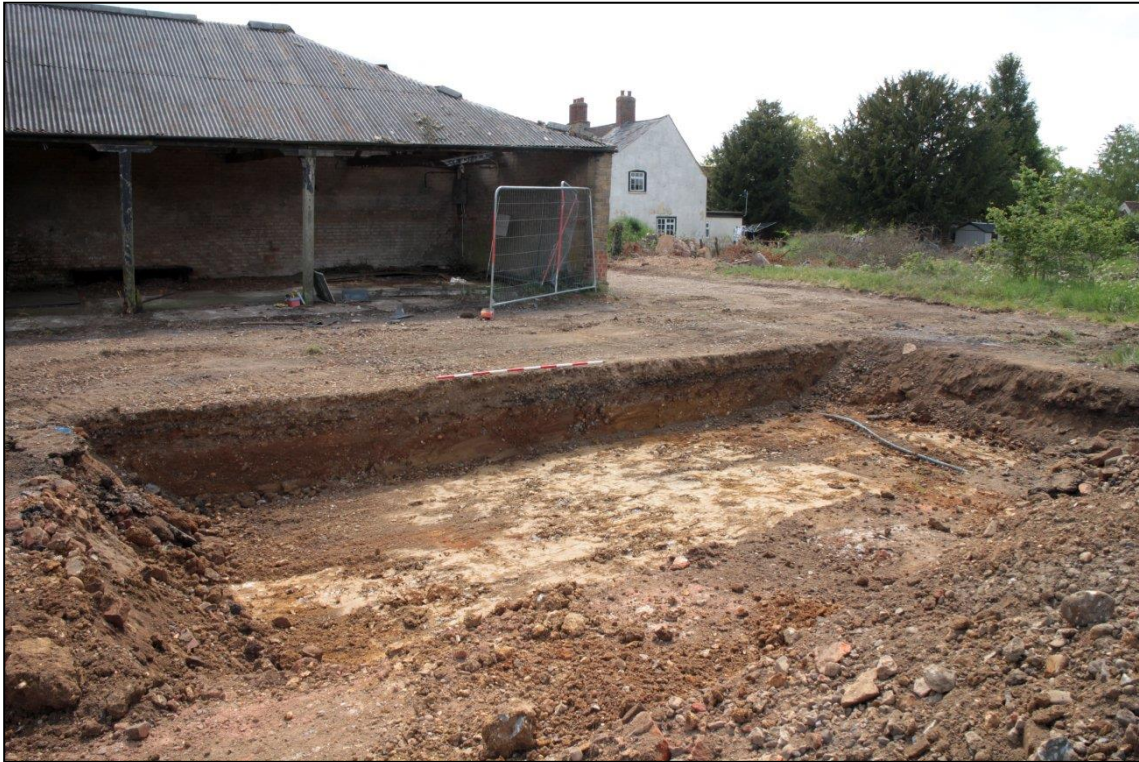
Image 5: Trench 4

Looking south-west showing trench for soakaway pit excavated to north of farm buildings
(Scale 2m)

The deposits to the north of the farm buildings were investigated in Trench 4 — a rectangular trench for a soakaway, 10m long, 5m wide and 0.8m deep. It was located approximately 6m to the north of the farm buildings.

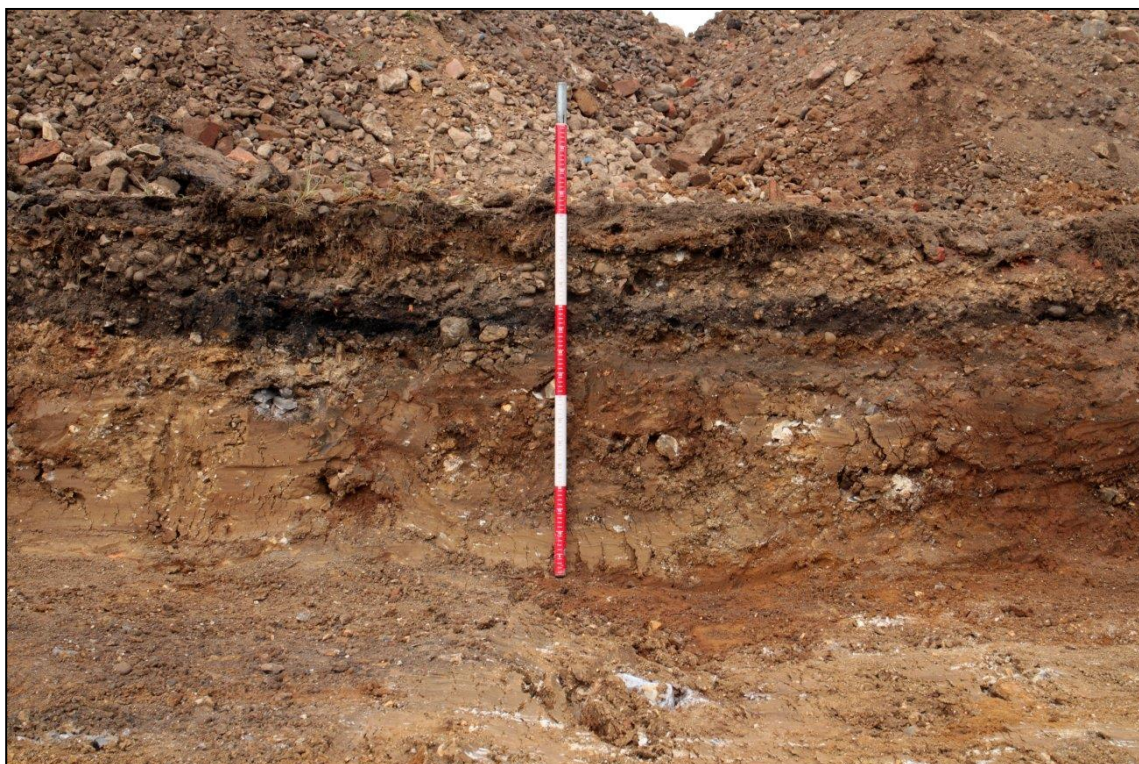
Image 6: Section 4, Trench 4

Looking north, showing layer of made ground (400, 401 and 402) above subsoil and
geological deposit (Scale 1m)

The upper 350–390mm in this trench consisted of made ground, comprising:

- an upper layer of gravel (400);
- a thin middle layer of black ashy material (401) and;
- a lower layer of rubble (402), consisting of mortar and fragments of yellow gault brick.

These layers represent imported material used to form an area of hardstanding or a track. The deposit lies just north of an open-fronted cart shed in the north range of the farm buildings, and this area may have been used for storing vehicles or farm machinery.

Below the made ground was a layer of red-brown clay (403), a subsoil layer derived from the underlying geological deposit.

The deposit in the base of Trench 4 was light yellow brown clay (404), containing flecks of chalk. This is the undisturbed superficial geological deposit, Oadby Member diamicton (boulder clay).
