VILLAGE FARM
HIGH STREET
SUTTON
BEDFORDSHIRE

HISTORIC BUILDING RECORDING

Project: VF3441
Document: 2019/61
Version: 1.0

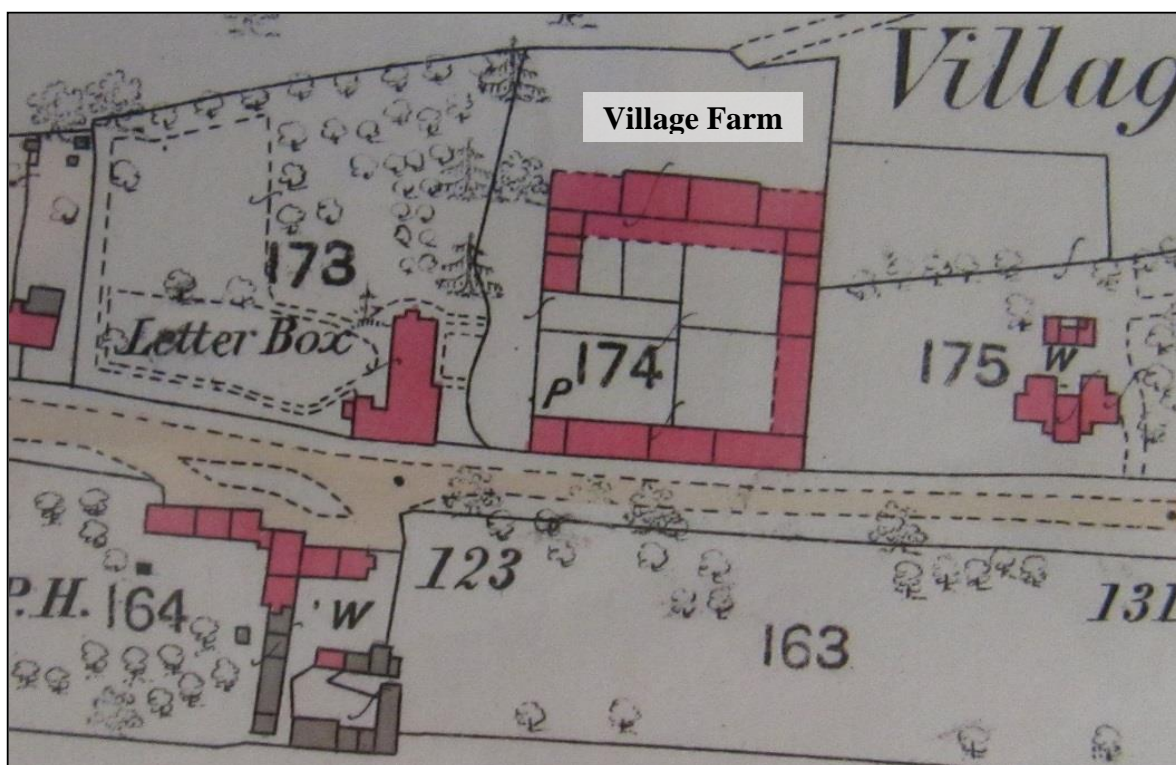
Figure 2: 1883 25-inch Ordnance Survey map
(Surveyed 1881, published 1883)

This map was surveyed in 1881 and published in 1882 (Bedfordshire sheet VIII-7). It is the earliest large-scale, topographically accurate map of the area. The first edition 25-inch maps were colour-coded to indicate the building materials (carmine for brick and stone and grey for timber and iron). Dashed lines were used to indicate open-fronted sections of a building.

The plan shows the adjacent farmhouse with a substantial garden which included coniferous trees along the boundary with the working farm area. The farm buildings are accurately mapped, including the internal subdivisions with only one internal division in the south range not shown (compare with existing plan Figure 6). The east range has one open-fronted compartment facing the courtyard and at both ends of the north range are open-fronted compartments facing outwards. In the north side of the yard is a narrow open-sided section corresponding to the lean-to on this side. The yard area is shown subdivided into a number of compartments. A rectangular section aligned east-west presumably formed the access into the yard and the access to the separate stock pens. The open-sided compartment and lean-to at the north would have been used as shelter sheds for animals in the pens around the north and east sides of the yard.

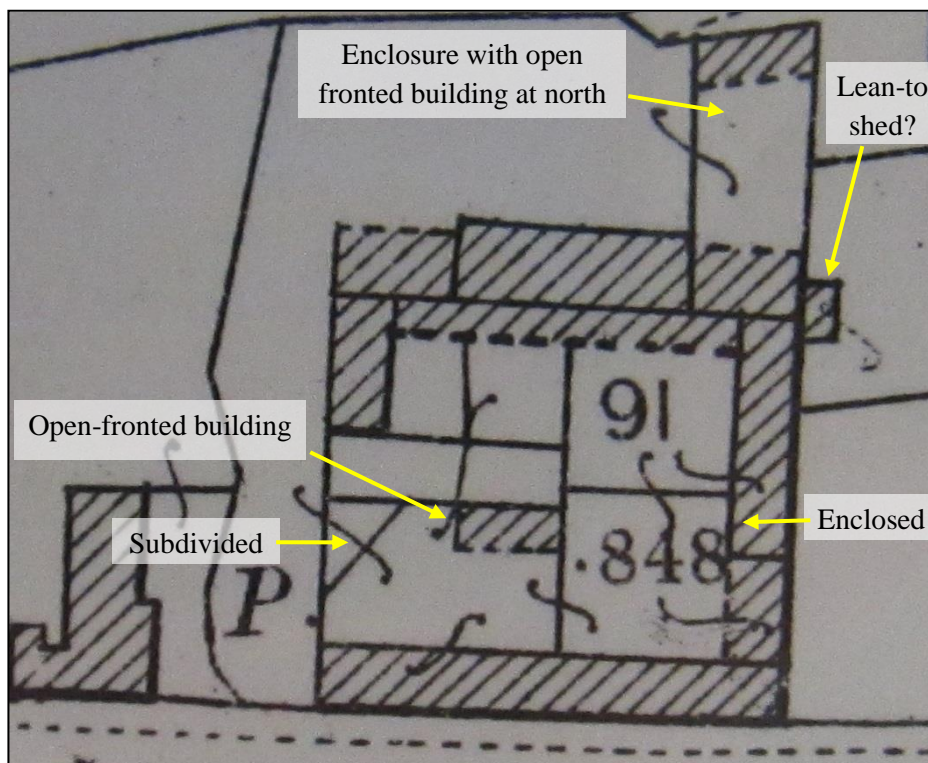
Figure 4: 1901 25-inch Ordnance Survey map

The second edition 25-inch OS map was revised in 1900 and published in 1901 (Bedfordshire sheet VIII-7). The later editions of the 25-inch map omit details of the internal subdivisions but still distinguish between the enclosed and open-sided sections of the buildings.

(Surveyed 1900, published 1901) (Annotated to show changes from previous edition)

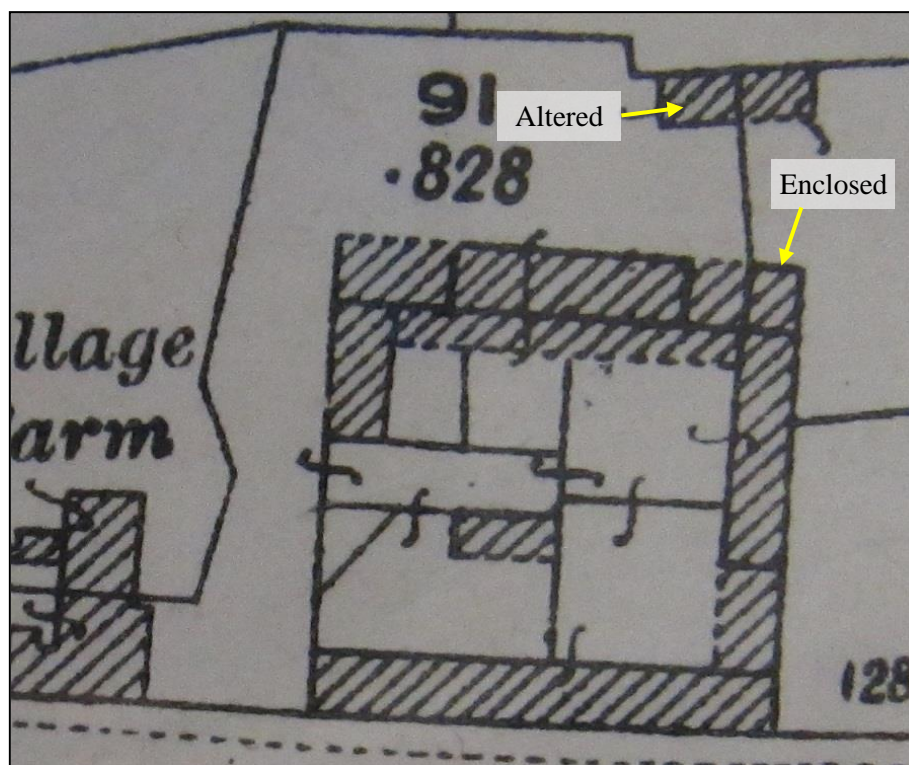
Figure 5: 1926 25-inch Ordnance Survey map

The third edition 25-inch OS map was revised in 1924 and published in 1926 (Bedfordshire sheet VIII-7). The 1926 edition of the map is very similar to the preceding edition with a few changes to the buildings at the north-east corner. The easternmost compartment in the north range was subdivided to form two sections; the one on the north-east corner was enclosed while the other half appears to have remained open-fronted. The small enclosure at the north-east was replaced by a single boundary and the associated building to the north of the farmyard was partly enclosed.

(Surveyed 1924, published 1926) (Annotated to show changes from previous edition)

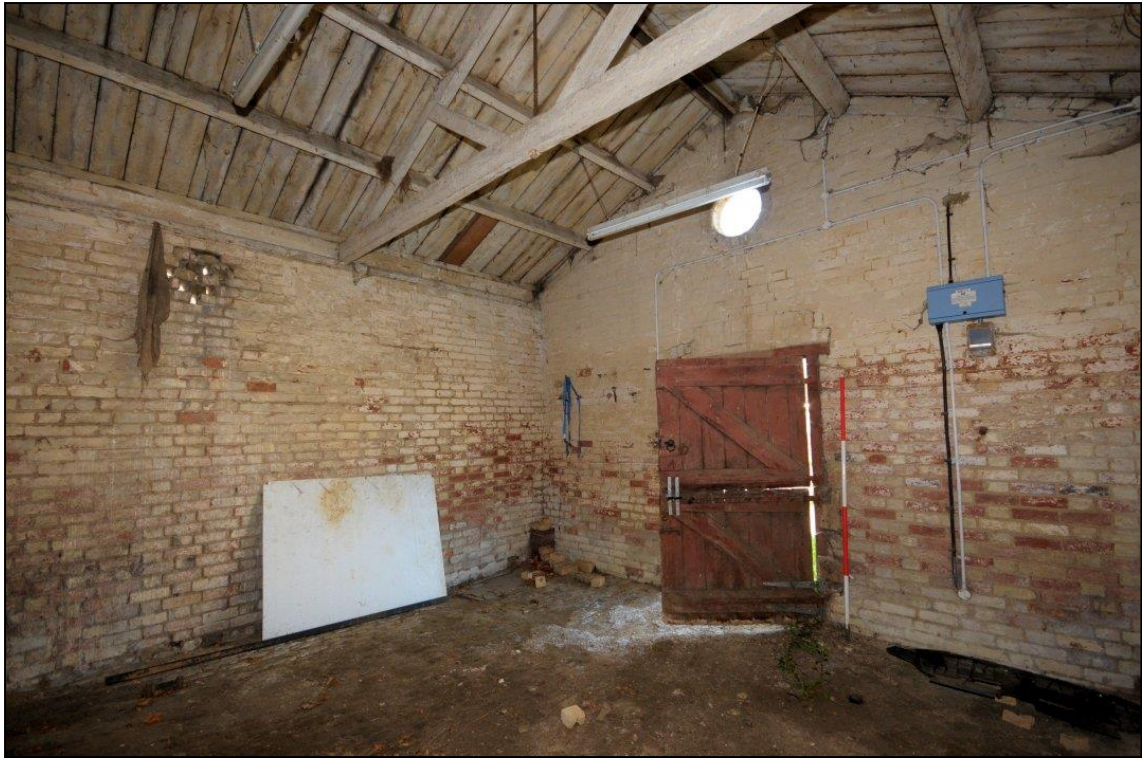
Image 7: South range: C1, looking south-west
Showing door in west wall (Scale 2m)

This is an approximately square compartment, measuring 4.9m east-west (Images 7 and 8). It is accessed by a stable door in the west end of the range. There is also a hatch with a plank-and-batten door set close to floor level at the west end of the north wall, in an opening 1.08m wide by 0.93m high. The floor is made of gault bricks aligned east-west; it is heavily worn and repaired with concrete. The only internal fittings are two tether rings set in the east wall *c.*1.8m above the floor. A band of brickwork on the east wall not covered by whitewash could indicate the former location of a feed trough (Image 8).

This compartment appears to correspond to a loose box listed in DV1/H10. This is probably consistent with its original use, having tether rings on the east wall and a low-level hatch, which was most likely used for mucking out.

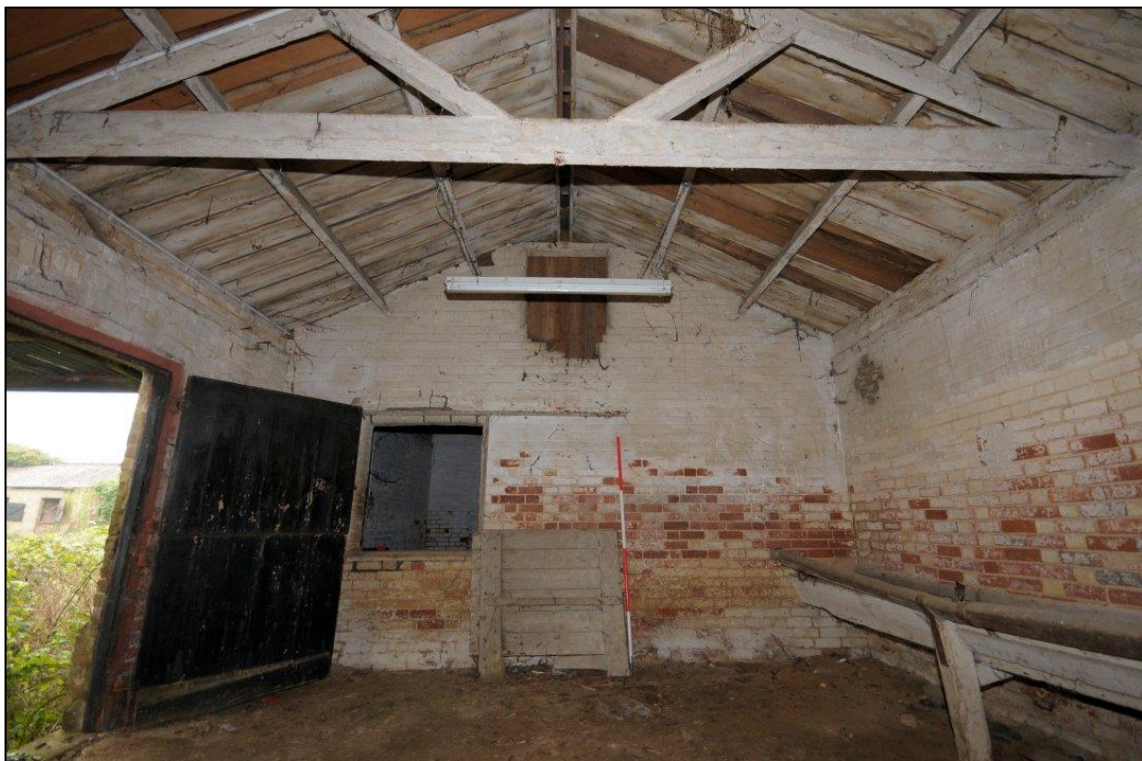
Image 10: South range, C2, east end, looking east

Showing opening to C3 in east wall with detached sliding shutter (Scale 2m)

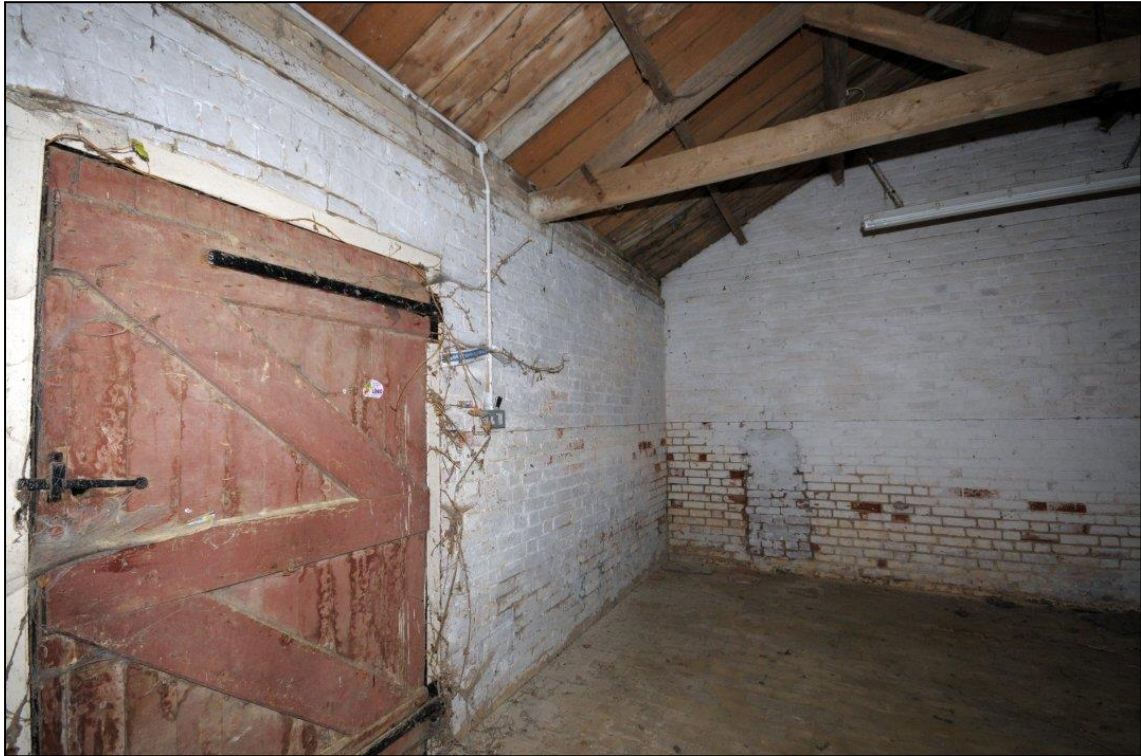
Image 13: South range: C3, looking north-east

This is an approximately square compartment, measuring 4.97m east-west (Image 13). It is accessed by a door in the west end of the north wall. The floor is in gault brick, aligned north-south. An internal 'window' to C2 has been noted above. Three ventilation holes in the lower part of the north wall in this compartment have been blocked with bricks. In the east wall is a roughly rectangular hole, in-filled with brick. The irregular edges of the hole indicate that it was cut into the wall rather than part of the original construction (Image 13).

Showing door in front (north) wall and blocked hole in east wall

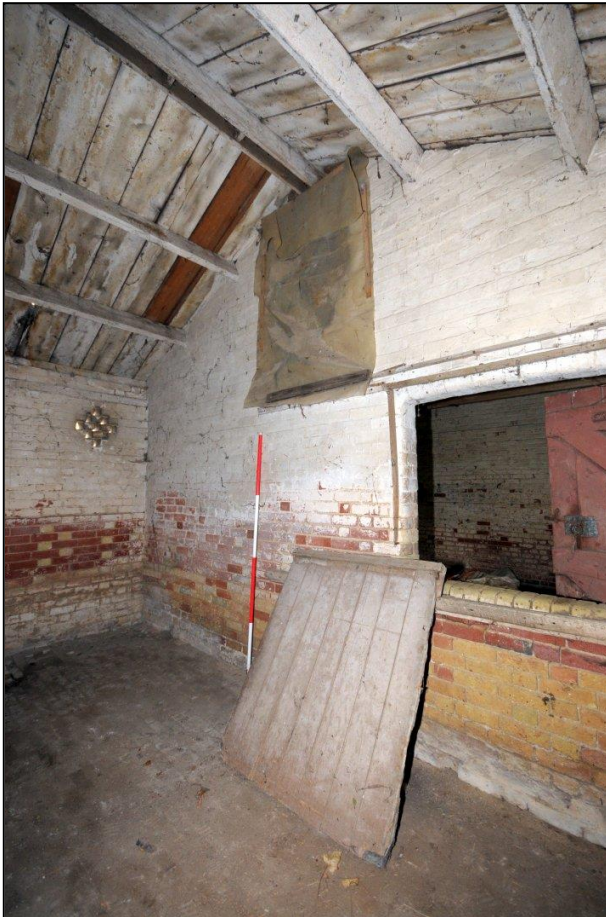
Image 19: South range, C5, west end,
looking south-west

Showing opening to C4 with detached
sliding shutter leant against wall
(Scale 2m)

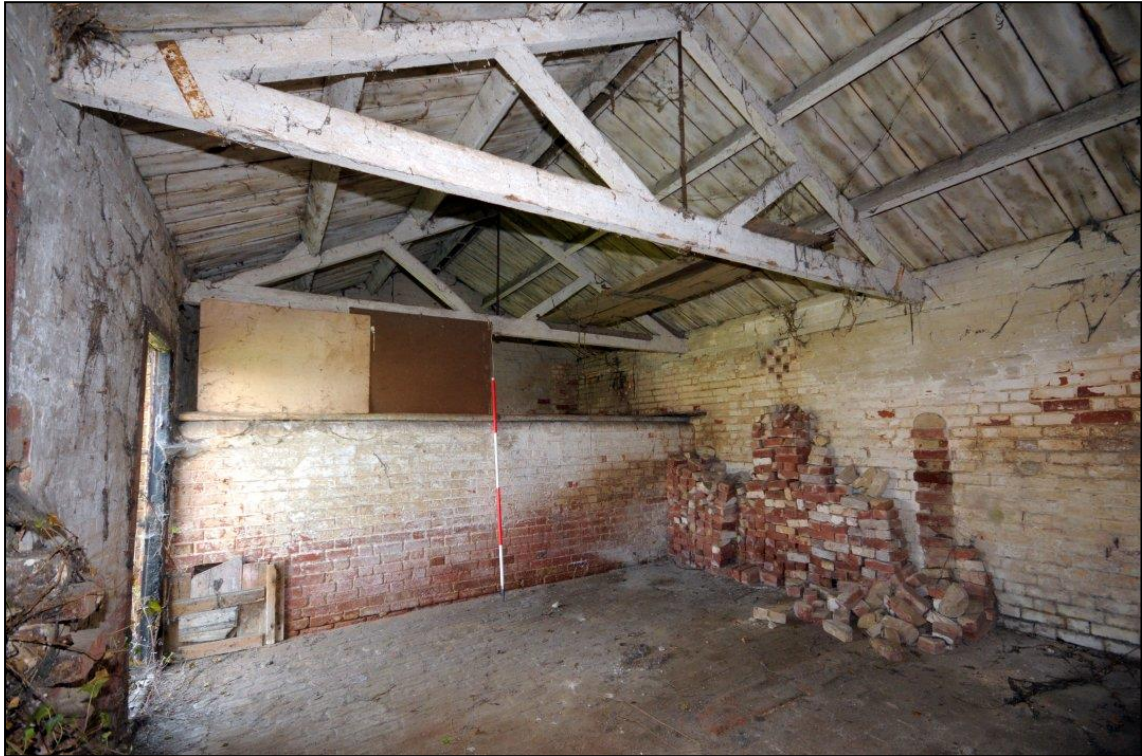
Image 27: East range: C7, looking north-east

Showing wall scar at right, left by demolished stable partition (Scale 2m)

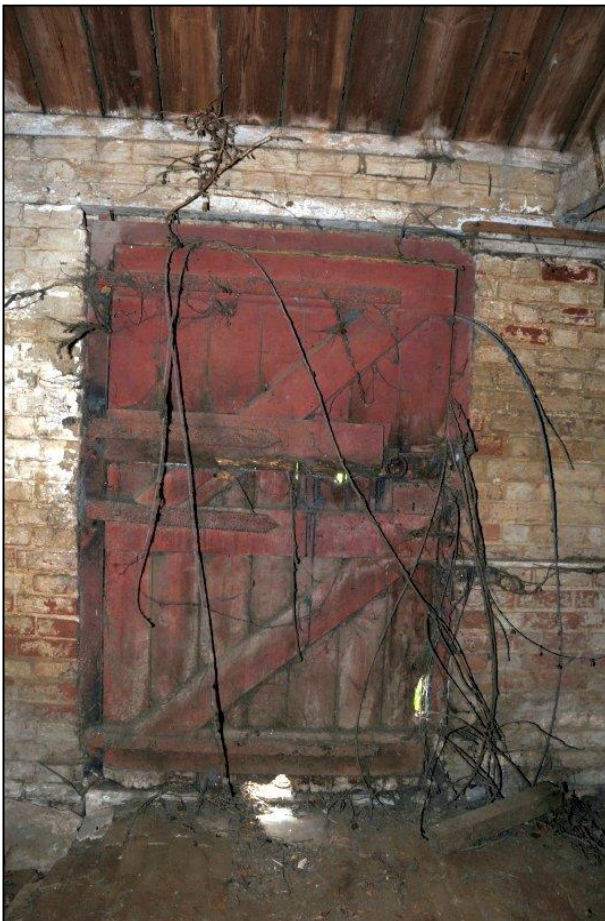
Image 32: East range: C9, detail showing external (east) door

Door modified by sawing into two parts to form a stable-type door

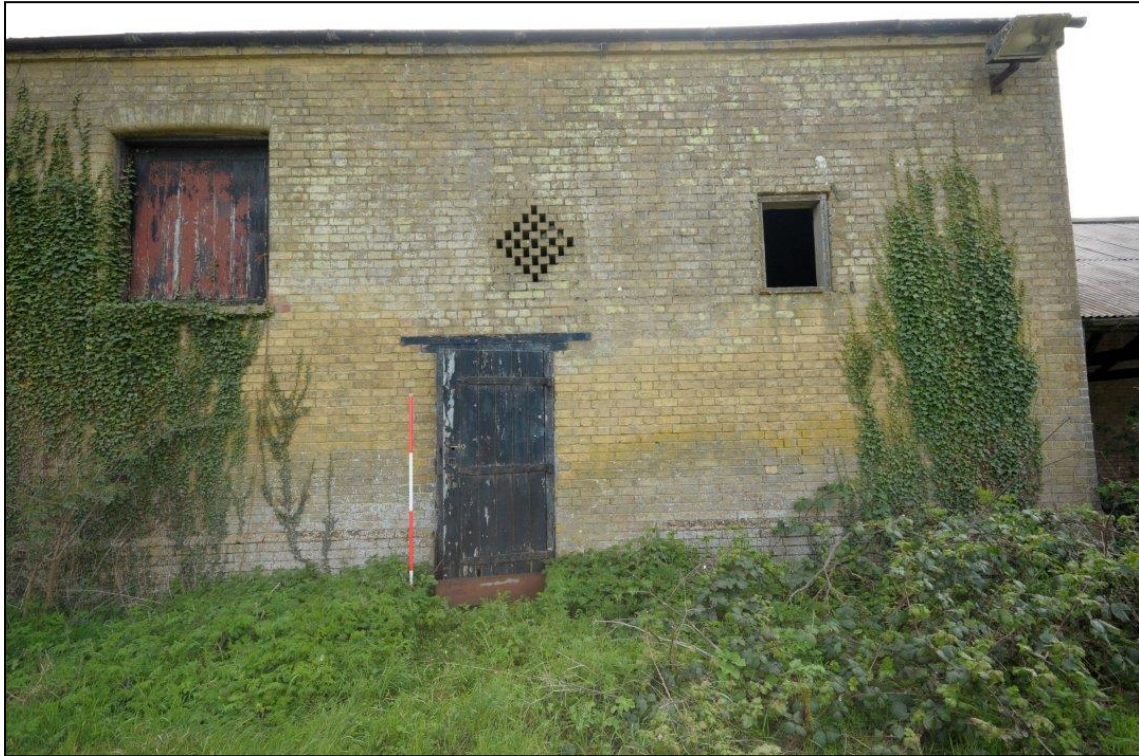
Image 35: North range, external elevation, detail of barn C12

The buildings are the result of a single construction phase with some minor later alterations and repairs. Structural alterations comprise the insertion of a cut-in door and high-level opening in the north side of compartment C12; and the

Showing taking-in door and honeycomb vent with later (cut-in) features comprising the door and the small opening (Scale 2m)

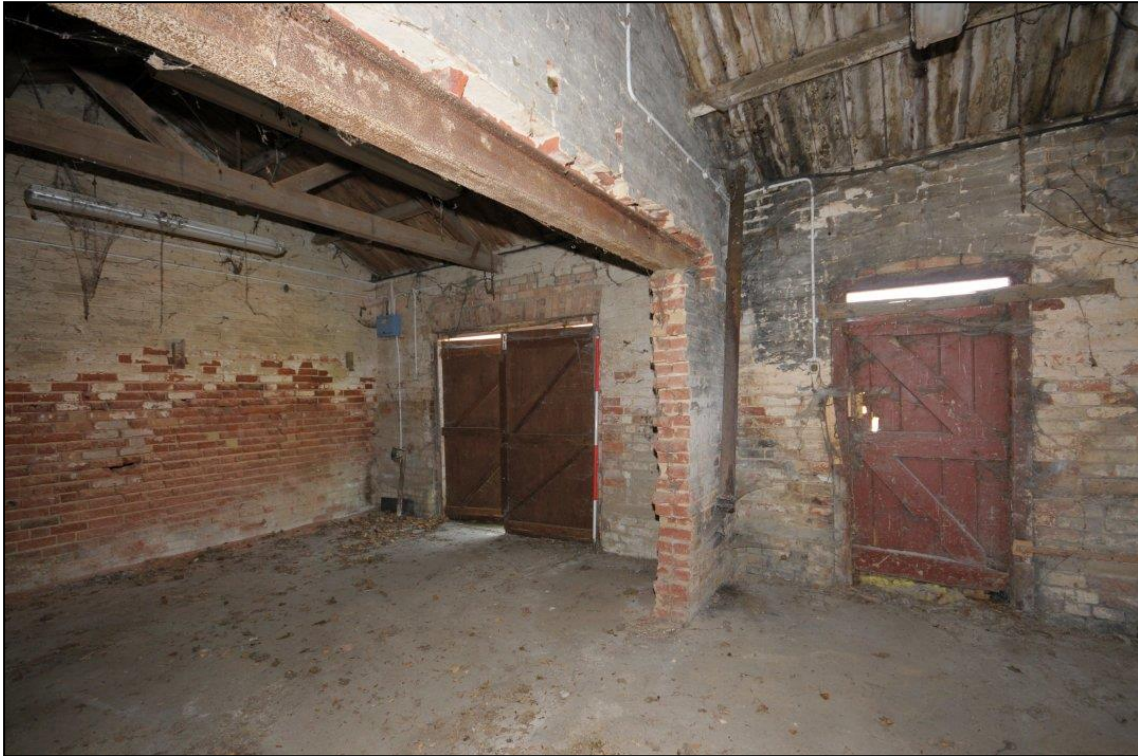
Image 45: West range: C14-C15, looking south-west

merging of compartments C14 and C15 by knocking through an internal cross-wall. The roof would have probably been in slate throughout but a large proportion has been replaced in corrugated asbestos concrete and corrugated iron. A pole barn type shelter has been constructed in the south side of the yard.

have been replaced with modern plywood doors. On the interior, the arch above the doorway has been rebuilt in modern brickwork, which contrasts with the original shallow segmental arch in the exterior elevation. The floor in C14 and C15 is concrete.

Showing knocked-through opening with RSJ between C14 and C15 (Scale 2m)

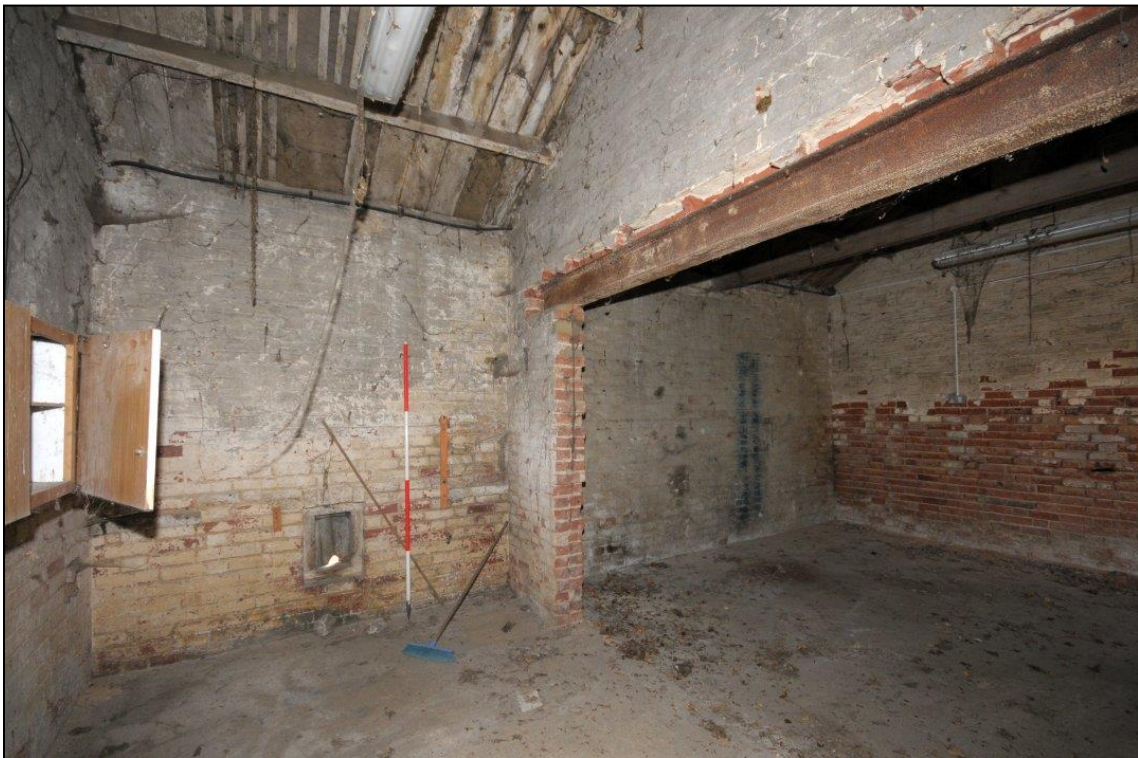
Image 46: West range: C14-C15, looking south-east

Showing rear (east) wall with small opening in lower part of wall of C14 (Scale 2m)
