**BAPTIST CHAPEL
HIGH STREET
THURLEIGH
BEDFORDSHIRE**

HISTORIC BUILDING RECORD

Project: BCT3488
Document: 2019/41
Version: 1.0

Produced for:
PJH Developments Ltd

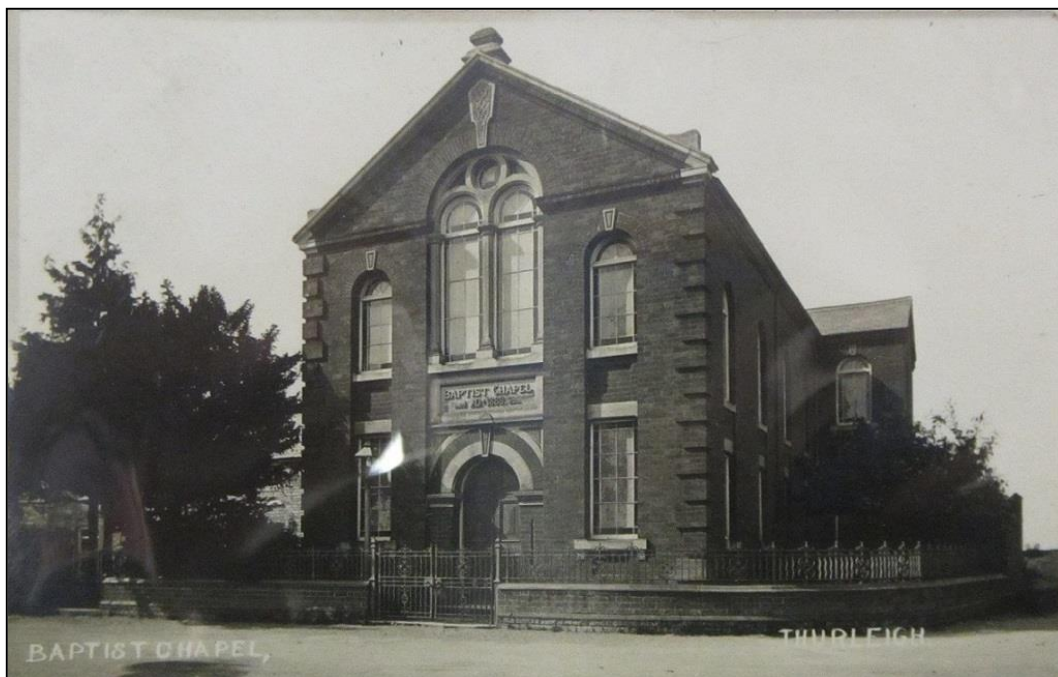
Figure 4: Postcard, view of chapel from south-east

Undated postcard c.1920 (Bedfordshire Archives and Record Service ref: X396-242)

Bedfordshire Archives and Records Service have several historic postcard images of the chapel dating from between c.1900 and 1920. Two of these have been selected to illustrate the building prior to 20th century alterations (Figure 4 and Figure 5).

The images show a boundary wall topped with iron railings and gate. The railings were removed after being requisitioned during World War II. The postcards also show original details of the windows and roof. As first built the window glazing had margins filled with tinted, coloured glass.

The historic postcard images show that the raised section of the boundary wall at the north-east corner of the building was present by the early 1900s. These images appear to show that this part of the wall enclosed a roof, sloping down towards the east end of the school room. Presumably this was a lean-to structure for outside toilets (mentioned in 1888 as the planned 'outside offices' which did not form part of the original construction contract).

Details of the roof shown on the postcards include: a projecting stone pediment on south gable with stone blocks at the ridge and eaves (acroteria); a metal vent in the centre of the ridge of the chapel roof and chimneys on the rear wall of the schoolroom block. All of these details on the roof have been removed during later repairs and the original slate roof replaced with concrete interlocking tiles.

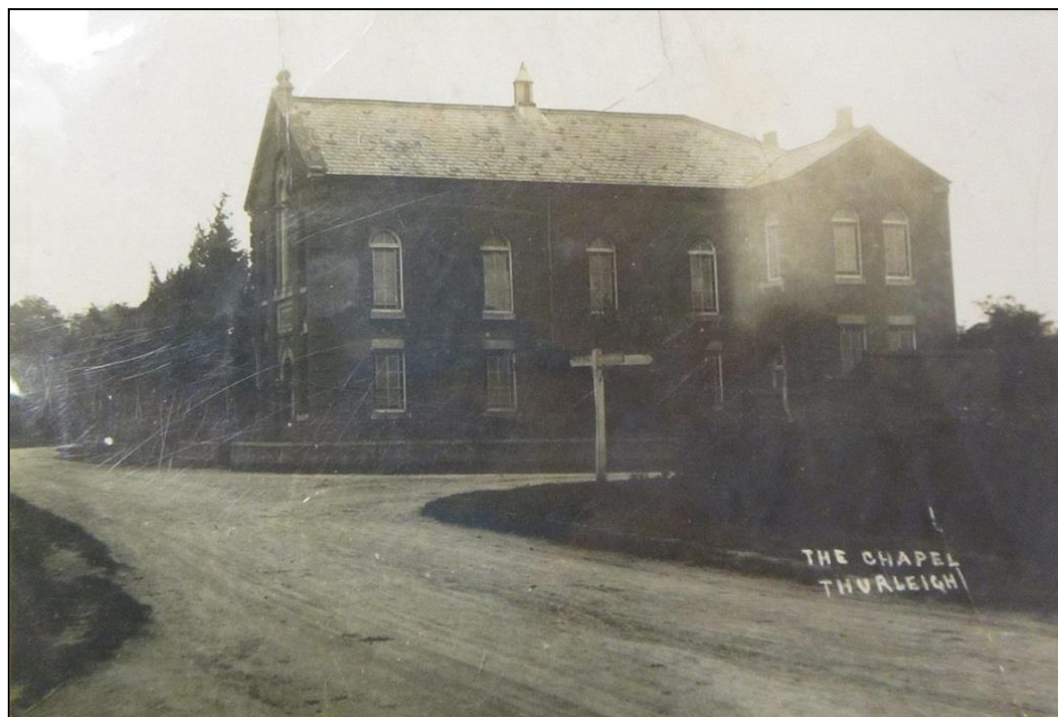
Figure 5: Postcard, view of chapel from the east

Postcard postmarked 1920 (Bedfordshire Archives and Record Service ref: Z1306-122-5-3)

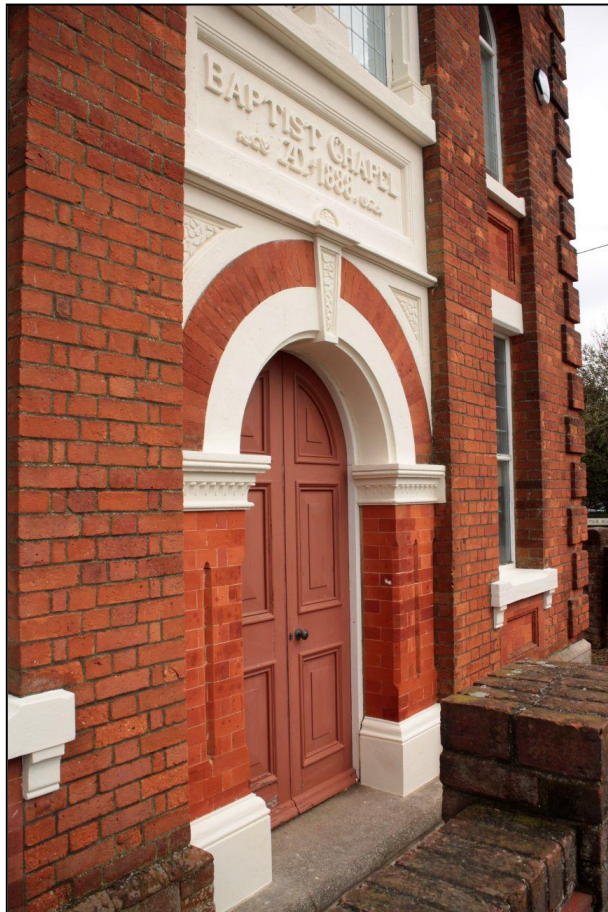
Image 7: South elevation, detail
(oblique)

Oblique view of elevation, looking
north-west

This is the most architecturally elaborate elevation with projecting brick quoins and a decorative treatment to the door and windows (Images 5 to 7). The brickwork is in an evenly fired orange-red brick with gauged/rubbed brick details. At the base is a brick plinth with a plain chamfer, approximately 500mm above ground level on this side where the ground rises slightly towards the street frontage.

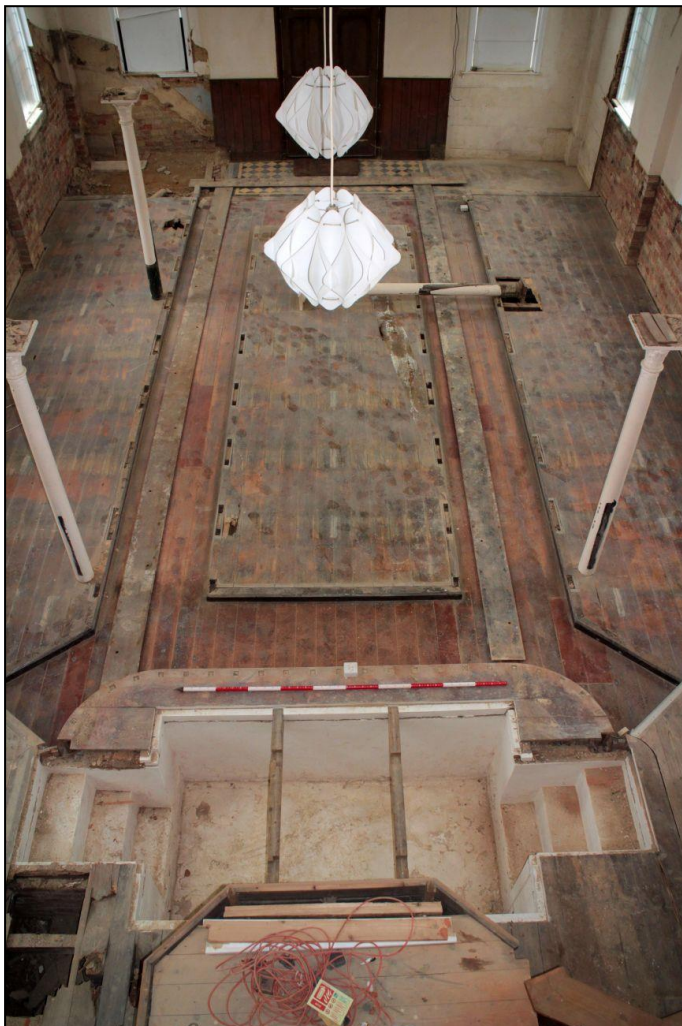
Image 12: Chapel, seen from Upper School Room

Note the long strips of material in the aisles and across the tiles near the south door are metal plates that would have formed part of the supporting structure on top of the columns which formerly held the gallery (Scale 2m)

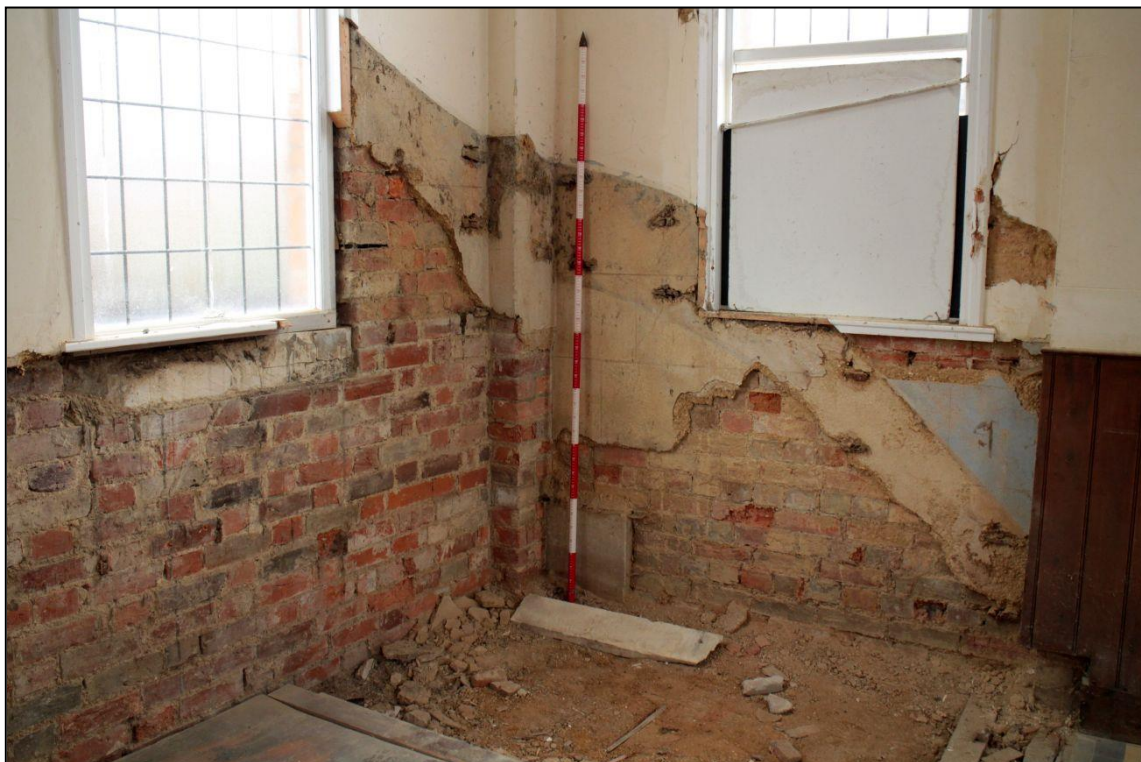
Image 16: Chapel, detail of south-east corner

Shows location of the former stairs with 'ashlar' lines scored in plaster and traces of blue paint (Scale 2m)

Evidence indicated a matching stair in the south-east of the chapel that had been removed during an earlier phase of alterations. Missing plaster near the south end of the west wall corresponds to the position of the wall string for the stair (Image 13). Images taken before the gallery was removed show a matchboard panel with a slightly darker finish to the rest of the woodwork which had been inserted to block the top of the removed stair (Image 27).

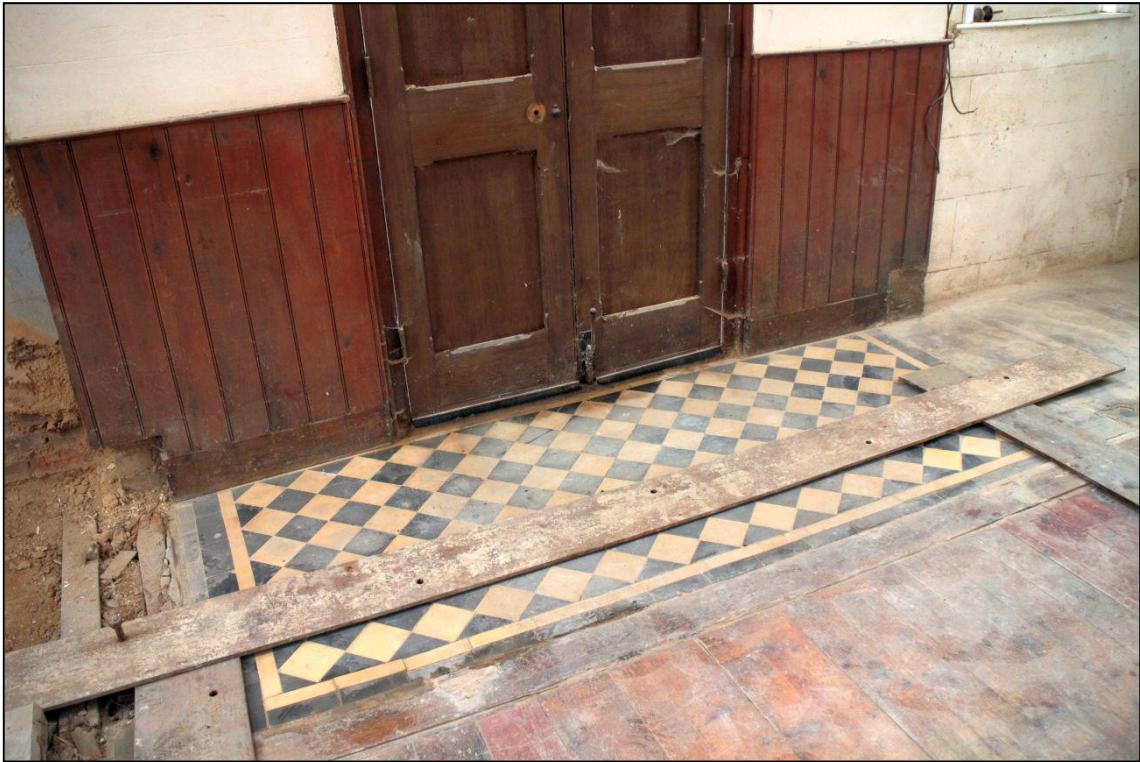
Image 17: Chapel, detail of front entrance

Looking south-west showing tiles inside the south door

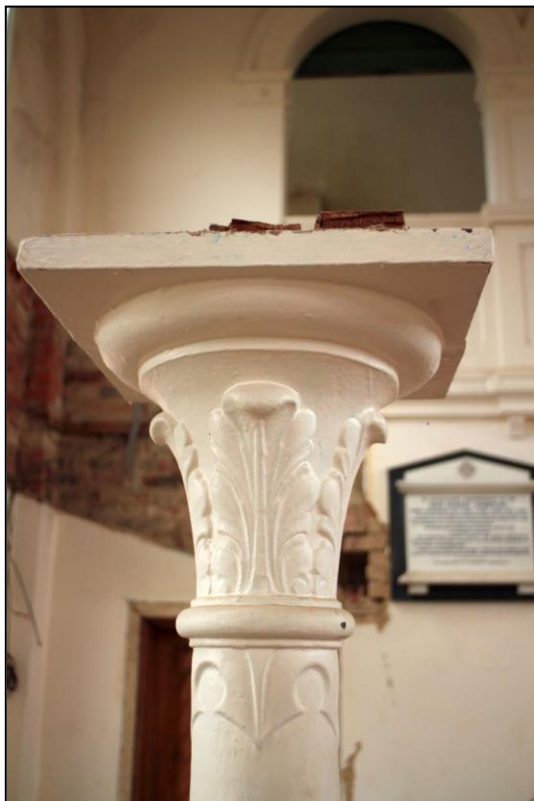
Image 18: Chapel, detail of column

Detail showing decoration at top of cast iron column

The gallery was supported by four cast iron columns set on brick foundations beneath the suspended floor. These have acanthus type decoration on the capitals (Image 18).

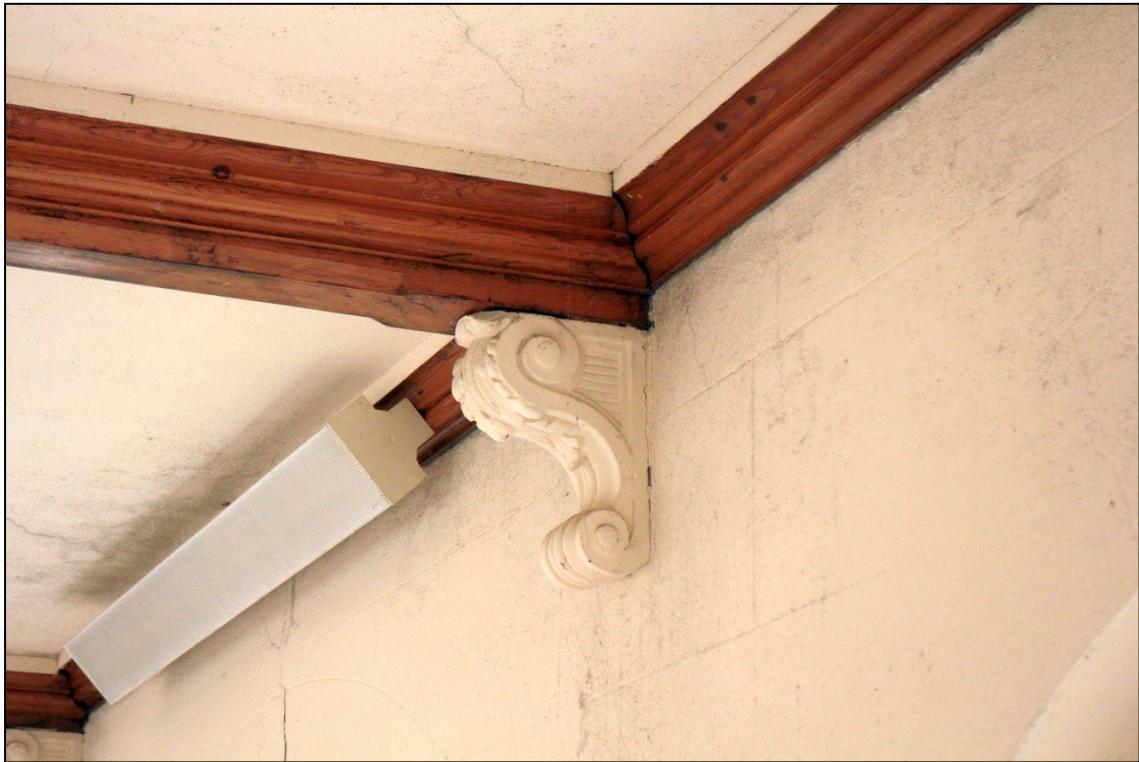
Image 19: Chapel, detail of ceiling corbel

View from gallery showing corbel and ceiling beam

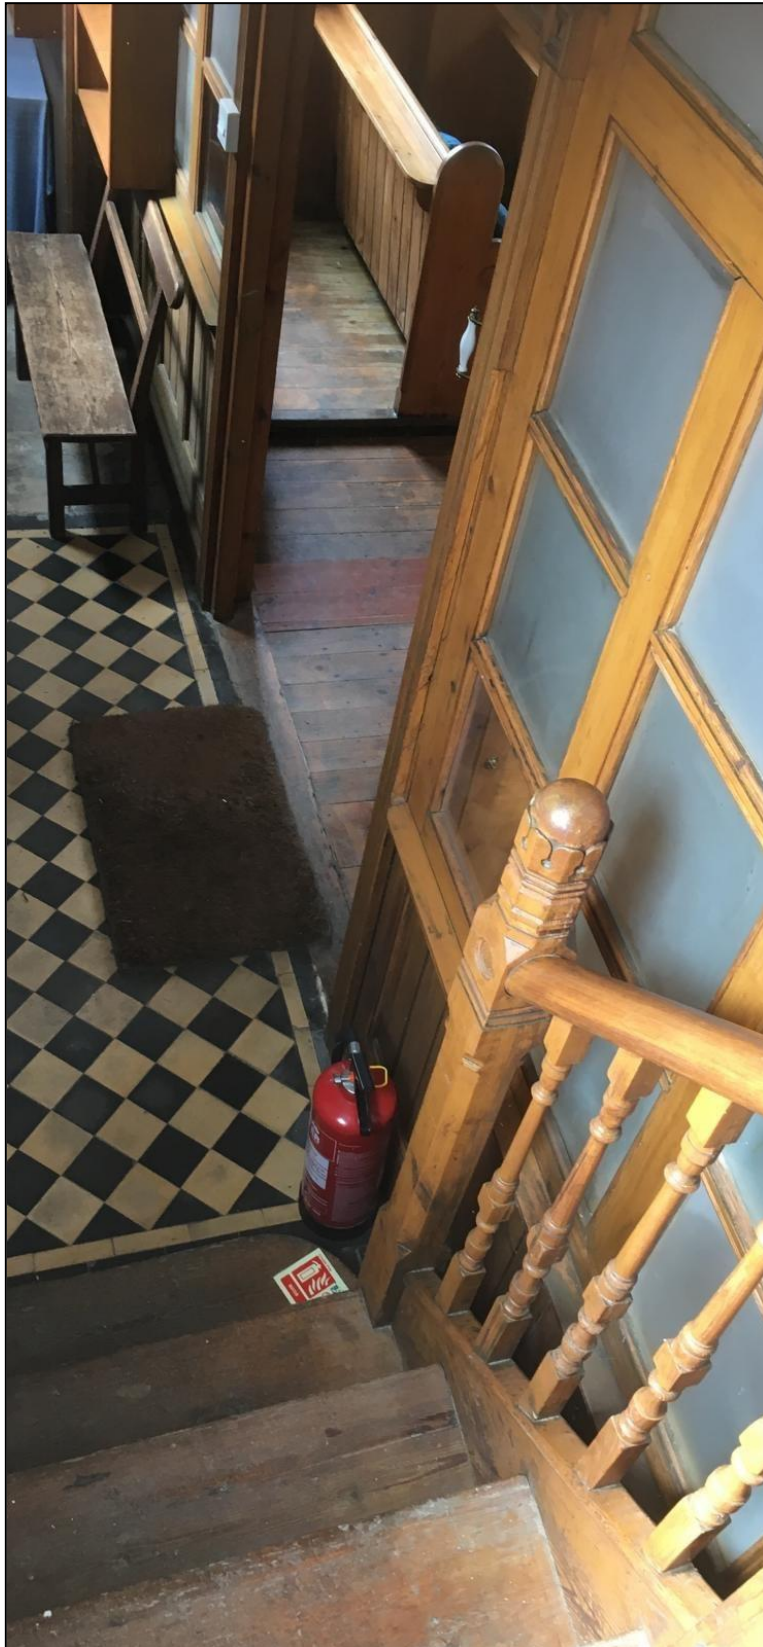
Image 24: Chapel, entrance lobby seen from stairs

Looking west from stairs to gallery

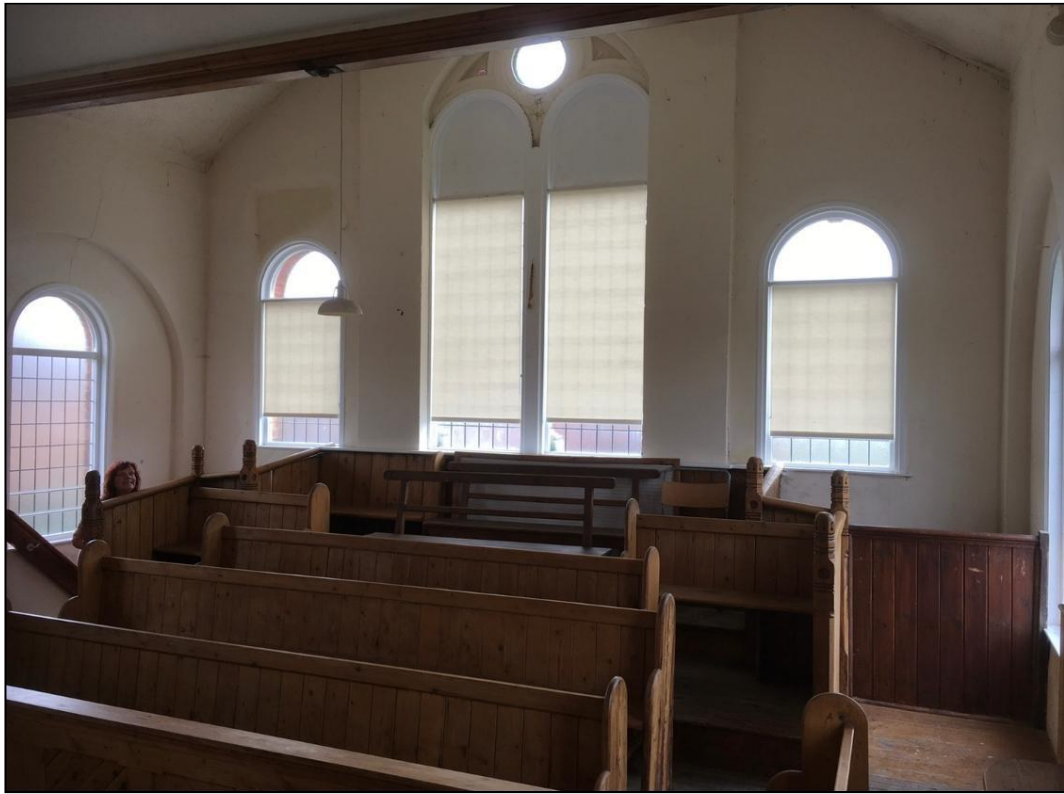
Image 27: Chapel, gallery looking south-east
Shows blocked former stair at right of image

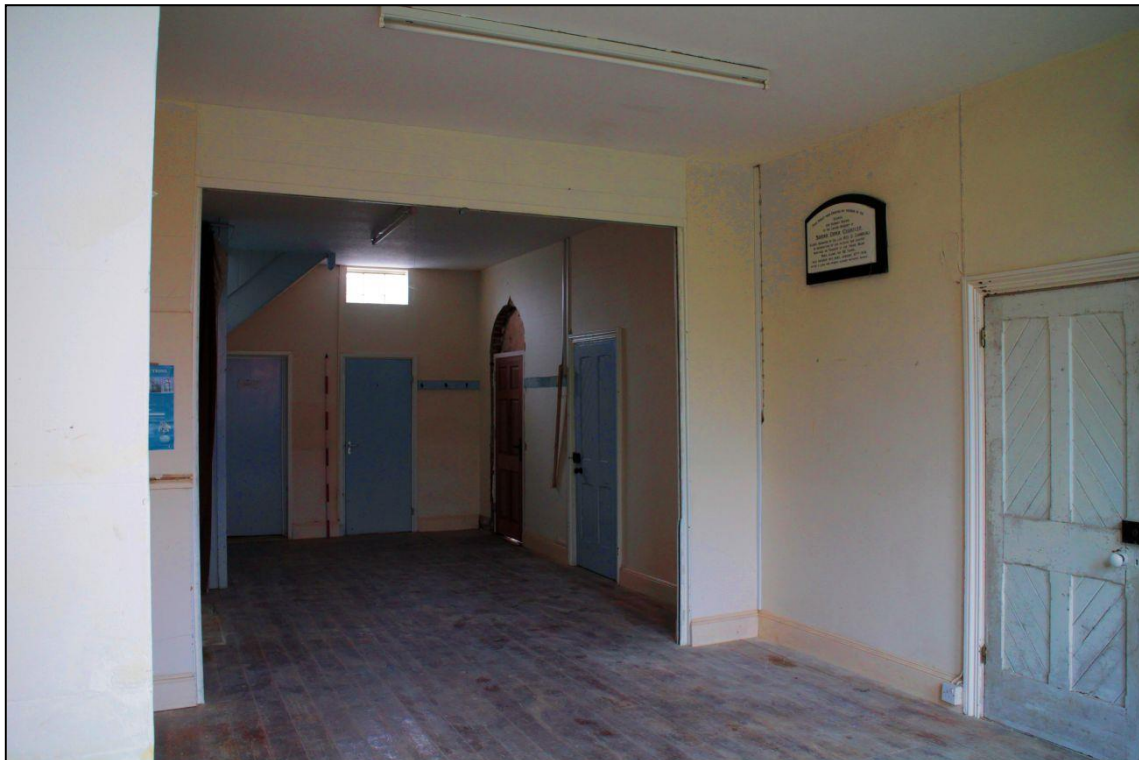
Doors in this room comprise two external doors in the south wall, two doors internal doors into the chapel (Image 30), a plain four panel door on a cupboard under the stairs and two modern flush doors to a kitchen and toilet off the east end of the room (Image 31). The external doors are modern units which have been recently fitted. The internal doors in the chapel are framed panel doors, included above in the description of the chapel.

Image 28: Lower School Room, looking east
Shows doors to chapel at right (Scale 2m)

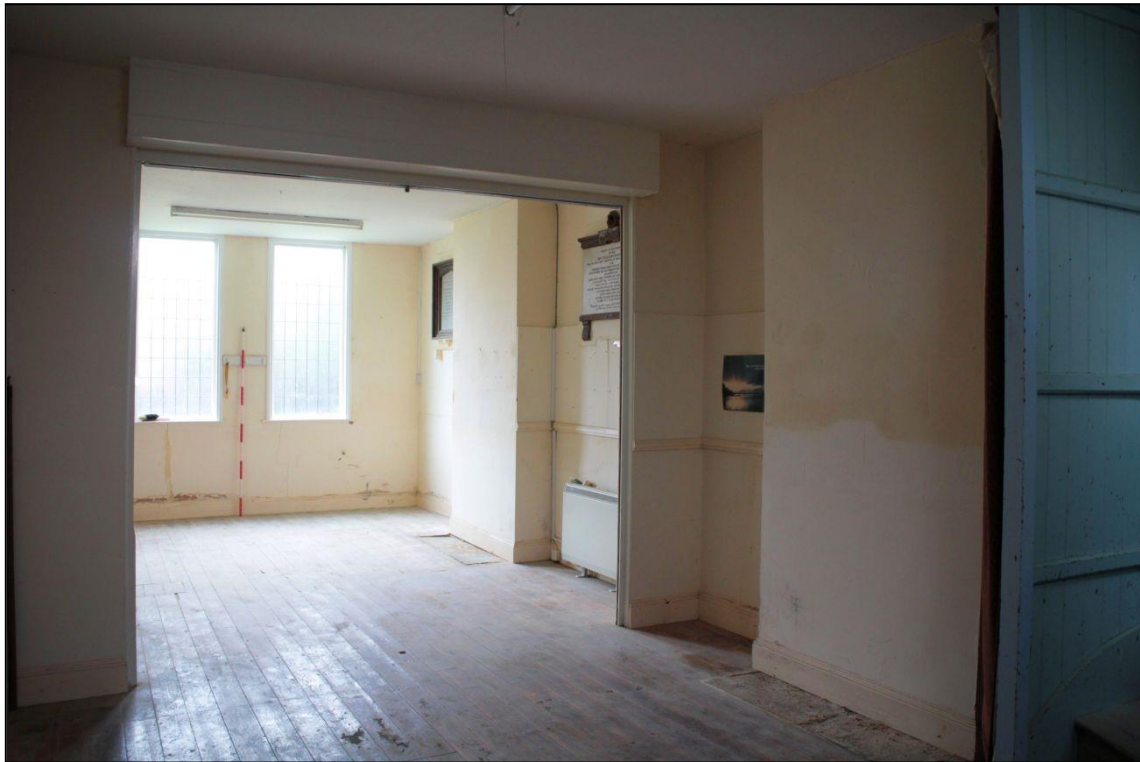
Image 29: Lower School Room, looking north-west

Shows blocked chimney breasts on north wall and roller shutter above middle of room (Scale 2m)

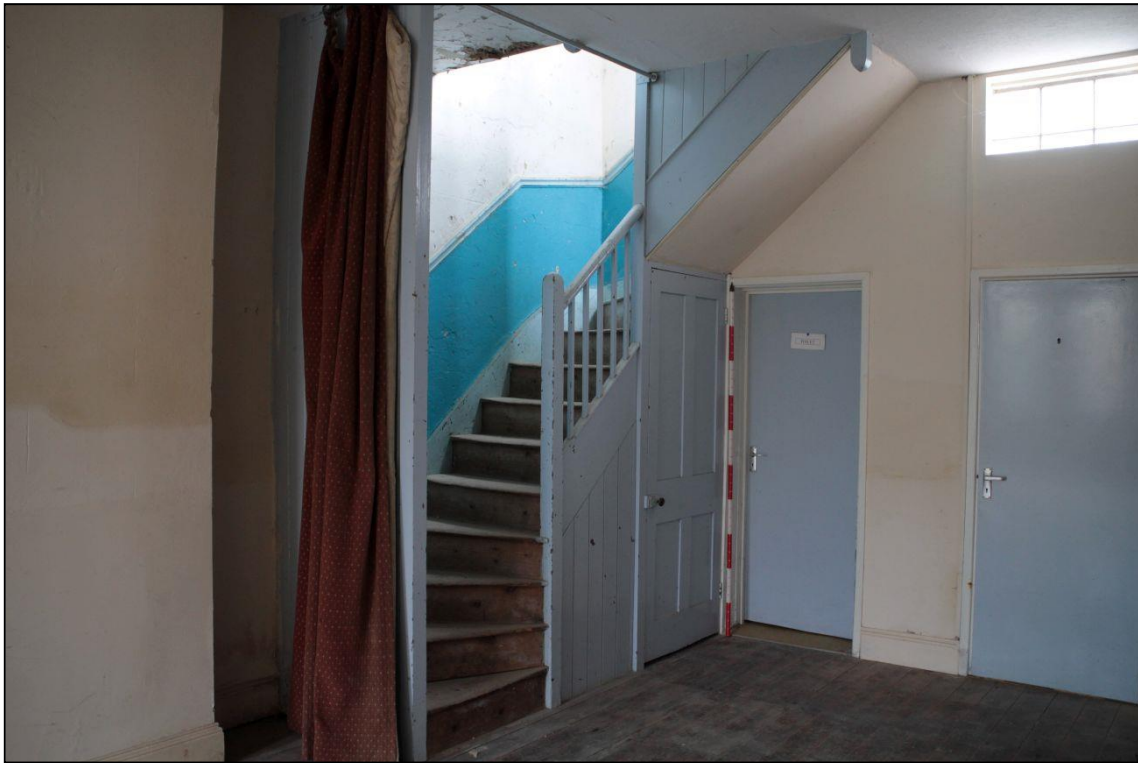
Image 31: Lower School Room, detail of stairs

The walls have traces of inscribed lines imitating ashlar stonework, but this has been partially obscured in places by re-plastering or repairs. The walls are painted in off-white/cream colour apart from on the stairs where the section below a dado rail is painted in a bright light blue (Image 31). Much of the woodwork in this room is painted pale light blue; including the woodwork enclosing the stair, two doors in the east wall and the eastern door into the chapel.

Stairs in the north-east corner of the room lead to the upper school room. This is an L-shaped corner stair with a winder section at the base and two straight flights with winder steps at the corner (Image 31). A short length of balustrade on the lower part of the stair has a plain square newel post and stick balusters.

Looking north-east showing stairs to first floor with modern doors to W.C. and kitchen to the right (Scale 2m)

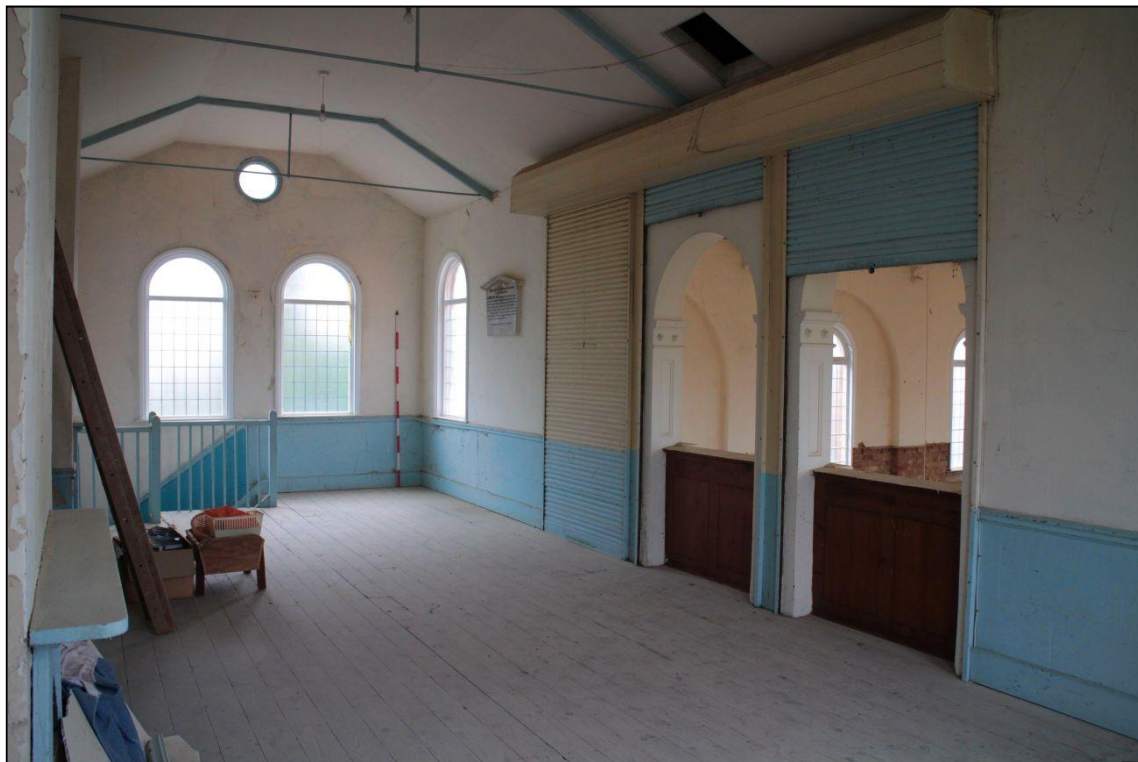
Image 32: Upper School Room, looking east

Showing openings overlooking chapel to right with roller shutters (Scale 2m)

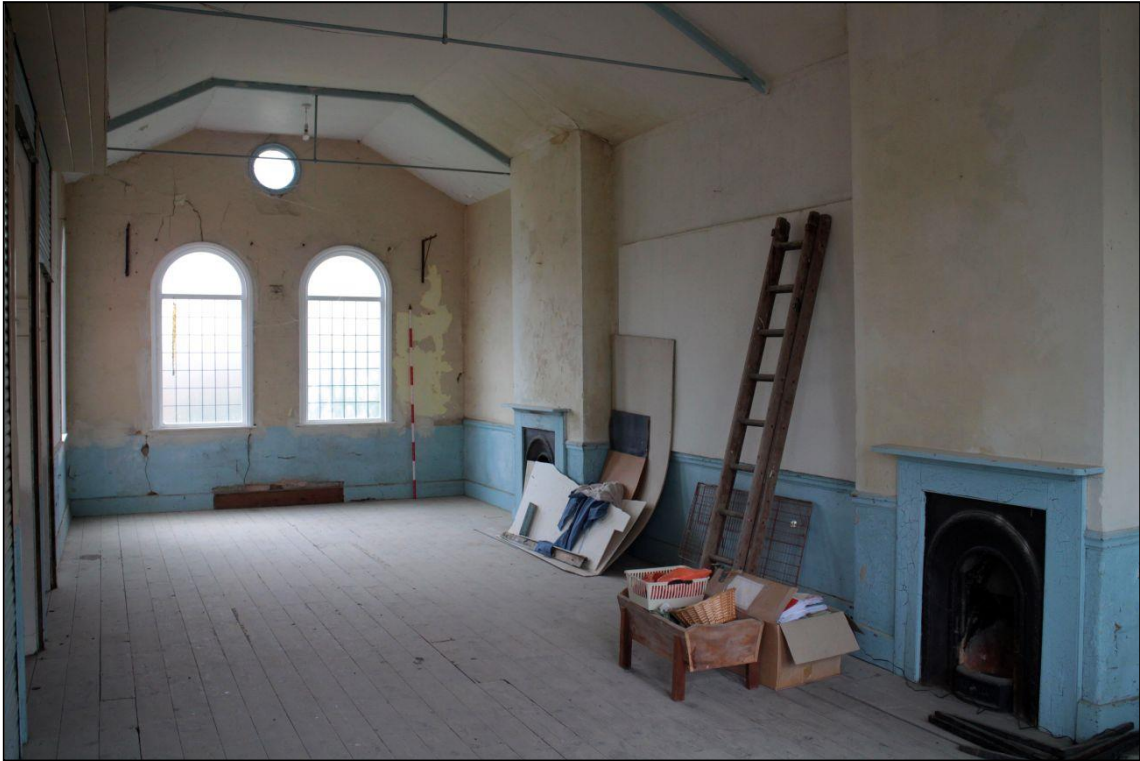
Two former fireplaces on the north wall have been blocked up and plastered over (Image 29). The chimney breasts remain in place with small hearth stones in the floor.

Image 33: Upper School Room, looking west
Showing fireplaces on north wall at right (Scale 2m)

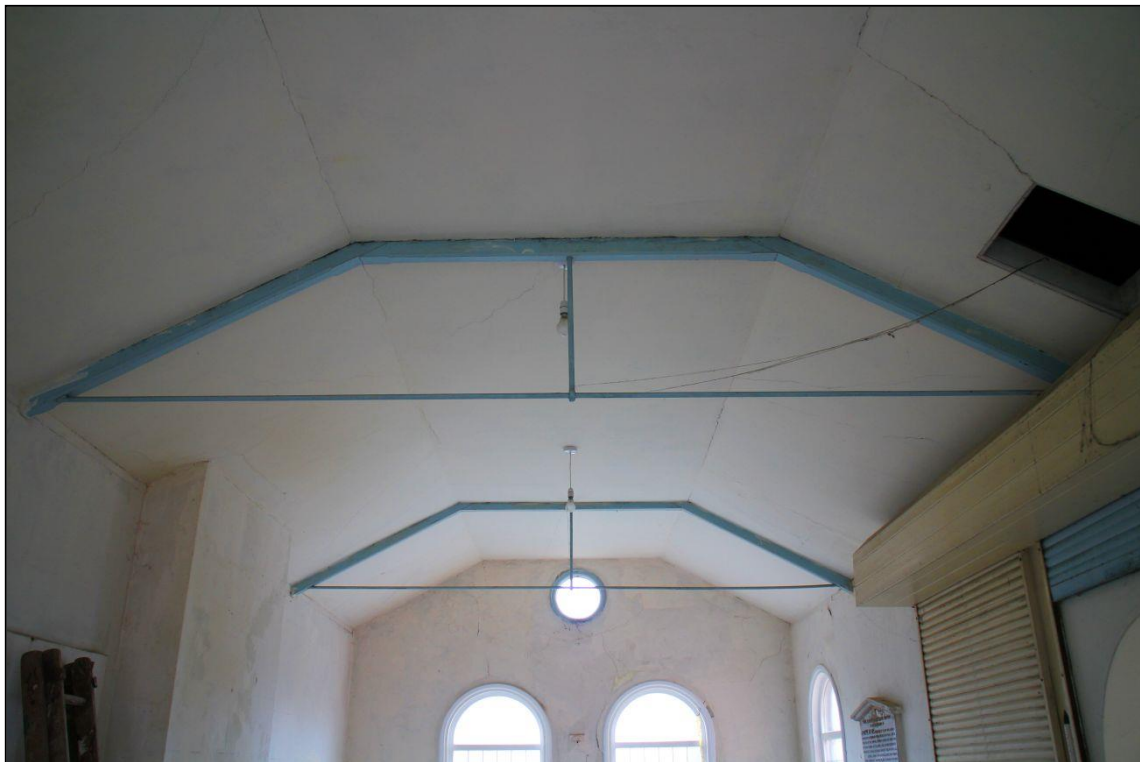
Image 34: Upper School Room, ceiling
Looking east showing roof trusses with metal ties

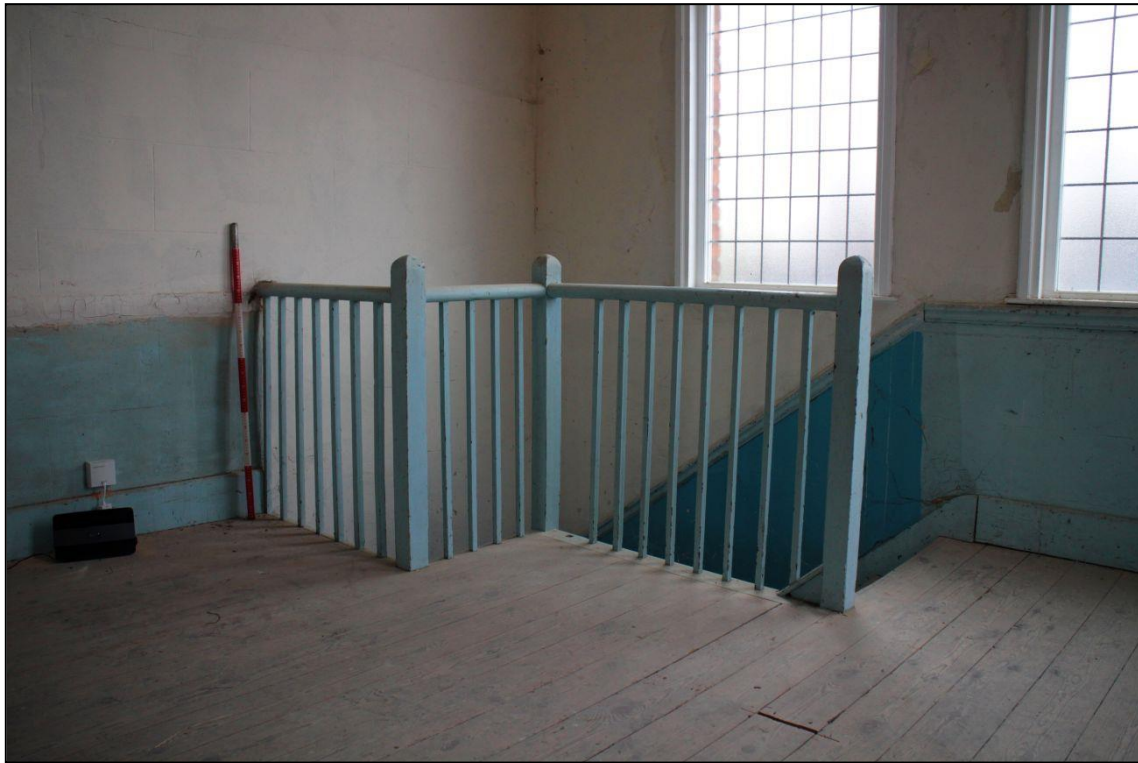
Image 35: Upper School Room, detail of stairs

The stairs in the north-east corner of the room have a balustrade with plain newel posts, stick balusters and a simple handrail (Image 35).

Looking north-east (Scale 1m)

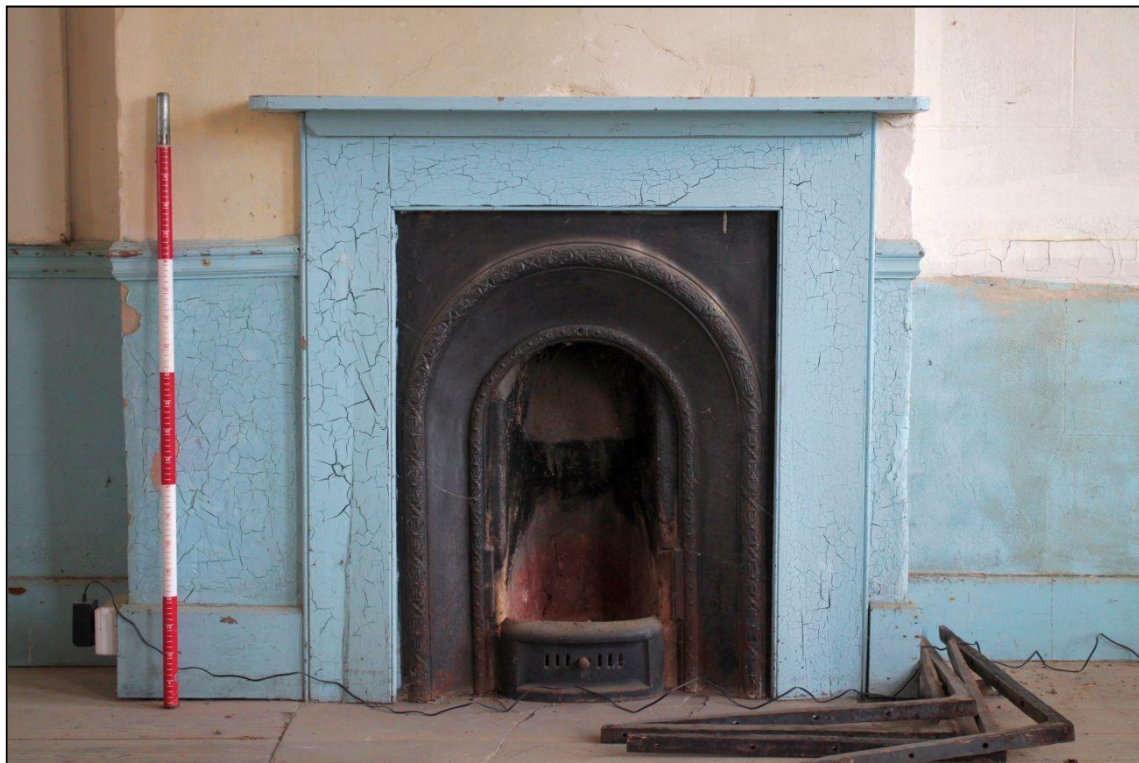
Image 36: Upper School Room, detail of fireplace

Two fire places on the north wall have cast iron grates with narrow openings and a semi-circular arched top (Image 36). The decoration on the grates consists of two bands with a repeating pattern of a floral motif separated ribbons. A timber fire surround is in plain timber with a simple bead-moulding on the edges with a plain mantelshelf.

Looking north, showing east fireplace (Scale 1m)

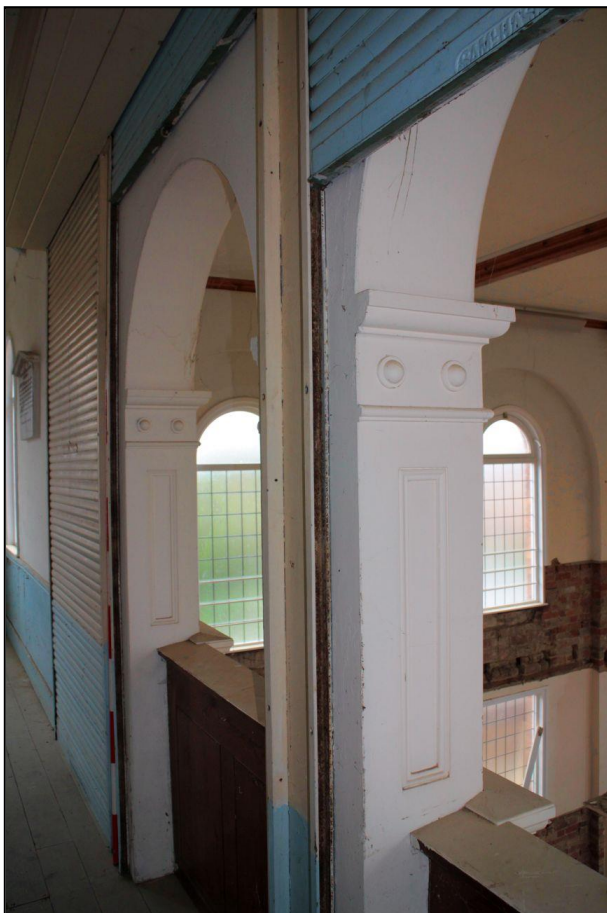
Image 37: Upper School Room,
detail of arched openings

Shows detail of openings giving view
of chapel with roller shutters
