**FAULKNER'S END FARM
ROUNDWOOD LANE
HARPENDEN
HERTFORDSHIRE
HISTORIC BUILDING RECORD**

HISTORIC BUILDING RECORD

Project: FE3120
Document: 2018/157
Version 1.0

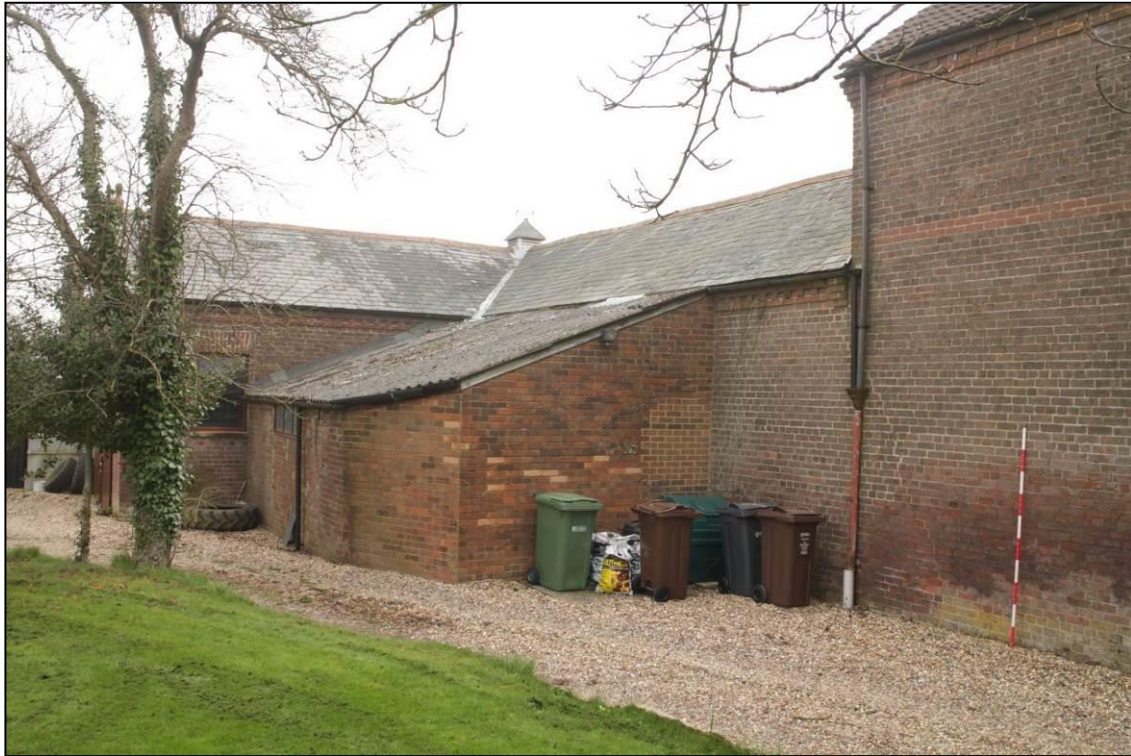
Image 1: West elevation, looking north-east

Shows rear wall of 19th-century L-shaped range with 20th-century lean-to extension in central part of image (scale 2m)

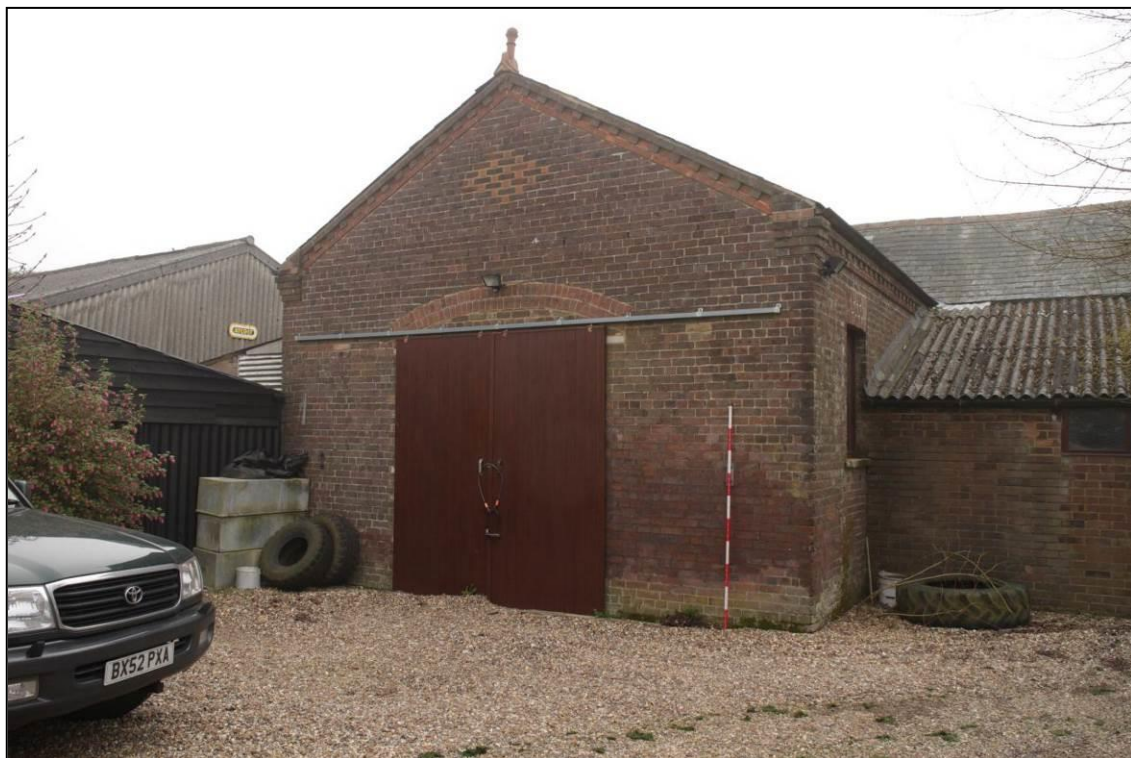
Image 2: West elevation, exterior of compartment G4

Shows the westernmost part of the 19th buildings with weatherboard shed (G7) to the left and 20th century extension (G5) to the right (scale 2m)

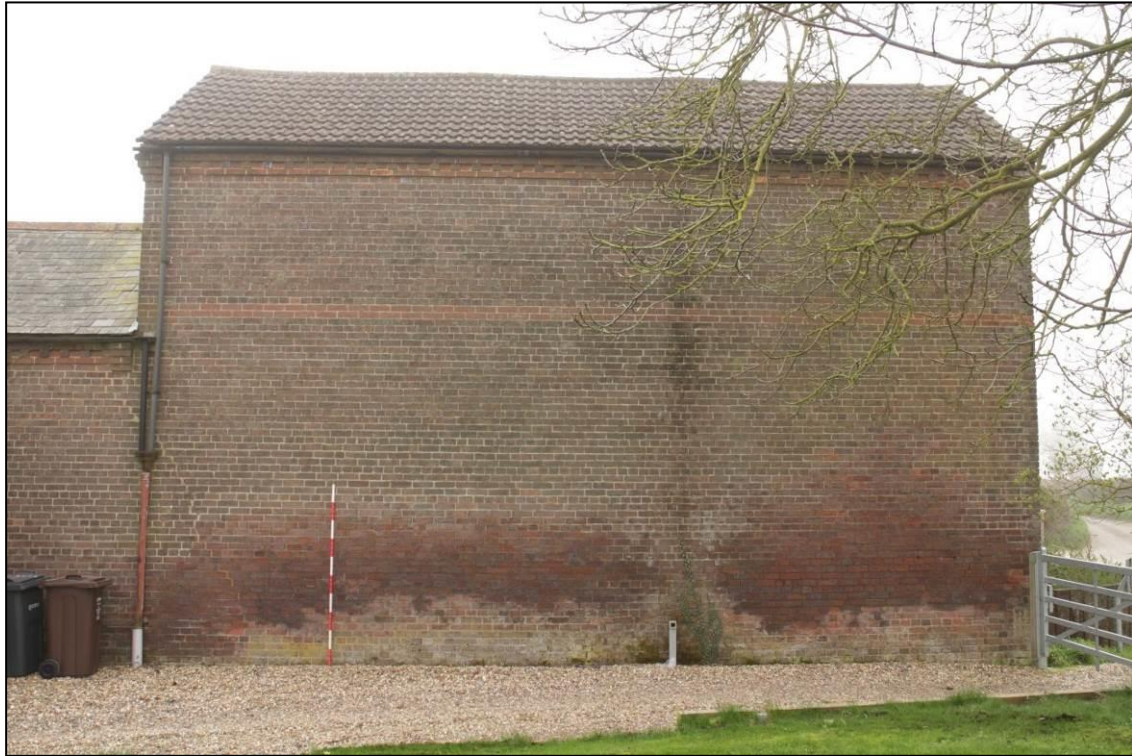
Image 3: West elevation, rear wall of cart shed and granary (G1-F1)

Shows wall with dentil eaves detail and concrete roof tiles (scale 2m)

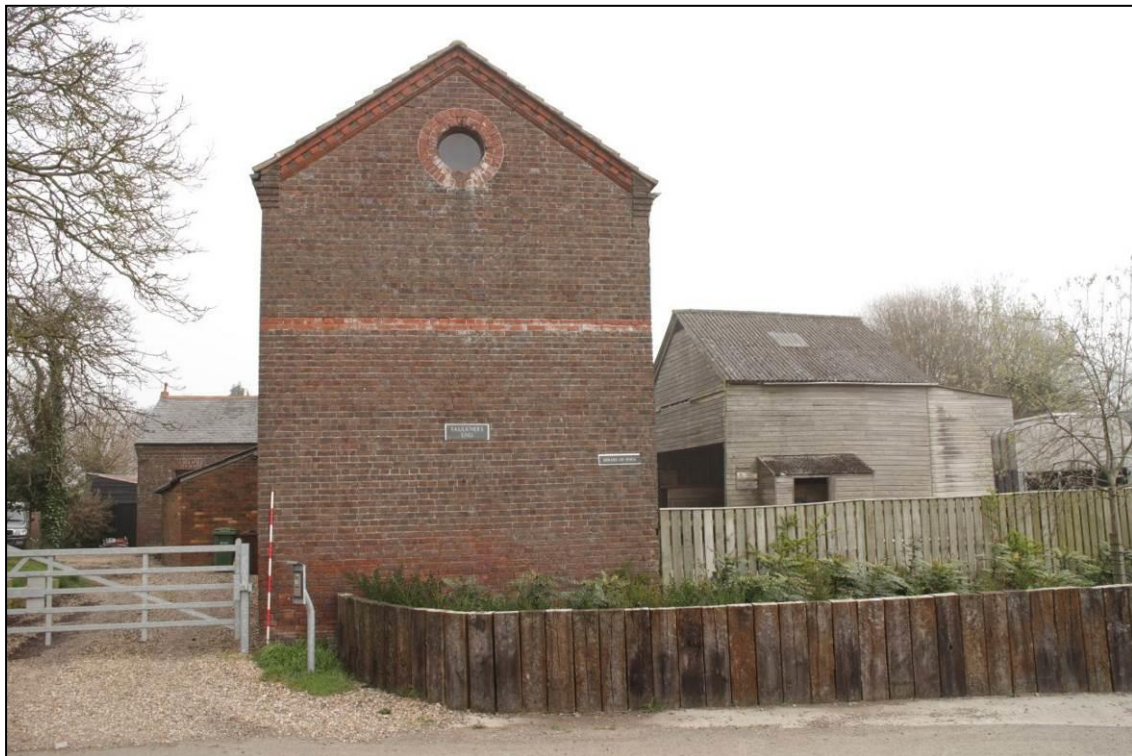
Image 4: South elevation

Shows gable end of 19th building with dentil eaves detail and circular window (scale 2m)

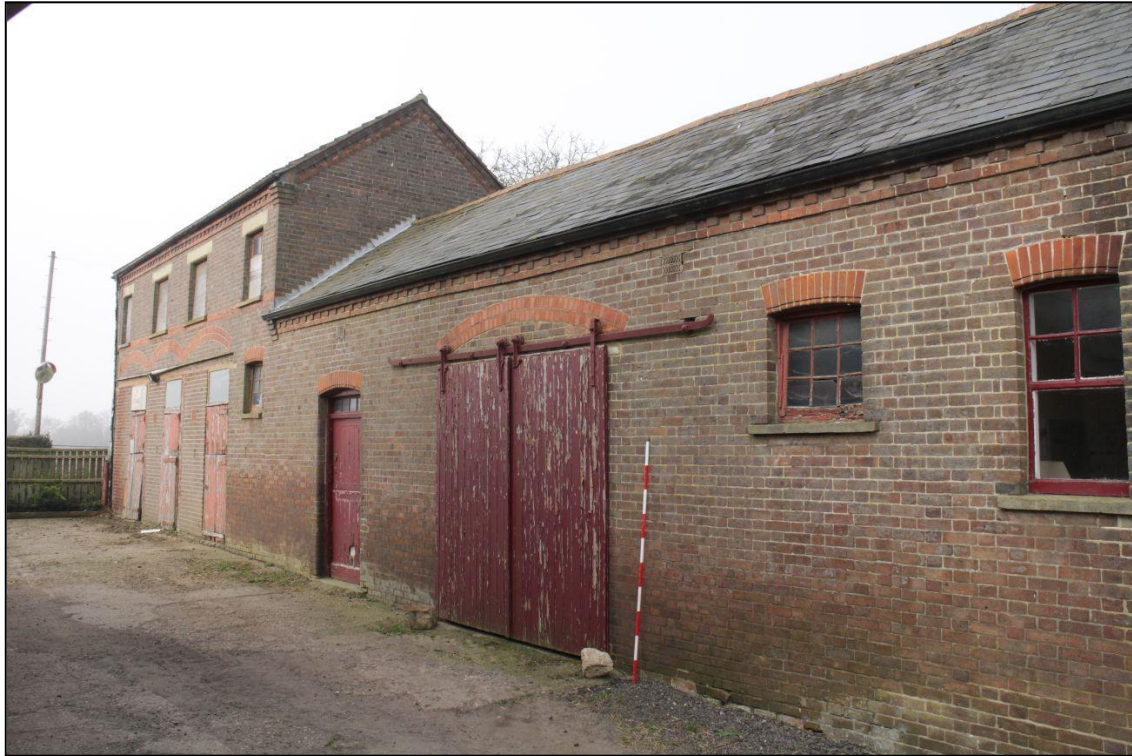
Image 5: East elevation, looking south-west

Shows left to right; cart shed/granary (G1-F1), barn (G2), with the left-hand window of office G3 at the right-hand edge of the image (scale 2m)

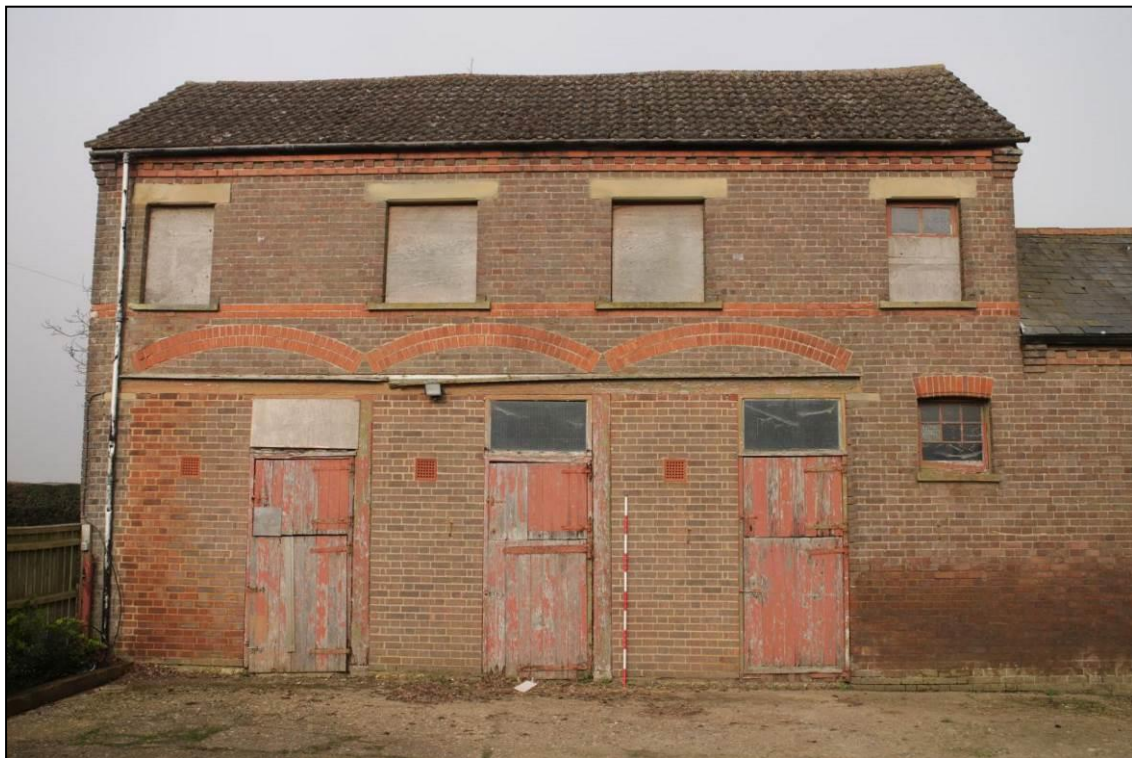
Image 6: East elevation, cart shed and granary (G1-F1)

Shows modern brick blocking in cart shed with windows of first floor store above (scale 2m)

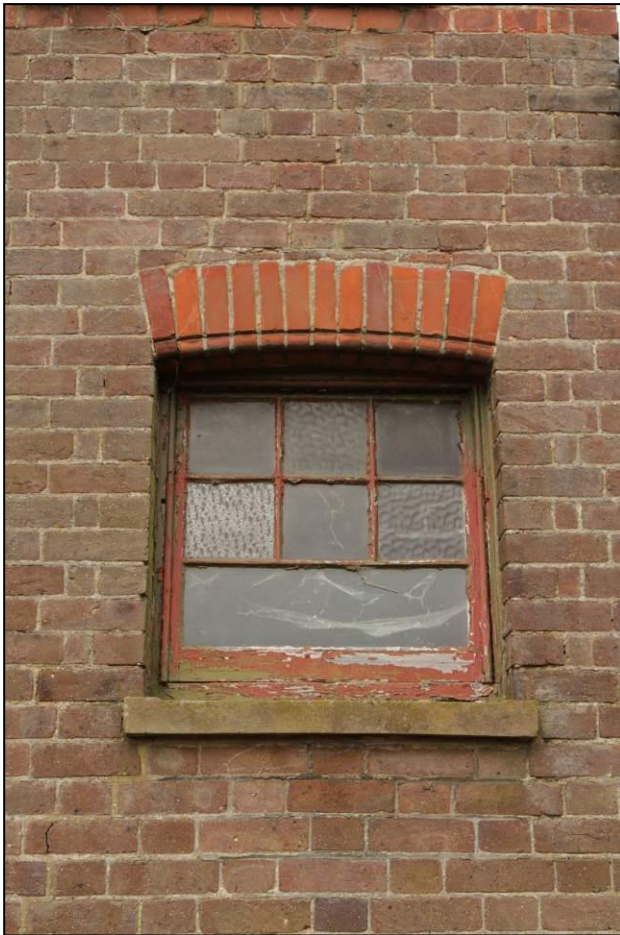
Image 7: East elevation, detail of window

The space is lit by four windows in the east side and a circular window in the upper part of the south wall. The windows in the east wall have been heavily repaired. The window at the north end of the wall is the most complete/original (Image 16). This has nine panes in the lower part with narrow glazing bars and a repaired two-pane section at the top which was probably the opening section but the details of its operation were unclear.

Shows window to right of cart shed with moulded brick lintel and wood framed horizontal pivot window

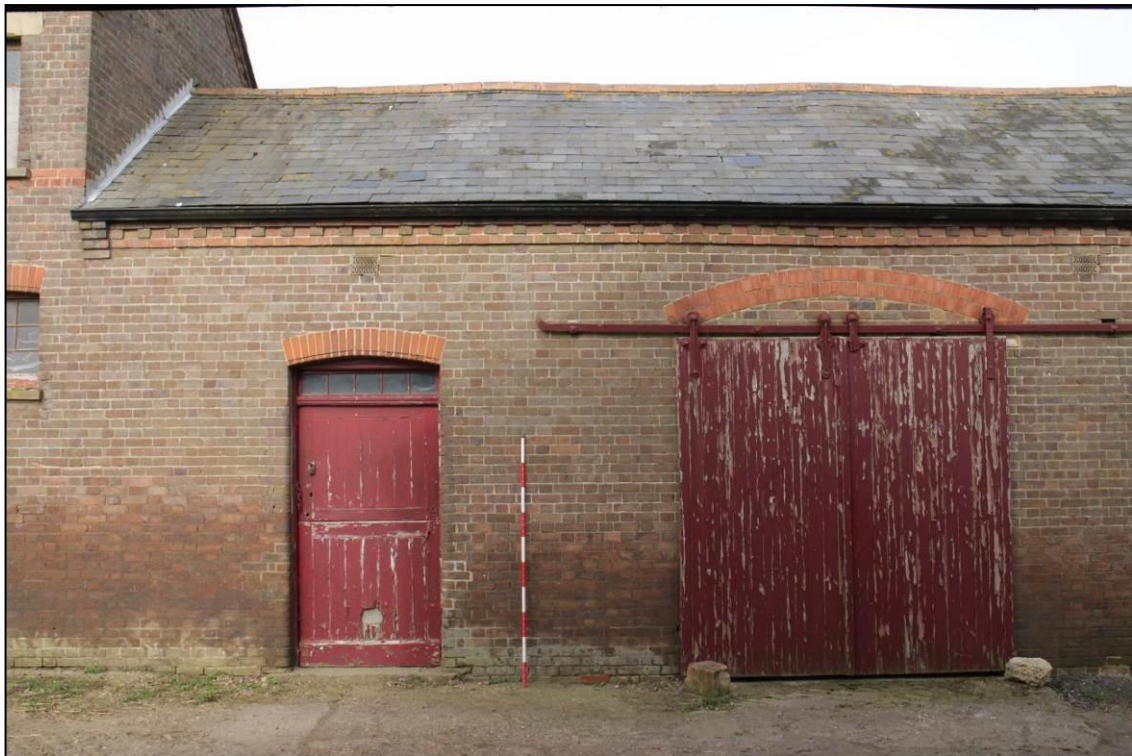
Image 8: East elevation, barn (G2)

Shows heck door and double sliding door (scale 2m)

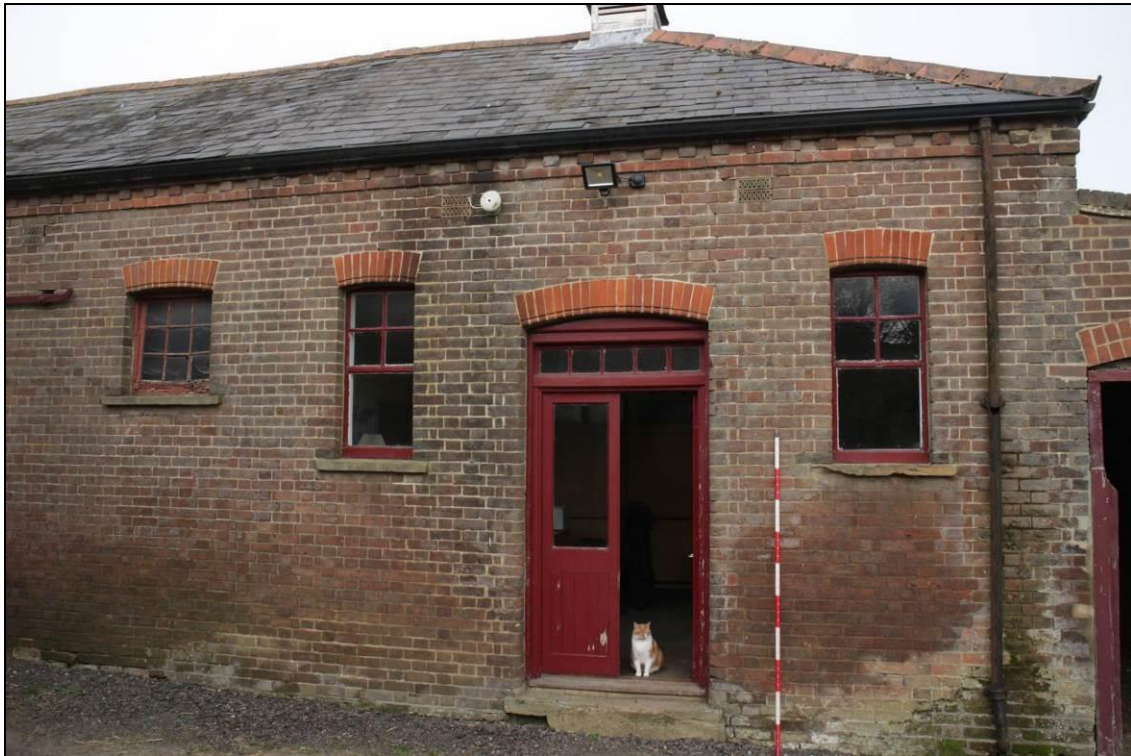
Image 9: East elevation, showing stable/farm office (G3)

Former stable converted to farm office. Pivot window in north end of G2 is visible at left and join with 20th century extension (G6) is visible at the top- right edge of the image (scale 2m)

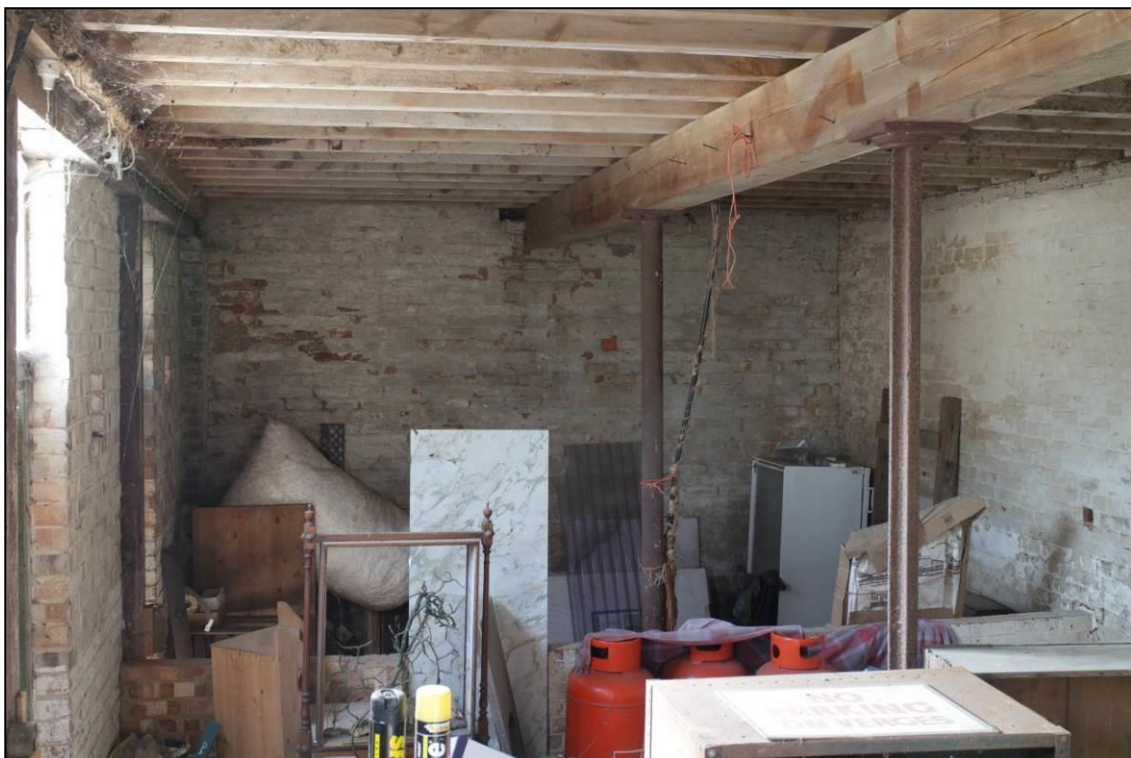
Image 10: Cart shed (G1) looking south

This compartment is c.9.8m long and 4.6m wide. It has a concrete floor and whitewashed brick walls. The floor of the loft above is supported on a large axial beam with closely spaced transverse joists (Image 10). The axial joist is supported by two metal posts located on the bay-divisions of the cart shed. The southern post is circular in section while the northern post appears to be a later replacement consisting of a reused section of I-beam. The loft floor contains a trap door above the north-east corner of the cart shed. An original internal door in the south-west corner of the cart shed is raised door, approximately 1m above floor level and opens off the adjacent stair landing (Image 11), presumably for loading carts. There is another internal door in the north-west corner of G1 for a store under the stairs.

General view looking towards the south end wall of cart shed (G1)

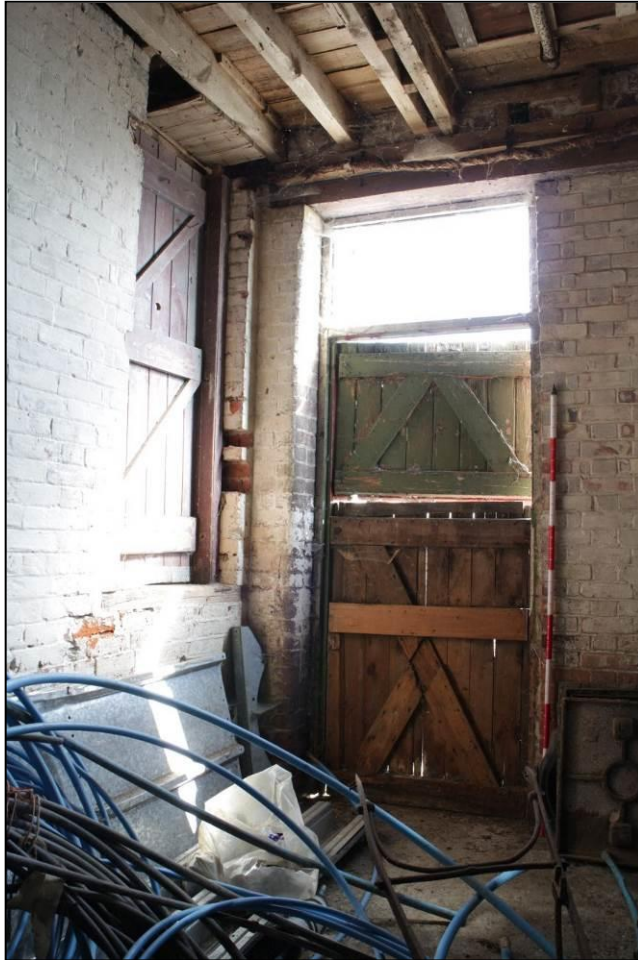
Image 11: Cart shed (G1),
north-east corner

Looking towards the front wall of the cart shed. The image shows a door at the left which opens off lower stair landing (scale 2m)

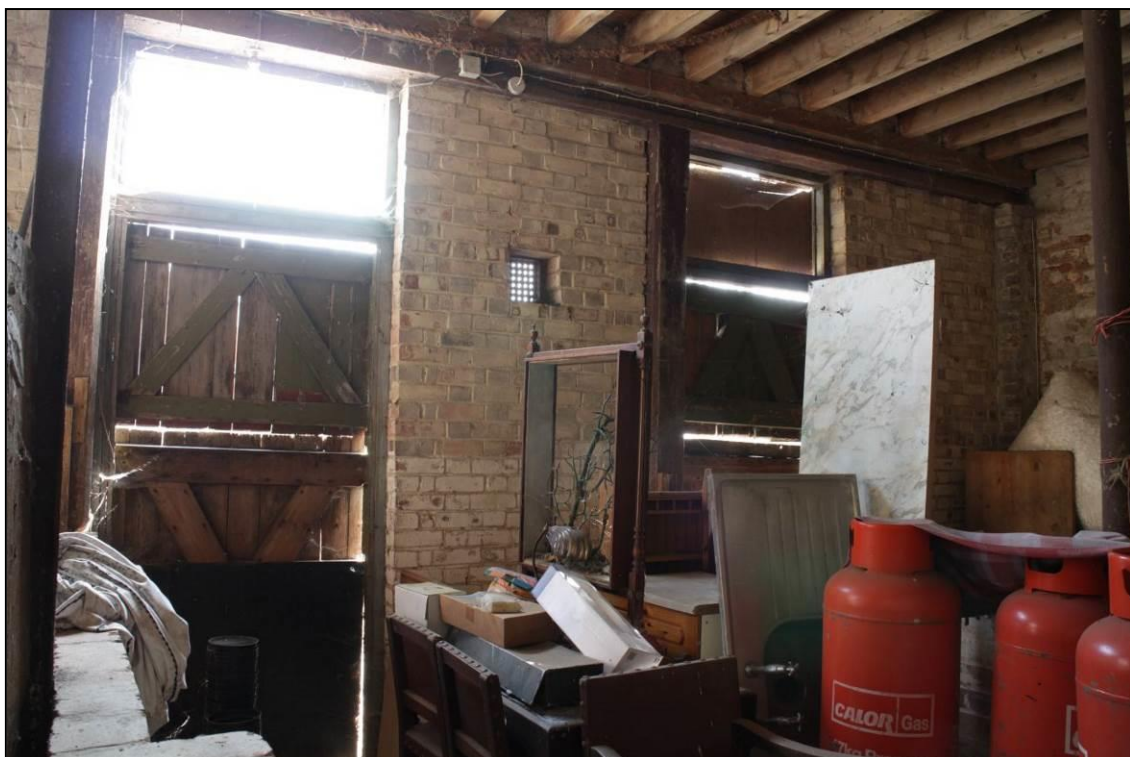
Image 12: Cart shed (G1), front wall

Looking east showing front wall with 20th century brick infill and heck (stable) doors.

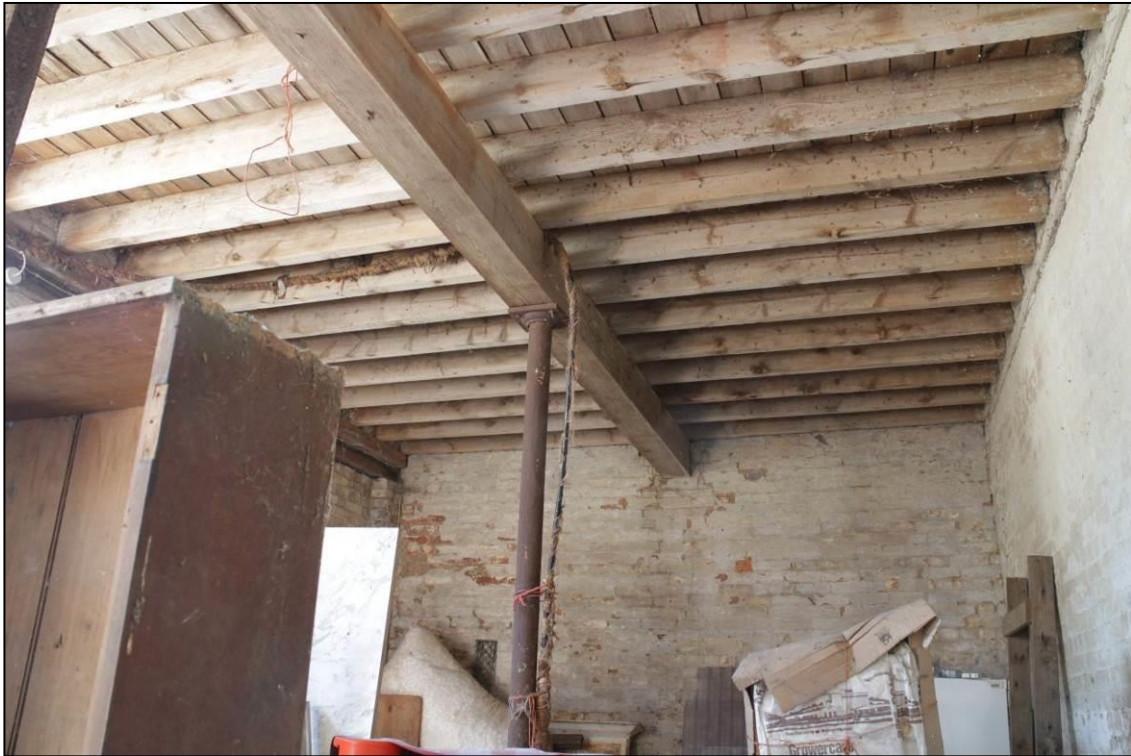
Image 13: Cart shed (G1), ceiling

Looking south-east, showing axial beam with metal posts on the southern bay division

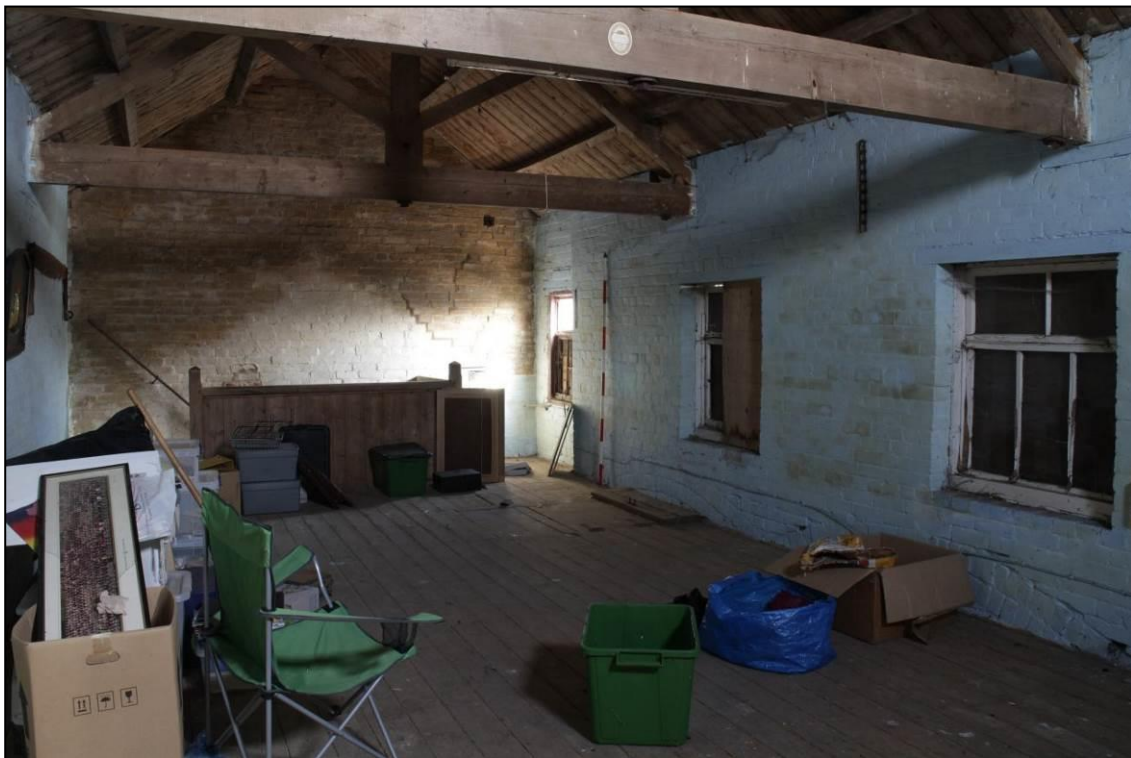
Image 14: Former granary (F1), north end

General view of room looking north-east (scale 2m)

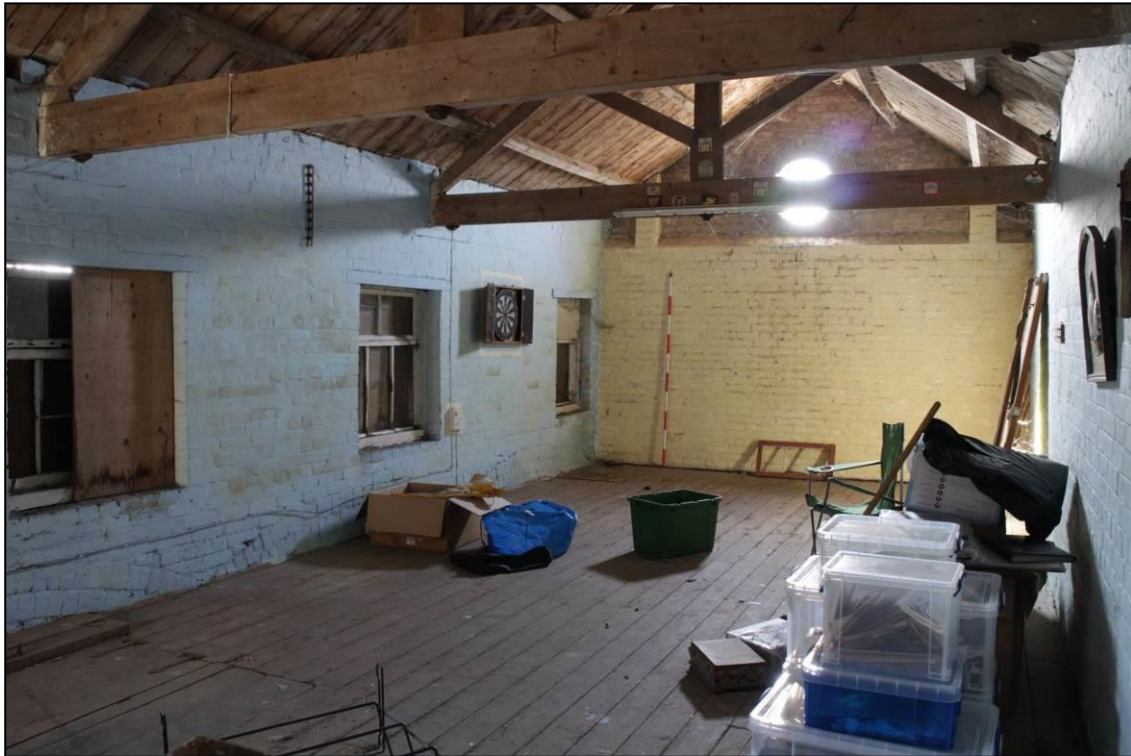
Image 15: First former granary (F1), south end
General view of room looking south-west (scale 2m)

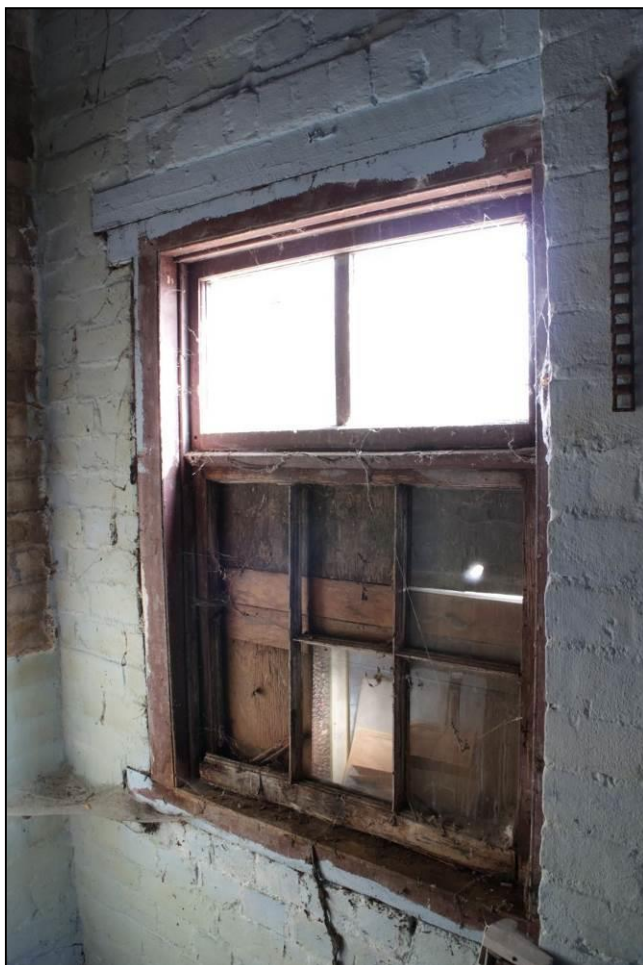
Image 16: Former granary
(F1), detail of window

Looking north-east, showing
window at north end of front wall

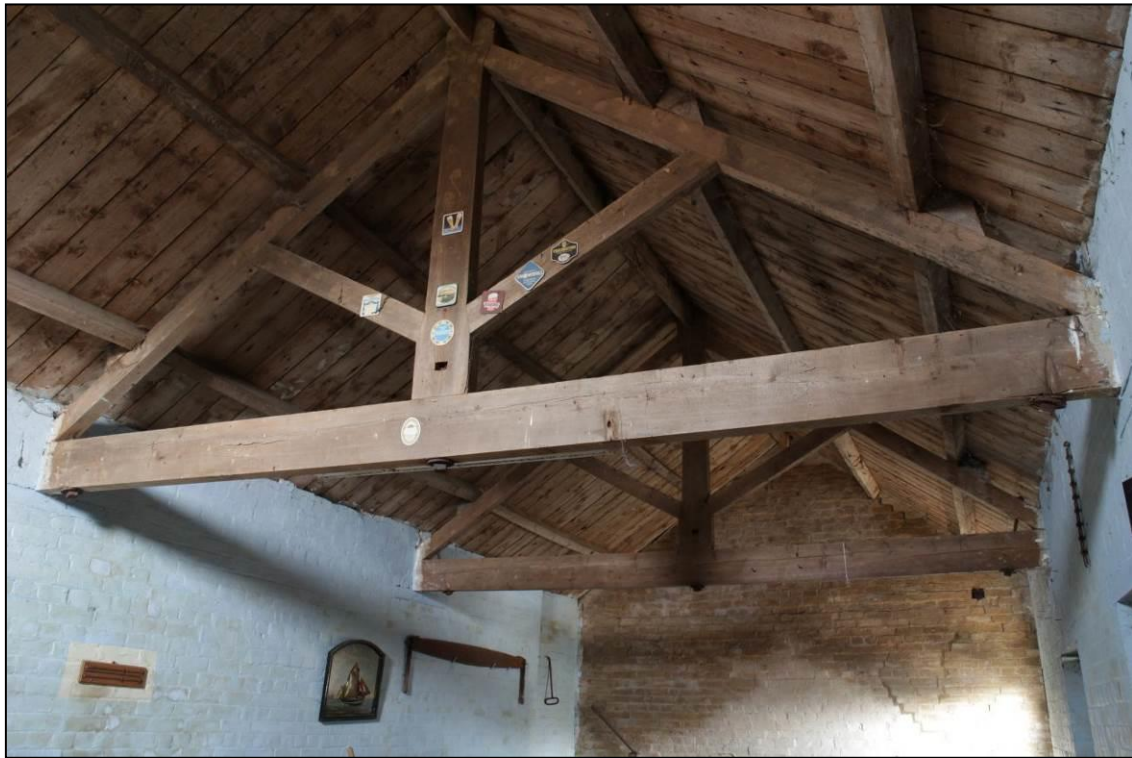
Image 17: Former granary (F1), roof

Looking north-west showing the kingpost roof trusses and purlins

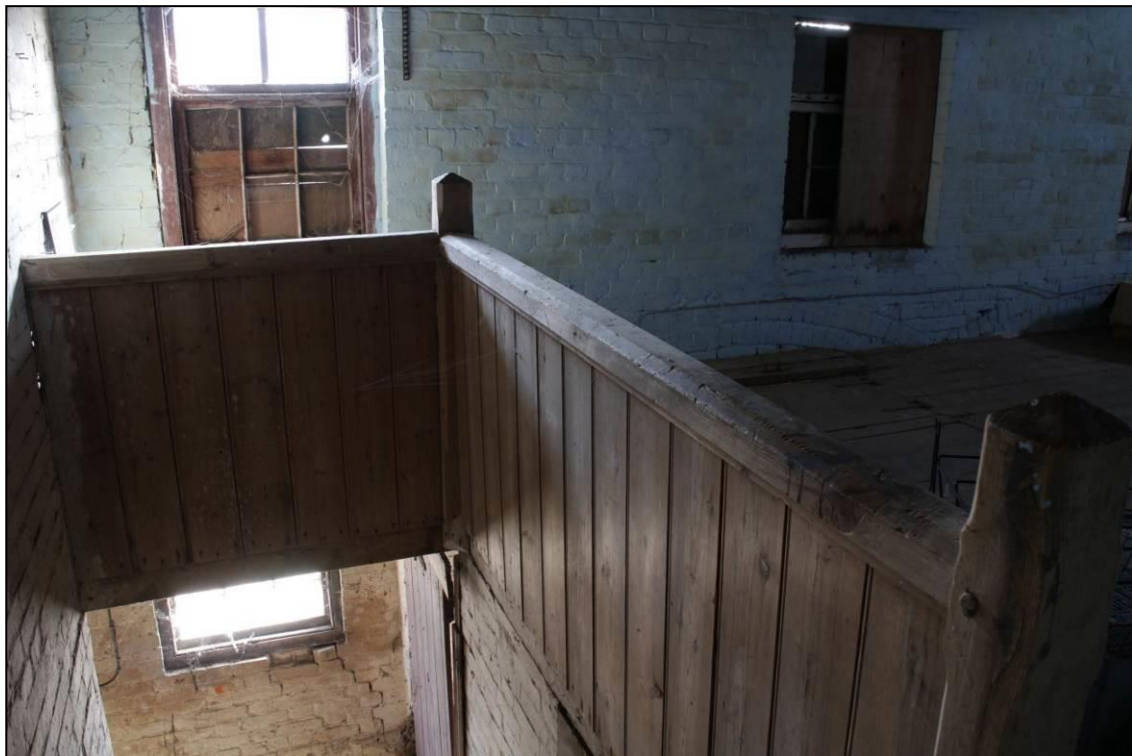
Image 18: Former granary (F1), stairs

leading up to the loft. The construction is of standard form with wooden treads and risers with the treads heavily worn by prolonged use. At the top is a balustrade formed from plain chamfered squared posts and a rail supporting tongue-and-groove boards.

Looking east showing detail at top of stairs

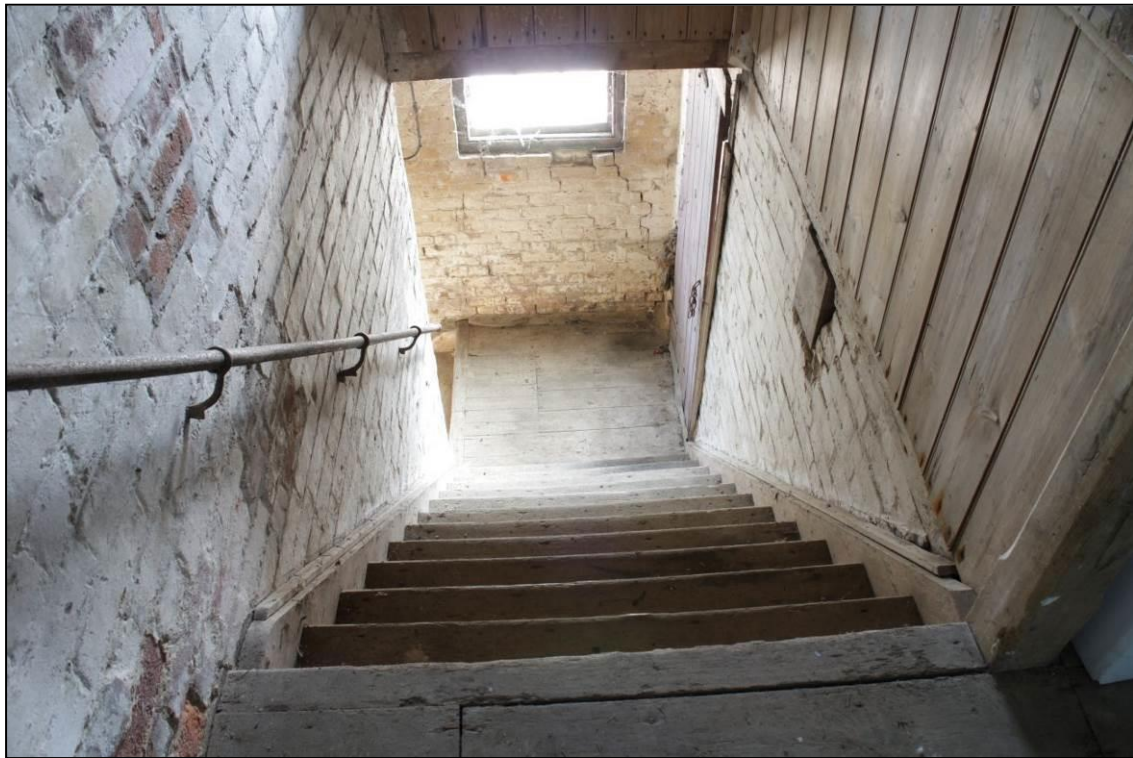
Image 19: Former granary (F1), stairs

Looking east, down the stairs toward the quarter landing situated between compartment G2 and the cart shed

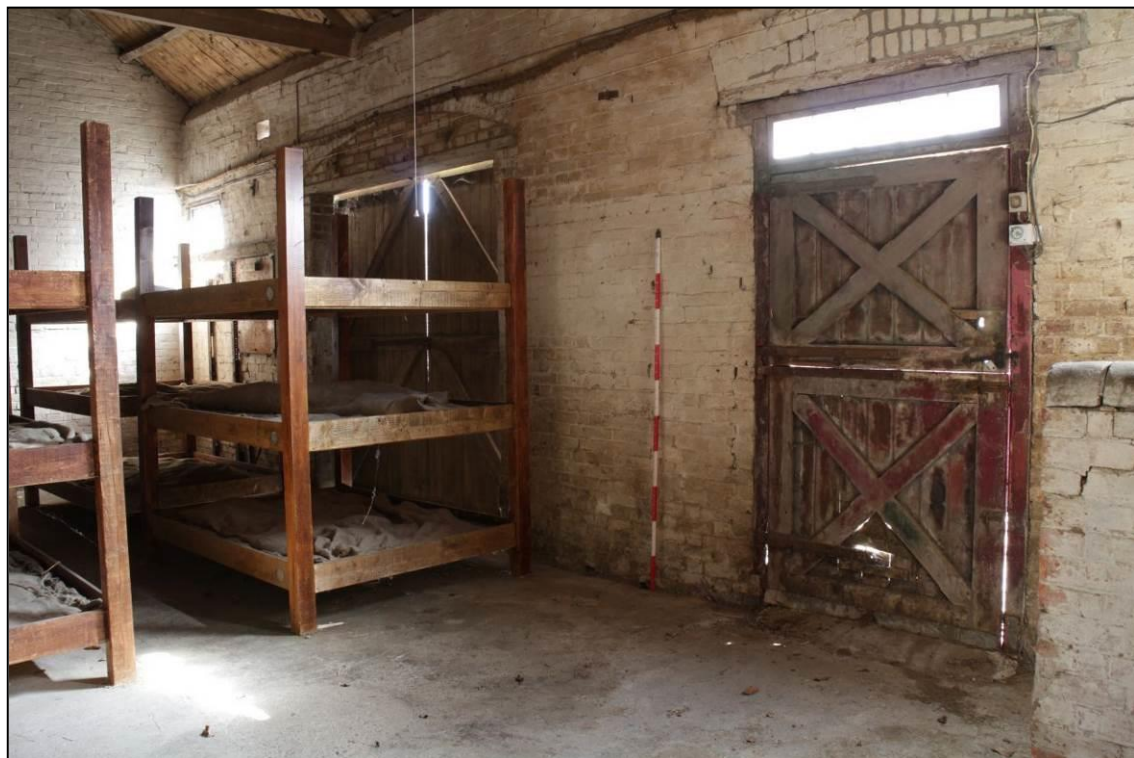
Image 20: Barn (G2), front wall

View looking north-east showing front wall with heck door at right and double sliding doors at centre (scale 2m)

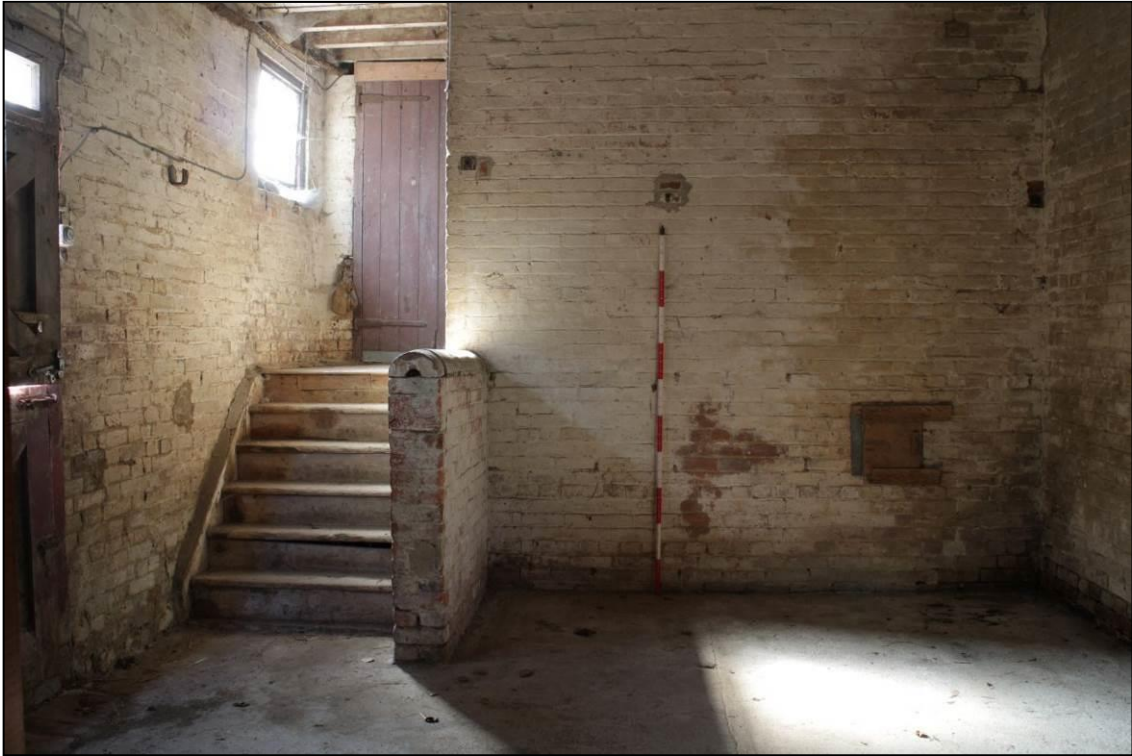
Image 21: Barn (G2), south end and stairs

Looking south, showing stairs and quarter landing with raised door to cart shed (G1)
(scale 2m)

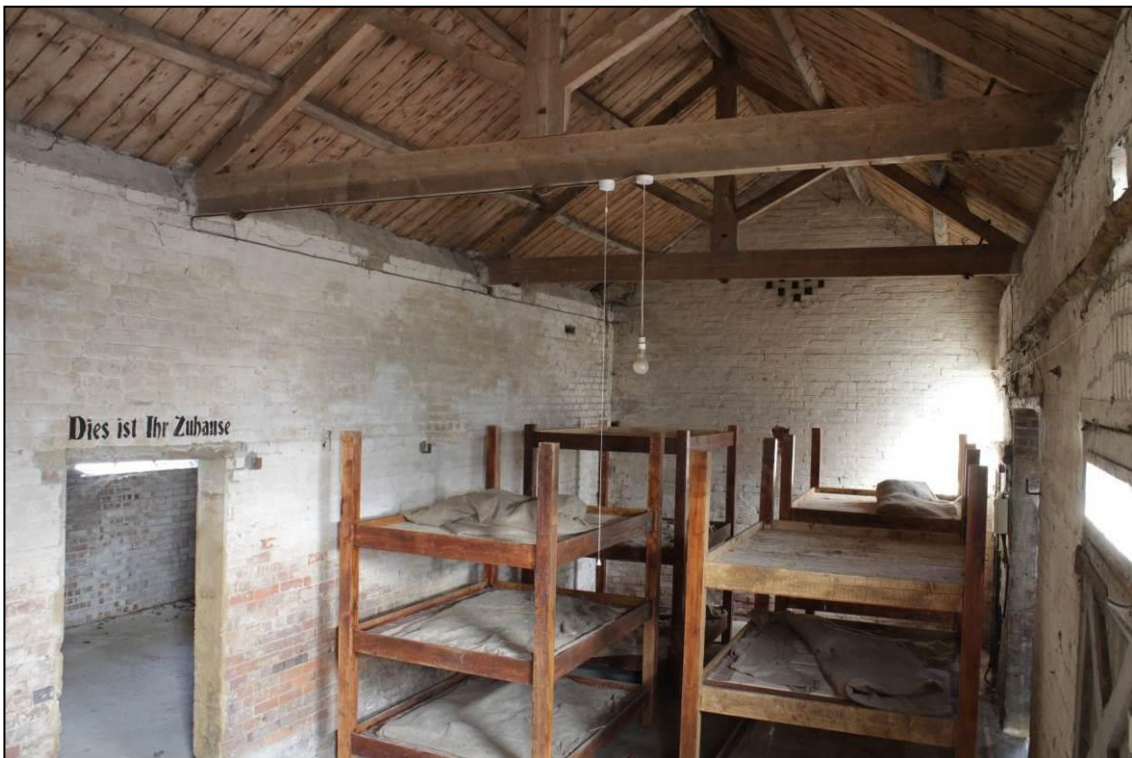
Image 22: Barn (G2), north end and rear wall

View looking north-west from the stair landing. At the left hand of the image is a cut-in opening which forms a doorway through to the later extension (G5)

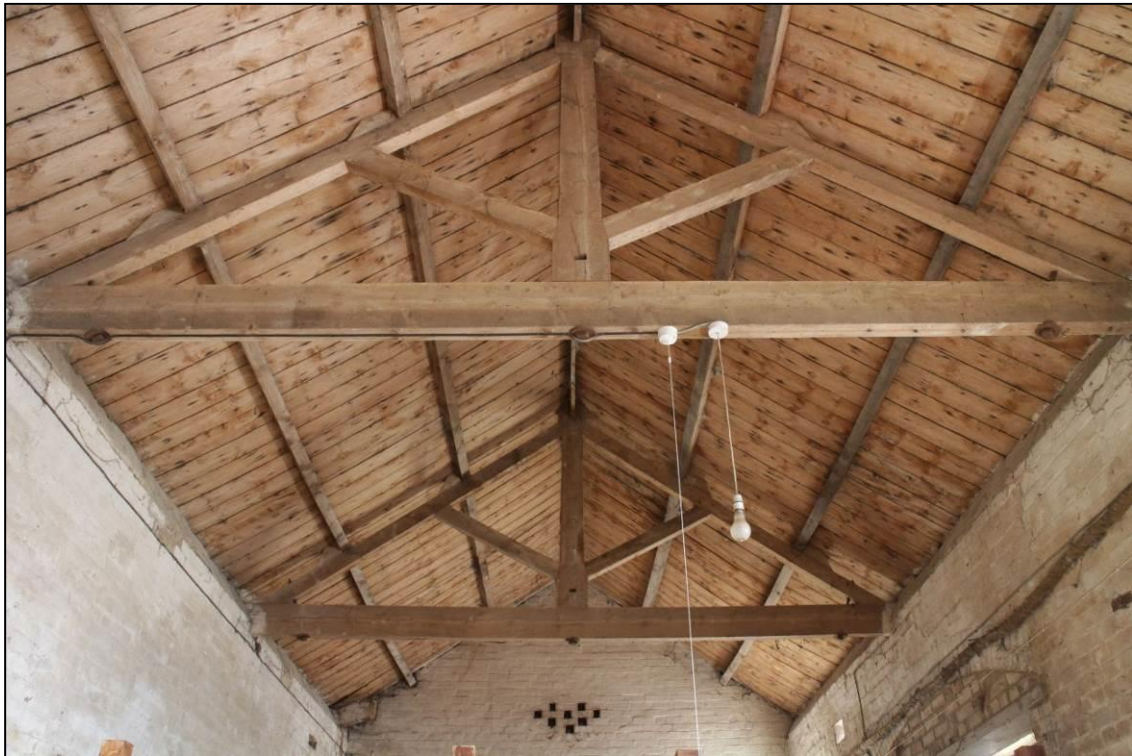
Image 23: Barn (G2), roof structure

Looking north, showing kingpost roof trusses, double purlins and also honeycomb vent in north gable wall

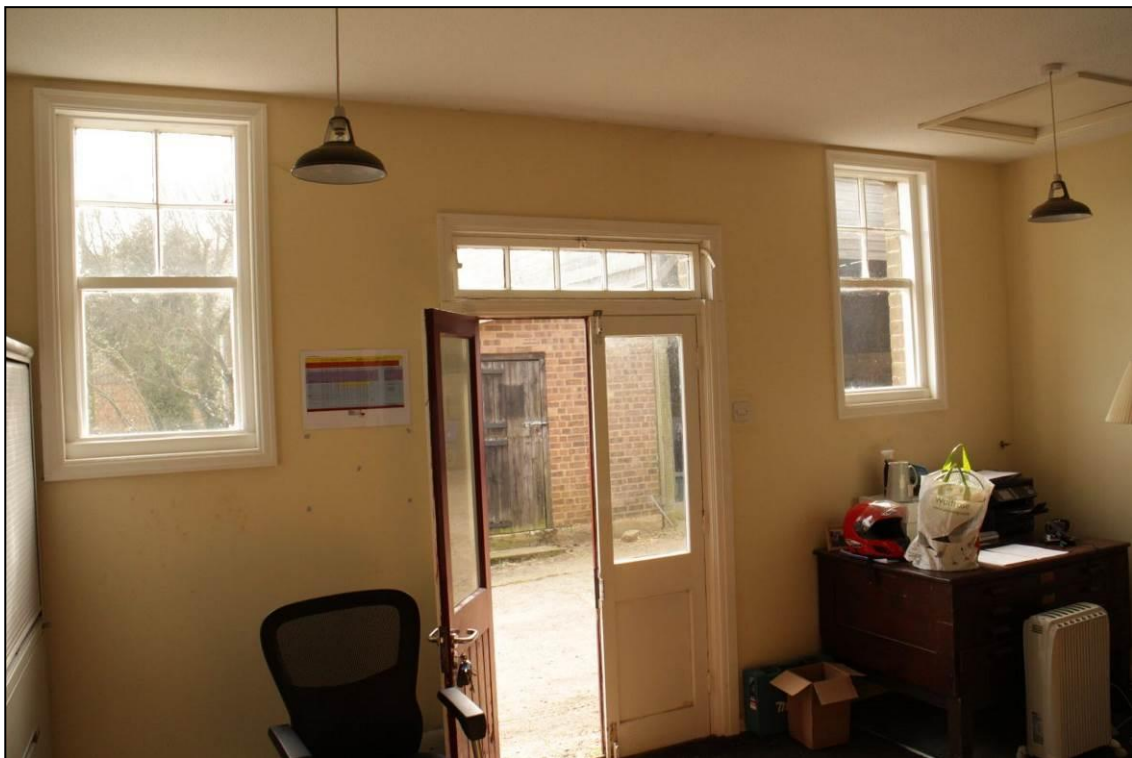
Image 24: Former stable, Farm office (G3), front wall

View looking south-east show modern internal finish in this room

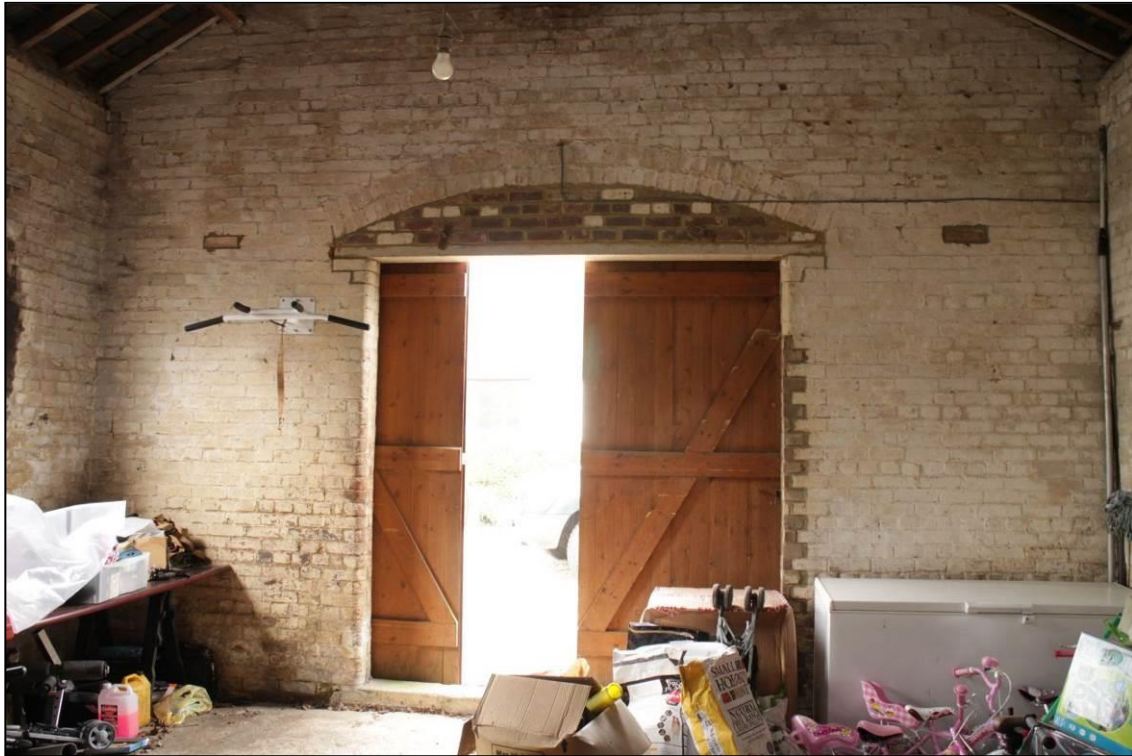
Image 25: West compartment (G4), west wall

The compartment is accessed via double sliding doors in the west wall and by a framed plank door in the north wall. Above the double door the brickwork has been repaired and a concrete lintel installed. The sliding doors are modern replacements. The walls are whitewashed brick.

Looking west showing end wall with double sliding doors

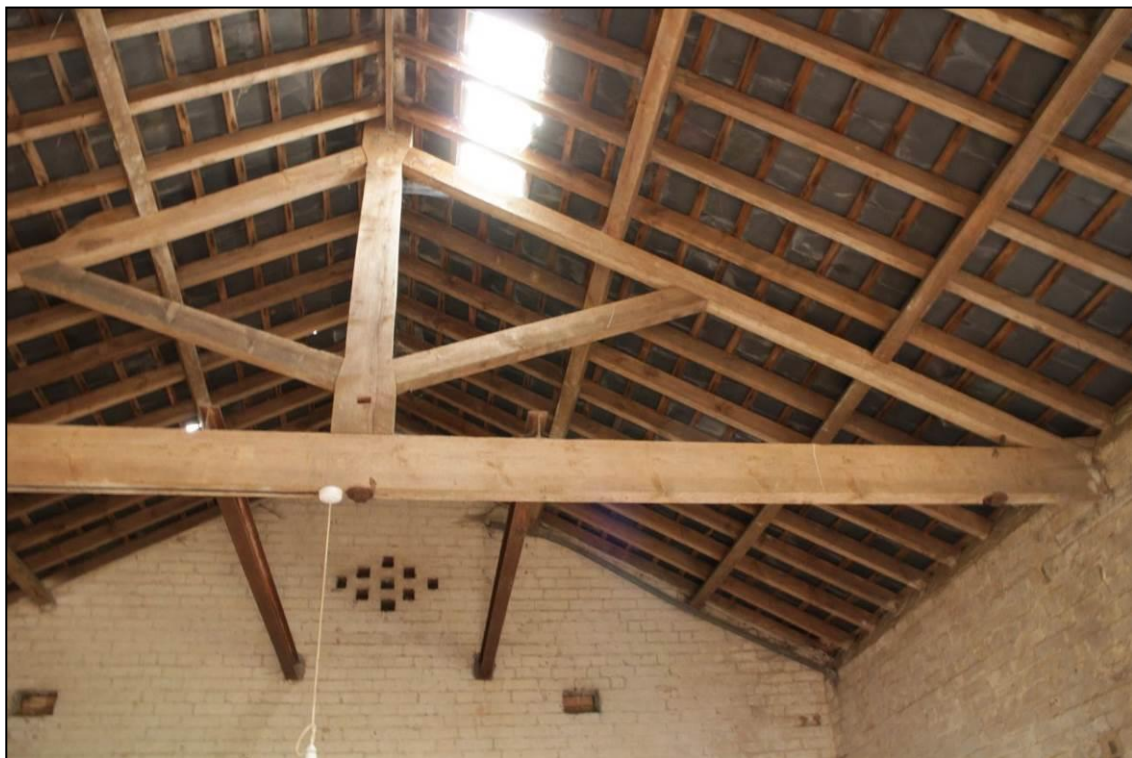
Image 26: West compartment (G4), roof

View looking east showing roof structure and east wall. Shows single kingpost truss and honeycomb brickwork vent to roof space over G3
