**FAULKNER'S END FARM
ROUNDWOOD LANE
HARPENDEN
HERTFORDSHIRE
HISTORIC BUILDING RECORD**

HISTORIC BUILDING RECORD

Project: FE3120
Document: 2018/157
Version 1.0

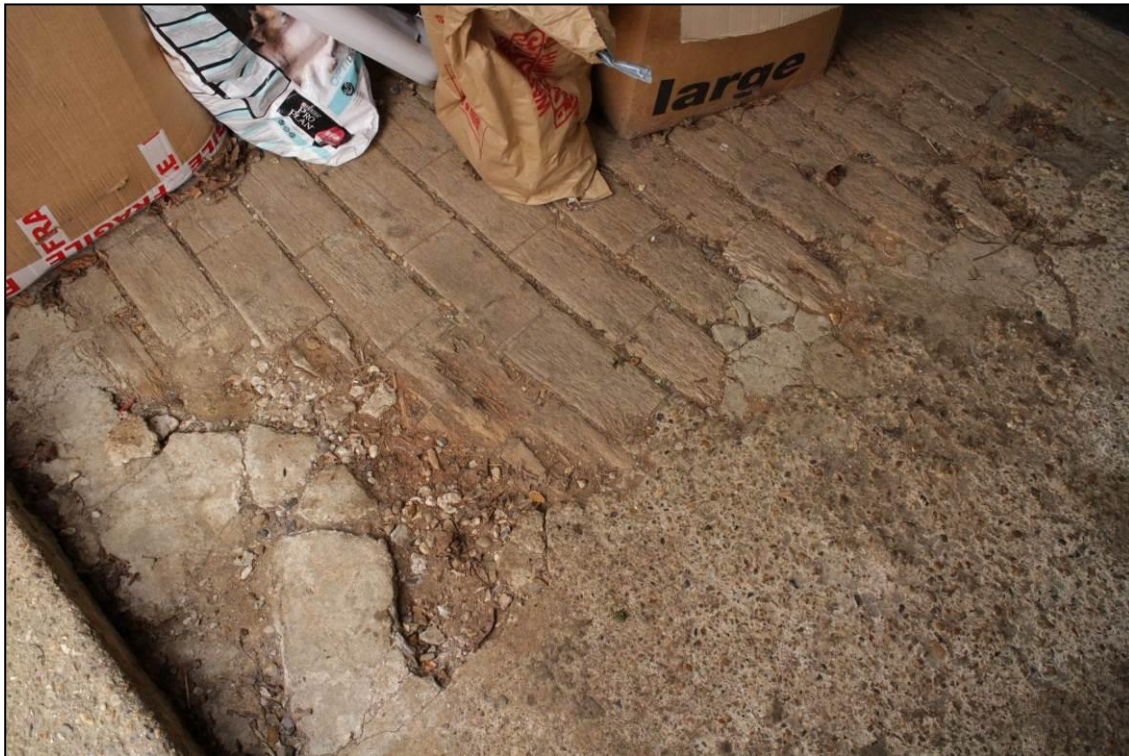
Image 27: West compartment (G4), woodblock floor

The floor is made of woodblocks measuring 240mm by 120mm. The woodblock floor is heavily worn, particularly near the west doors. Sections of the floor have been lost to wear and decay and it has been patched with concrete. Flooring of this type is not usually associated with agricultural buildings. This compartment may have been used as a garage or may have been used for processing grain or animal feedstuffs.

Showing remains of woodblock flooring with concrete repairs

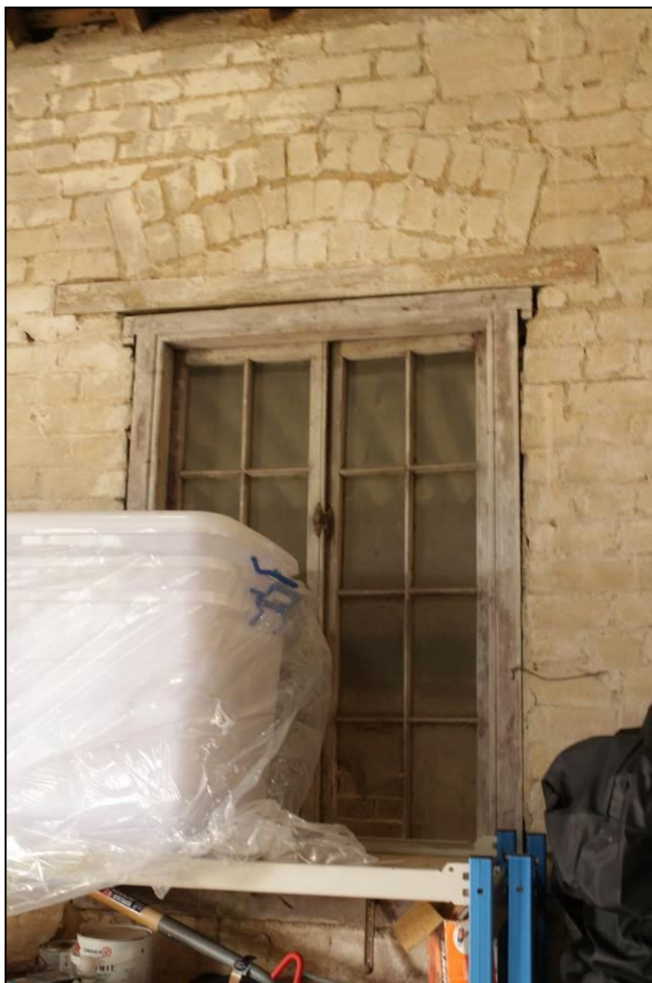
Image 28: West compartment (G4), north window

Interior view of window in north wall of compartment G4

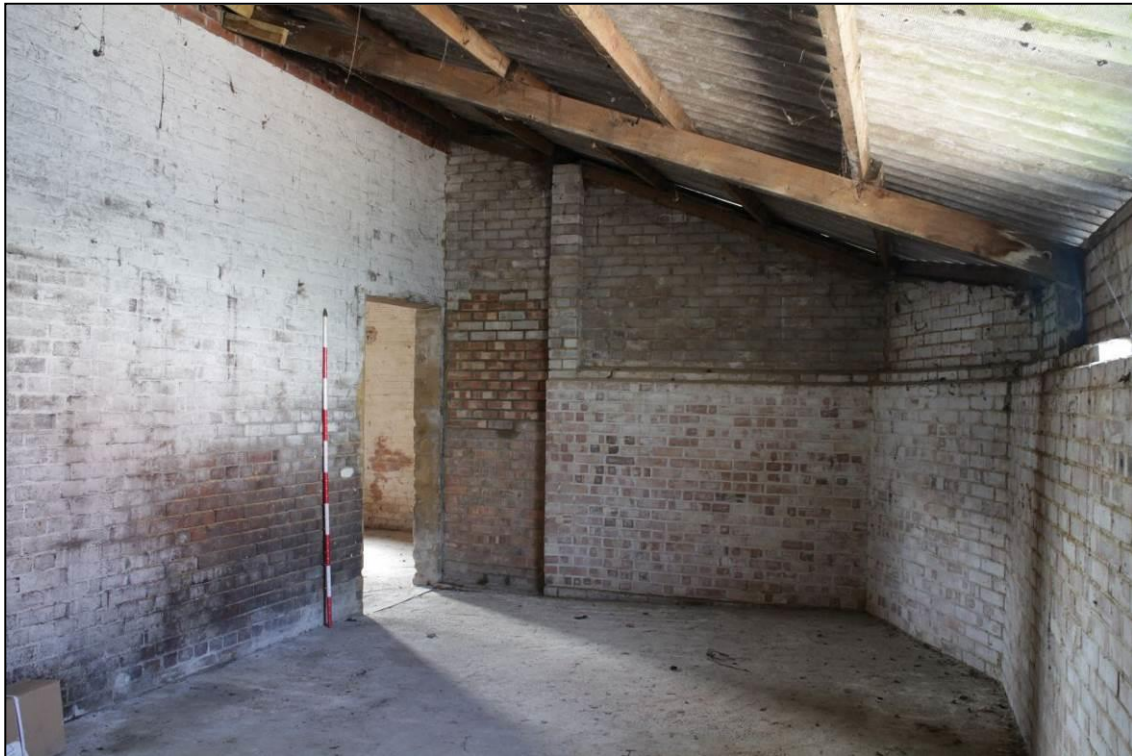
Image 29: Western lean-to extension (G5), south end

Looking south-east towards cut-in door opening in rear wall of barn (G2), (scale 2m)

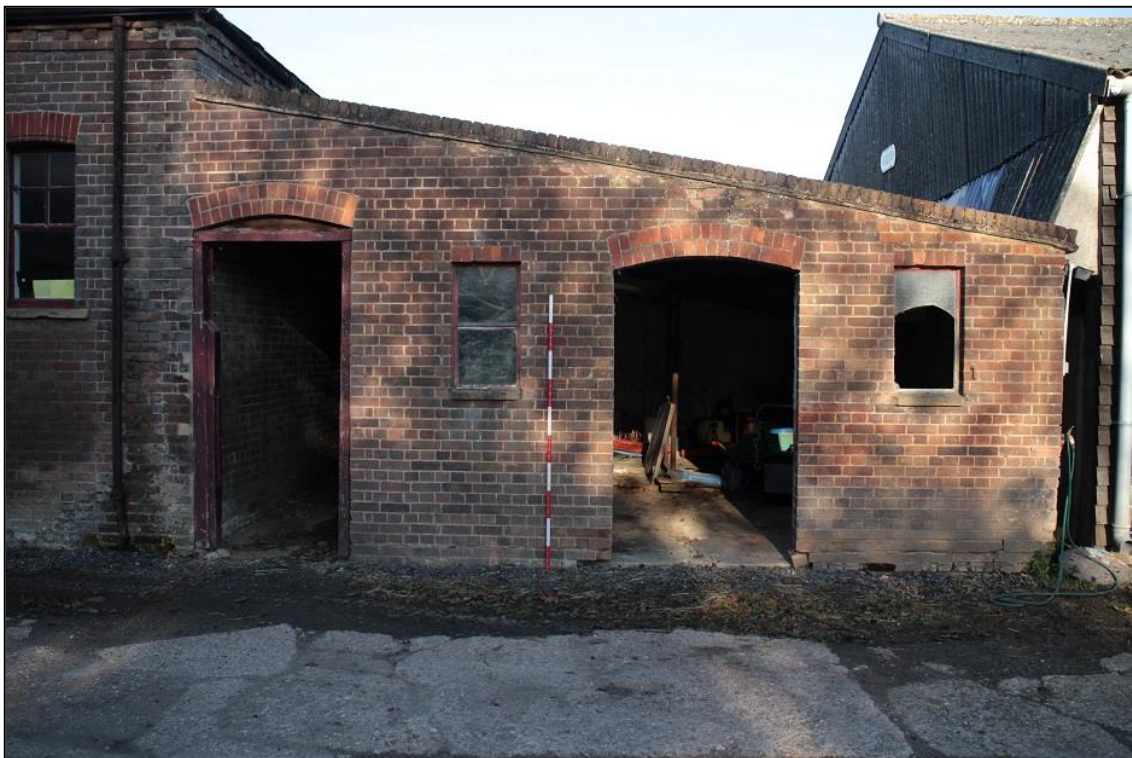
Image 30: Northern lean-to extension (G6), front elevation

Shows front (east) wall of building (scale 2m)

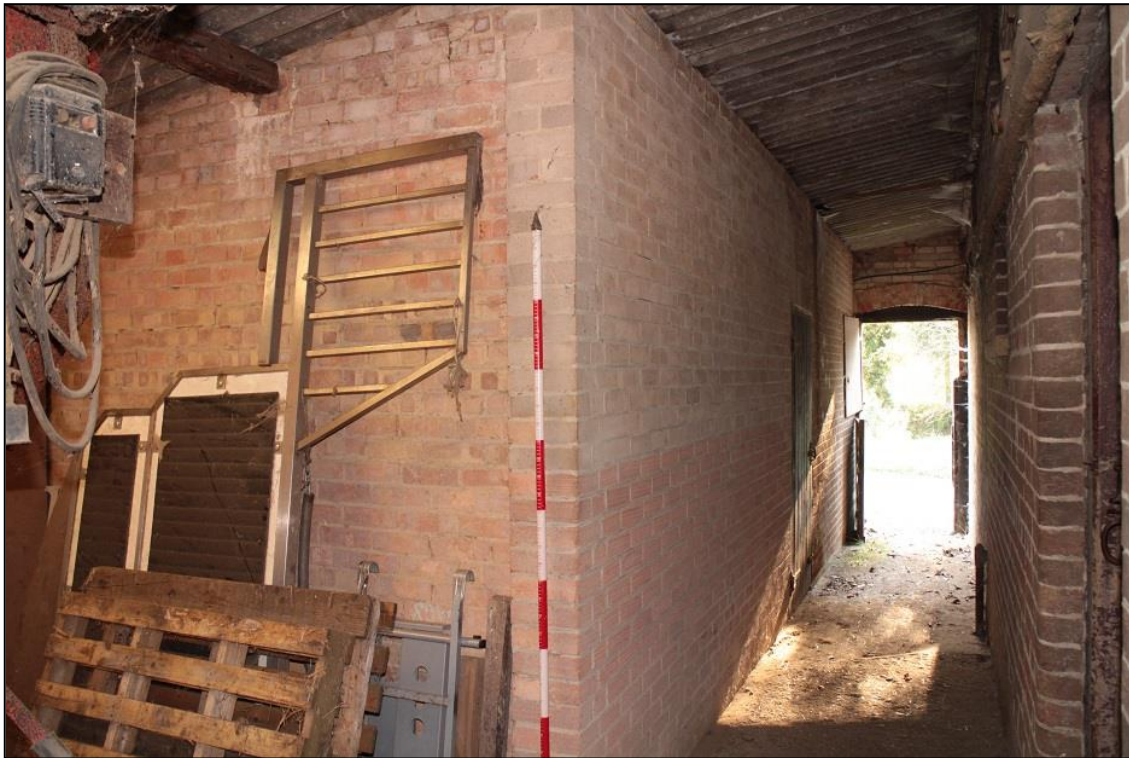
Image 31: Northern lean-to extension (G6), corridor

Looking east along corridor between the lean-to and the 19th-century building at right. The rear compartment (G6b) of the lean-to is on the left. (scale 2m)

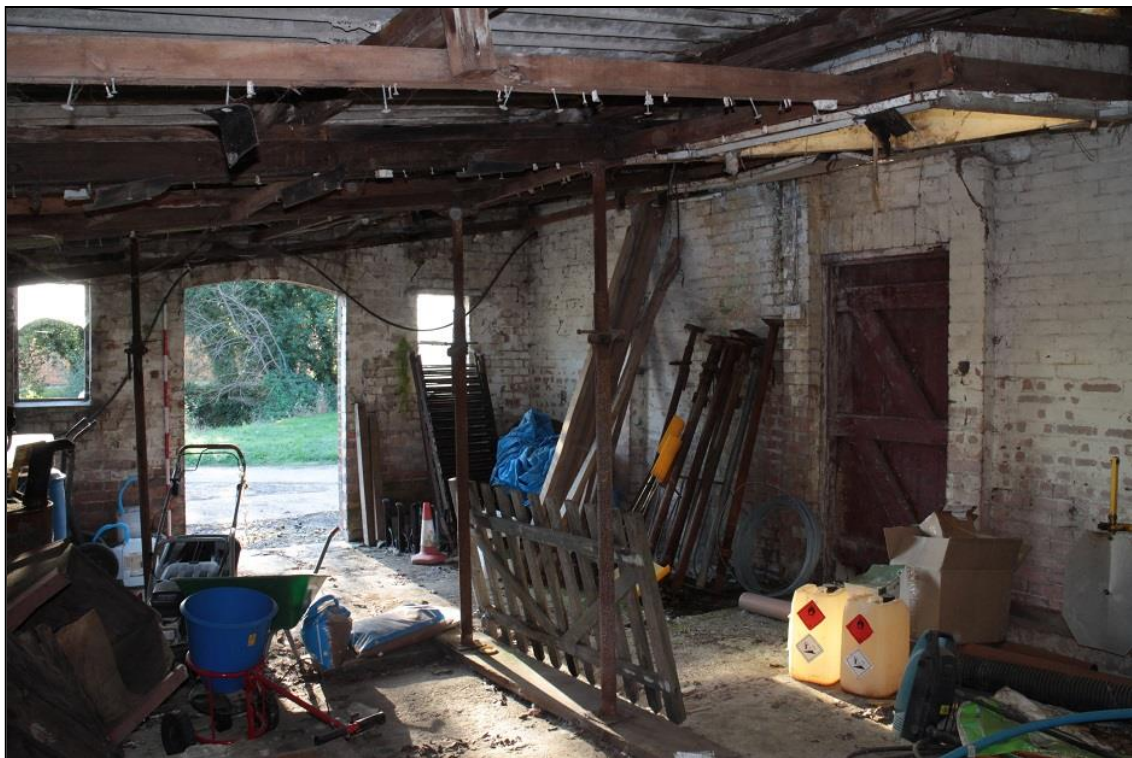
Image 32: Northern lean-to extension (G6), looking south-east

Shows front wall at left and door in south wall at right (scale 2m)

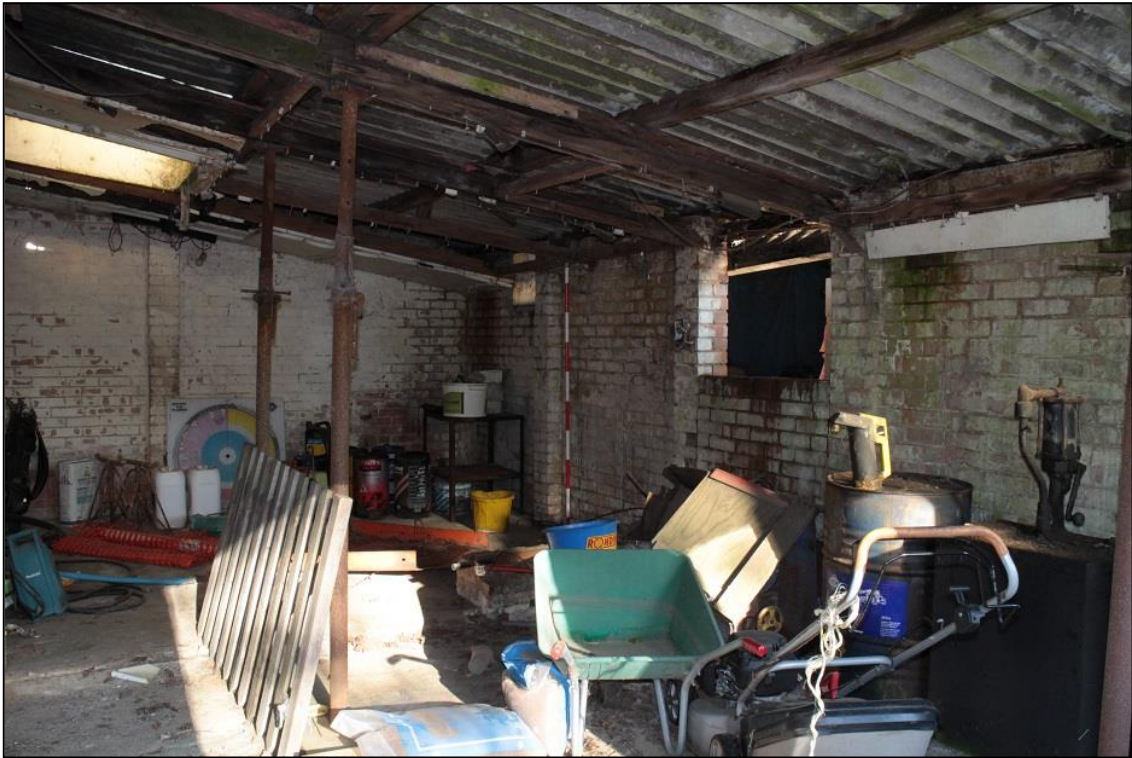
Image 33: Northern lean-to extension (G6), looking north-west

Shows blocked door opening at right (scale 2m)

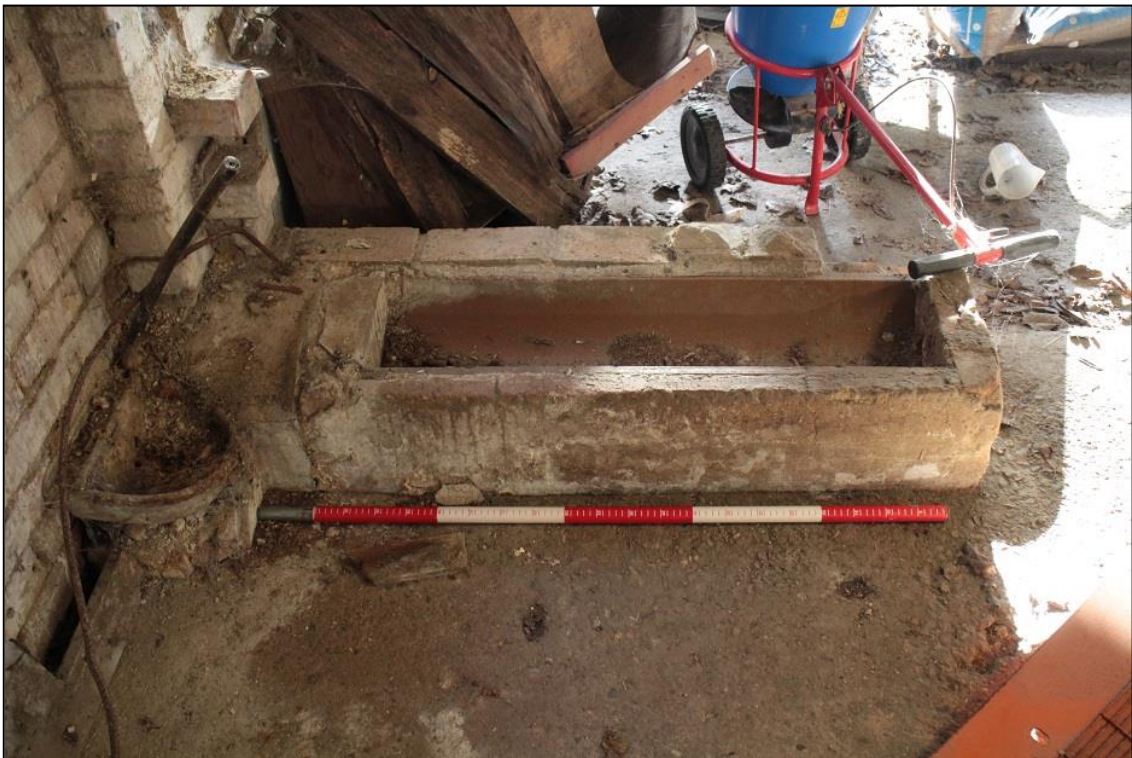
Image 34: Northern lean-to extension (G6), detail of feed trough

Feed trough and water bowl (scale 1m)

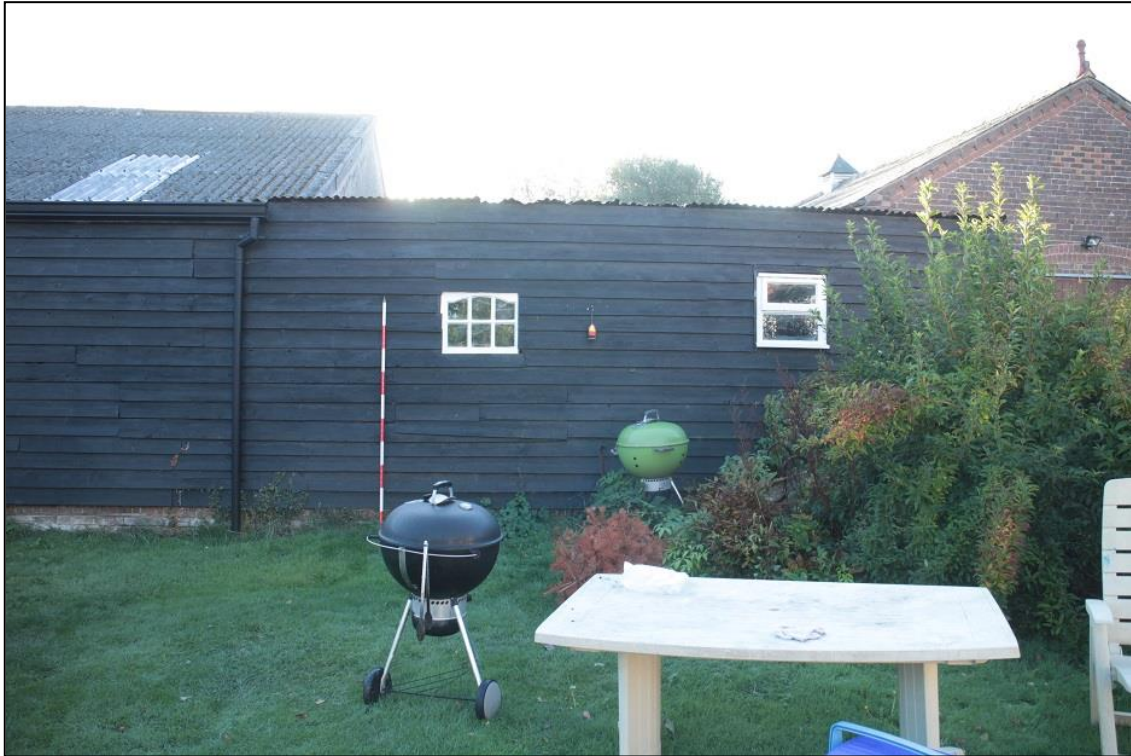
Image 35: Timber-framed compartment (G7), west elevation

West wall of G7 showing modern windows (scale 2m)

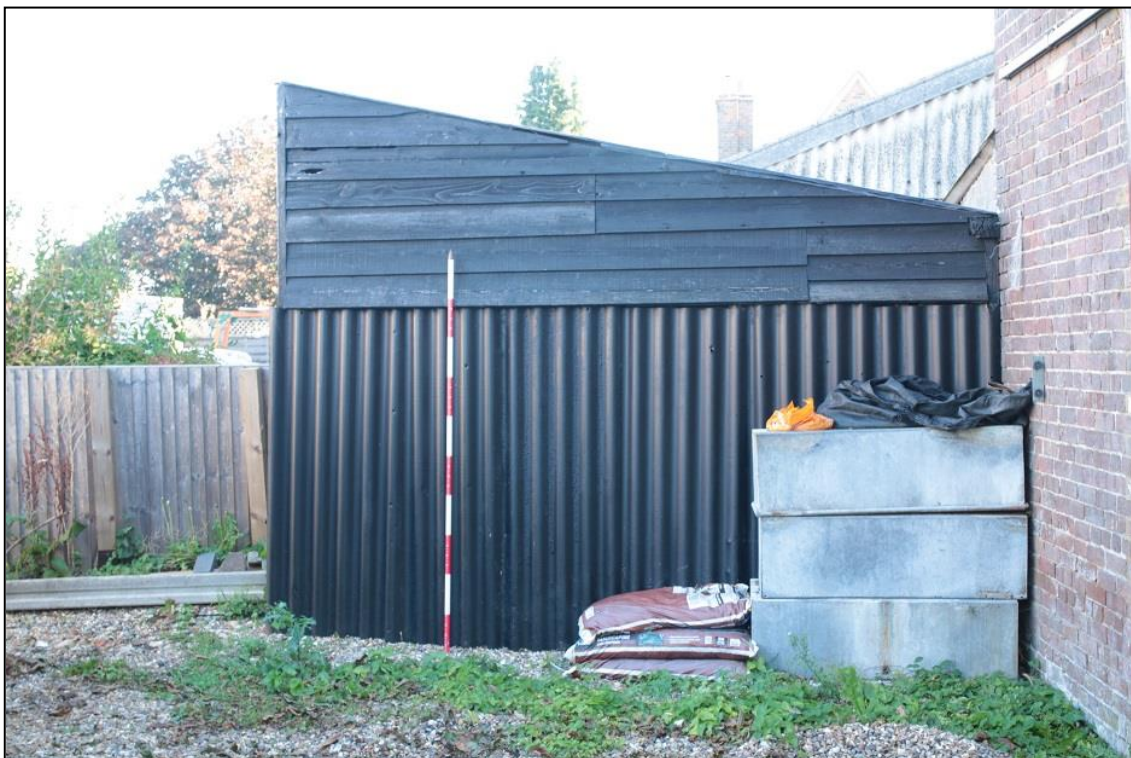
Image 36: Timber-framed compartment (G7), north elevation

Shows mixture of corrugated sheet and weatherboard cladding (scale 2m)

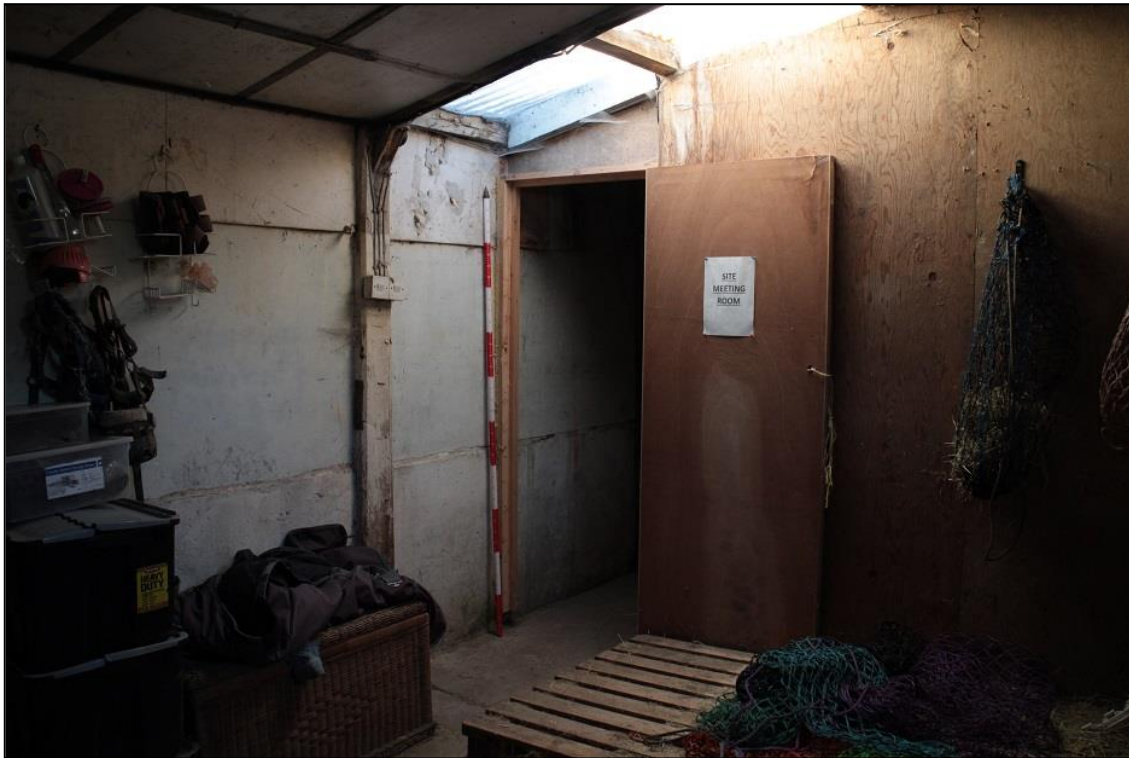
Image 37: Timber-framed compartment (G7), looking north-east

Shows post in east wall at mid-left with concrete lower wall and plywood partition wall at right (scale 2m)

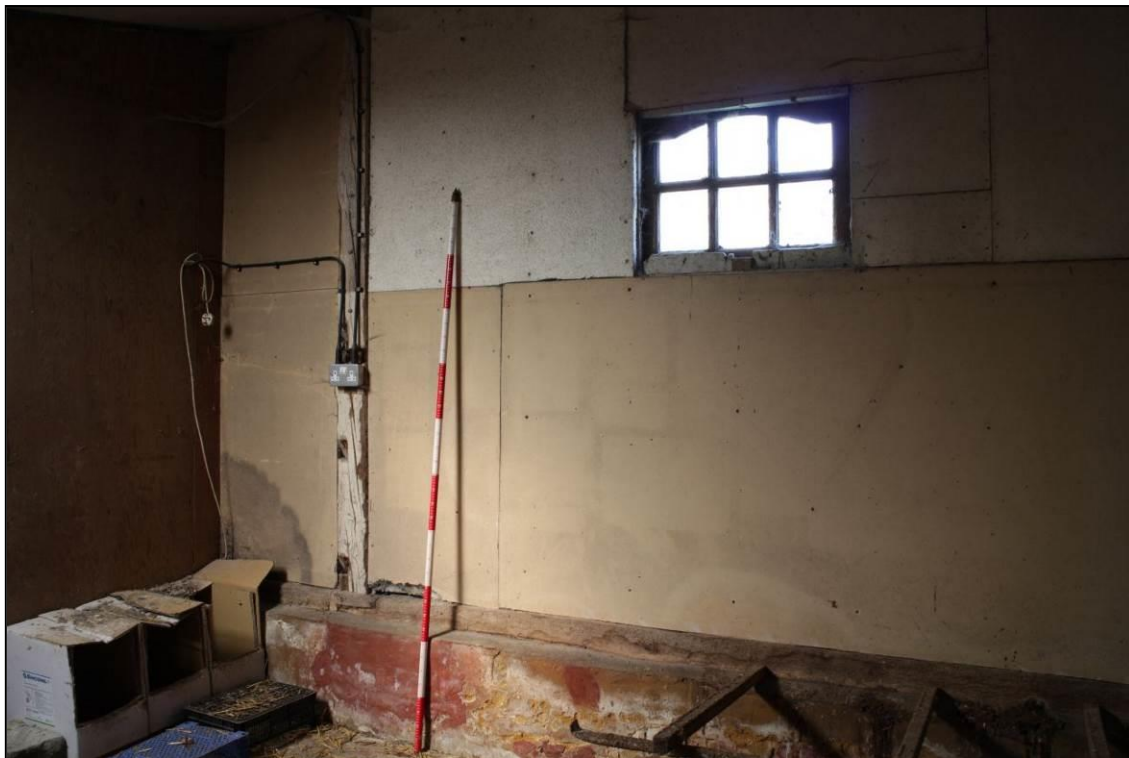
Image 38: Timber-framed compartment (G7), looking north-west

Shows post in west wall and sill beam on low sill wall (scale 2m)

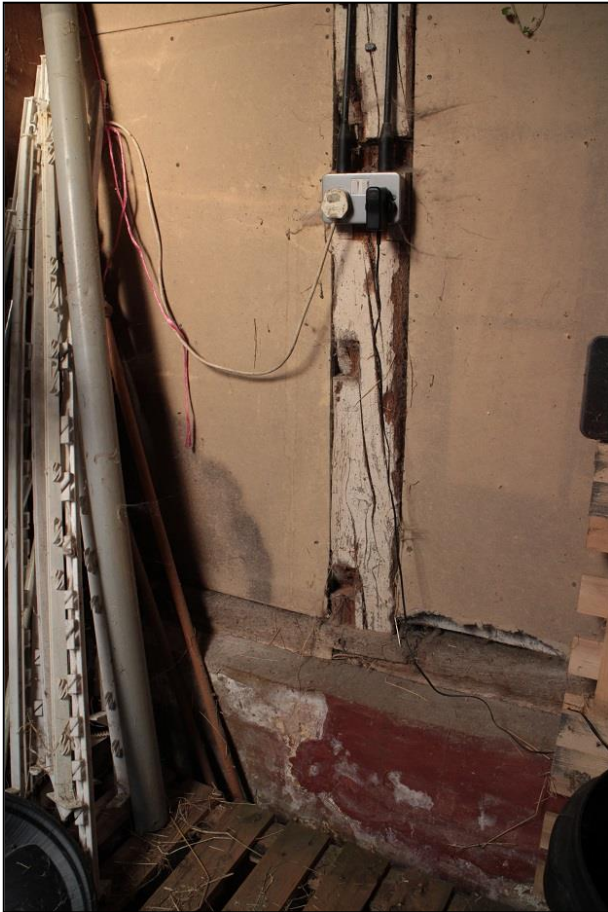
Image 39: Timber-framed compartment (G7), detail of frame

Shows post, sill beam and sill wall in west wall

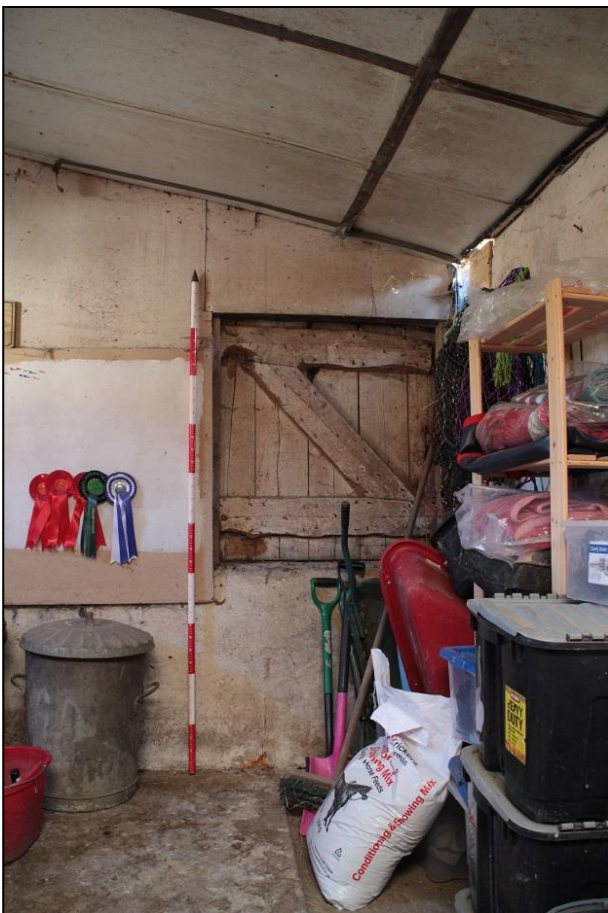
Image 40: Timber-framed compartment (G7), north wall

Looking north, showing hatch in east side of north wall (scale 2m)

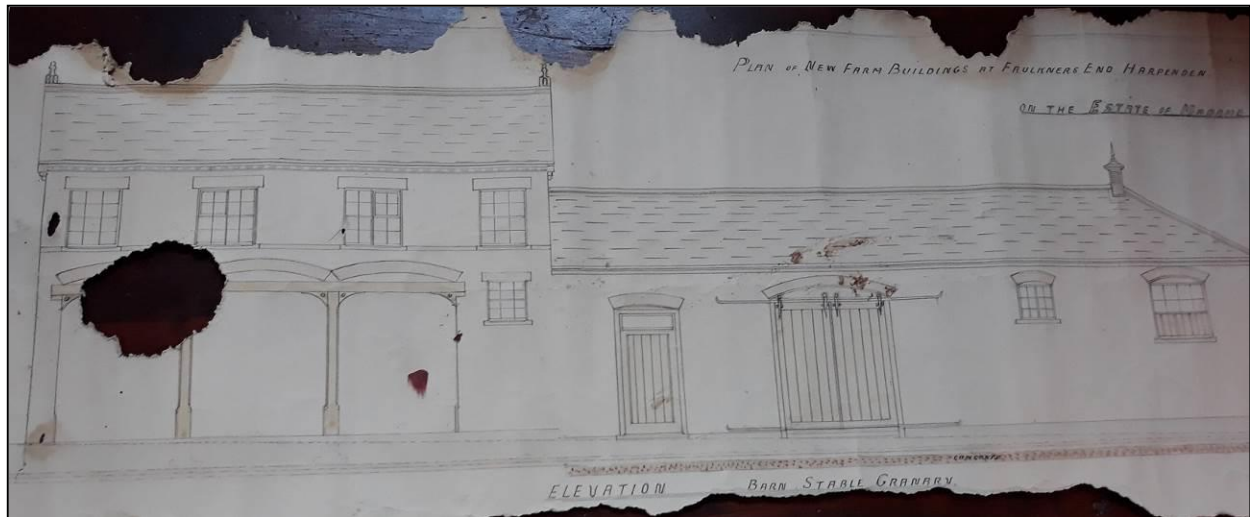
Image 41: Original construction drawing

One of the original construction drawings for the late 19th farm buildings is held by the present owner of the farm (Image 41). The drawing is undated and has been damaged by what appears to be rodent gnawing. The remaining section shows the front (east) elevation of the buildings. It is titled "PLAN of NEW FARM BUILDINGS at FAULKNER'S END HARPENDEN". The elevation is labelled as "BARN STABLE GRANARY". At the left end of the elevation it shows an open-fronted, 3-bay cart shed with the granary above. The middle part of the elevation, the barn, shows a single door, double sliding doors and a small window as they remain today. The right-hand part of the drawing differs from the present arrangement. It shows a single window, glazed in the upper part with a hit-and-miss vent in the lower part, whereas the present arrangement consists of a door with a small window to either side (Image 8). The design appears to have been modified during construction as the existing openings appear to form part of the original construction.

Undated drawing in possession of current owner shows the original design for the east elevation of late 19th century buildings.
