**LAND ADJACENT TO THE MANOR HOUSE
AIRTON
NORTH YORKSHIRE
SD 9021 5919**

ARCHAEOLOGICAL FIELD EVALUATION

Project: AM 1288

Document: 2008/02
Version 1.0

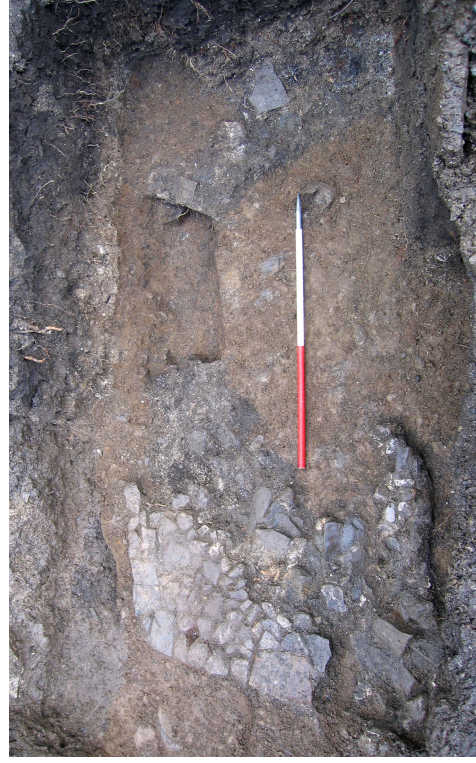
Figure 2: Trench 1 — all features plan

Excavation of Trench 1 revealed the north-western corner of a cobbled surface (13) (Figs 2 and 3). A single skin of squared stones, the largest of which was 220mm x 160mm x 90mm in size, had been placed along the outer edge of the surface, whereas the interior comprised a rough assortment of cobbles of various shapes and sizes. Much of the surface had been eroded or otherwise removed, with cobbles only surviving at or near the very corner.

Part of the cobbled surface had been destroyed by modern feature [16] (Fig. 2), which had been dug through the backfill or levelling layer (15). This curvilinear feature was packed with stones and cobbles, and is most likely to represent the foundation of a garden or retaining wall, up against which the concentration of refuse observed in the topsoil (Section 3.1) was deposited. Pottery recovered from its infill indicates that the wall was constructed no earlier than the late 19th century.

Another feature [18] was observed in the northern extension of the trench. Only a small part of it was revealed, but it had vertical sides, and pottery from its infill suggests it was broadly contemporary with modern wall [16].

Trench 1 features, looking north;
scale 1m

The evaluation revealed the presence of a cobbled surface (13) at the southern edge of the development area (Fig. 2), which had been cut into the hillside. The southern and eastern extent of the surface is unknown, as only the north-western corner was exposed, but it probably once extended along the front of the Manor House, with which it is likely to have been associated. The survival of only the corner of the surface is not surprising, as the corners and edges of such cobbled yards would have suffered least erosion from the movement of people, animals and carts.

The two modern features [16] and [18] appear to have been broadly contemporary, created in the late 19th / early 20th century. Although [16] is most likely to have been a wall foundation, its shape in plan suggests that it was part of a garden wall rather than a building. This is supported by the absence of any buildings shown on Ordnance Survey maps of this date.

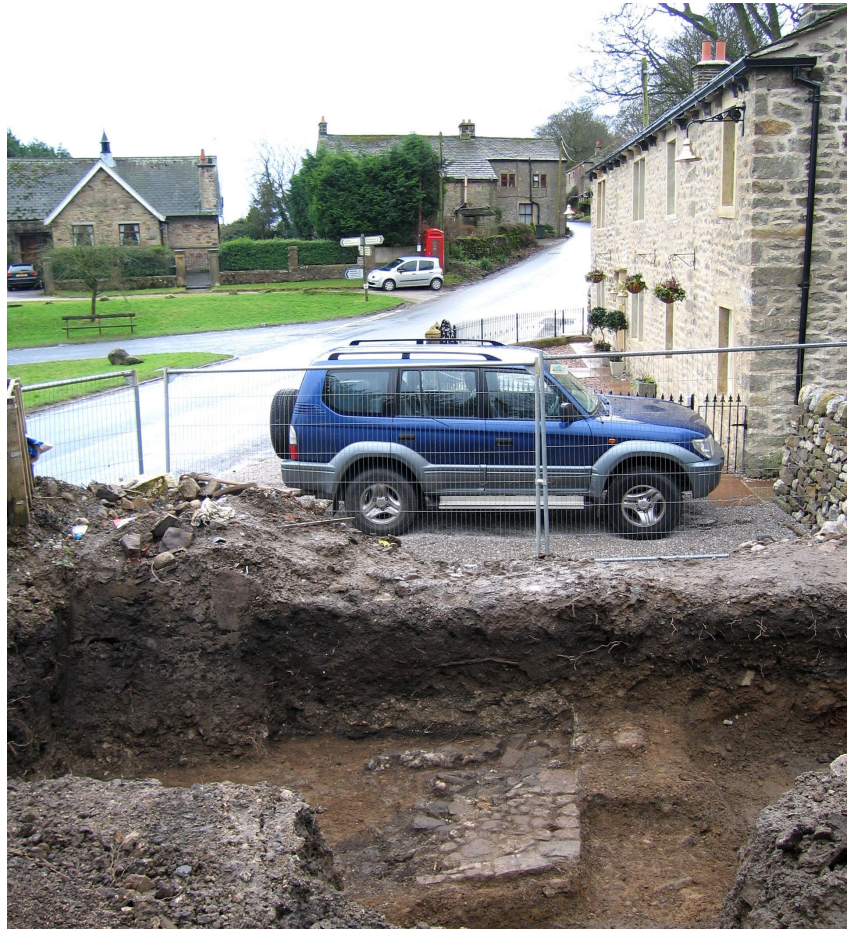
Overlying the cobbles was a thin layer of dark grey silt (14), which contained a high concentration of small fragments of slate. This layer extended beyond the southern and eastern limits of the trench.

Photograph 1: Cobbled surface in Trench 1, looking south

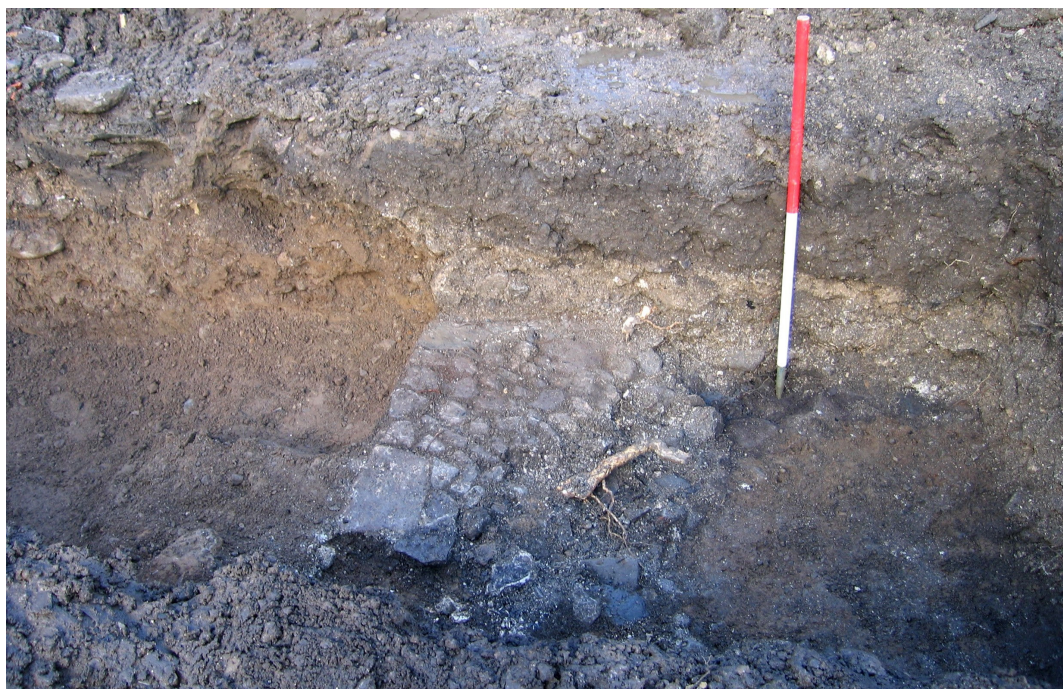
The cobbled surface had been cut into the hillside. Its construction cut [12] was up to 0.3m deep (Fig. 3). The land was subsequently built up again when the cobbled surface was no longer in use; this backfill or levelling layer (15) incorporated a high density of crushed or decayed mortar, and contained thirteen sherds, weighing 1015g, of 18th century pottery.

Photograph 2: Construction cut and cobbled surface in Trench 1, looking north;
Scale 1m

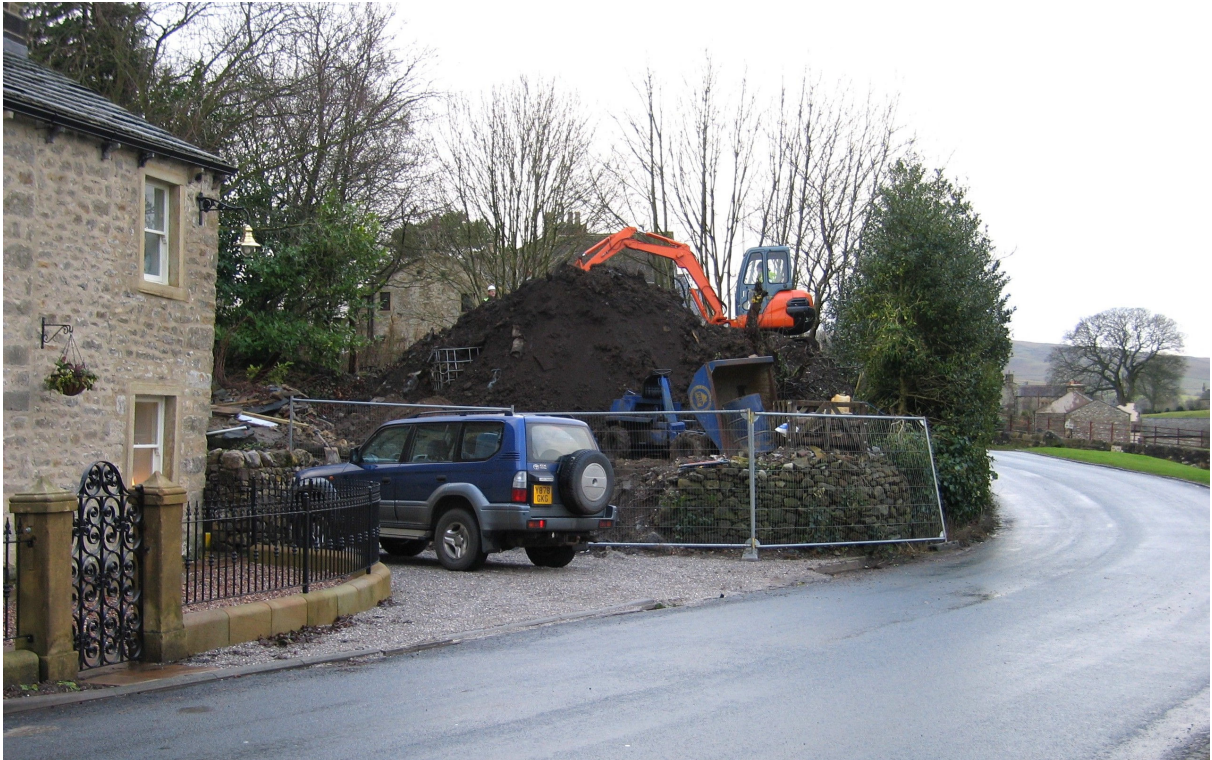
The trenches were opened by a mechanical excavator fitted with a toothless bucket, under close archaeological supervision. Overburden was removed down to the top of the archaeological deposits or undisturbed geological deposits, whichever was encountered first. The spoil heaps were scanned for artefacts.

Photograph 3: Machining of Trench 2

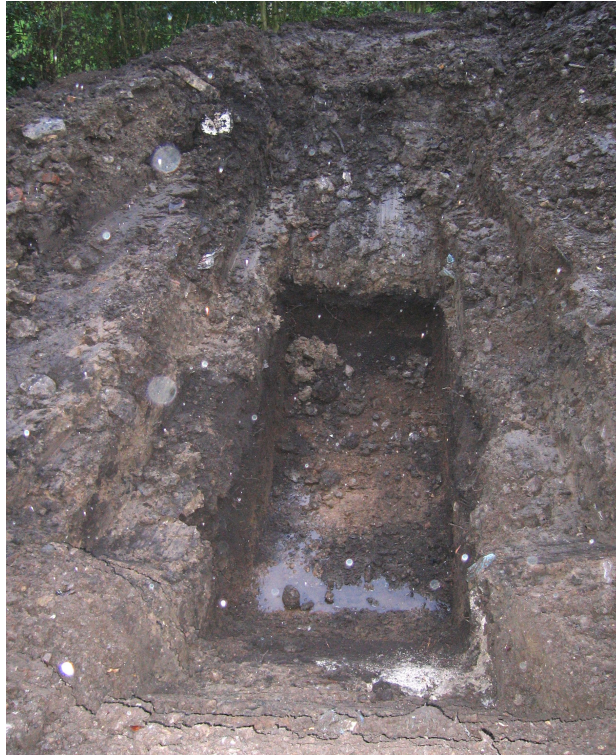
No deposits or features of archaeological significance were revealed in Trench 2. Substantial modern disturbance was evident at the western end of the trench, cutting through both the subsoil (21) and topsoil (20), which are described above (Section 3.1).

Photograph 4: Trench 2, looking east. Trench 1.5m wide
